CERTAIN 2006 AND 2007 MODEL YEAR EXPLORER, MOUNTAINEER, AND SPORT TRAC VEHICLES - TRANSMISSION GEARSHIFT LEVER PARK DETECT SWITCH

OVERVIEW

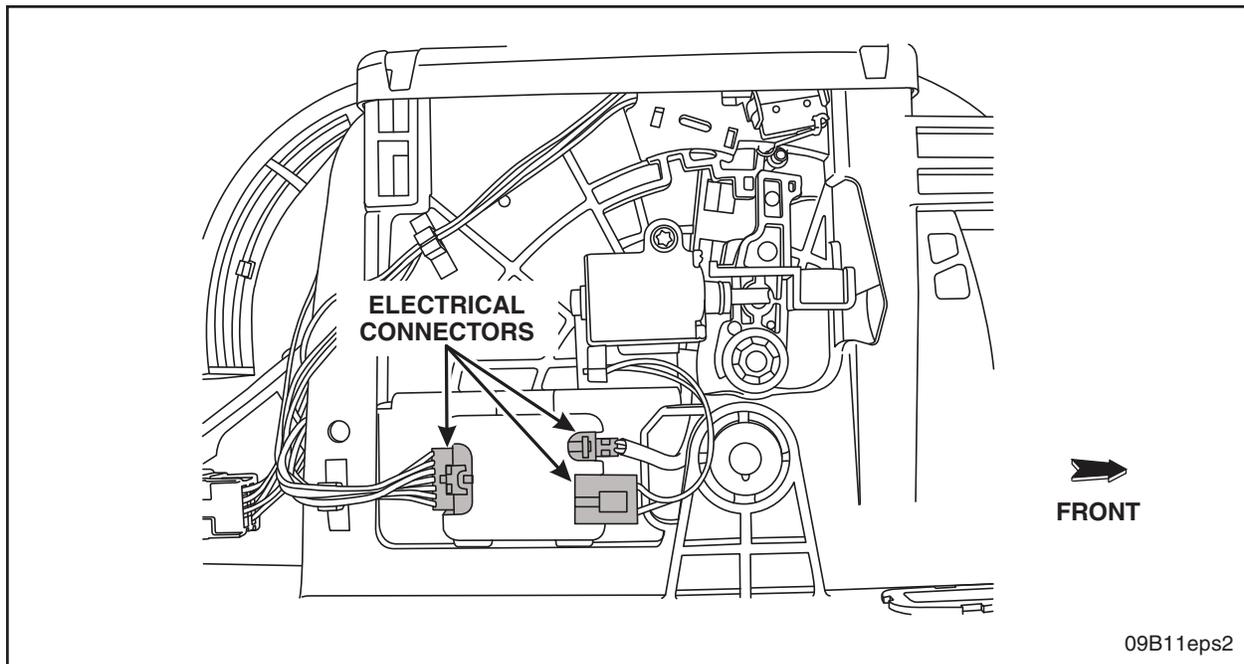
FIGURE 1

In some of the affected vehicles, the transmission gearshift lever may not move out of the park position even when the brake pedal is depressed. This "stuck in park" condition can develop due to silicon dioxide contamination building up on the contacts of the park detect switch located on the transmission gearshift lever.

Disconnect the three electrical connectors from the white circuit board that is located on the lower RH section of the transmission gearshift lever. See Figure 1.
