FORD:

2001-2009 Escape
2005-2009 Escape Hybrid

MERCURY:

2005-2009 Mariner
2006-2009 Mariner Hybrid

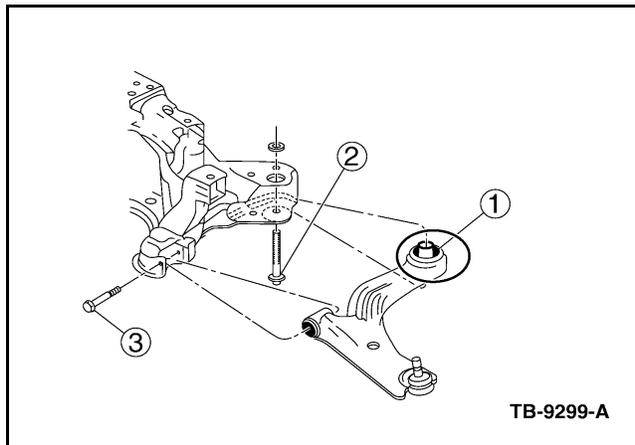
Figure 1 - Article 09-5-1

The LCA bushing is located at the rear of the front suspension lower control arm. The bushing is identified as number 1 of Figure 1. The control arm is mounted in the front subframe with bolts number 2 and number 3. The bushing is part of the LCA and cannot be serviced separately from the arm.

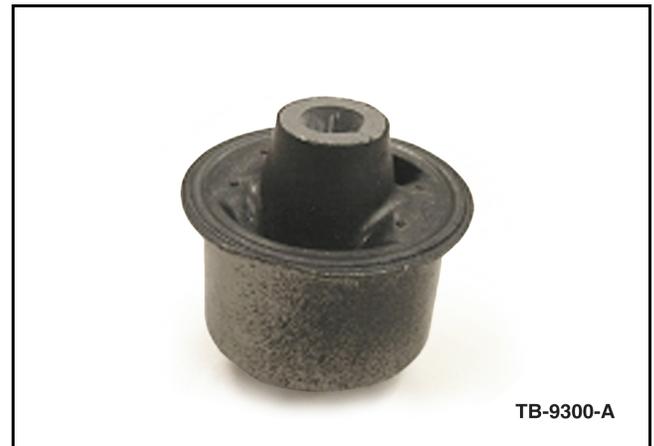
Figure 2 - Article 09-5-1

Figure 2 - Shows a new bushing prior to assembly into the control arm. Bolt number 2 passes through the inner sleeve and the outer sleeve is pressed into the control arm. The rubber bushing is bonded to both the inner and outer sleeves.

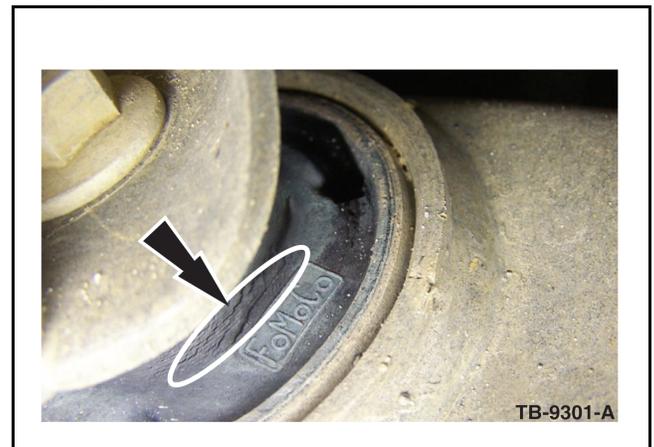
Figure 3 - Article 09-5-1

Figure 3 - Illustrates a generic bushing showing minor surface cracks that do not adversely affect the performance of the bushing. Bushings exhibiting surface cracks with a depth less than 3/8" (10 mm) are acceptable and will continue to function normally. These do not require replacement.

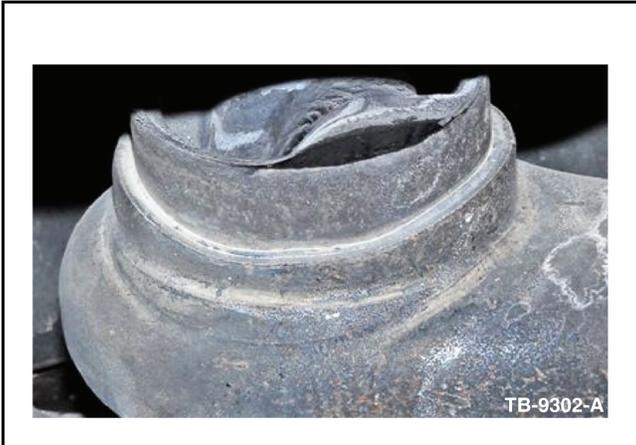
Figure 4 - Article 09-5-1

Figure 4 - Illustrates a partial separation between the rubber and the outer sleeve. The bushing may show signs of movement on the rubber surface, making the surface shiny. Bushings with a separation or crack depth less than or equal to 3/8" (10 mm) are acceptable and meet all functional requirements. These do not require replacement.

Bushings with a separation or crack greater than 3/8" (10 mm) in depth should be replaced. The customer may hear a bang or clunk in the front suspension if there is enough separation for the arm to contact the subframe. This does not affect the retention of the control arm to the vehicle as the bushing is sandwiched in the subframe and held in place with the bolt. The vehicle can be safely operated in this condition until the bushing is replaced.
