STRUCTURAL CONDITION ASSESSMENT

**BOYD THEATER
1910 CHESTNUT STREET
PHILADELPHIA, PA.**

STRUCTURAL CONDITION ASSESSMENT
BOYD THEATRE
PHILADELPHIA, PA

06 SEPTEMBER, 2013

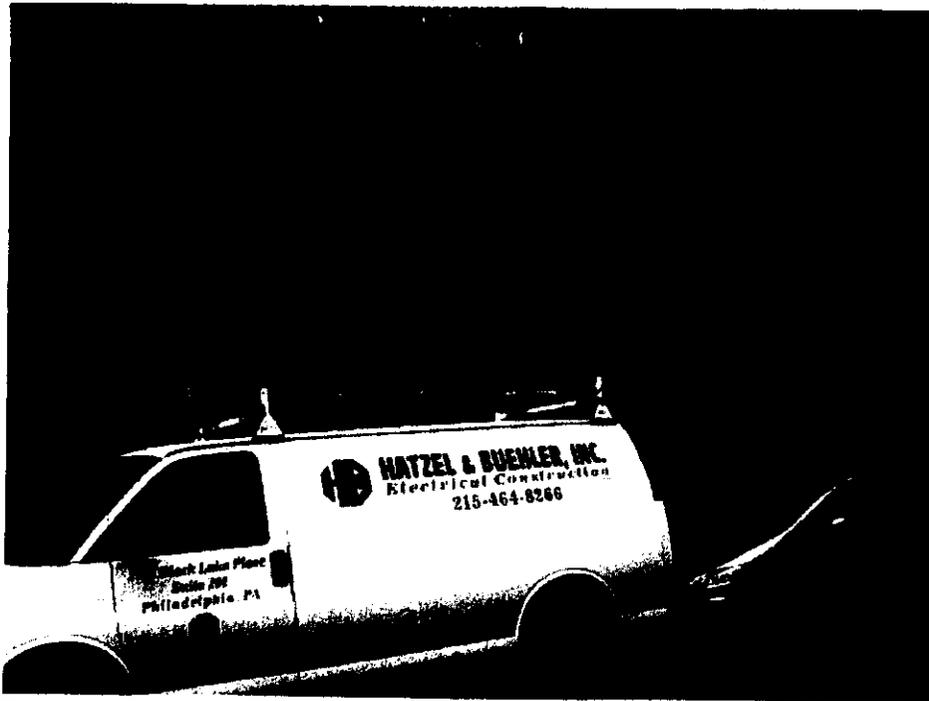
Vertical cracks were observed at approximately 15 feet on center in the south wall. Vertical cracks near the roof were observed at the north and south ends of that wall (Photos 22, 27 & 30). Biological growth was observed below the scuppers and below the exit stairs (photographs 24, 27 & 29). Deterioration of the brick was observed at several locations – primarily below scuppers, below the exit stairs and at street

Photograph 29 – Cracked, stained and deteriorated brick on south wall (Sansom Street)
