Feasibility Study
of the
Royal Theater
for
Universal Companies

January 17, 2007

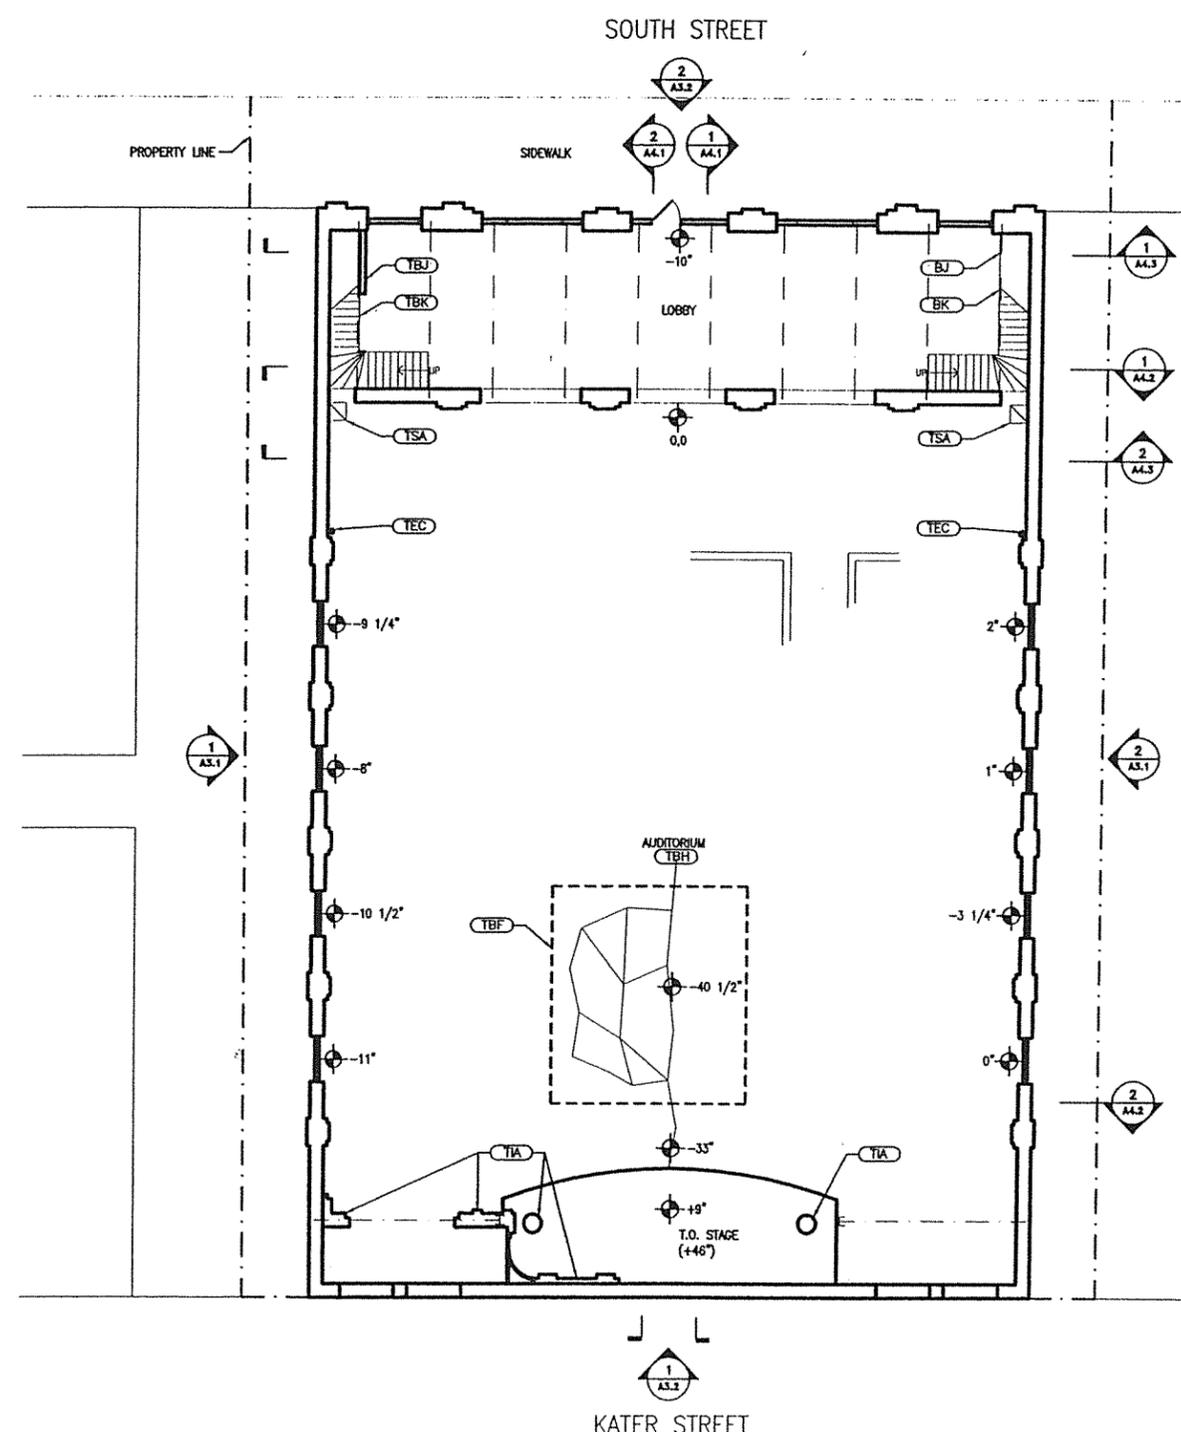
2 FIRST FLOOR PLAN
SCALE: 1" = 20'-0"

A sinkhole was observed at the slab on grade at the theater floor near the stage. This portion of the existing slab on grade has settled significantly.

- (TBA) INSTALL TEMPORARY SHORING FOR DAMAGED CAUSED BY FIRE.
- (TBB) REMOVE DAMAGED CONCRETE. INSTALL TEMPORARY WOOD SHORING TO STABILIZE WALL.
- (TBE) REBUILD TRUSS BEARING PLATES WITH MASONRY.

- (TBF) GEOTECHNICAL INVESTIGATION REQUIRED TO DETERMINE TREATMENT OF SLAB. INSTALL PLYWOOD BARRIERS AROUND DAMAGED SLAB.
- (TBG) REMOVE ALL PLANT GROWTH. REMOVE THE TOP 30 COURSES OF BRICK AND REBUILD WALL WITH NEW BRICK TO MATCH EXISTING IN COLOR, SIZE, AND TEXTURE FOR FULL LENGTH OF AUDITORIUM WALL.

- (TBH) SOUND CONCRETE SLAB.
- (TBI) DISMANTLE AND REBUILD CHIMNEY WITH BRICK TO MATCH EXISTING IN COLOR, SIZE, AND TEXTURE.
- (TBJ) DISMANTLE DETERIORATED WALL.

- INTEGRITY OF BUILDING ENVELOPE**
- (TEA) INSTALL NEW EPDM ROOF.
- (TEB) REMOVE ALL PLANT GROWTH AND DEBRIS FROM GUTTERS. LINE WITH NEW MEMBRANE.
- (TEC) CLEAN AND REPAIR EXISTING RAINWATER CONDUCTORS DOWN TO CITY STORM WATER SYSTEM. TEST RAINWATER CONDUCTORS FOR WATER-TIGHTNESS AFTER CLEANING.

- (TED) REPORT WITH HISTORIC MORTARS.
- (TEE) REPLACE/RECONSTRUCT BRICK WALL.
- (TEF) INSTALL WOOD FRAMING AND PAINTED PLYWOOD IN MASONRY OPENING.
- (TEG) REMOVE PLANT GROWTH; ROOTS, VINES, ETC. AREA SHOWN SHADED:

- (TEH) SECURE EXISTING PLYWOOD IN OPENING. ELIMINATE ANY GAPS BETWEEN PLYWOOD AND MASONRY OPENING.
- (TEJ) REPAIR CRACK WITH NEW BRICK AND REINFORCE WALL.

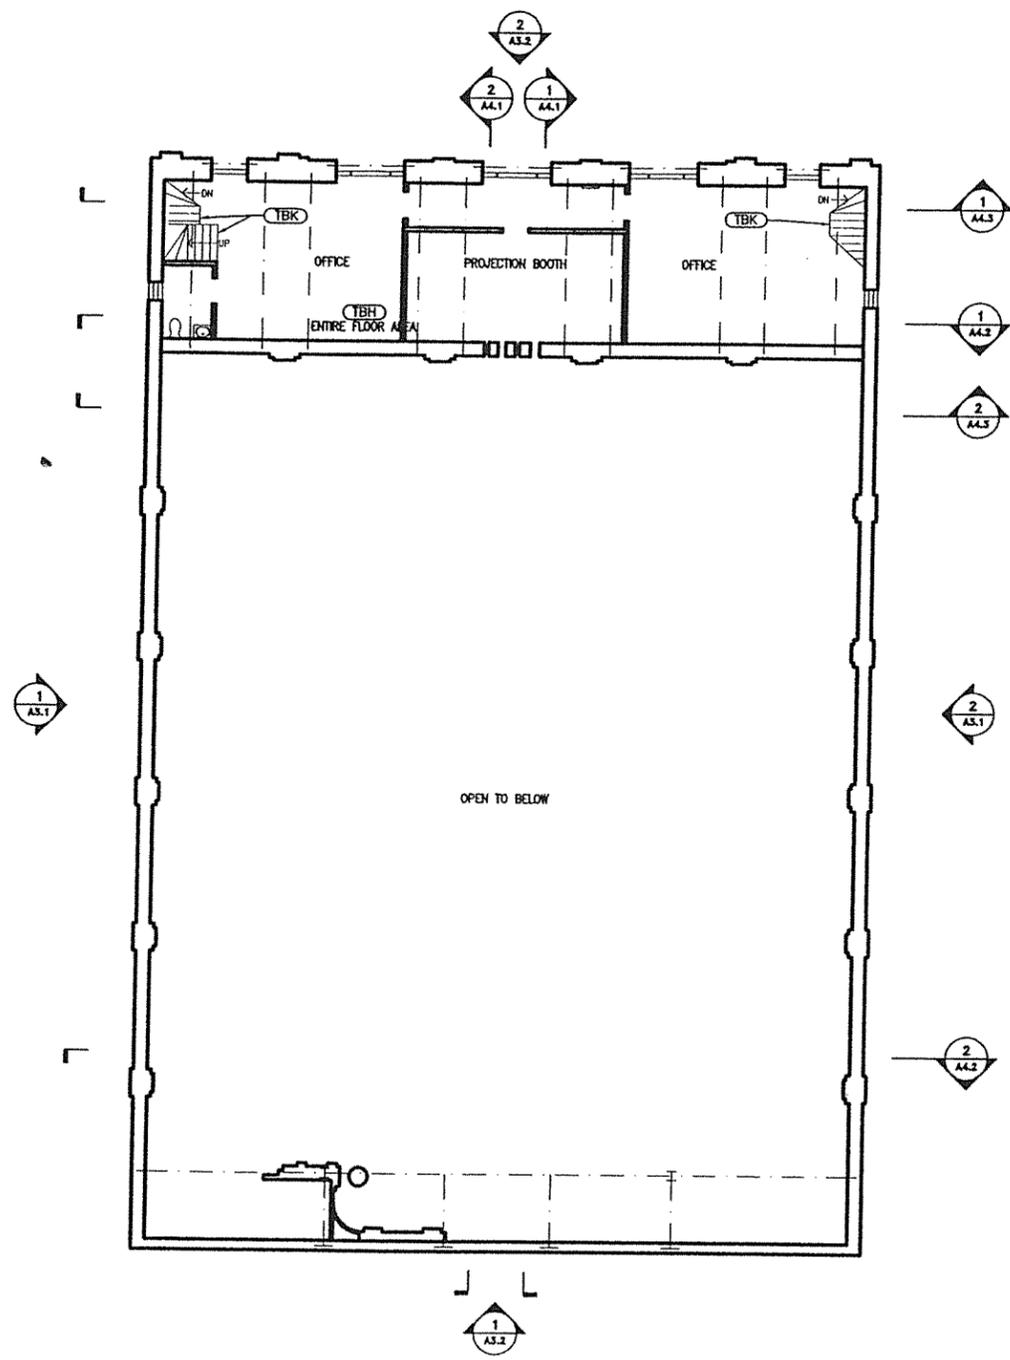
1 SECOND FLOOR PLAN
SCALE: 1" = 20'-0"

Due to an apparent existing fire on the floor levels above the lobby, the existing wood framing at the roof has experienced significant deterioration and distress. The wood framing will need to be removed and replaced with a new structure.

- (TBA) INSTALL TEMPORARY SHORING FOR DAMAGED CAUSED BY FIRE.
- (TBB) REMOVE DAMAGED CONCRETE. INSTALL TEMPORARY WOOD SHORING TO STABILIZE WALL.
- (TBE) REBUILD TRUSS BEARING PLATES WITH MASONRY.

- (TBF) GEOTECHNICAL INVESTIGATION REQUIRED TO DETERMINE TREATMENT OF SLAB. INSTALL PLYWOOD BARRIERS AROUND DAMAGED SLAB.
- (TBD) REMOVE ALL PLANT GROWTH. REMOVE THE TOP 30 COURSES OF BRICK AND REBUILD WALL WITH NEW BRICK TO MATCH EXISTING IN COLOR, SIZE, AND TEXTURE FOR FULL LENGTH OF AUDITORIUM WALL.

- (TBI) SOUND CONCRETE SLAB.
- (TBI) DISMANTLE AND REBUILD CHIMNEY WITH BRICK TO MATCH EXISTING IN COLOR, SIZE, AND TEXTURE.
- (TBJ) DISMANTLE DETERIORATED WALL.

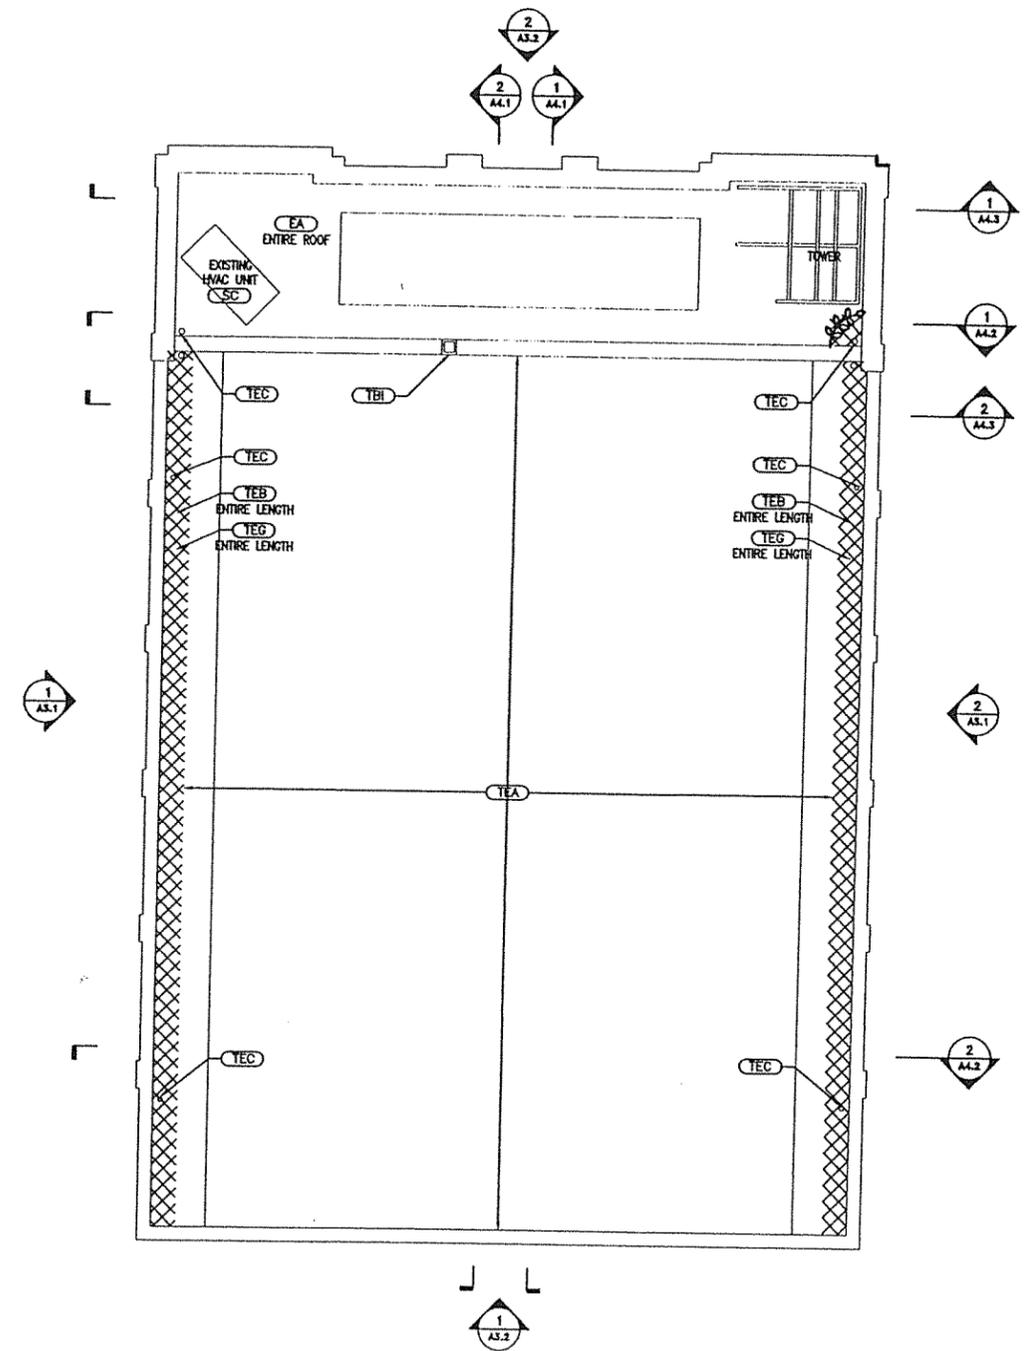
1 ROOF PLAN
SCALE: 1" = 20'-0"

The roof membrane over the Auditorium is missing on over half of the concrete slab. The trees and debris in the gutters are so extensive that the gutters are not working. The terra cotta coping tiles appear to be in good condition with only a few tiles that are cracked or missing.

There is an existing chimney on the roof that is in very poor condition and will need immediate attention.

- (TBA) INSTALL TEMPORARY SHORING FOR DAMAGED CAUSED BY FIRE.
- (TBB) REMOVE DAMAGED CONCRETE. INSTALL TEMPORARY WOOD SHORING TO STABILIZE WALL.
- (TBE) REBUILD TRUSS BEARING PLATES WITH MASONRY.
- (TBF) GEOTECHNICAL INVESTIGATION REQUIRED TO DETERMINE TREATMENT OF SLAB. INSTALL PLYWOOD BARRIERS AROUND DAMAGED SLAB.
- (TBG) REMOVE ALL PLANT GROWTH. REMOVE THE TOP 30 COURSES OF BRICK AND REBUILD WALL WITH NEW BRICK TO MATCH EXISTING IN COLOR, SIZE, AND TEXTURE FOR FULL LENGTH OF AUDITORIUM WALL.
- (TBH) SOUND CONCRETE SLAB.
- (TBI) DISMANTLE AND REBUILD CHIMNEY WITH BRICK TO MATCH EXISTING IN COLOR, SIZE, AND TEXTURE.
- (TBJ) DISMANTLE DETERIORATED WALL.
- (TBK) REMOVE ALL DEBRIS AND SOUND CONCRETE STAIRS.
- G REMOVE GRAFFITI.
- (TBL) REMOVE TREES. DISMANTLE AND RECONSTRUCT BRICK WALL FOR THE FULL DEPTH AND WIDTH.

- (TEA) INSTALL NEW EPDM ROOF.
- (TEB) REMOVE ALL PLANT GROWTH AND DEBRIS FROM GUTTERS. LINE WITH NEW MEMBRANE.
- (TEC) CLEAN AND REPAIR EXISTING RAINWATER CONDUCTORS DOWN TO CITY STORM WATER SYSTEM. TEST RAINWATER CONDUCTORS FOR WATERIGHTNESS AFTER CLEANING.
- (TED) REPOINT WITH HISTORIC MORTARS.
- (TEE) REPLACE/RECONSTRUCT BRICK WALL.
- (TEF) INSTALL WOOD FRAMING AND PAINTED PLYWOOD IN MASONRY OPENING.
- (TEG) REMOVE PLANT GROWTH; ROOTS, VINES, ETC. AREA SHOWN SHADED:

- (TEH) SECURE EXISTING PLYWOOD IN OPENING. ELEMIMATE ANY GAPS BETWEEN PLYWOOD AND MASONRY OPENING.
- (TEJ) REPAIR CRACK WITH NEW BRICK AND REINFORCE WALL.

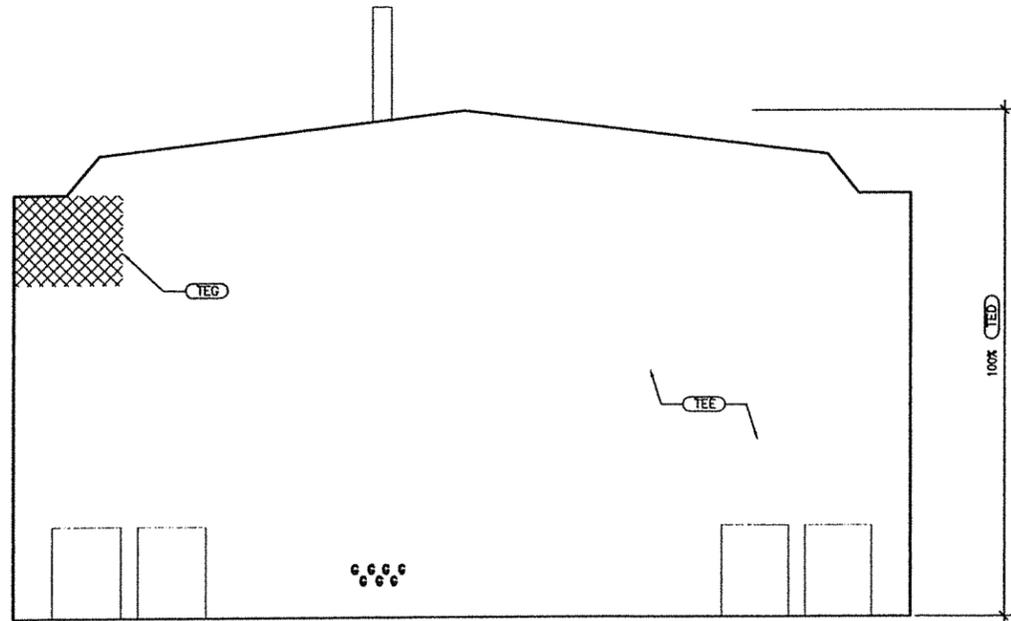
1 SOUTH ELEVATION
SCALE: 1/16" = 1'-0"

The rear wall along Kater Street is also missing mortar from the joints and there are areas where the brick is missing. The four openings from the theater have all been infilled with concrete block and sections of the wall along the southeast and southwest corners have received a cementitious coating and some sections of the masonry wall have been painted.

- (TBA) INSTALL TEMPORARY SHORING FOR DAMAGED CAUSED BY FIRE.
- (TBB) REMOVE DAMAGED CONCRETE. INSTALL TEMPORARY WOOD SHORING TO STABILIZE WALL.
- (TBE) REBUILD TRUSS BEARING PLATES WITH MASONRY.
- (TBF) GEOTECHNICAL INVESTIGATION REQUIRED TO DETERMINE TREATMENT OF SLAB. INSTALL PLYWOOD BARRIERS AROUND DAMAGED SLAB.
- (TBG) REMOVE ALL PLANT GROWTH. REMOVE THE TOP 30 COURSES OF BRICK AND REBUILD WALL WITH NEW BRICK TO MATCH EXISTING IN COLOR, SIZE, AND TEXTURE FOR FULL LENGTH OF AUDITORIUM WALL.
- (TBH) SOUND CONCRETE SLAB.
- (TBI) DISMANTLE AND REBUILD CHIMNEY WITH BRICK TO MATCH EXISTING IN COLOR, SIZE, AND TEXTURE.
- (TBJ) DISMANTLE DETERIORATED WALL.
- (TBK) REMOVE ALL DEBRIS AND SOUND CONCRETE STAIRS.
- G REMOVE GRAFFITI.

- (TEA) INSTALL NEW EPDM ROOF.
- (TEB) REMOVE ALL PLANT GROWTH AND DEBRIS FROM GUTTERS. LINE WITH NEW MEMBRANE.
- (TEC) CLEAN AND REPAIR EXISTING RAINWATER CONDUCTORS DOWN TO CITY STORM WATER SYSTEM. TEST RAINWATER CONDUCTORS FOR WATERIGHTNESS AFTER CLEANING.
- (TED) REPOINT WITH HISTORIC MORTARS.
- (TEE) REPLACE/RECONSTRUCT BRICK WALL.
- (TEF) INSTALL WOOD FRAMING AND PAINTED PLYWOOD IN MASONRY OPENING.
- (TEG) REMOVE PLANT GROWTH; ROOTS, VINES, ETC. AREA SHOWN SHADED:

- (TEH) SECURE EXISTING PLYWOOD IN OPENING. ELIMINATE ANY GAPS BETWEEN PLYWOOD AND MASONRY OPENING.
- (TEJ) REPAIR CRACK WITH NEW BRICK AND REINFORCE WALL.

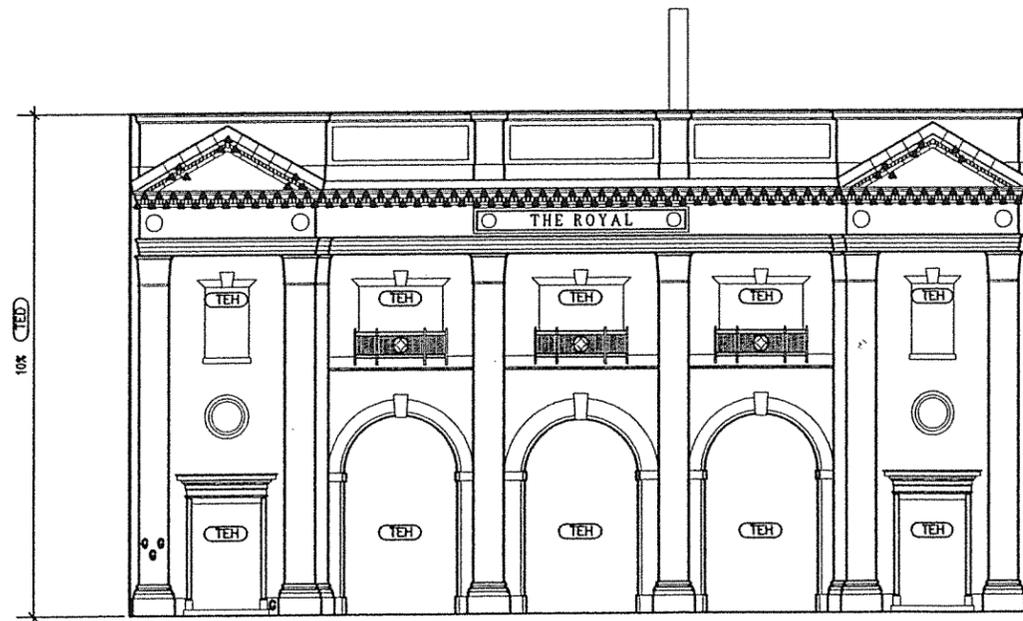
2 NORTH ELEVATION
SCALE: 1/16" = 1'-0"

The exterior of the building is in good condition along South Street and fair condition on the other three elevations. The masonry wall along South Street has been repointed and the majority of the terra cotta appears to be in good condition with the exception of the lower eight feet of terra cotta pilasters that were painted. The terra cotta cornice is discolored but appears to be in good condition, the iron balconies also appear to be in good condition. The side and rear masonry are missing a majority of the mortar and there are areas where the face brick is missing. The top sections of the brick walls are covered with invasive vegetation that grows from the inside of the building out through the gutter and brick wall and over the top of the parapet walls. There are also smaller vines and plants that are causing damage to the masonry wall. The door openings located in the east and west walls have been secured with unpainted plywood.

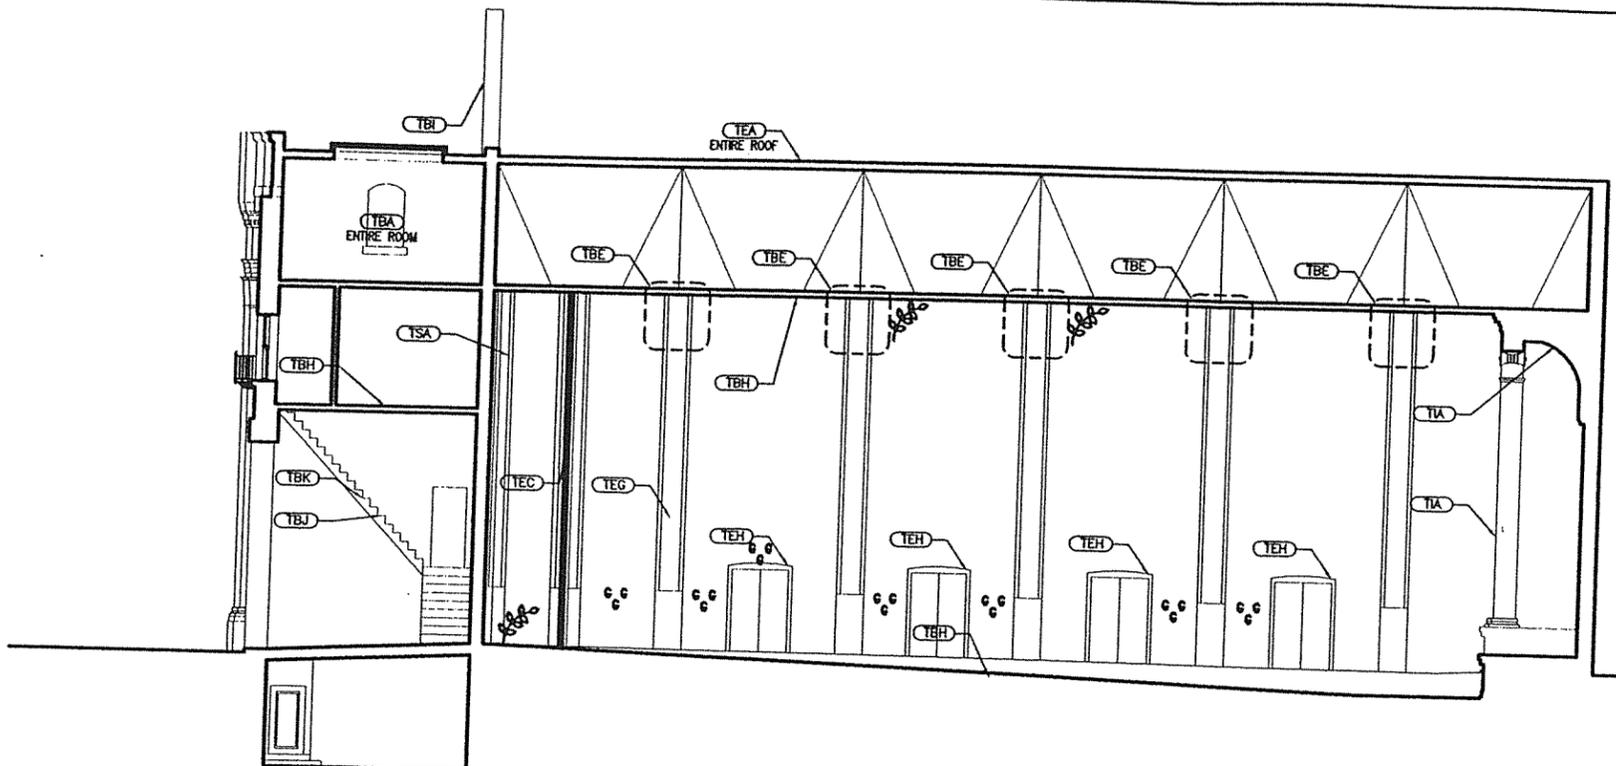
1 LONGITUDINAL SECTION LOOKING EAST
SCALE: 1/16" = 1'-0"

With the exception of the front wall, the remainder of the exterior walls shows significant signs of deterioration and distress, particularly the top 9 feet of the east and west walls.

- BUILDING TREATMENTS:**
- (TBA) INSTALL TEMPORARY SHORING FOR DAMAGED CAUSED BY FIRE.
 - (TBB) REMOVE DAMAGED CONCRETE. INSTALL TEMPORARY WOOD SHORING TO STABILIZE WALL.
 - (TBE) REBUILD TRUSS BEARING PLATES WITH MASONRY.
 - (TBF) GEOTECHNICAL INVESTIGATION REQUIRED TO DETERMINE TREATMENT OF SLAB. INSTALL PLYWOOD BARRIERS AROUND DAMAGED SLAB.
 - (TBG) REMOVE ALL PLANT GROWTH. REMOVE THE TOP 30 COURSES OF BRICK AND REBUILD WALL WITH NEW BRICK TO MATCH EXISTING IN COLOR, SIZE, AND TEXTURE FOR FULL LENGTH OF AUDITORIUM WALL.
 - (TBH) SOUND CONCRETE SLAB.
 - (TBI) DISMANTLE AND REBUILD CHIMNEY WITH BRICK TO MATCH EXISTING IN COLOR, SIZE, AND TEXTURE.
 - (TBJ) DISMANTLE DETERIORATED WALL.
 - (TBK) REMOVE ALL DEBRIS AND SOUND CONCRETE STAIRS.
 - G REMOVE GRAFFITI.
 - (TBL) REMOVE TREES. DISMANTLE AND RECONSTRUCT BRICK WALL FOR THE FULL DEPTH AND WIDTH.

- (TEA) INSTALL NEW EPDM ROOF.
- (TEB) REMOVE ALL PLANT GROWTH AND DEBRIS FROM GUTTERS. LINE WITH NEW MEMBRANE.
- (TEC) CLEAN AND REPAIR EXISTING RAINWATER CONDUCTORS DOWN TO CITY STORM WATER SYSTEM. TEST RAINWATER CONDUCTORS FOR WATER TIGHTNESS AFTER CLEANING.
- (TED) REPOINT WITH HISTORIC MORTARS.
- (TEE) REPLACE/RECONSTRUCT BRICK WALL.
- (TEF) INSTALL WOOD FRAMING AND PAINTED PLYWOOD IN MASONRY OPENING.
- (TEG) REMOVE PLANT GROWTH; ROOTS, VINES, ETC. AREA SHOWN SHADED:

- (TEH) SECURE EXISTING PLYWOOD IN OPENING. ELIMINATE ANY GAPS BETWEEN PLYWOOD AND MASONRY OPENING.
- (TEJ) REPAIR CRACK WITH NEW BRICK AND REINFORCE WALL.
