**Existing Structural Condition Report by Keast & Hood Structural Engineers**

**Structural and Masonry Evaluation Report  
1920 Sansom Street  
Philadelphia, PA 19103**

*Existing Conditions and  
Recommendations for Repairs  
October 12, 2015*

## 1920 SANSOM - GARAGE / FUNERAL PARLOR

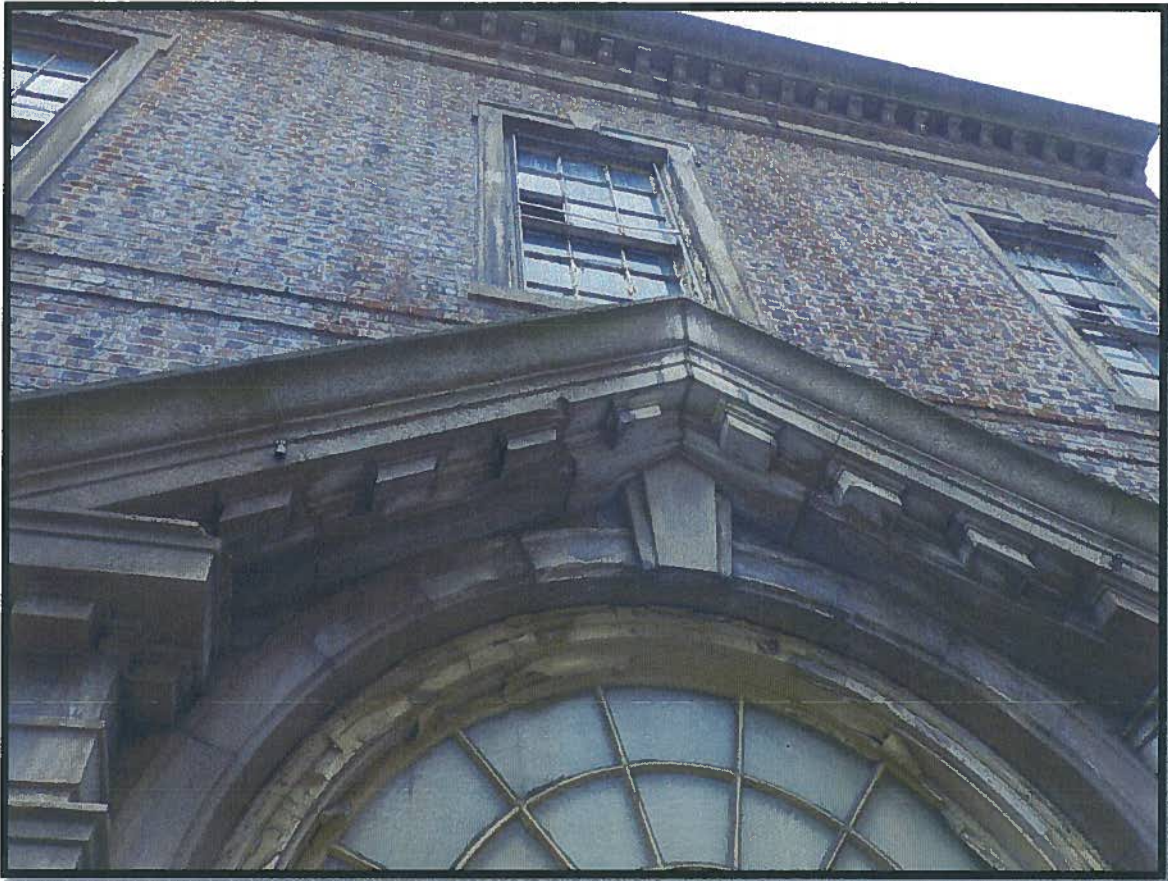
A tremendous volume of water permeation over many years left extensive salt deposits and damaged embedded wood elements such as window frames.

- Multiple passes on the front façade will be necessary to clean the stone and draw out some of the crystalized salt deposits embedded in the brick. However, because most of the back-up (interior) brick has been so weakened by freeze-thaw cycles, it is recommended that the entire front wall be reconstructed

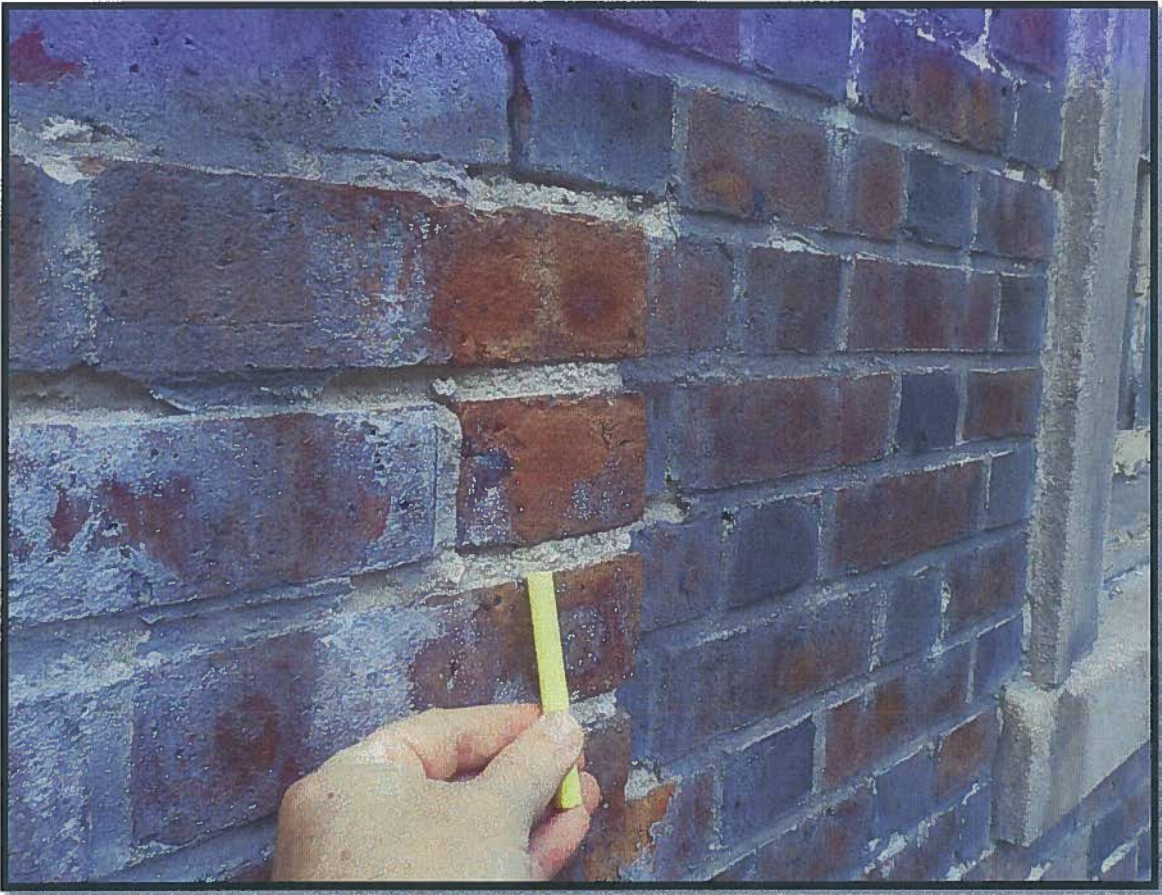
The water migration has washed out the calcium and caused the mortar to turn to powder due to freeze-thaw cycles.

- After the masonry is sufficiently dried out so as to not trap moisture in the core of the walls, all exterior and interior faces of the masonry would have to be re-pointed; and in the case of the west wall, the application of the stucco would follow if it is needed

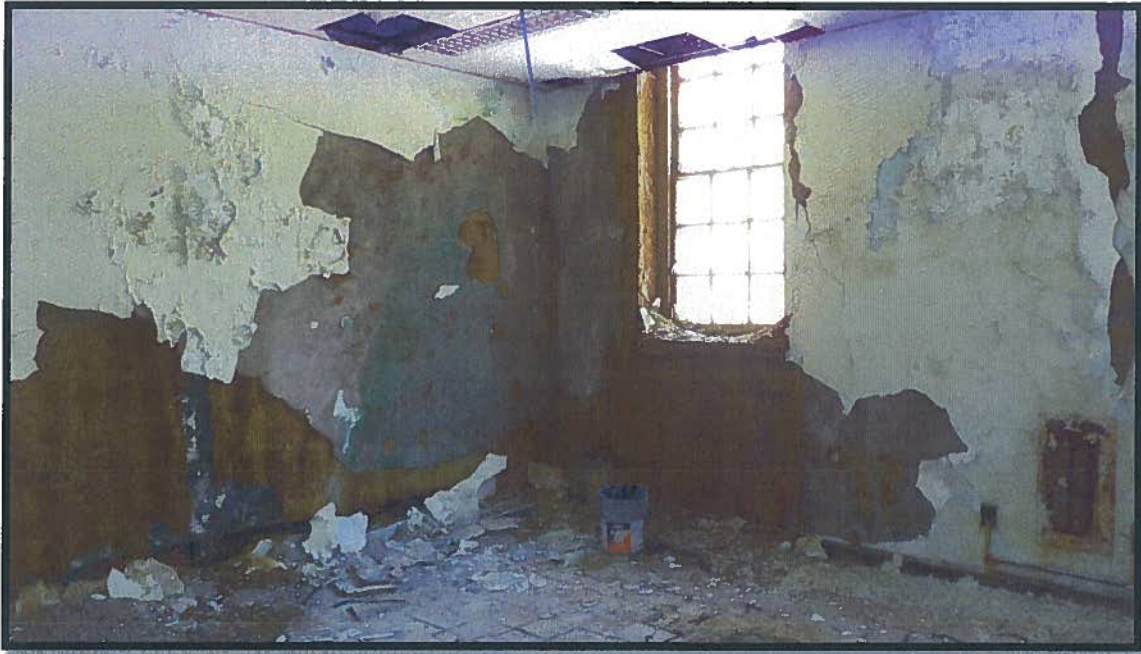
Condition of the wire mesh that supported the plaster on the second floor. Behind this, the salmon brick is saturated. Many bricks are crumbling from freeze-thaw cycles and must be replaced, or the wall rebuilt.

- Remove (and eventually replace; see below) the stucco on the outside face of the west wall
- In some areas of the side and rear walls the inside wythes of brick should be cut out and replaced due to excessive freeze-thaw degradation
