**Exhibit I**

**Existing Mechanical, Electrical, Plumbing, and Fire Protection Conditions Report by  
Edwards & Zuck Consulting Engineers**

## **1920 SANSOM MEP/FP Existing Building Narrative**

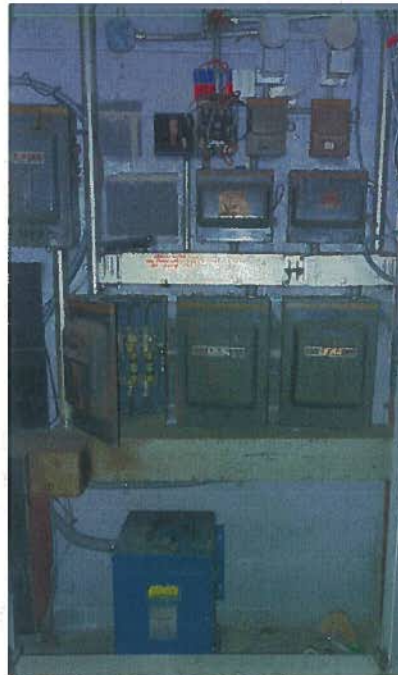
- a) The existing electrical service box is located in an electrical closet in the back of the existing building. The existing building has a 225 amp, 120/208v, 3-phase, 4-wire service. The house meter and associated electrical distribution is located in the closet adjacent to the service entrance and meter.
- b) The existing service meter and end box appeared to be in suitable condition. All electrical distribution downstream of the service box and meter should be disconnect and removed, as it has outlived its useful life.
- c) The existing service appears to have inadequate capacity for all of the options outlined in the proposed building narrative and should be re-configured as required for the proposed layout.

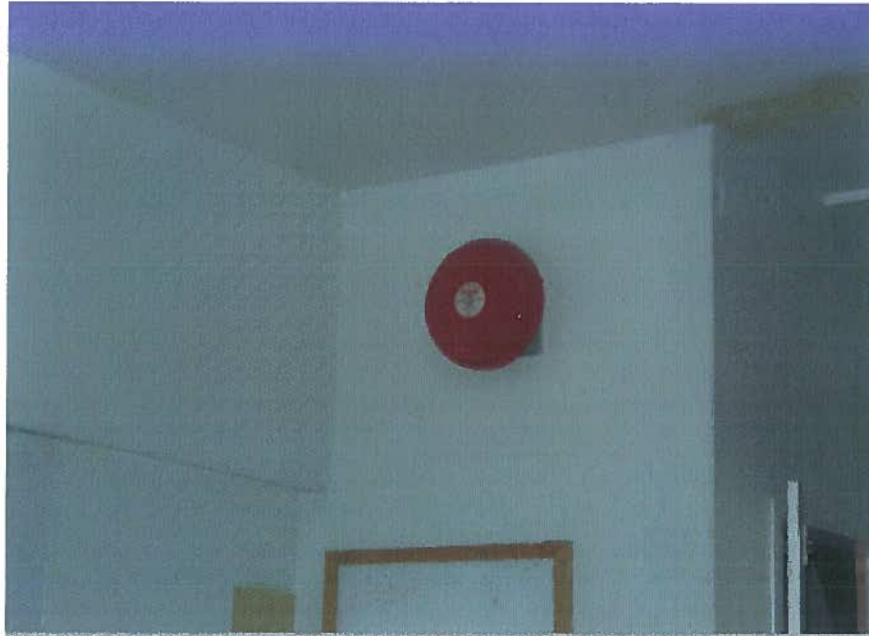
- a) A localized fire alarm system was observed in the building. The system consists of the following devices: manual initiation devices, audio notification devices.
- b) The system appears to be non-addressable and is obsolete. E&Z Recommends for the existing system to be removed/ replaced.
