**Structural Assessment for Reuse Scenarios by The Harman Group Structural Engineers**

**1918-20 SANSOM STREET  
"OLIVER H. BAIR FUNERAL HOME"  
STRUCTURAL RE-USE EVALUATION**

**16 OCTOBER, 2015**

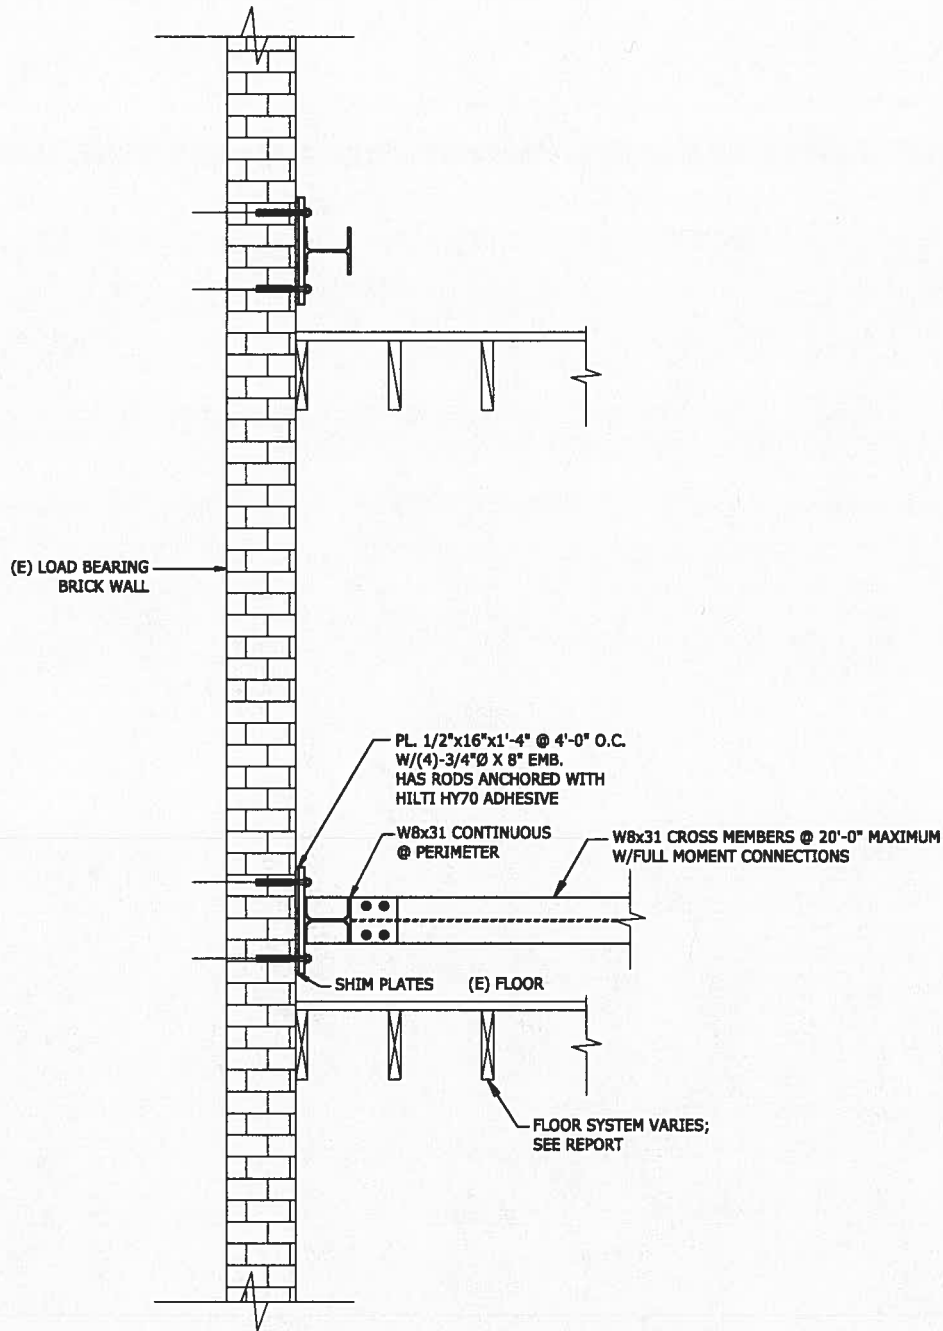
**1** TEMPORARY STABILIZATION

See attached CSKS-01 for main building structure stabilization requirements. Due to the nature of demolition and new construction activity within the existing space, other non-structural elements may require stabilization. See Keast and Hood report for further information. Sketch CSKS-01 shows installation of a perimeter ring of structural steel cinched to the exterior walls at (4) feet on center with intermediate full-width bracing members. These members are to be completely installed prior to any demolition occurring.
