Exhibit C

Photographs by George E. Thomas of Civic Visions LP

1904 Sansom Street
Photos August 2015

Warwick Apartments, 1906-16 Sansom Street

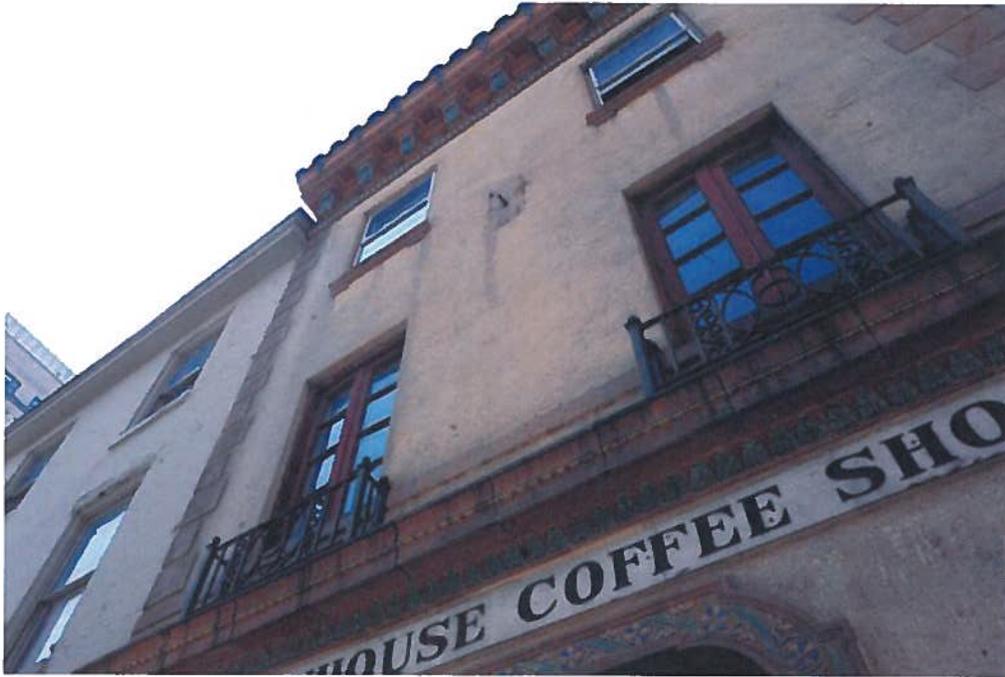
Sansom Street façade looking up, dark staining at joints of terra cotta blocks may indicate water damage to hangers; original 1923 balcony railings; evidence of removed sign in middle of wall above second floor windows' 1923 cornice at top. (August 2015)

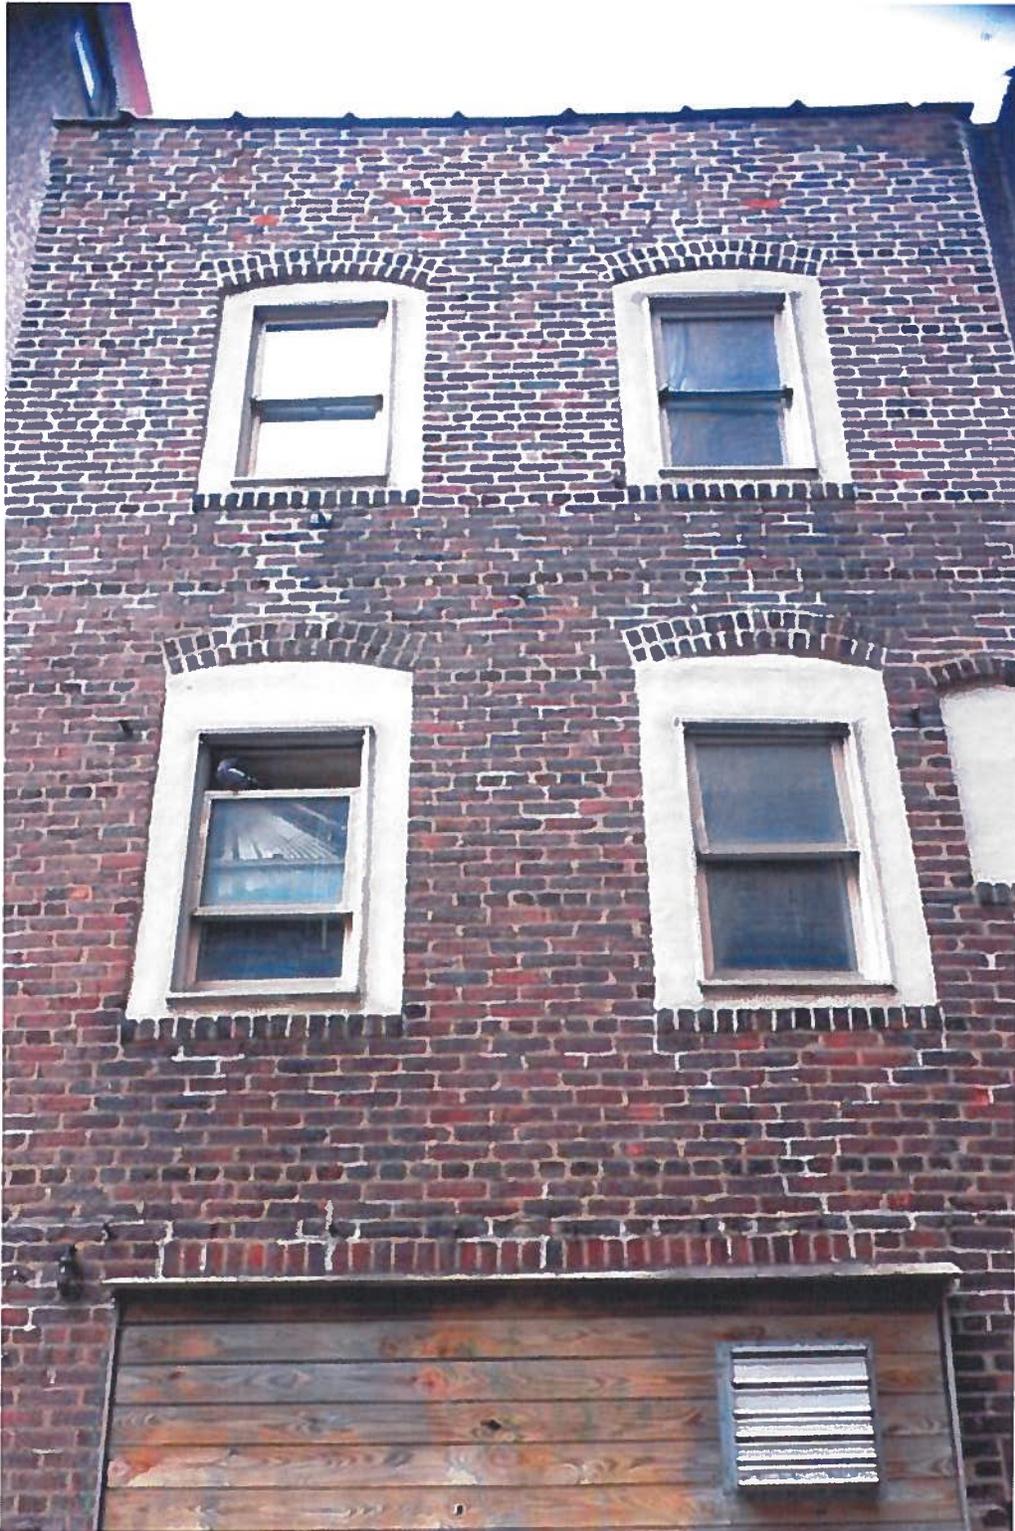
1904 Sansom Street rear wall facing Moravian Street; 1920s brickwork; industrial windows openings, windows removed and infilled with smaller sash; repointing in same manner and using the same mix as on the Warwick (August 2015)

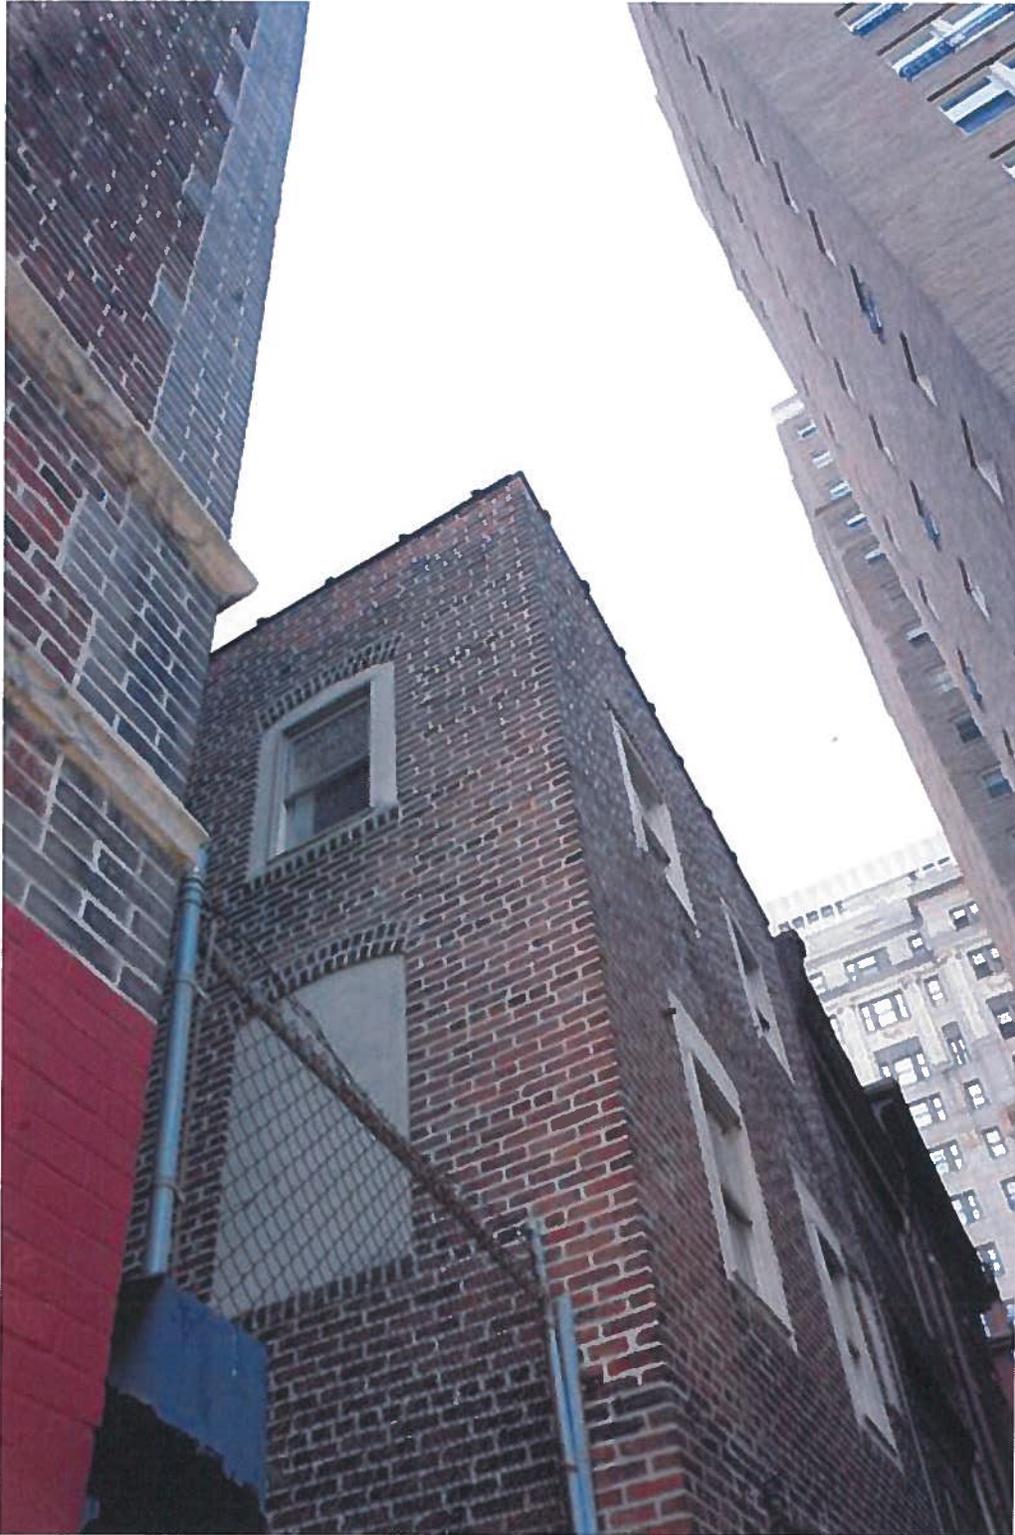
1904 Sansom, oblique view of Moravian Street façade, 1923 addition, period brickwork; period industrial window openings and sills, infilled with modern replacement sash; terra cotta wall copings; most of façade pointing repaired similar to work on the Warwick (August 2015)

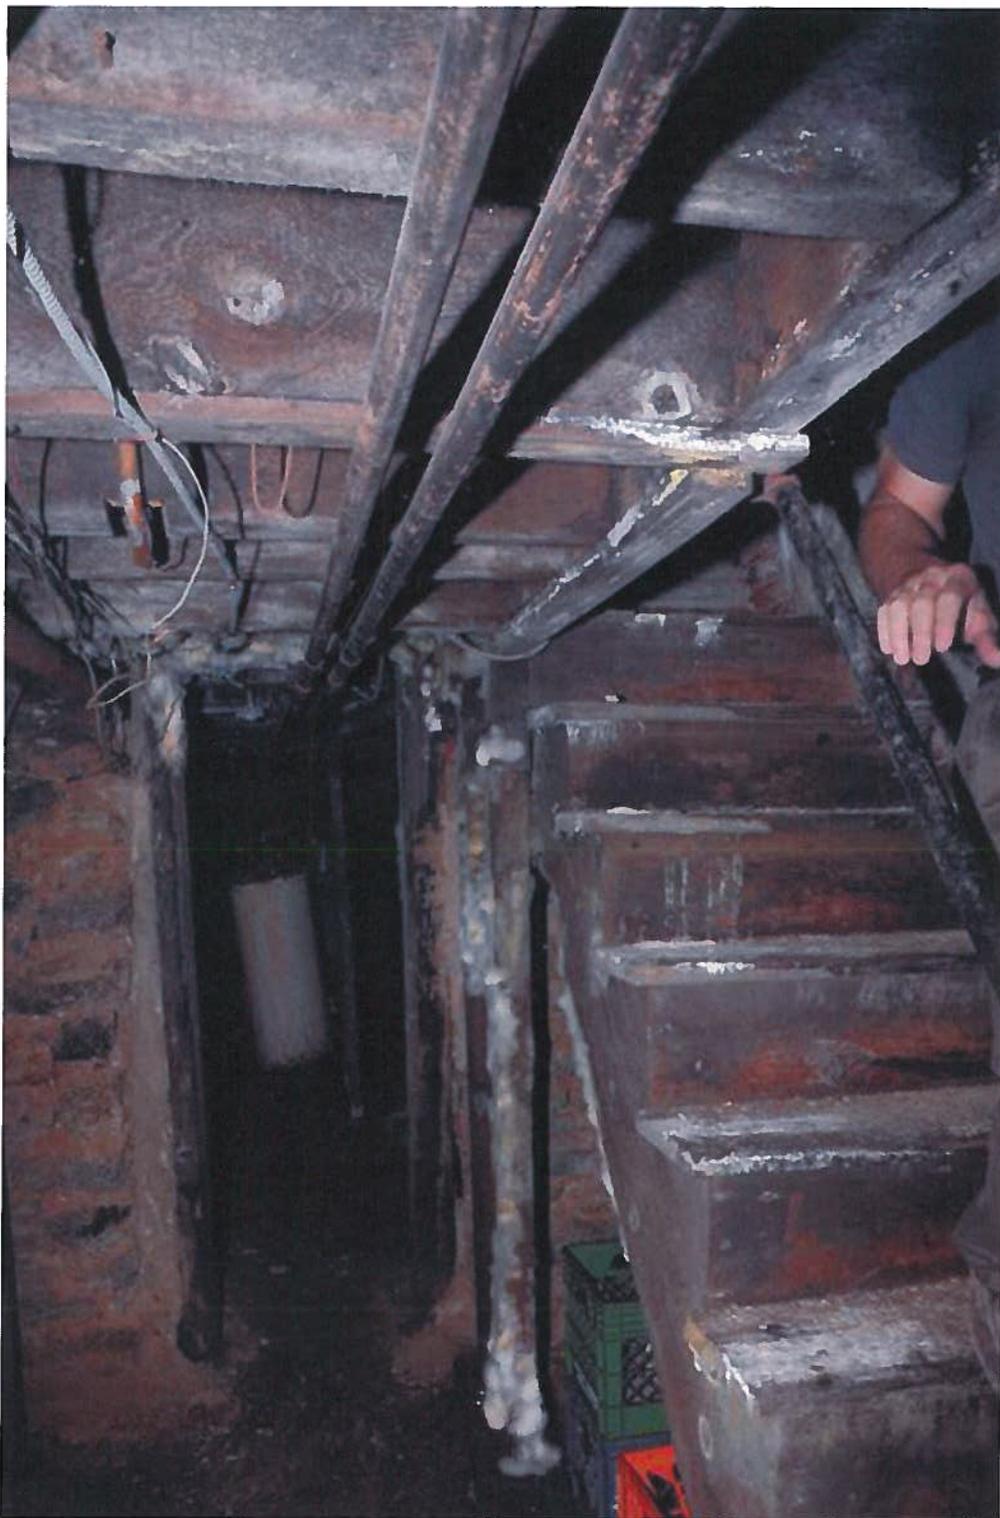
1904 Sansom Street, white mold explosions covering saturated wood; extensive water damage to basement walls and structure (August 2015)

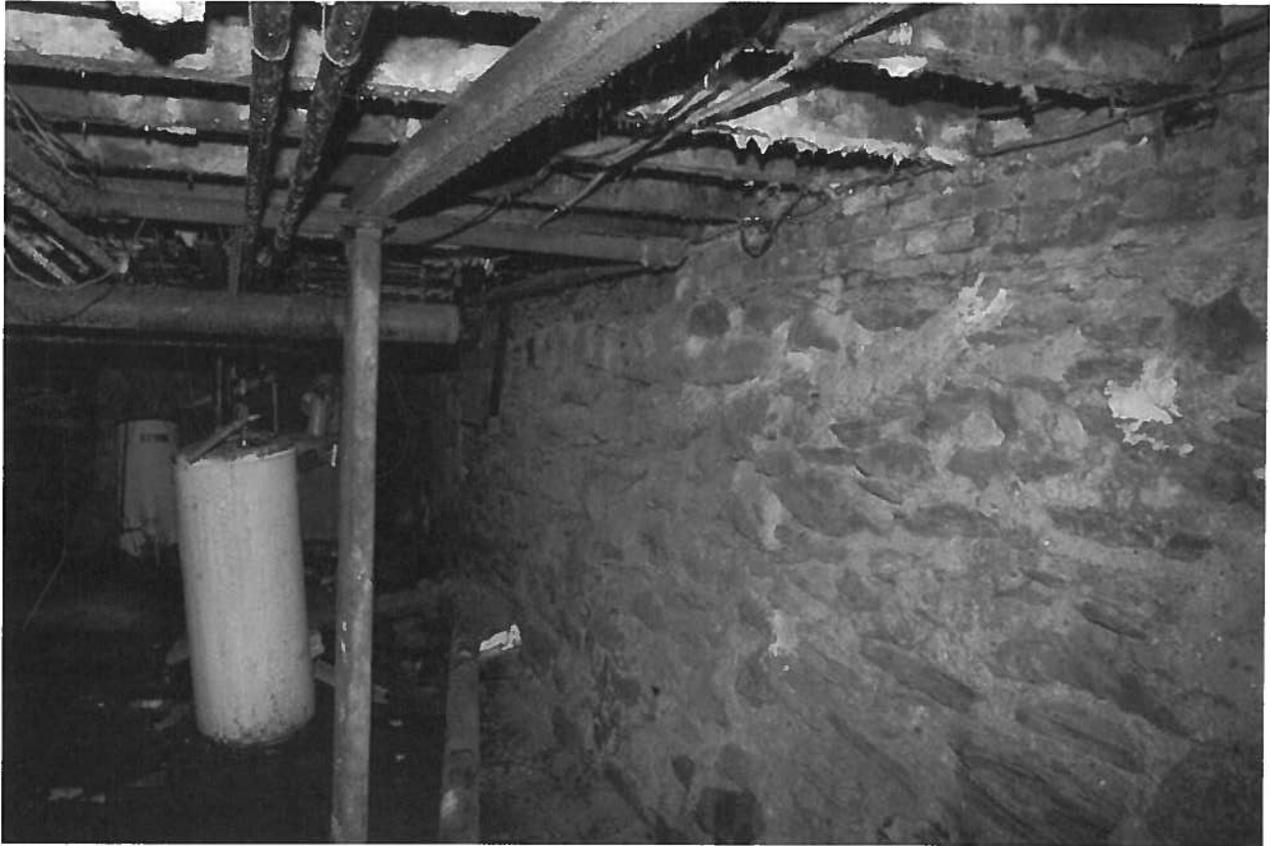
1904 Sansom Street, rear of basement; extensive water damage; mold stalactites hanging from joists; jury rigged steel supports; clay lime mud basement mortar crumbling from water exposure (August 2015)

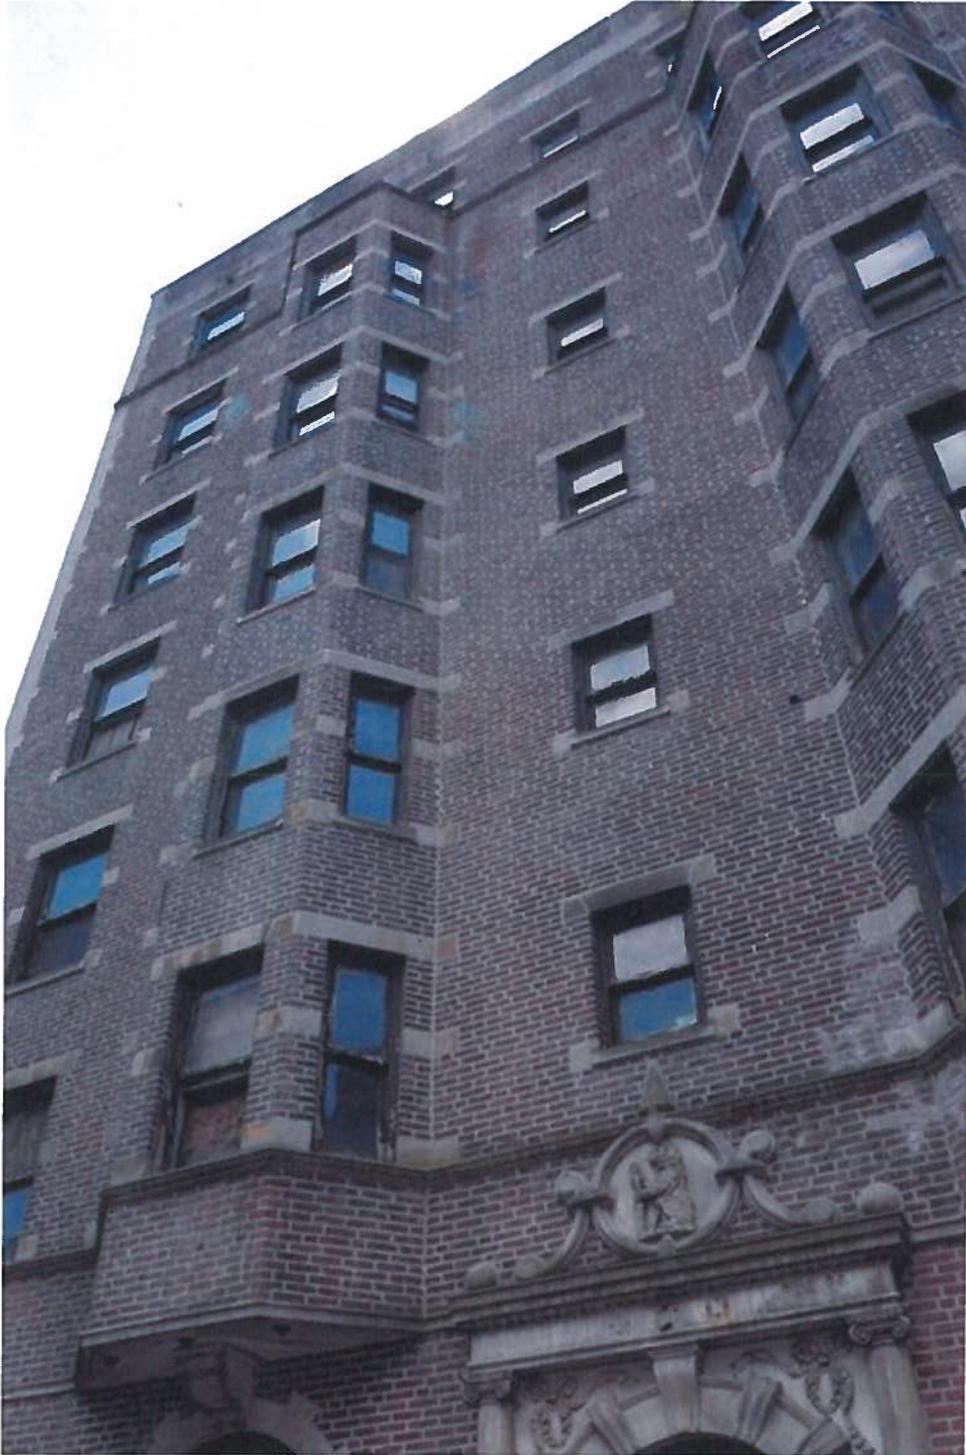
The Warwick, looking up main front, 100% repointing, damage to bay bases, significant brick exfoliation, graffiti on brick, missing cornice at top of building (August 2015)

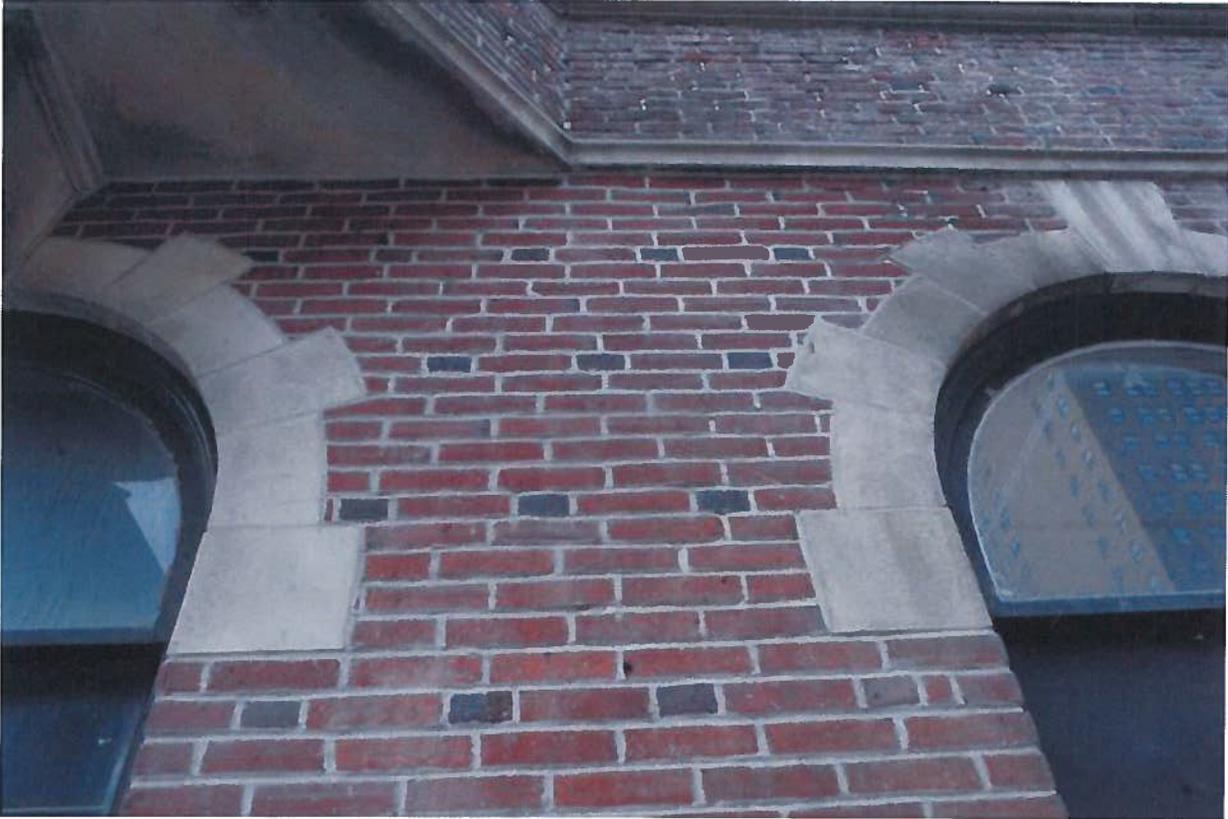
The Warwick, entirely replaced panel of brick, first floor (August 2015)

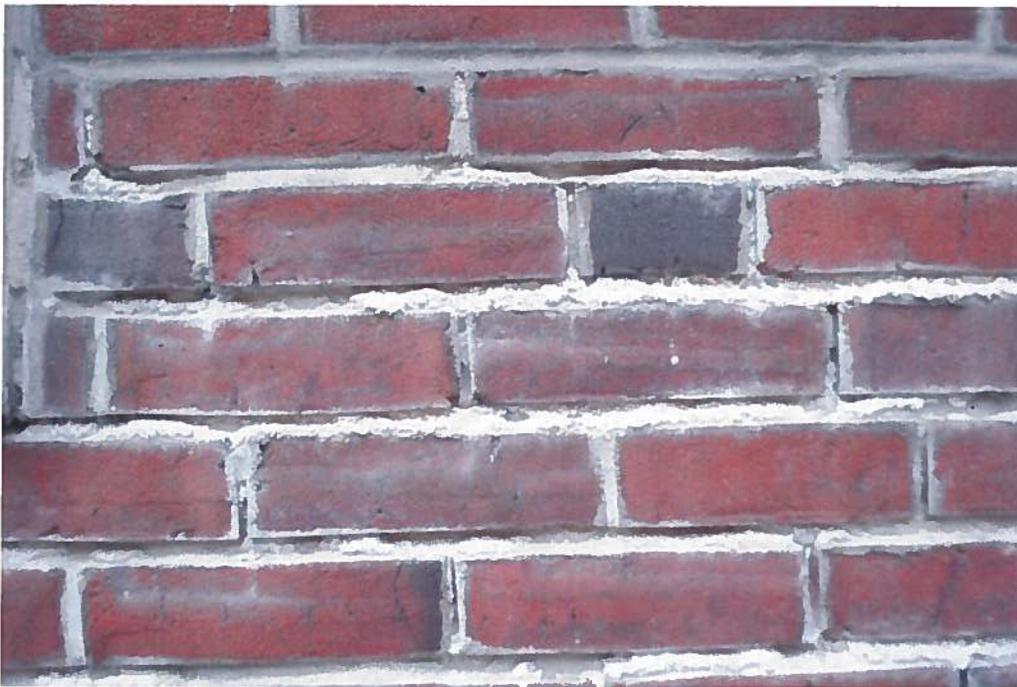
The Warwick, replaced brick first floor, 100% repointing (August 2015)

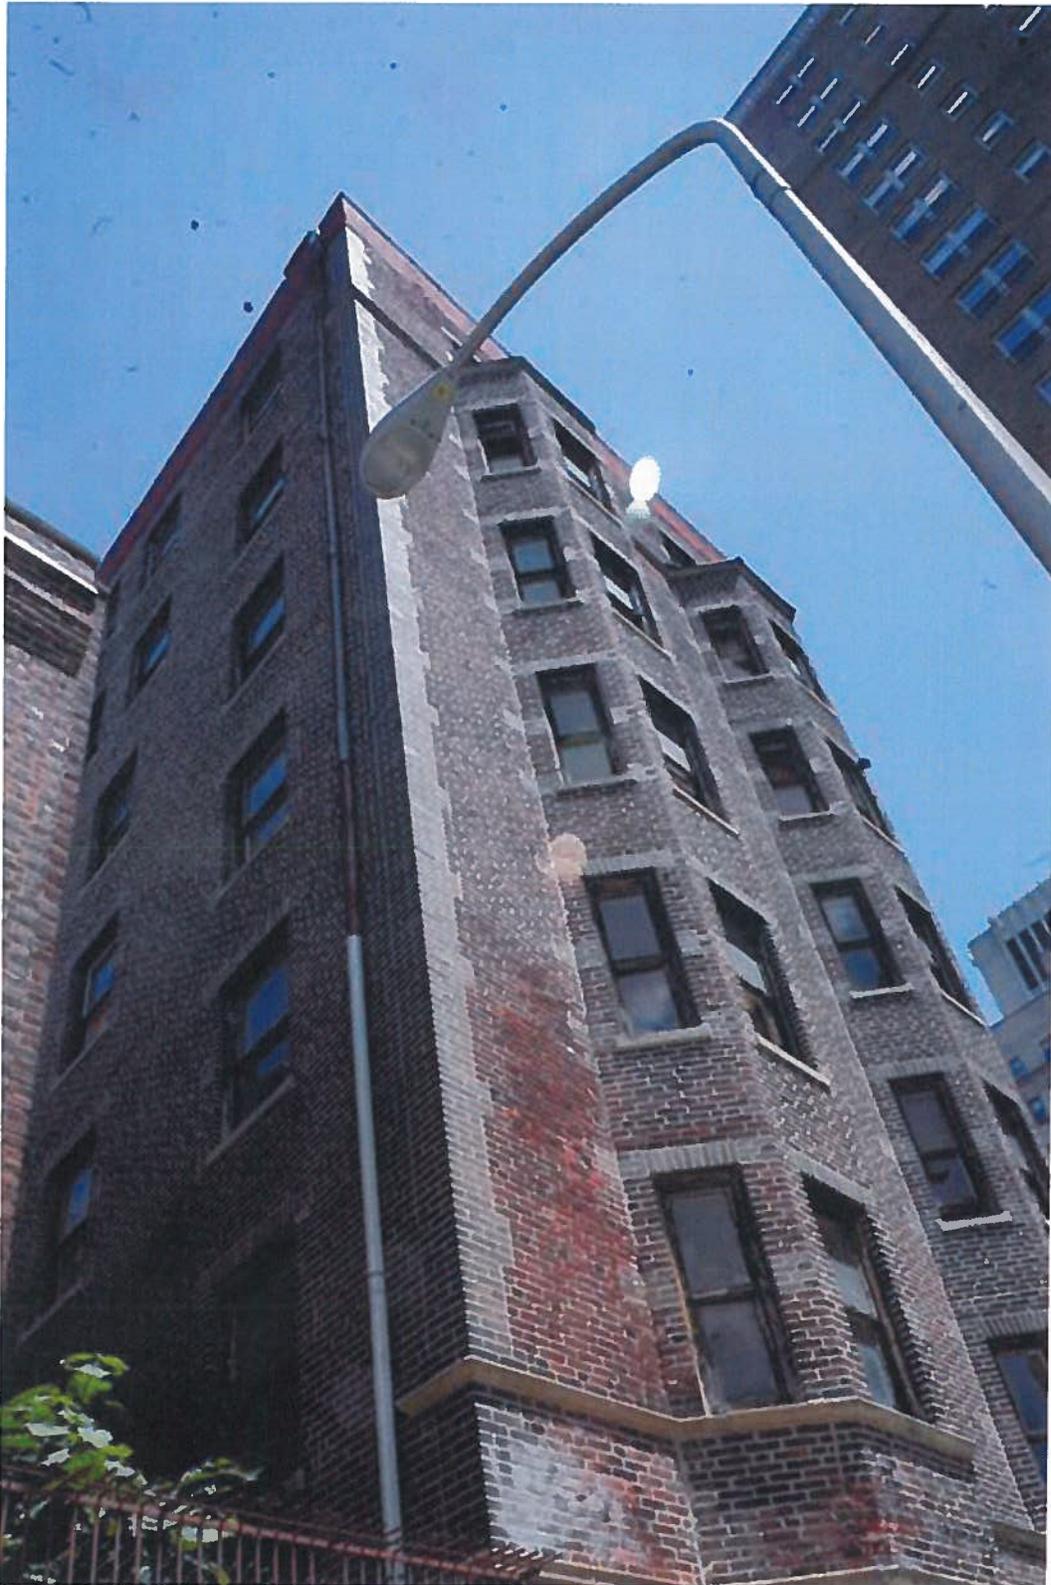
The Warwick, rear façade toward Moravian Street, large areas of loss of brick fired surface; altered lintels and quoins, missing cornice; significant masonry deterioration (August 2015)

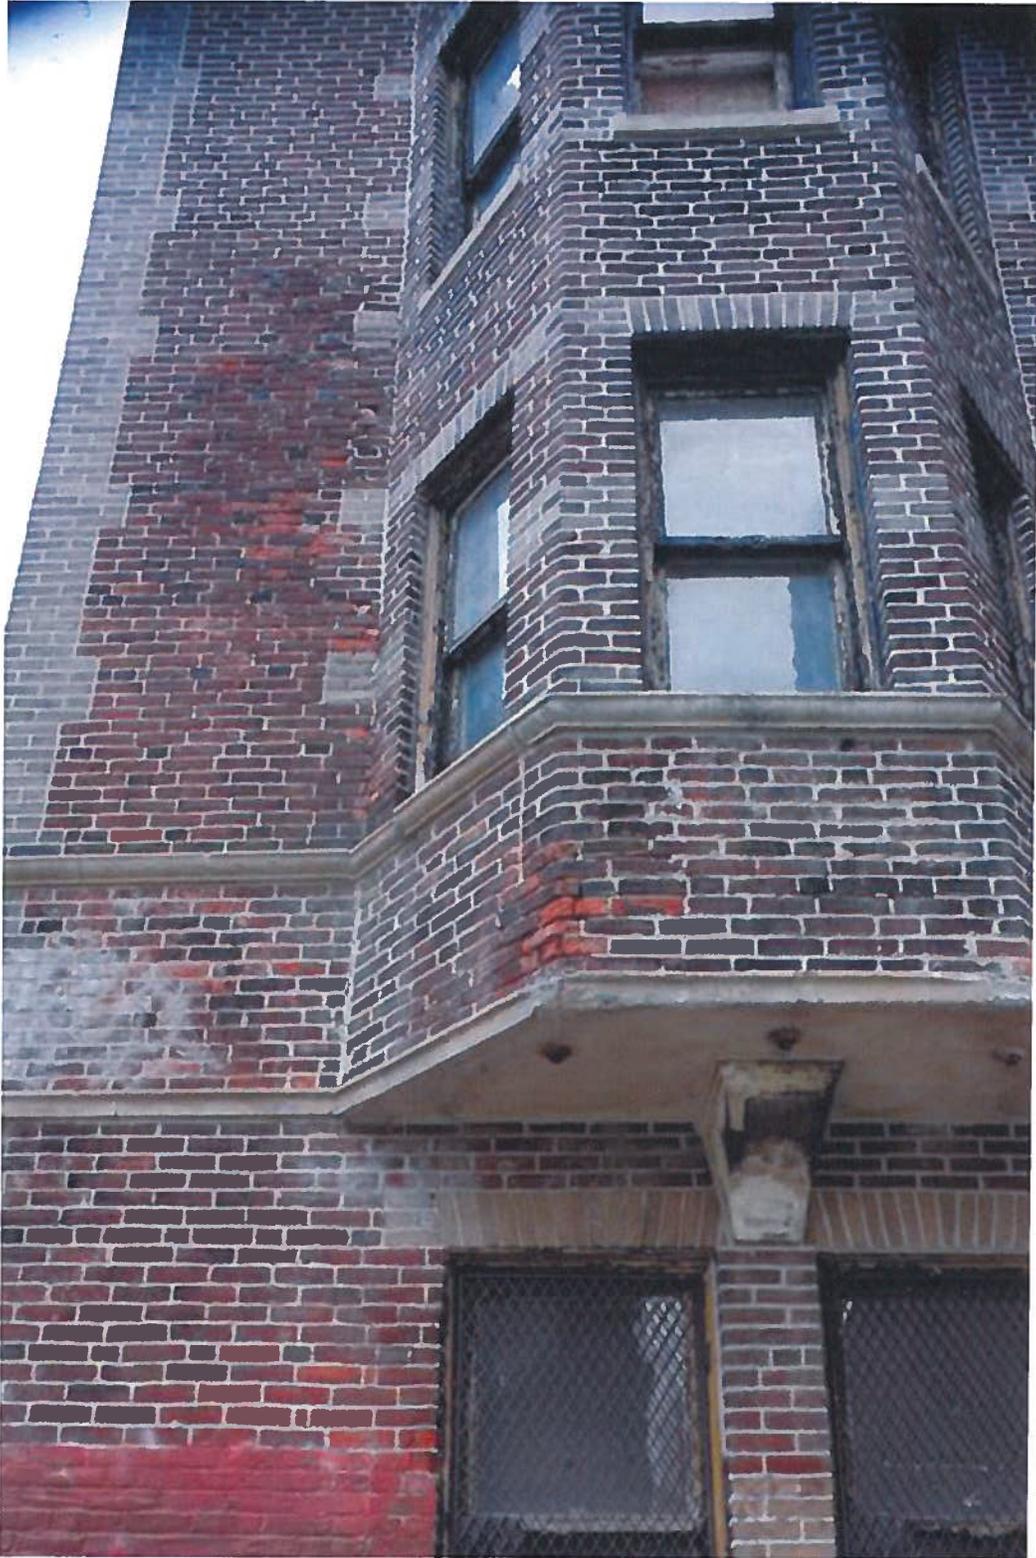
The Warwick Apartments, failure of original brick, replaced lintels, failed stone base to bay (August 2015)

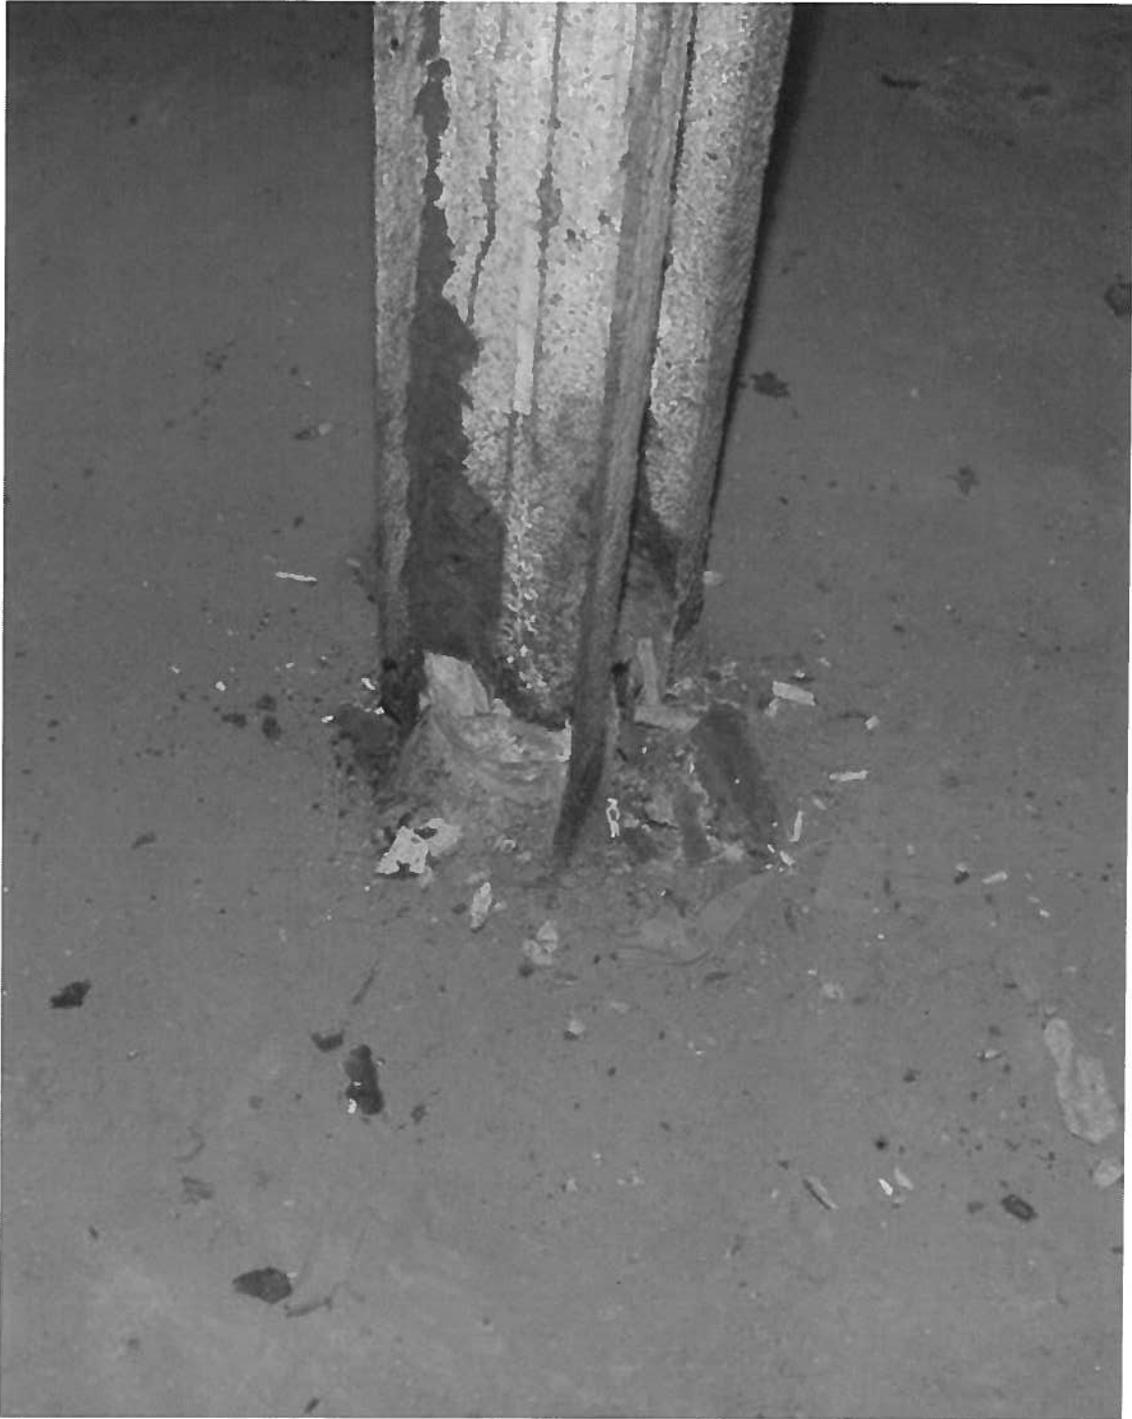
The Warwick, basement column rusted out, jury-rigged repair with concrete support (August 2015)

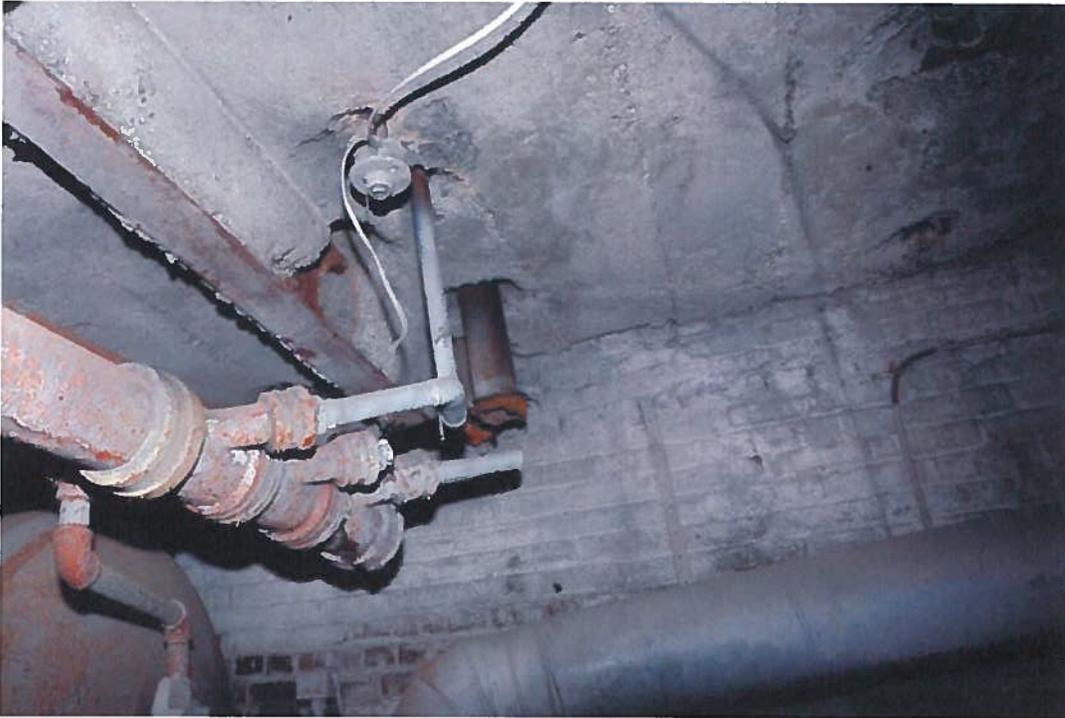
The Warwick, basement, honeycombing of concrete slab, failure of concrete fire-proofing around steel, pushed off by rust-jacking of steel surface (August 2015)

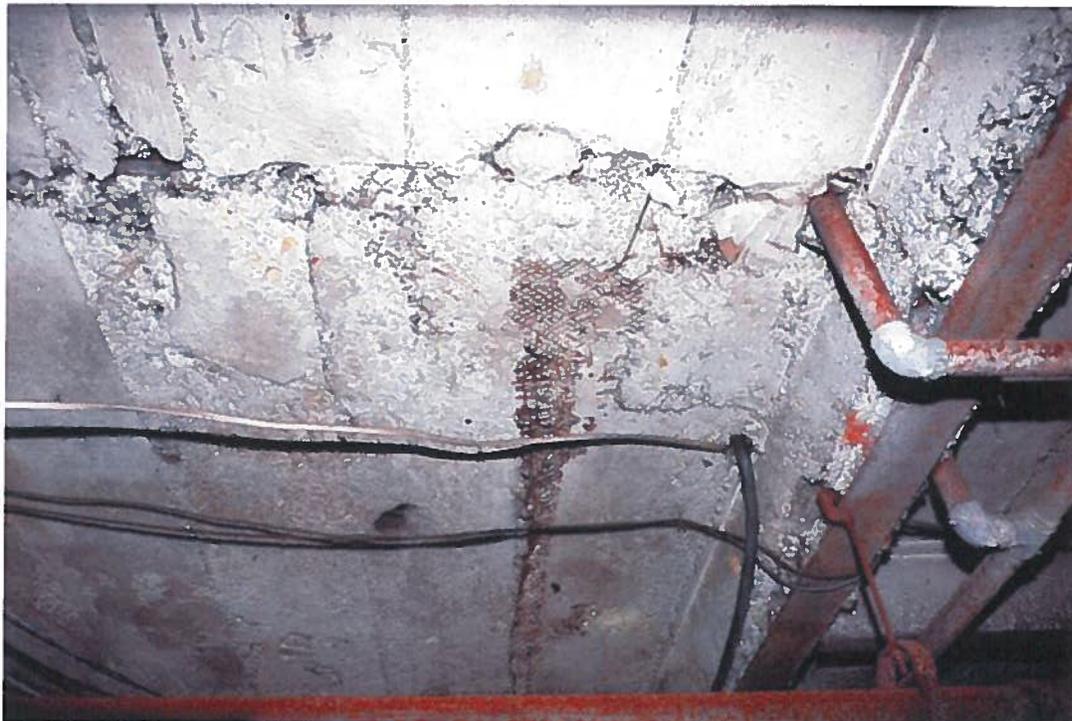
The Warwick, basement, exposed, rusted draped mesh of concrete slab system, honey-combing of concrete on beam; rust jacking of concrete fire-proofing (August 2015)

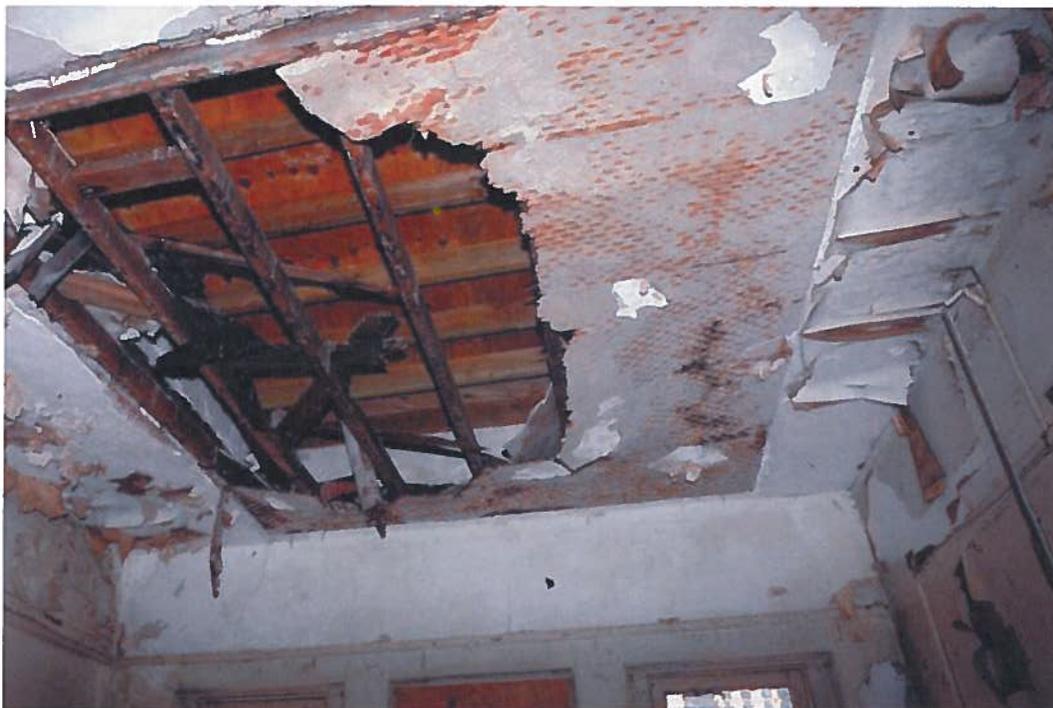
The Warwick, top floor, failed skylight, wire lath plaster added to cover skylight, rusted through and failed (August 2015)

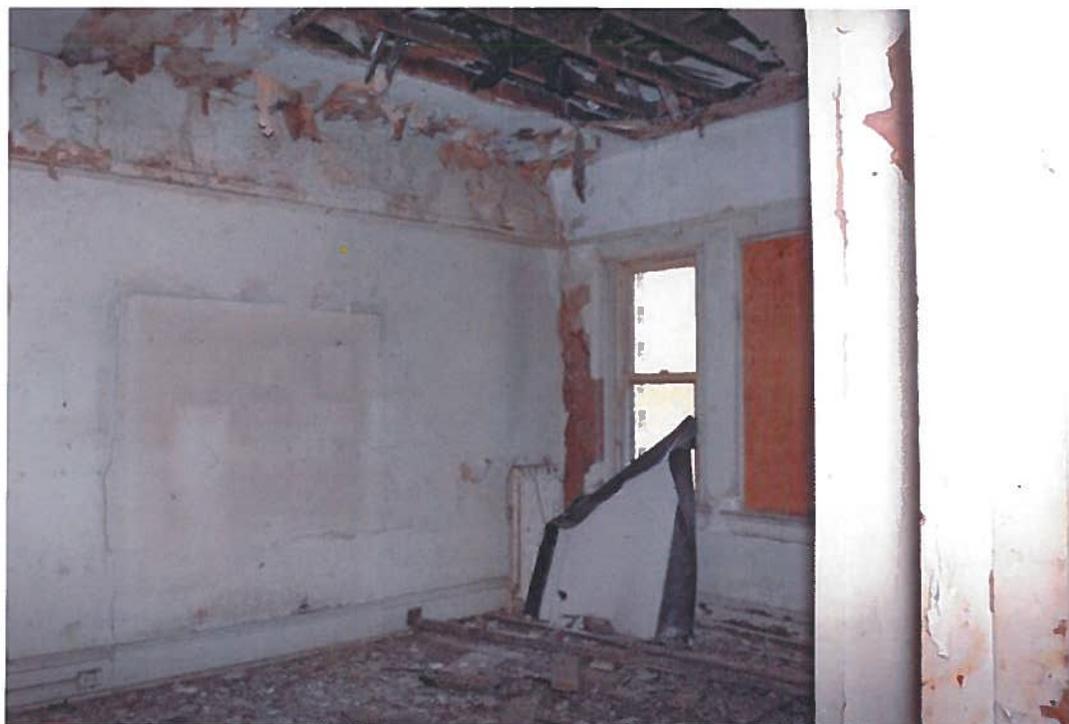
The Warwick, top floor front, failure of roof, ceiling, floor below (August 2015)

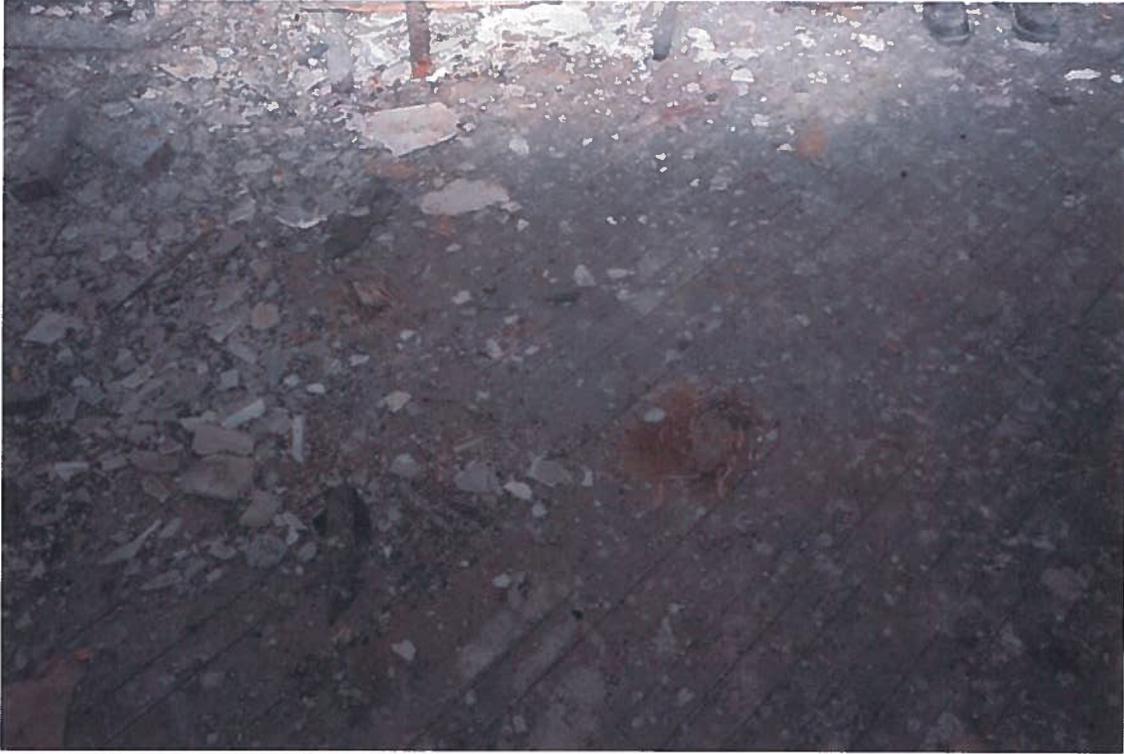
The Warwick, top floor, rotted floor below failed skylight (August 2015)

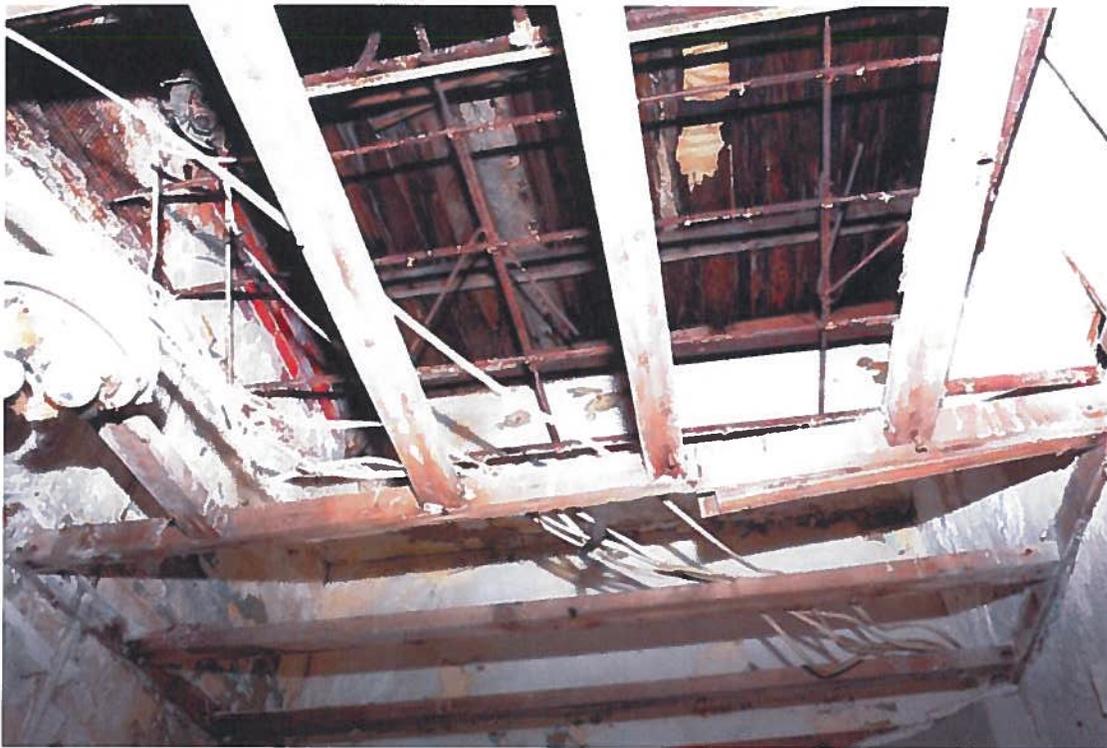
The Warwick, Top floor, rear apartment – failed skylight and multiple ceiling system failures(August 2015)

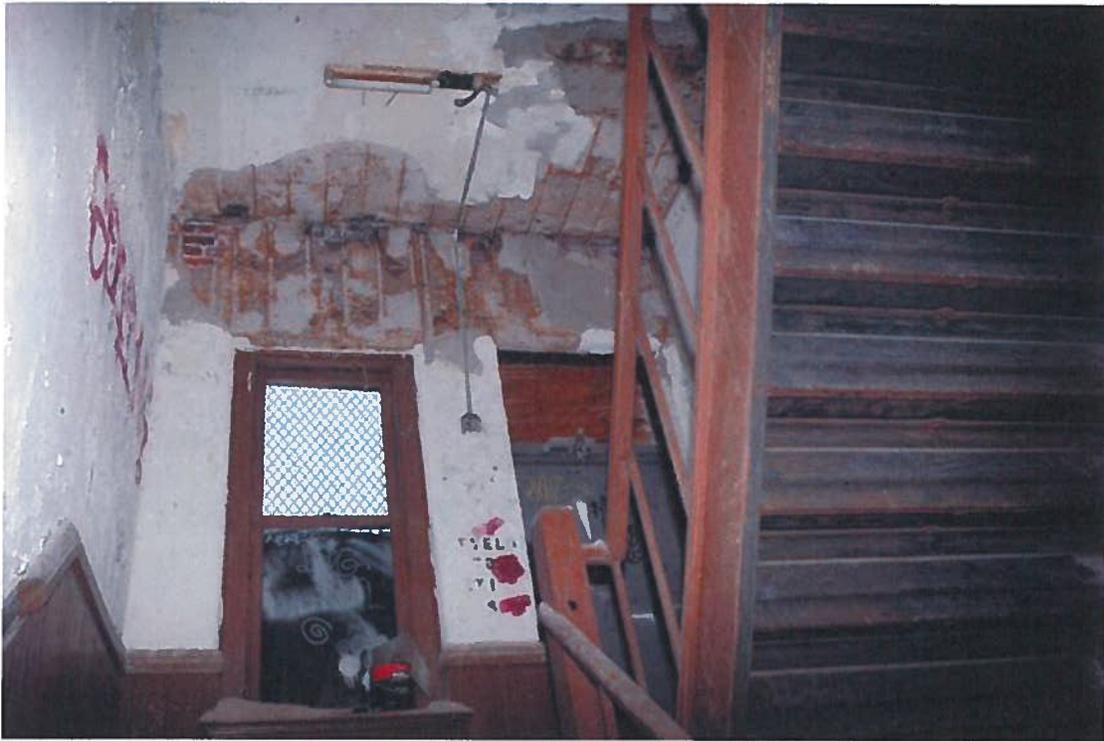
The Warwick, stairwell, water damage to ceiling and wall, 6th floor (August 2015)

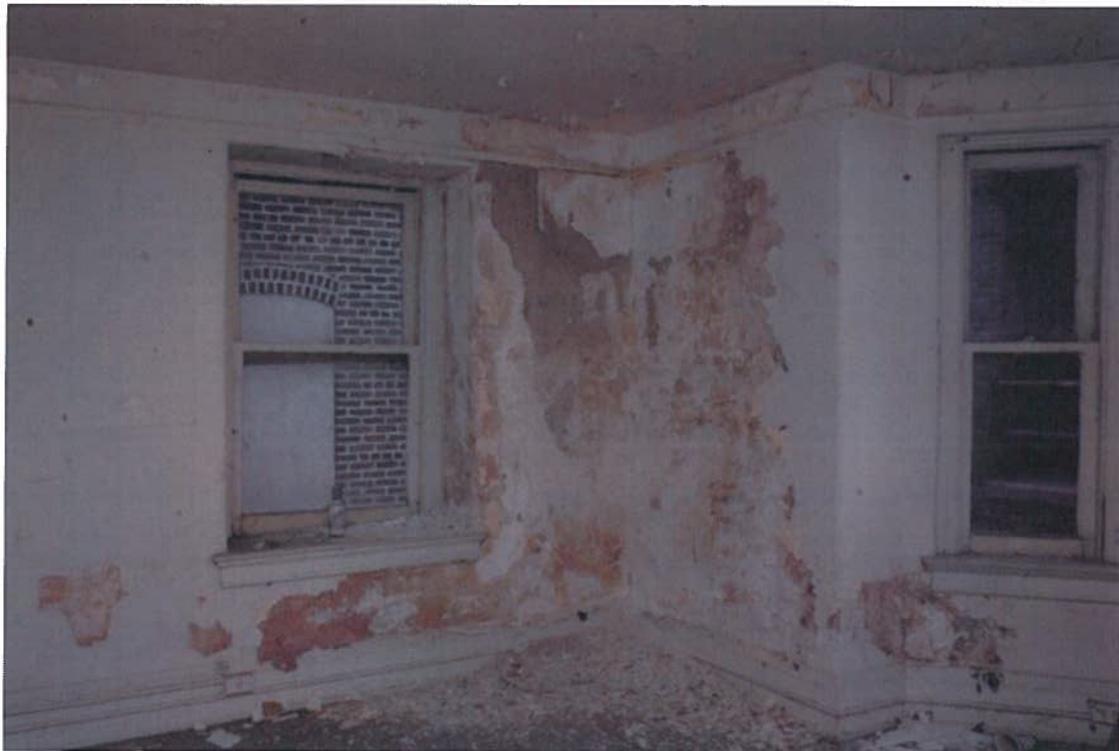
The Warwick, third floor water damage from roof passing through rear corner

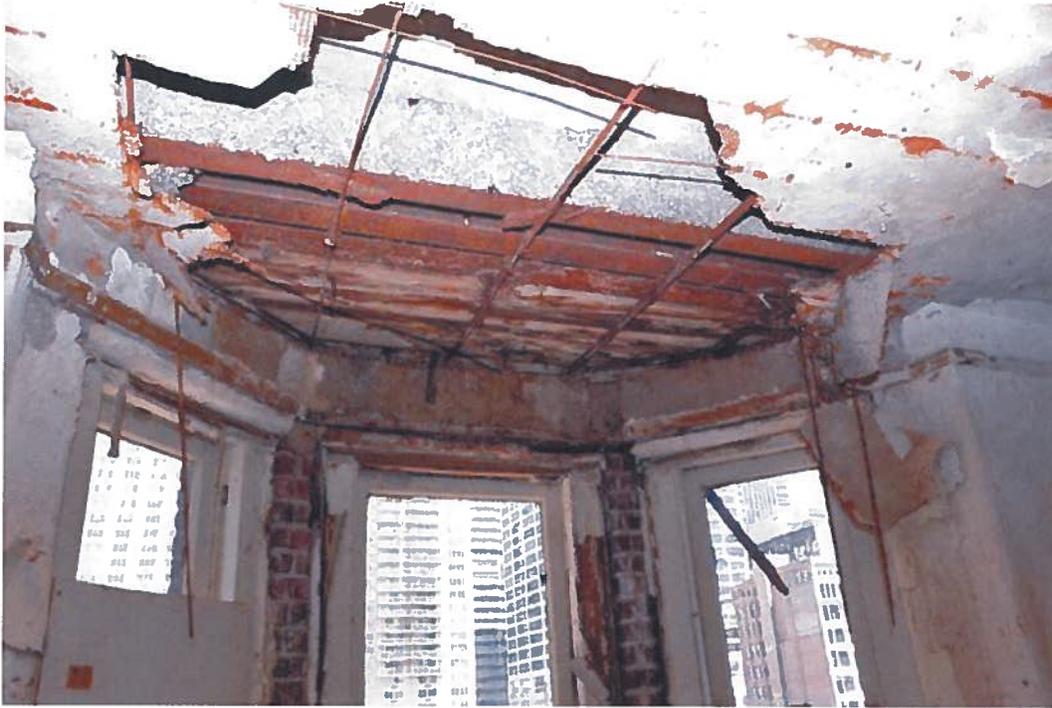
The Warwick, ceiling of bay, front of building, 6th floor, total failure of interior systems, rusting steel and lath system (August 2015)

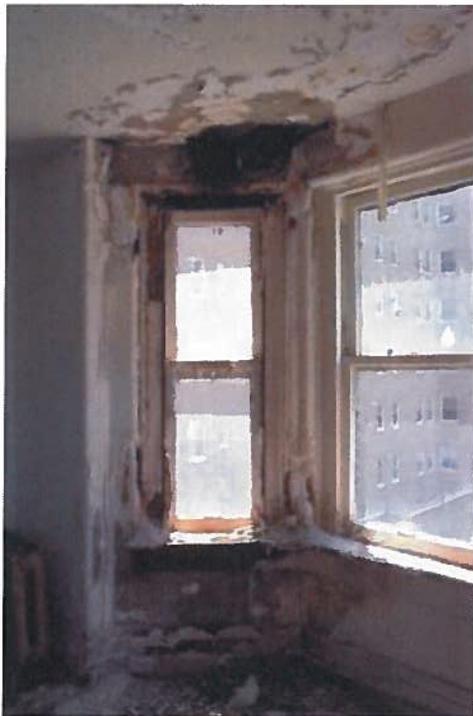
The Warwick, failure of rear bay, water penetration all systems (August 2015)
