Exhibit C

Photographs by George E. Thomas of Civic Visions LP

1904 Sansom Street
Photos August 2015

Warwick Apartments, 1906-16 Sansom Street

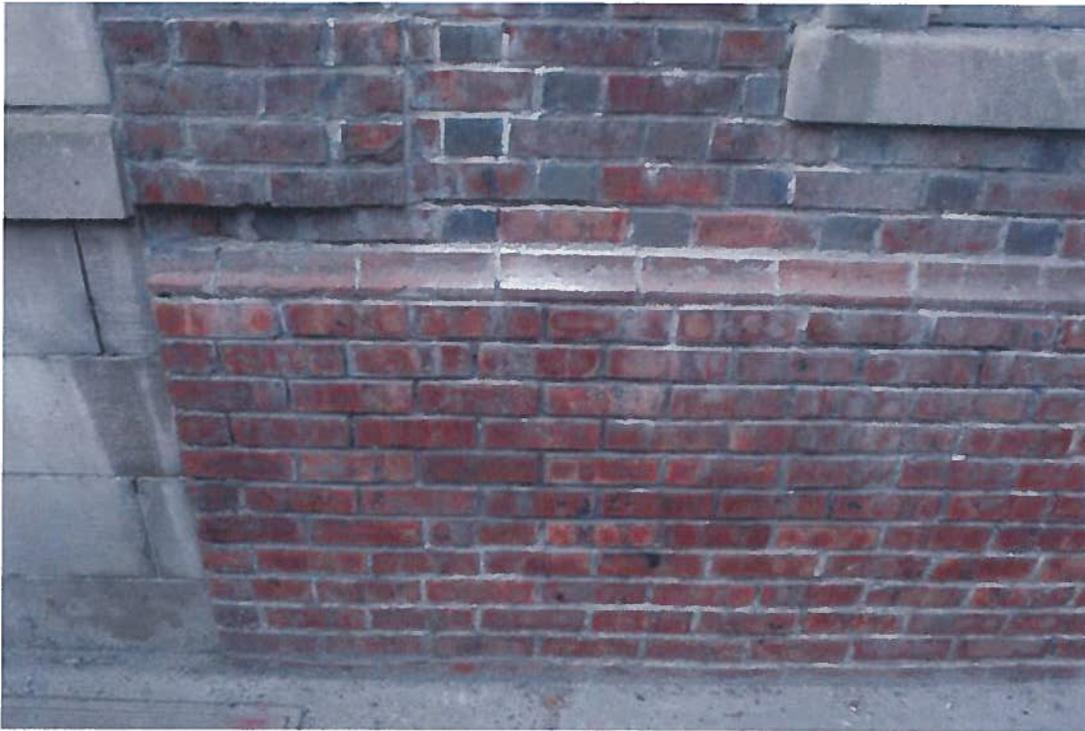
1918 -20 Sansom Street, water staining, spalling damage, and overpointing, brick of Sansom Street façade (August 2015)

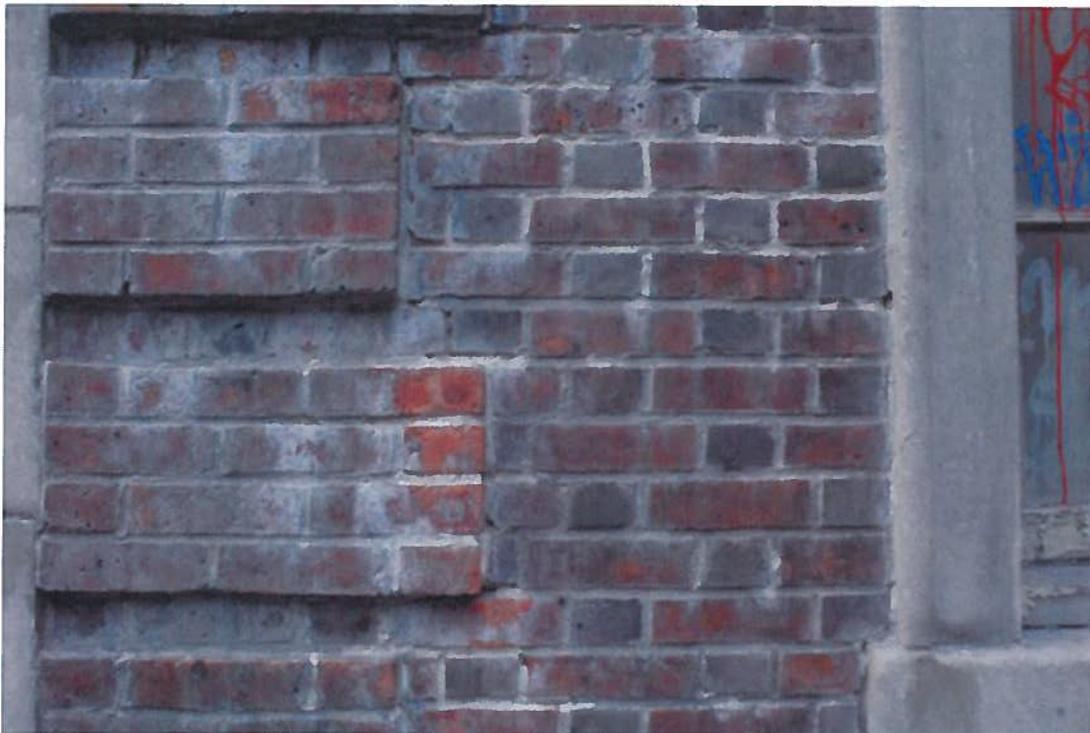
1918-20 Sansom Street, water staining, spalling and efflorescence through brick and stone, Sansom Street façade (August 2015)

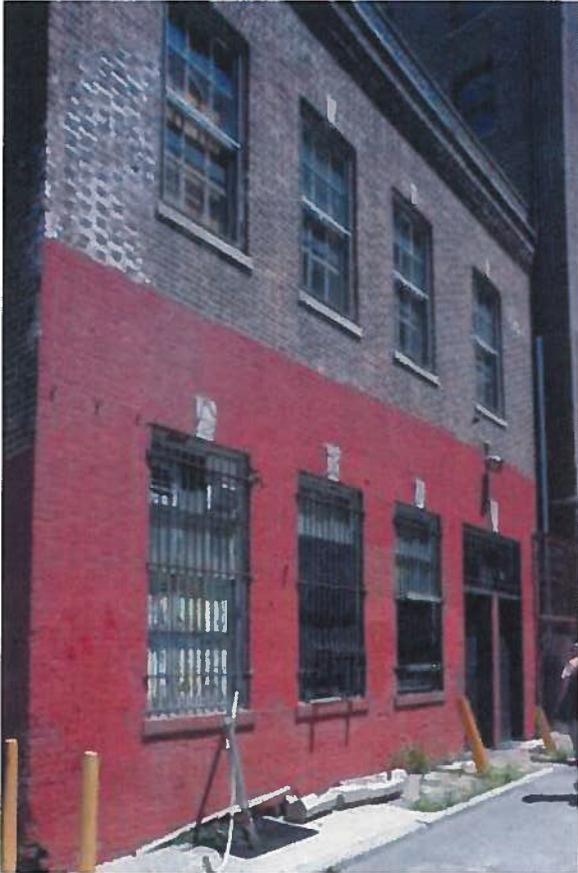
1918-20 Sansom Street, rear façade, paint over brick base with large areas of efflorescence from roof water damage

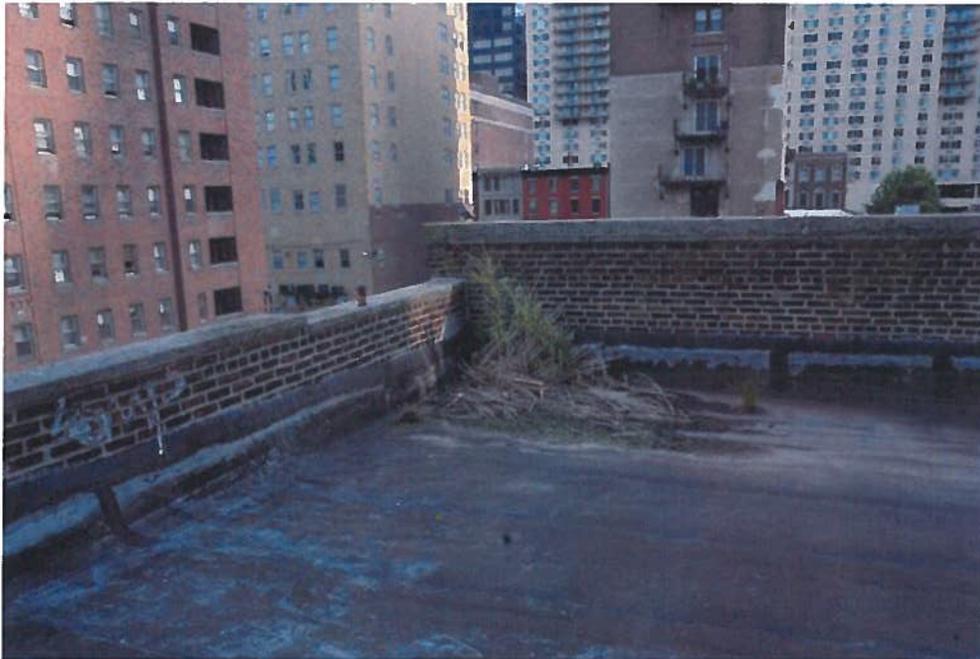
1918-20 Sansom Street, plants growing in roof drains, evidence of level of roof water damage

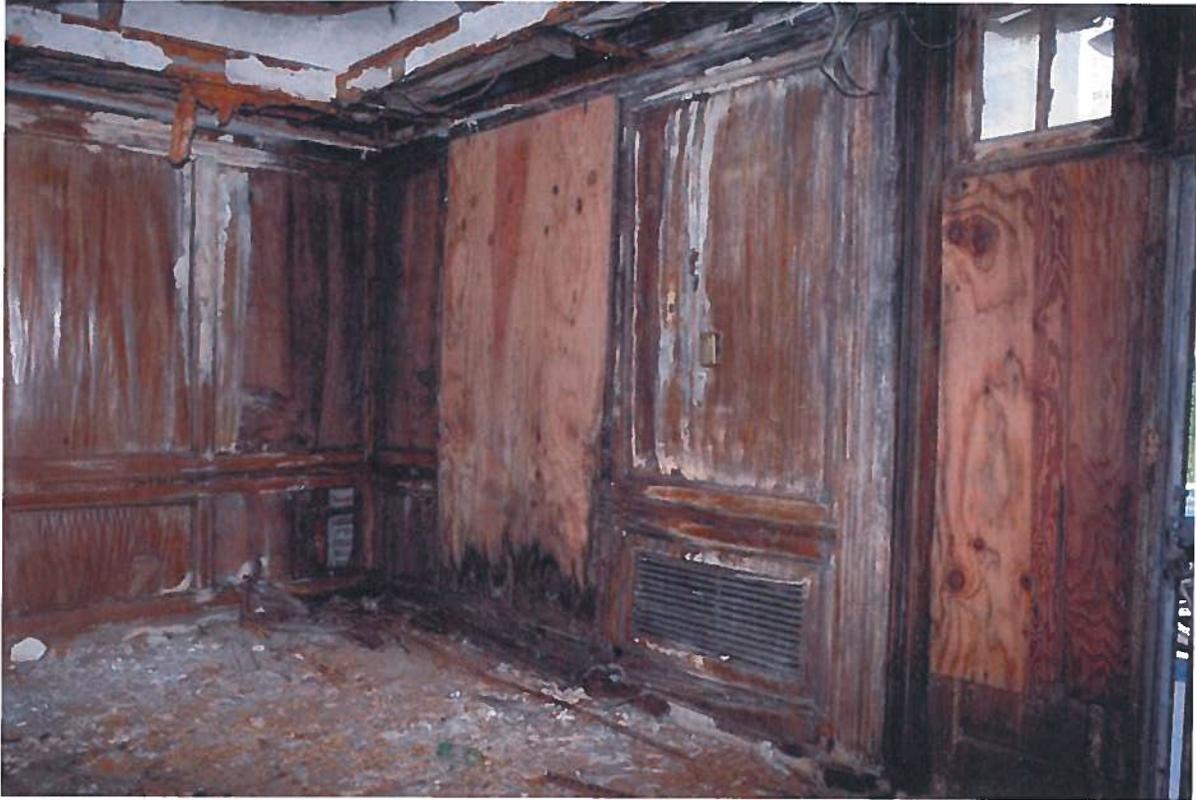
1918-20 Sansom Street, front lobby, NW corner, showing extent of water damage from roof drains (August 2015)

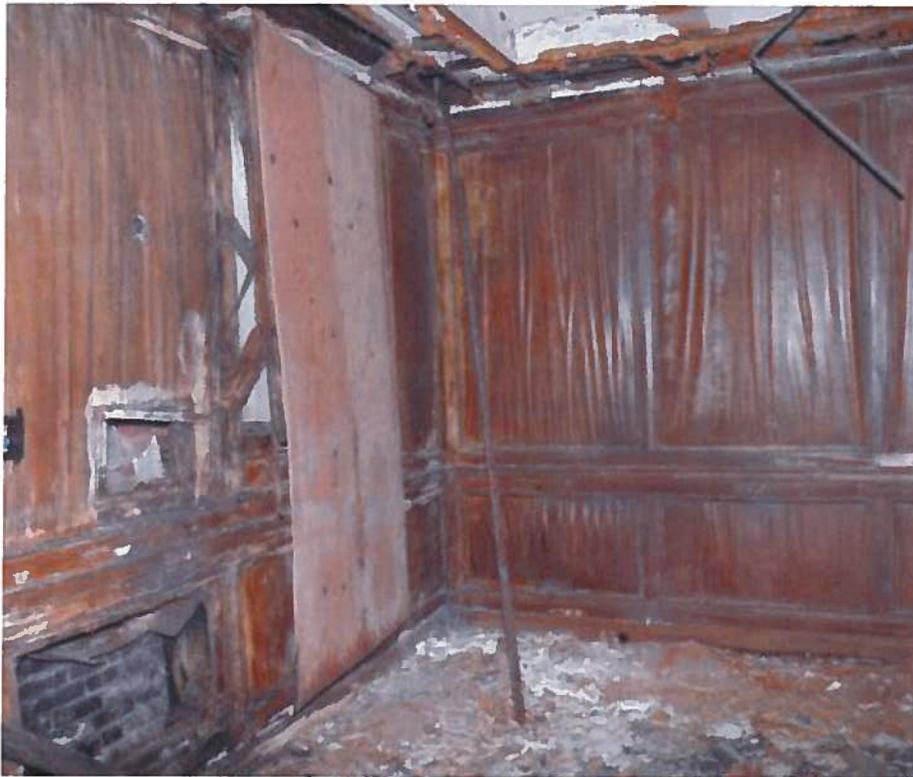
1918 -20 Sansom Street, front lobby NE corner, showing extent of water damage from roof drains, (August 2015)

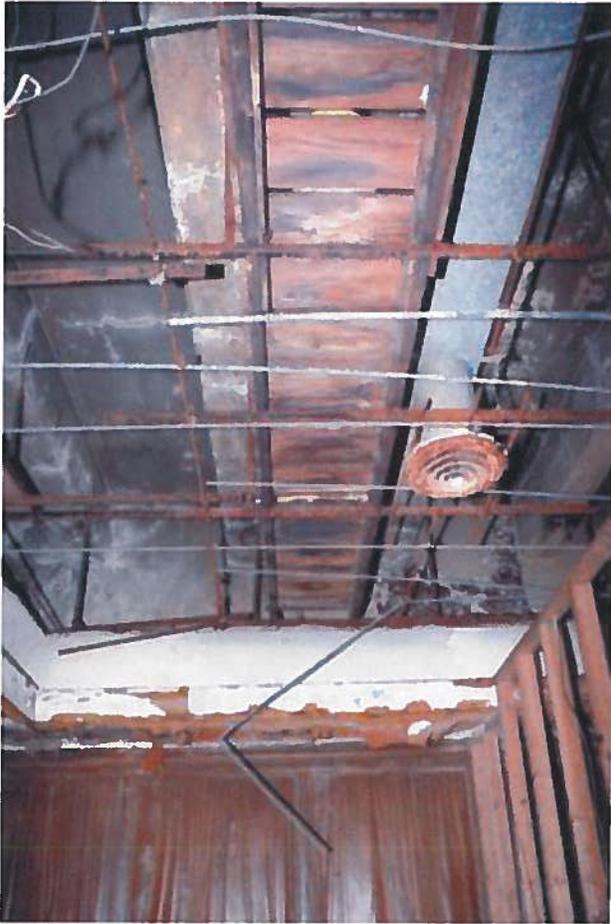
1918-20 Sansom Street – ceiling damage front lobby

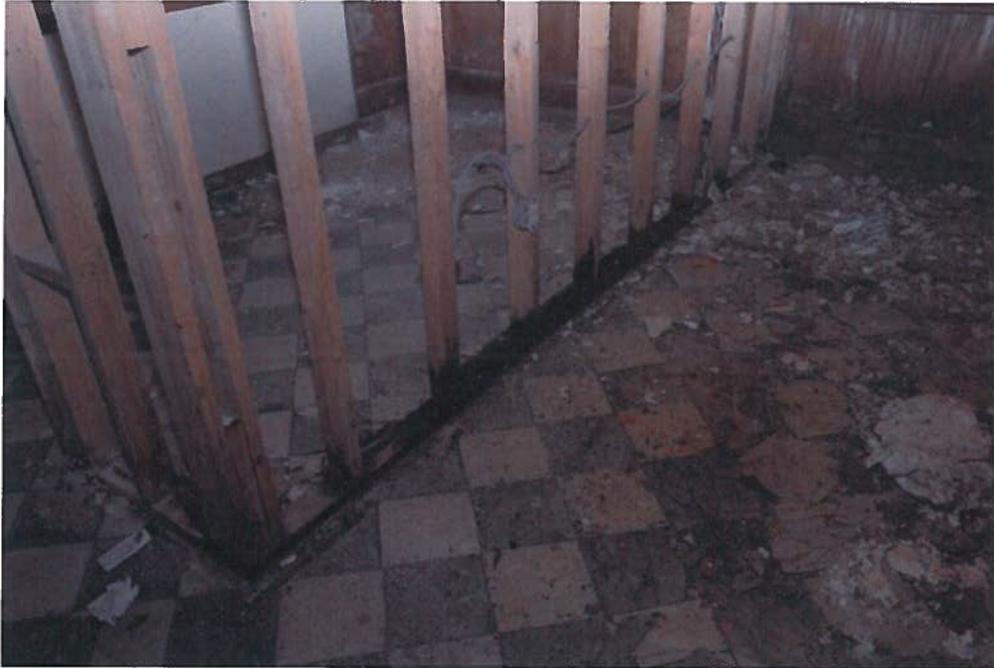
1918-20 Sansom Street, rot damage to modern partition (August 2015)

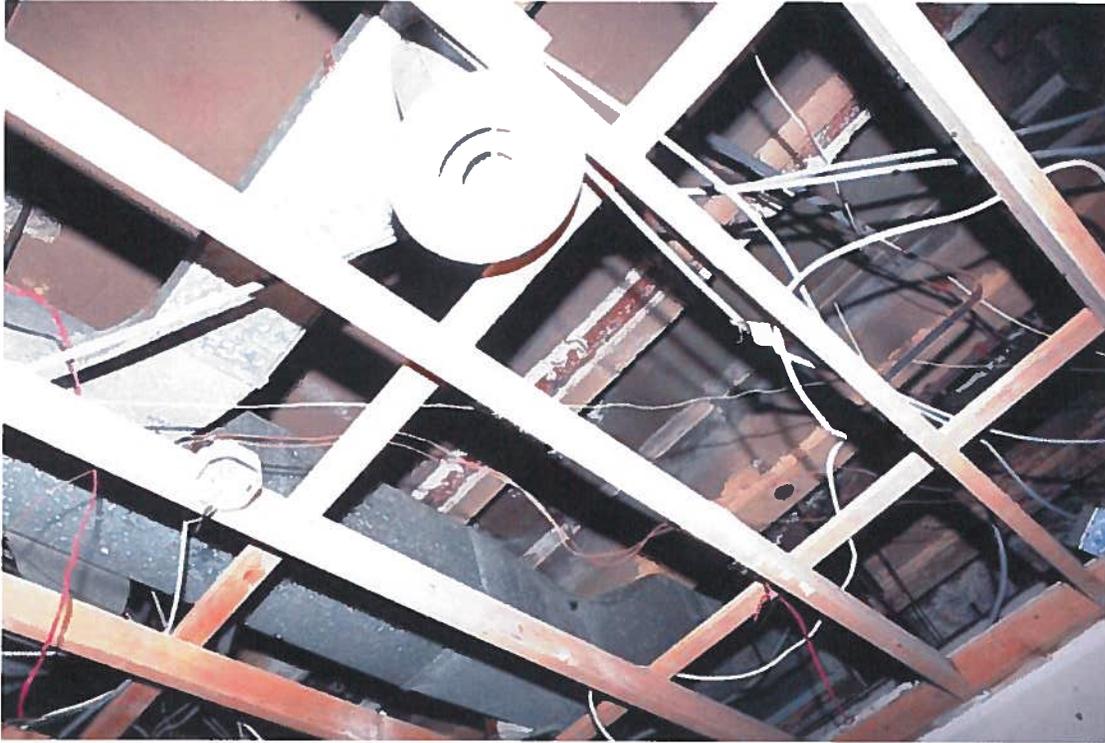
1918-1920 Sansom Street, Steel encased beam, first floor, rust and loss of fireproofing above dropped ceiling (August 2015)

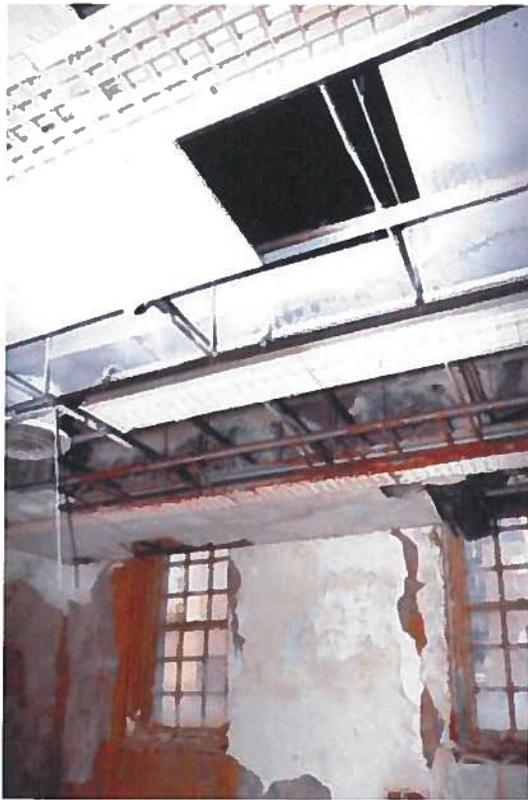
1918-1920 Sansom Street, rust damage to steel reinforcing for suspended ceiling, second floor (August 2015)

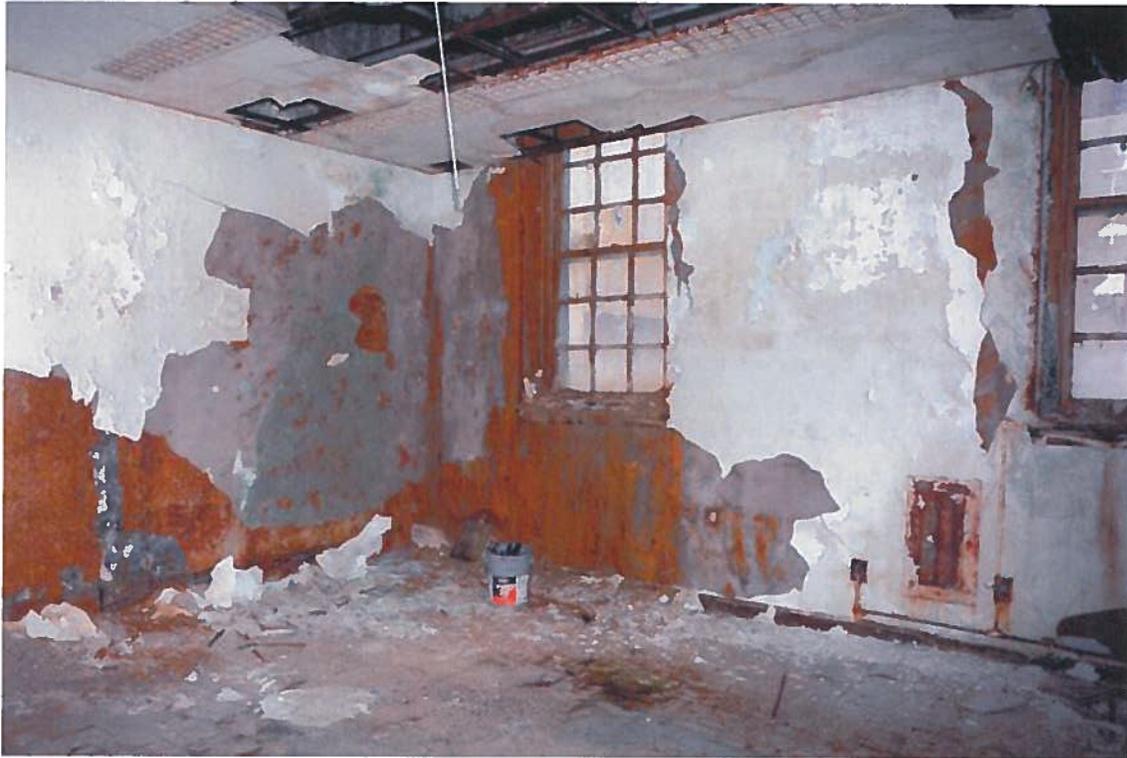
1918-1920 Sansom Street, NW corner second floor front, multiple layers of wire lath and plaster, destroyed by water; suspended ceiling (August 2015)

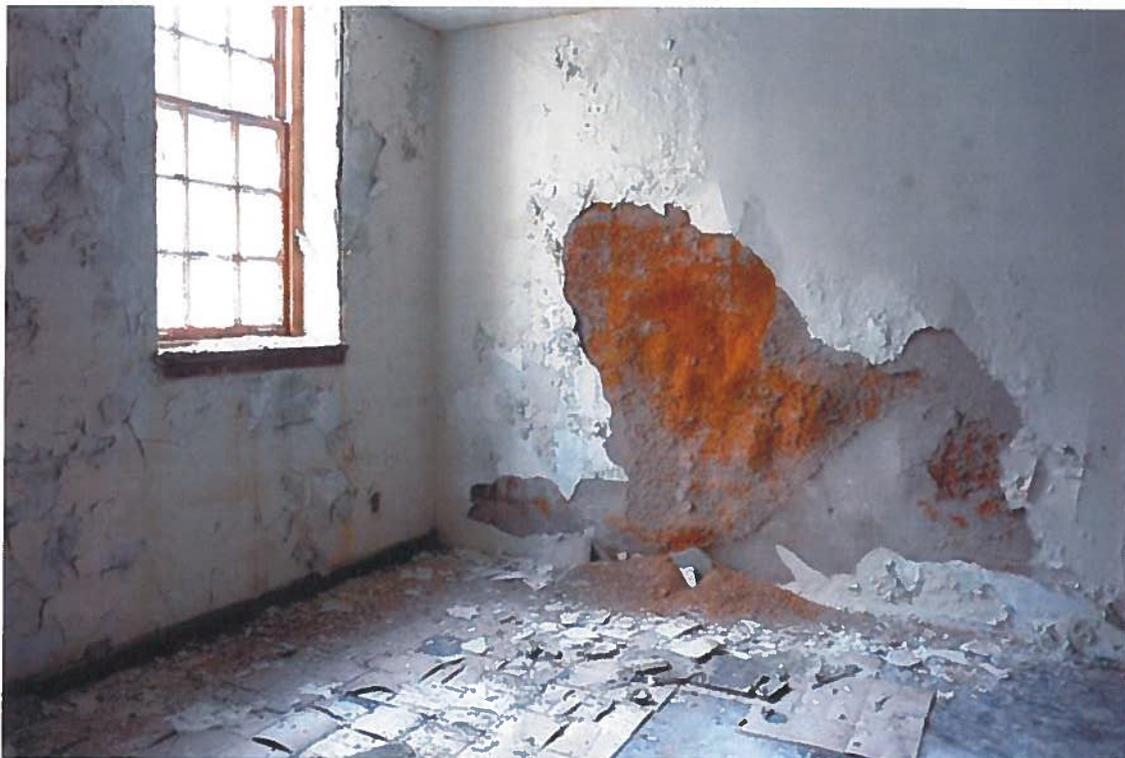
1918-20 Sansom Street, NE corner, second floor front, destroyed wire lath, east wall under failed roof drain (August 2015)

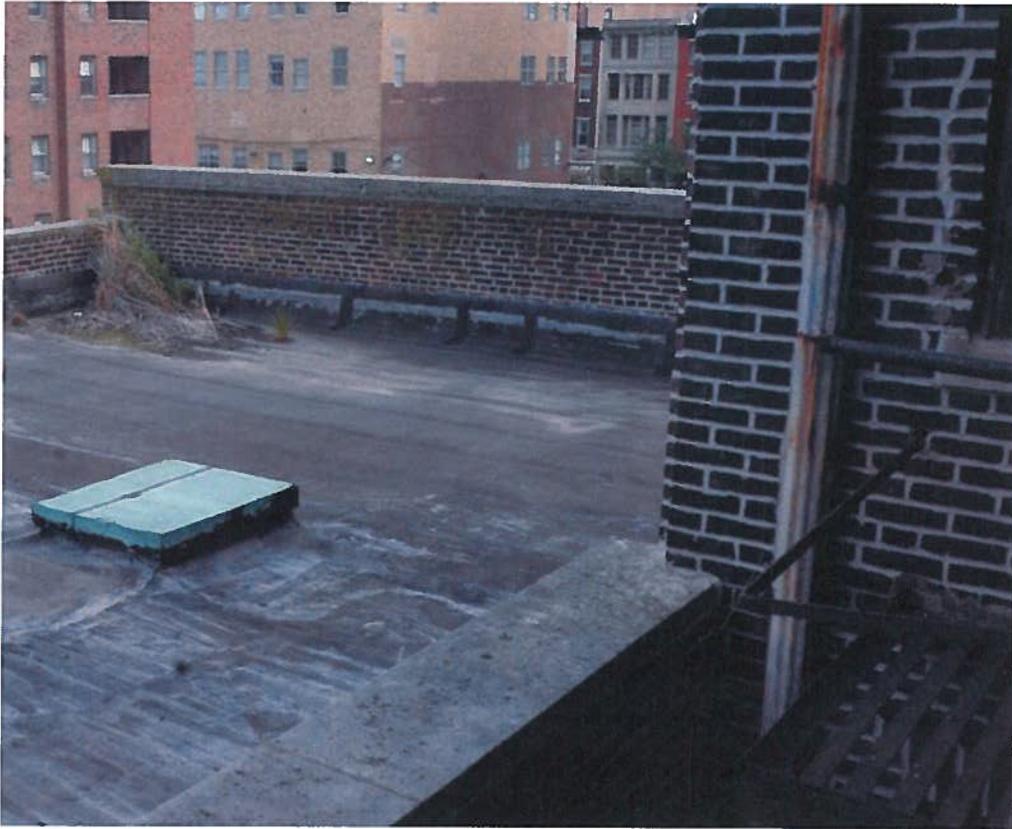
1918-1920 Sansom Street, levels of water damage in parapet and roof from blocked drains (August 2015)

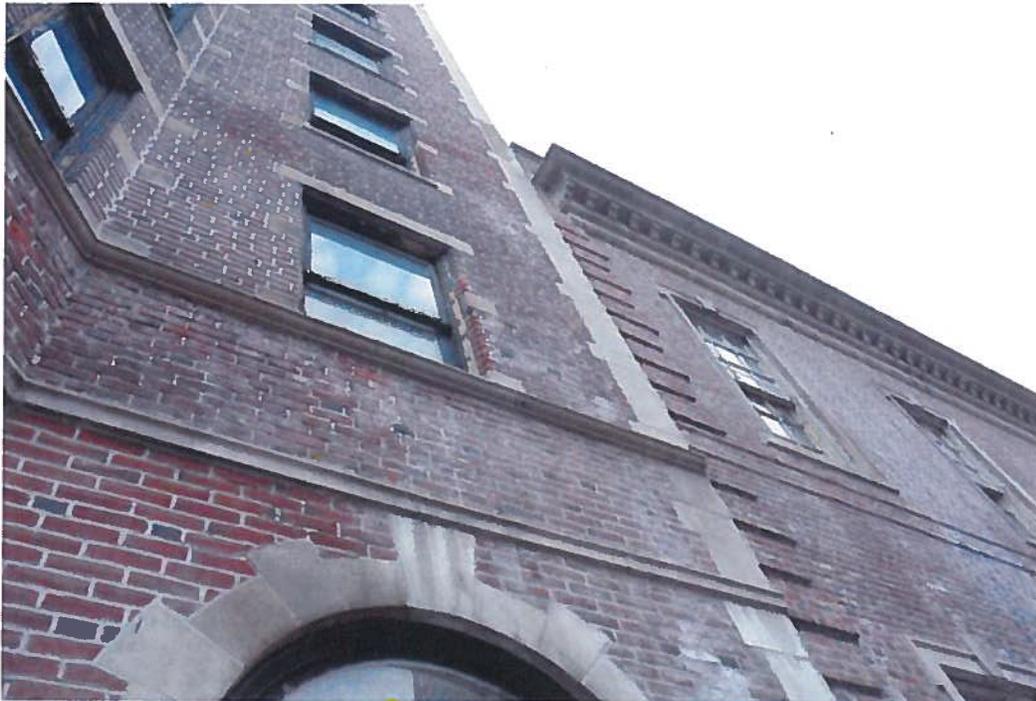
1906-12 and 1918-1920 Sansom Street, efflorescence and water damage where 1918 -1920 roof drains cause leakage into both buildings
