Existing Structural Condition Report by Keast & Hood Structural Engineers

**Structural and Masonry Evaluation Reports
1904, 1906, and 1920 Sansom Street
Philadelphia, PA 19103**

*Existing Conditions and
Recommendations for Repairs
October 12, 2015*

**Frederick C. Baumert, PE
400 Market Street, Suite 1250
Philadelphia, PA 19106
215-625-0099
KH Project #150076A**

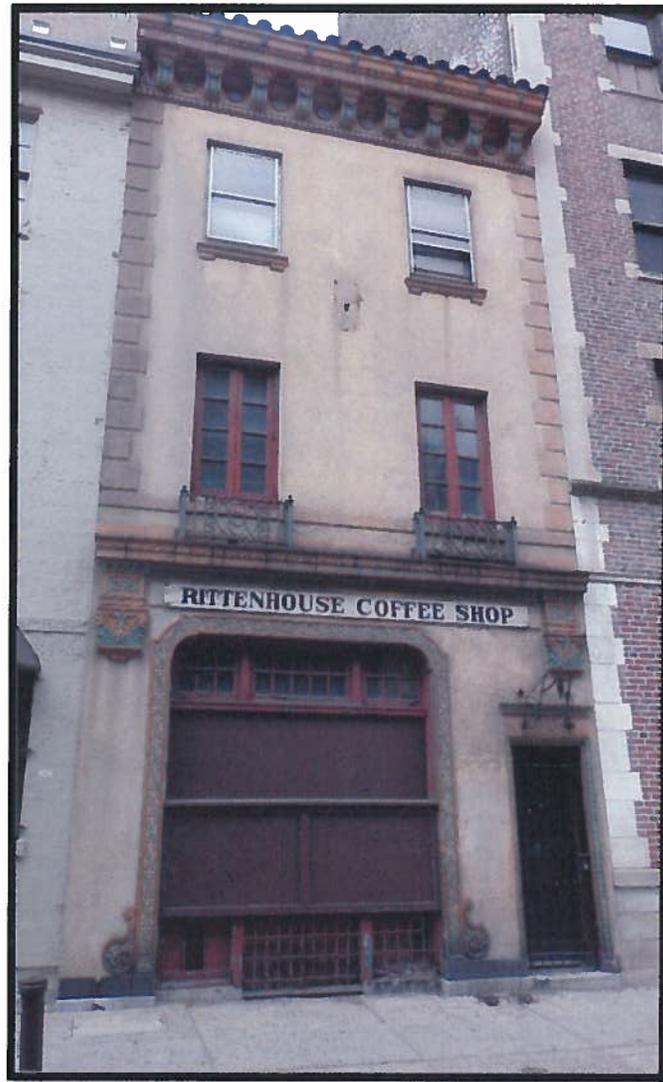
Front façade showing terra cotta elements.

- A “hands-on” review of the terra cotta cornice should be performed before the framing work is started, to ensure that any loose pieces will not be jarred off the building.

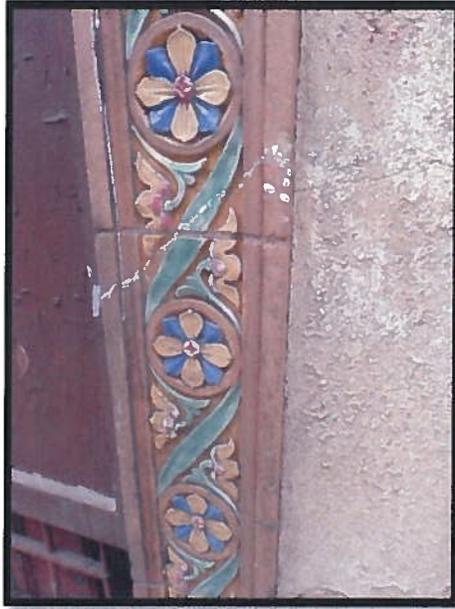
Detail showing water migration and salt deposits through cracks.

- All exterior walls should be re-pointed, which will require removal and replacement of the plaster stucco on the front elevation. However, the repointing and plaster work should not take place until after the masonry has been dried out so that moisture is not trapped in the core of the walls. The drying effort may take as much as eight months; a specialty contractor will be needed for this work.

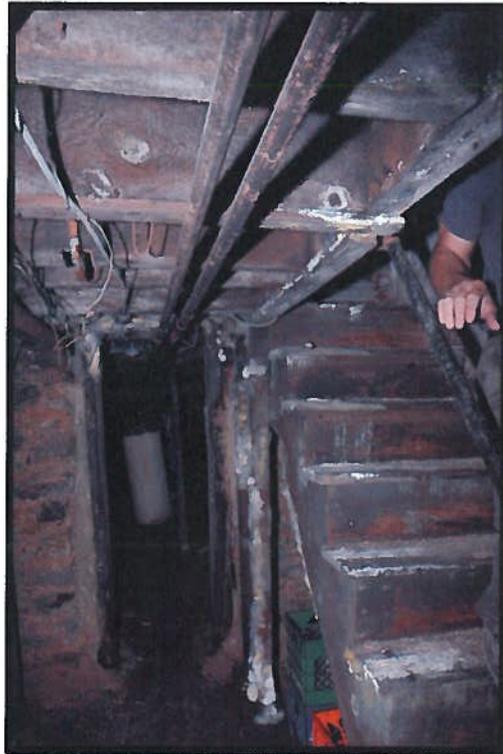
The first floor framing was found to be collapsing in the center section due to decay of the wood joists, thus the center and rear portions of that floor were not accessed. The basement was extremely

humid and large fungal blooms were found on the wood framing supporting the first floor in the front section. Multiple varieties of mold were observed on all surfaces. It is likely that the roof drain pipes have broken and the water is collecting in the basement. Due to the collapsing floor above, the remainder of the basement was not visited. It must be emphasized that the first floor should be considered dangerous and thus entry to the property should be barred. Caution should be exercised when using the stair to the basement as well, and respirators should be required for protection against the mold spores in the air.

Large fungal blooms on all wood elements
Indicate accelerating decay.
Photo by G. Thomas

- All of the first floor framing must be replaced. This work may require temporary bracing of the bearing walls to brace the weakened foundation walls against earth pressure.

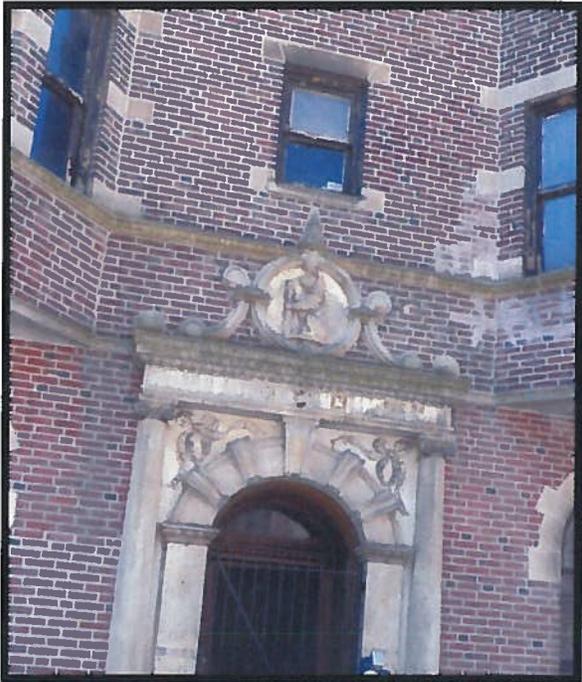
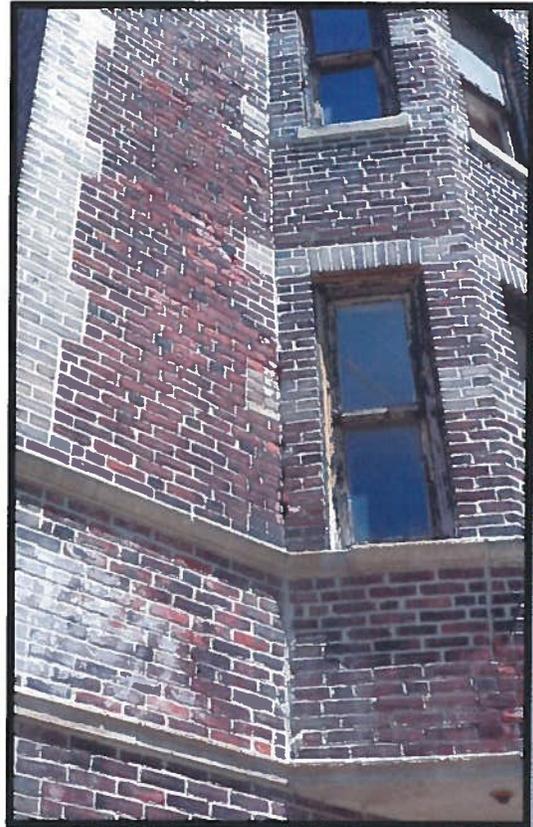
The façade had been repointed by the previous owner using a modern cement mortar. There are significant amounts of spalling of the face of the brick. This was caused by the Portland cement mortar that is stronger than the brick, directing thermal expansion forces into the weaker face shell and fracturing it. With the lack of heat for many years, freeze-thaw cycles in the moisture-laden brick are now damaging that material, making large areas candidates for replacement (especially on the projecting bays, which have thinner walls and thus more damage) and creating a long-term maintenance problem. The exterior walls, as well as some of the interior partitions, are brick that is similar to and likely made by the regional Sayre & Fisher Company. This type of brick is no longer manufactured and is difficult to match.

There are two projecting bays on both the front and rear façades; these are supported by cantilevered framing at the floors. At the bottom of each of these is a large limestone "base" that is hung from the second floor framing. Apparently the original hangers had failed because there are now several large (and unsightly) bolts supporting each of the four limestone slabs; it may be desirable to replace these as part of the renovation. One of the four base sections had fractured into five pieces and is very poorly patched. The front face of the building has numerous carved limestone trim pieces. On the rear most of those limestone inlays had been removed and replaced with modern (non-matching) bricks. A substantial number of the remaining limestone sections have fractures, likely also caused by the introduction of too-hard mortar and lack of internal heating to drive out moisture.

Front and rear respectively. Note the missing limestone on the rear, extensive brick face spalls, and the fractures in the limestone. The fake jack arches are poorly executed as well.

- The exterior walls have been damaged by the too-hard mortar and should be fully repointed with an appropriate mortar mix. Spalled bricks should be replaced with suitable matched units.

- Fractured limestone elements should be pinned and the cracks repaired, or the sections replaced.
- There are exterior steel fire balconies on the east and west walls (which are the only access to the upper floors from the fire stairs) that are in poor condition; they should be renovated before the rest of the building is opened to construction crews, even if they are eventually removed.

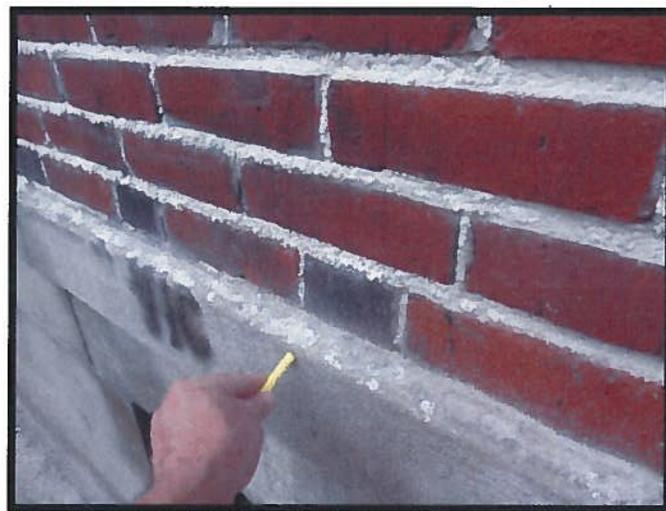
The water migration through the masonry has washed out the calcium and caused the mortar to turn to powder due to freeze-thaw cycles.

- The moisture content of the masonry should be checked at several locations on each exterior wall and a drying program initiated as needed. There are signs of significant “wash” across the front of the Warwick from the adjacent building on the west. The drying process could take as long as eight months.

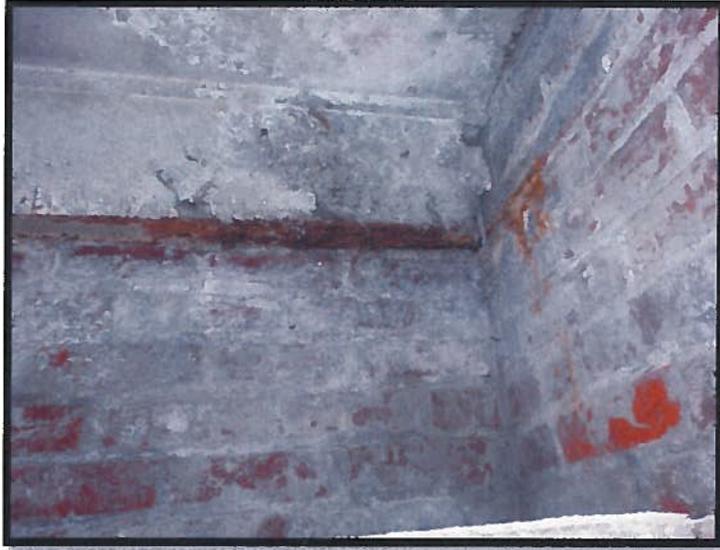
Corrosion of an embedded beam in the rear of the basement. Notice all the calcium deposits, too

- The corroded columns need to be reinforced at the base of each one.
- The corroded bearing plates where the beams pocket into the walls should be replaced.

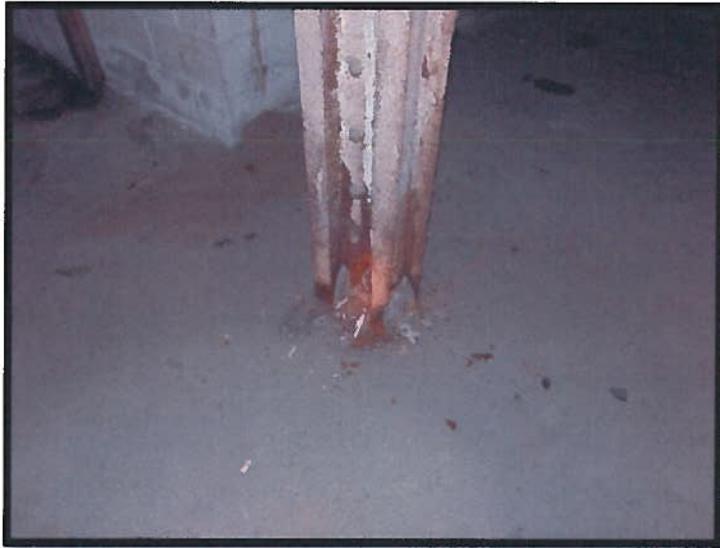
Extensive moisture damage was also observed in the basement. Advanced corrosion was noted at the bottom of the columns where they are embedded in the floor slab – the condition of the hidden portion is likely to be worse. These columns are made of steel angles and plates that were riveted together. Repairs would entail excavation of the area around the column, removal of rusted steel, and reinforcement with new steel plates or angles. The contractor doing the work should be prepared to install temporary shoring if the corrosion is found to be severe below the slab surface. The beams supporting the first floor also are corroded because there is no ceiling (or paint) protecting the bottom flanges and exposed areas of the webs. Additionally, moisture penetrating the concrete or masonry from multiple sources would be held against the steel, causing hidden corrosion. A few areas of the beams have been exposed, revealing that the corrosion has not advanced to the point of significant loss of cross-section, except where the bearing ends are buried in the exterior masonry.

Typical corroded column base. What is hidden within the slab and below is likely to be worse.

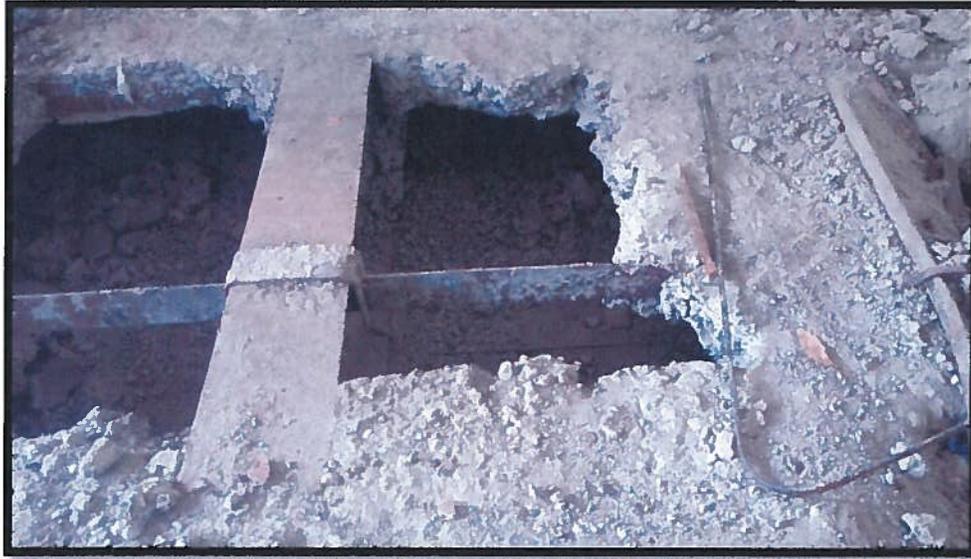
It appeared the roof had leaked substantially prior to the repairs, causing extensive damage to the ceilings, walls, and the flooring. There were concerns that the floor structure has suffered deterioration of the cinder concrete due to cycles of water saturation (the slag in the cinders expands), and that acids from the cinders are corroding the steel bars and beams within the concrete – corrosion damage is obvious on the seventh floor and to a lesser extent on the sixth floor. Therefore concrete cores were taken from the seventh floor in four locations (report attached). One was sent for petrographic analysis, and the other three tested for density and compressive strength. It was found that the long-term exposure to wetting cycles has indeed compromised the strength of the floor slab, as the range of values was reported to be from 2,640 psi (expected) to only 450 psi (alarmingly low). The lower figures indicate internal micro-fractures due to the slag expansion and freeze-thaw cycles; this may be further proved when the petrography results are received.

Seventh floor exploration of the cinder concrete system. It was found that the concrete under major roof leaks was extremely weakened and brittle, and should be replaced.

- The roof structure should be replaced in its entirety, and portions of the parapets rebuilt.
- The limited testing program indicates that the concrete floor slab at the seventh floor has areas that are significantly deteriorated. A more thorough testing program may identify the limits of those areas, but for the moment it is recommended that the entire seventh floor and sixth floor be scheduled for replacement of the concrete; the second floor should be investigated due to water intruding from 1920 Sansom. With careful analysis, it is probable

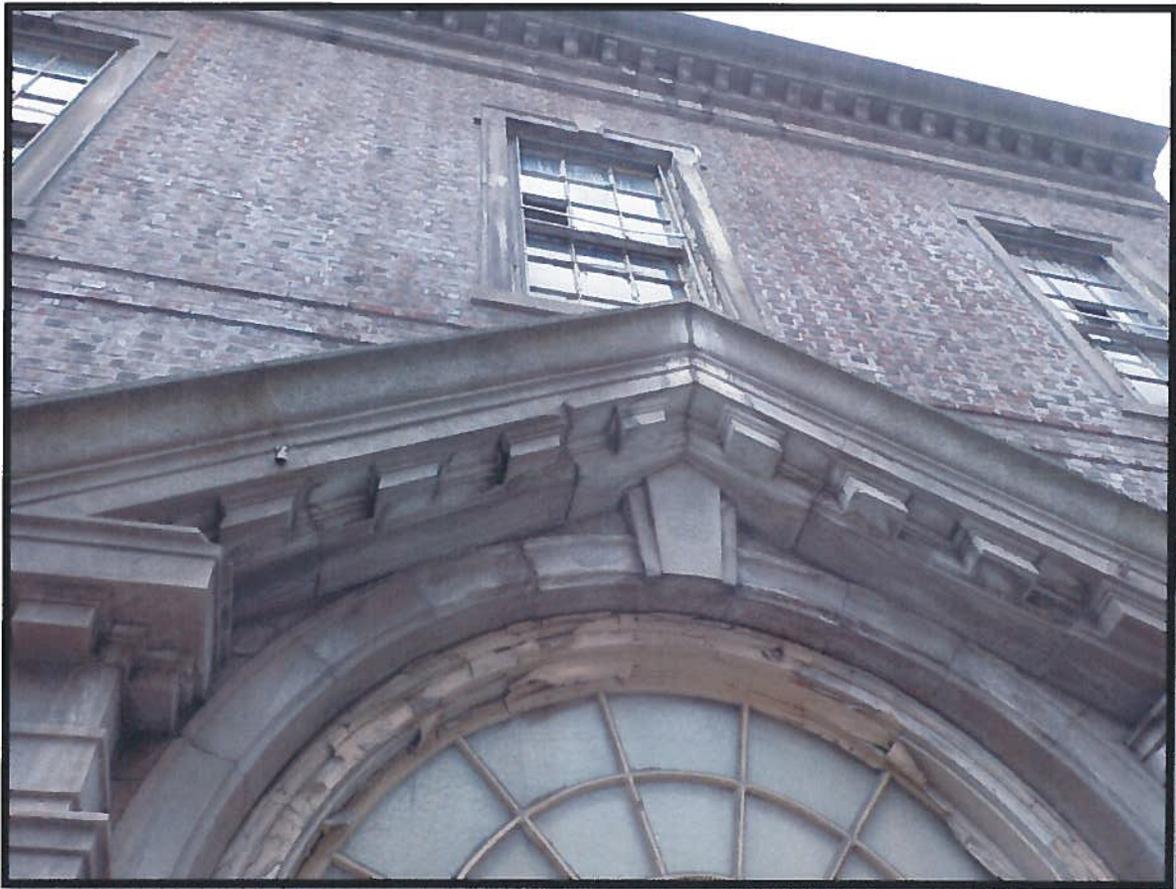
All of the exterior walls consist of multi-wythe brick masonry. The front face has carved limestone ornamentation, stained green from algae and lichens. Most of the front wall is coated with salt deposits from efflorescence, and several bed joints were turning to friable powder. Sections of the plaster stucco covering part of the west wall (a party wall that may consist of soft "salmon" brick) is peeling off as a result of long-term water intrusion and should be removed; the condition of the underlying brick should then be examined and addressed as necessary.

A tremendous volume of water permeation over many years left extensive salt deposits and damaged embedded wood elements such as window frames.

- Multiple passes on the front façade will be necessary to clean the stone and draw out some of the crystalized salt deposits embedded in the brick. However, because most of the back-up (interior) brick has been so weakened by freeze-thaw cycles, it is recommended that the entire front wall be reconstructed

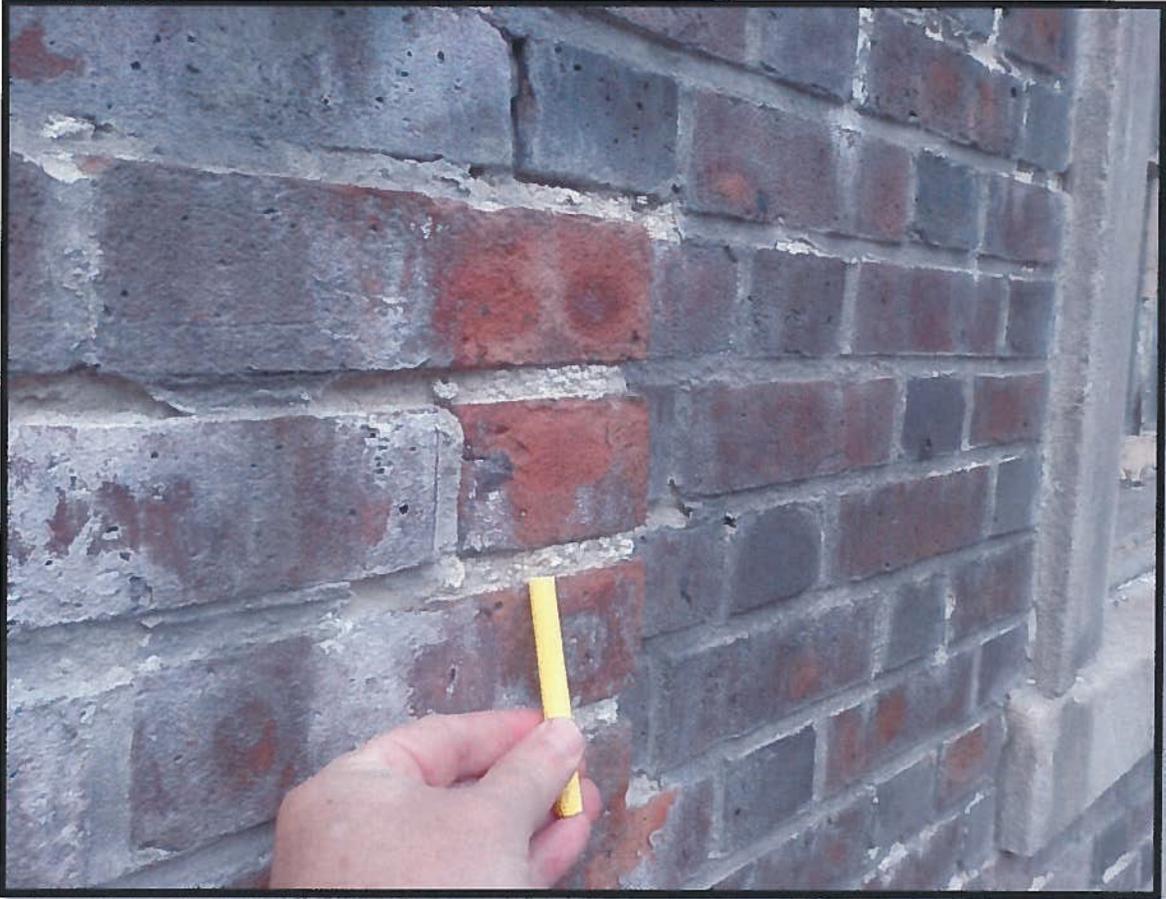
The water migration has washed out the calcium and caused the mortar to turn to powder due to freeze-thaw cycles.

- After the masonry is sufficiently dried out so as to not trap moisture in the core of the walls, all exterior and interior faces of the masonry would have to be re-pointed; and in the case of the west wall, the application of the stucco would follow if it is needed

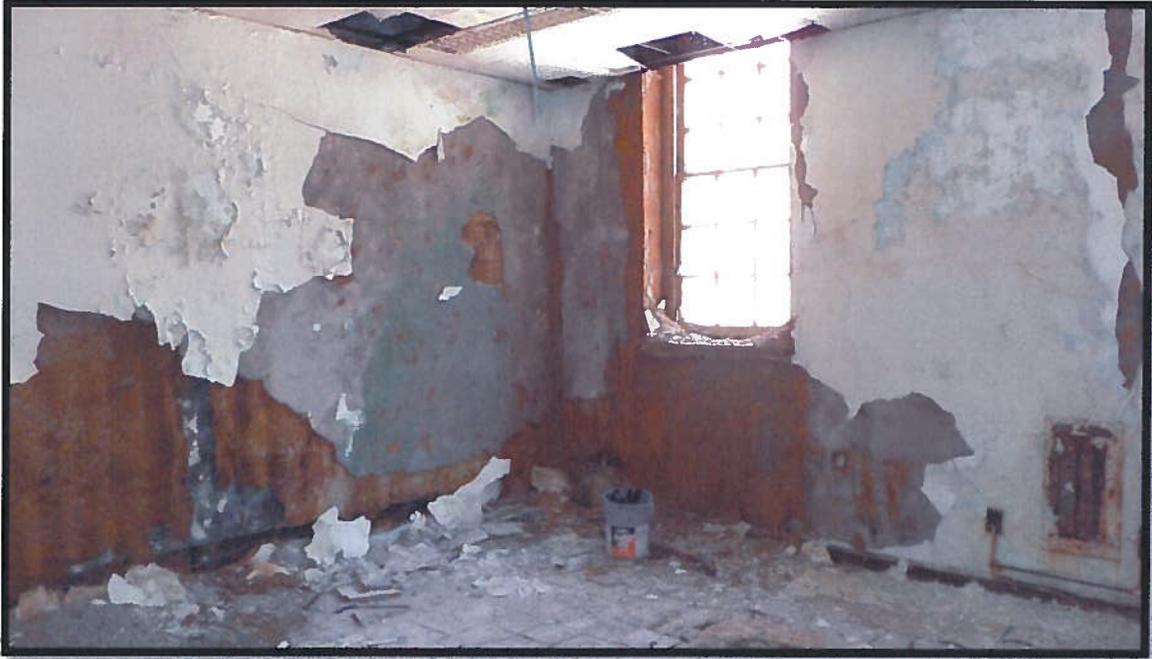
Checked from the interior, the front wall and portions of the side walls were saturated from roof to first floor, with mold growing on all finishes. Two sample bricks were removed from the wall, one from the exterior and the other from the interior face; both were found to be saturated and have completely wetted the sealed bags in which they are stored. We observed advanced deterioration of the bricks and mortar behind the wall finishes, especially above the second floor. The extent of damage will require reconstruction of most of the front wall and portions of the side walls.

Condition of the wire mesh that supported the plaster on the second floor. Behind this, the salmon brick is saturated. Many bricks are crumbling from freeze-thaw cycles and must be replaced, or the wall rebuilt.

- Remove (and eventually replace; see below) the stucco on the outside face of the west wall
- In some areas of the side and rear walls the inside wythes of brick should be cut out and replaced due to excessive freeze-thaw degradation

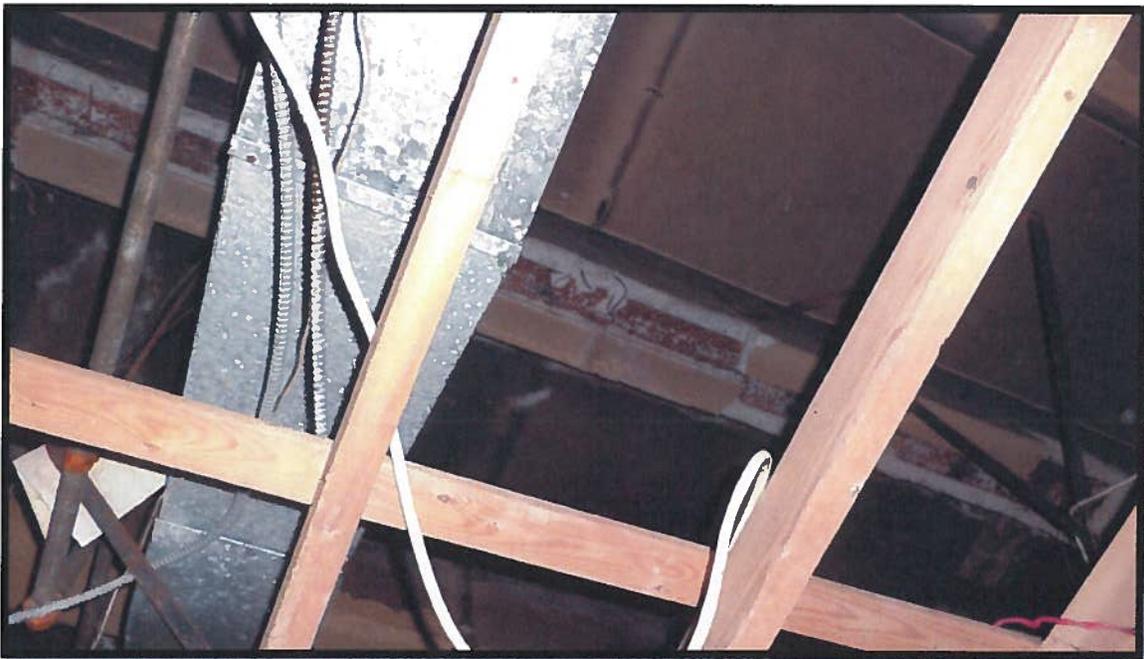
The front spandrel beams for the second floor and roof are partially embedded in the front wall and were found to be suffering corrosion within the concrete encasement². Other beams have less severe corrosion – although the extensive failure of the concrete fireproofing around the beams suggests rust jacking of the steel surface caused by the moisture. Likewise there is significant corrosion where the beams pocket into the walls.

Concrete encasement is spalled at the underside of the beam due to corrosion (rust jacking).

- The concrete encasement removed from the internal steel beams, and the beams reinforced where corrosion is found, cleaned, painted and fire-protected
