**Existing Mechanical, Electrical, Plumbing, and Fire Protection Conditions Report by
Edwards & Zuck Consulting Engineers**

1904, 1906, 1920 SANSOM MEP/FP Existing Building Narratives

October 8th, 2015

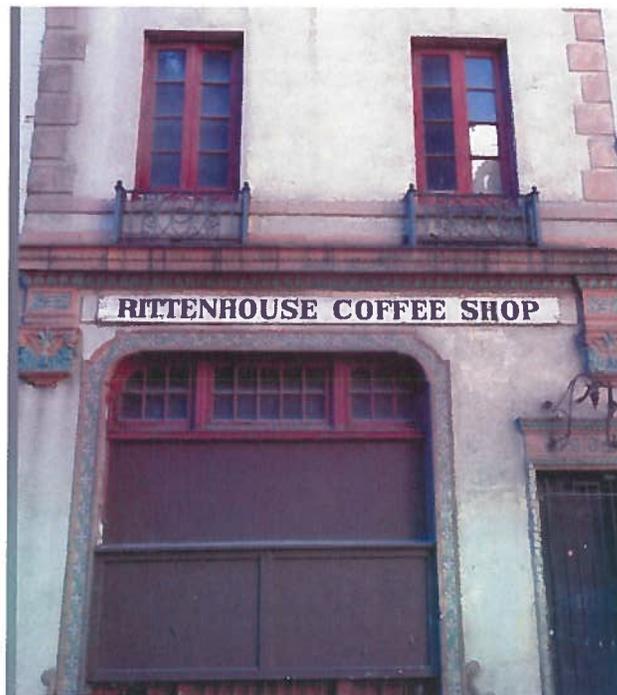
- 1) Electrical
 - a) The existing building is served by an existing electrical service that is estimated to be sized at about 400 amps. We were unable to open the service end box due to the fact that PECO owns and operates the enclosure.
 - b) The service end box provides power to two 200 amp feeds. Each feed has its own direct meter owned by PECO which monitors the consumption of the respective service switch.
 - c) One service switch serves the old coffee shop on the first floor of the building. The other service accommodates an existing meter ray assembly with four, 208v, single phase meters and enclosed circuit breakers. Three of the four meter assemblies serve condo units on the upper floor of the building. The fourth meter assembly serves house loads for power and lighting in the corridor and cellar areas.

- d) All distribution has outlived its useful lifespan and is recommended to be replaced/ removed.
- e) The existing service is of adequate capacity to serve some of the options outlined in the proposed building narrative. Depending on whether PECO deems the existing condition of the service to be adequate or not, this service could potentially be re-used to serve the new program. All distribution will be required to be disconnected, removed, and re-configured for the new proposed layouts.

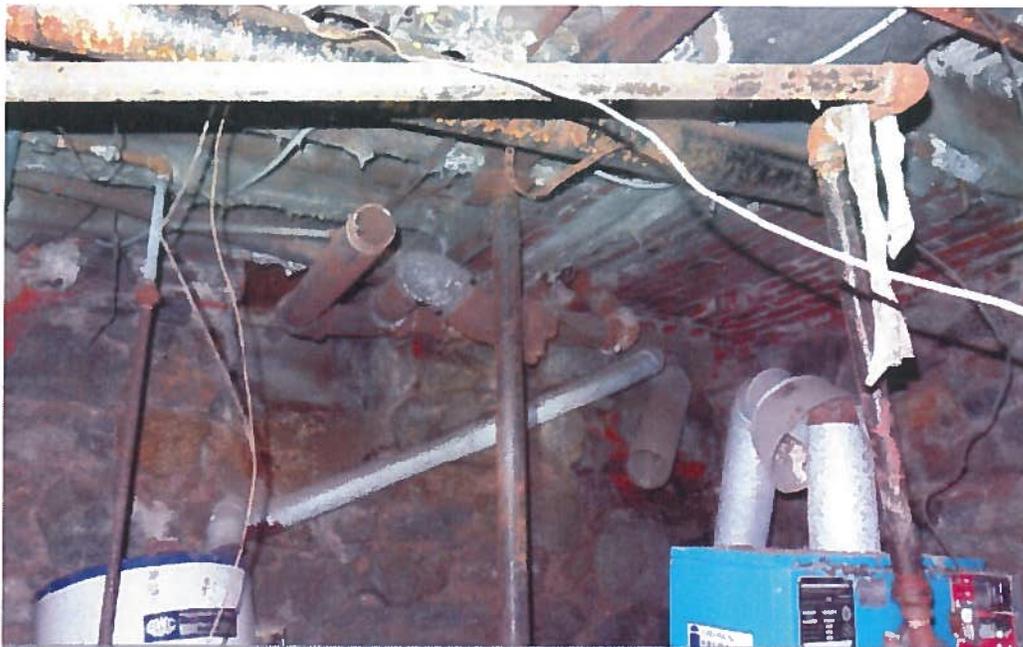
- a) Gas
The existing building contains a 1" incoming gas main. The gas main was not metered and is non-operational. Gas piping throughout is black steel. Piping throughout is in fair condition.

- b) Water
Water service for the building appears to come from Moravian Street. Exact location could not be determined in field. Piping into the building is 3" ductile iron. Piping is corroded throughout & in poor condition. There was no backflow prevention device located within the building, as required by code. The water service is currently not active.

- c) Sanitary
Sanitary piping throughout the building is extra-heavy cast iron (XHCI) with hub & spigot fittings. Various areas of sanitary & vent piping appear to have been modified with cast iron no-hub pipe & fittings. There were no house traps visible within the cellar, as required by code. Sanitary system piping is in poor condition & corroded throughout.

- d) Storm
There was no storm water system visible within the building, as required by code.

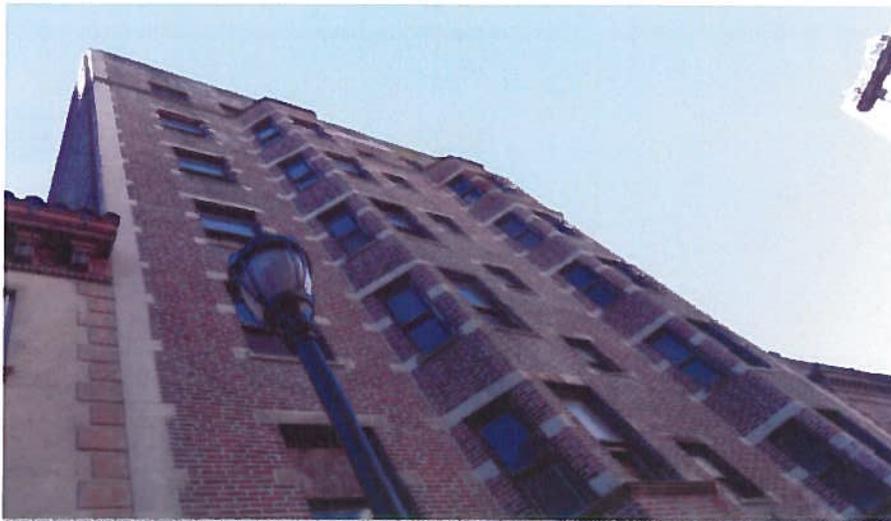
- a) The existing building is accommodated by one electrical service. The service end box feeds two 400 amp, 3-phase, 4-wire service switches serving meter arrays. Each of the meter arrays are composed of 16 tenant 120/208v, 1-phase, 3-wire, 60 amp feeds and meters.

- b) There are two additional existing service switches which are dedicated to house loads. One switch and associated meter serves the elevator equipment, while the other appeared to serve house corridor / stair lighting and power. All service switches are direct metered by PECO.

- c) All existing feeders to the tenant panels from the existing metering arrays was observed to be achieved via knob and tube. This installation is prohibited by the current National Electrical Code and should be removed and ultimately replaced with a modern means of distribution.

- d) Each tenant has a 120/208v, 70 amp lug, 1-phase, 3-wire panelboard to distribute branch wiring throughout.
- e) All distribution has outlived its useful lifespan and is recommended to be replaced/ removed.

- f) The existing PECO service may be able to be re-utilized, but all existing electrical distribution will be required to be disconnected, removed, and re-configured to achieve any of the newly proposed options for this address.

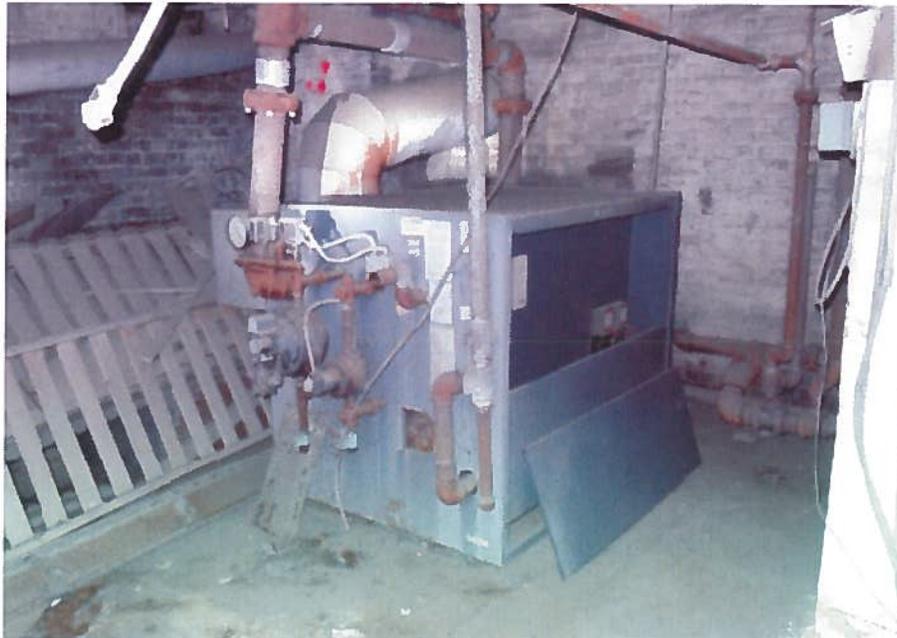
The existing building contains a 3” incoming gas main with meter. The gas service is non-operational. Existing piping within the building served the boiler & gas cooking fixtures at each apartment. Gas piping throughout is black steel. Piping throughout is in fair condition.

Water service for the building could not be determined in field. (1) Existing domestic water pump is located within the cellar. Pump discharge piping is corroded throughout & in poor condition. There was no backflow prevention device located within the building,

as required by code. There was no domestic hot water heaters observed. The water service within the building is currently not active.

Sanitary piping throughout the building is extra-heavy cast iron (XHCI) with hub & spigot fittings. There were no house traps visible within the cellar, as required by code. Sanitary system piping is in poor condition & corroded throughout.

Storm water piping below grade is extra-heavy cast iron (XHCI) with hub & spigot fittings. Above grade, external building leaders run from the roof to the ground level. There were no house traps visible within the cellar, as required by code. Storm water system piping is in poor condition & corroded throughout.

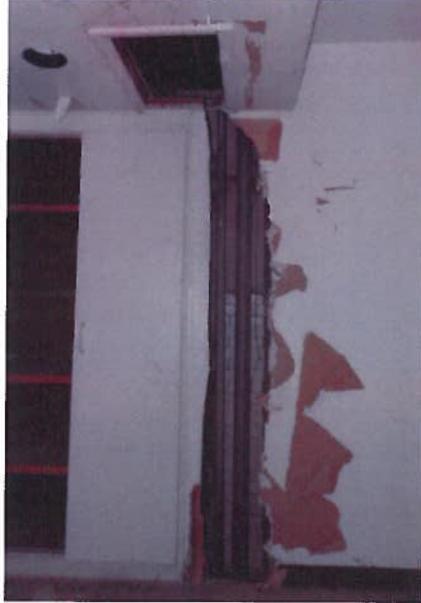
There is no Fire Protection system within the building, as required by code.
