5. INVENTORY

MIDVALE AVENUE

MIDVALE – ODD-NUMBERED SIDE

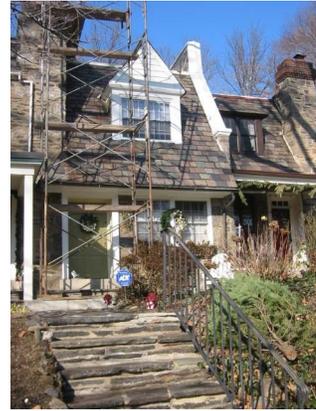
Front - Lamp: Replaced

Front - Second-Floor Steel Casement: Replaced with one/one double-hungs, artificial divided lights

Style Note: No door pediment or transom

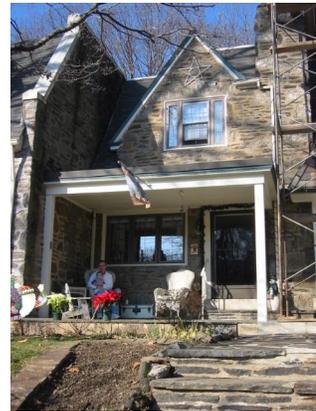
3407 Midvale

Exterior Physical Condition: Good

Roof - Slate: Slate replaced with asphalt shingles

Front - Lamp: Replaced

Front - Second-Floor Steel Casement: Replaced with one/one double-hungs w/ two flanking panes, artificial divided lights

Front - Storm/Screen Door: Replaced with aluminum storm door

Style Note: Flat roof porch; party wall acts as single wall to porch due to house setback

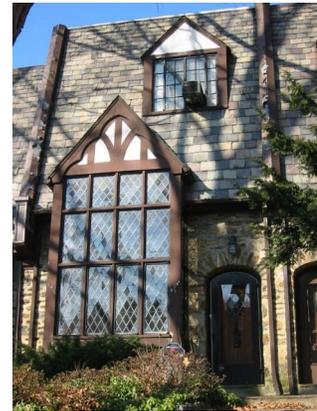
Front - Lamp: Replaced

Front - Second-Floor Steel Casement: Single muntin removed for air conditioning unit

Front - Storm/Screen Door: Replaced with aluminum storm door

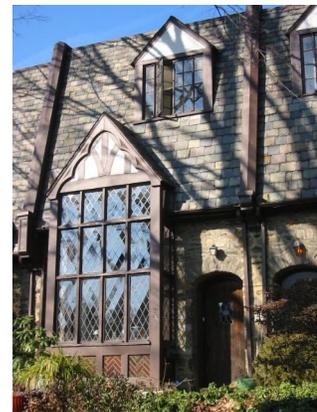
Front - Lamp: Replaced

Front - Door Leaded Glass Pane: Replaced with leaded glass, non-facsimile

Front - Second Floor Casement Surround: Aluminum clad sill

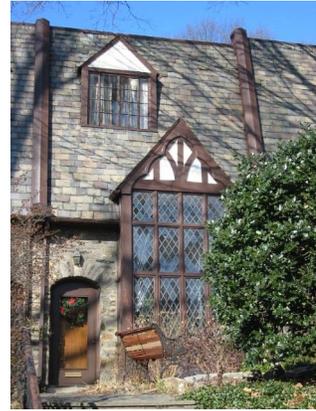
Front - Storm/Screen Door: Replaced with aluminum storm door

Front - Leaded Bay Surround: Aluminum clad sill

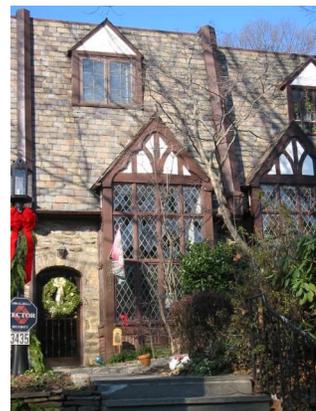
Front - Second-Floor Steel Casement: Replaced with two casement leaves, artificial divided lights

Front - Door Leaded Glass Pane: Leaded facsimile or original

Front - Storm/Screen Door: Replaced with aluminum storm door

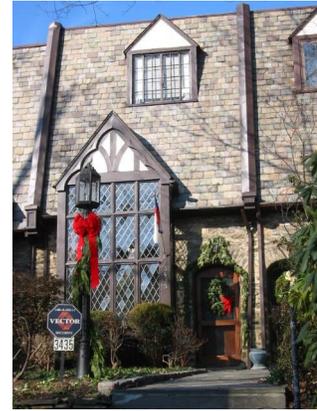
Front - Door Leaded Glass Pane: Leaded facsimile or original

Front - Storm/Screen Door: Replaced with wood storm door

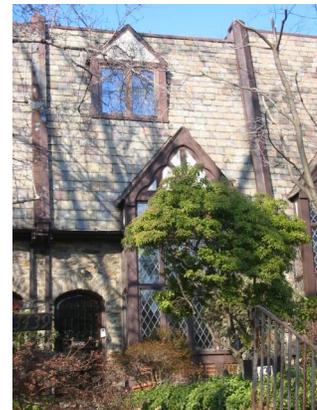
Front - Lamp: Replaced

Front - Second-Floor Steel Casement: Replaced with two casement leaves, artificial divided lights

Front - Door Leaded Glass Pane: Replaced with leaded glass, non-facsimile

Front - Storm/Screen Door: Replaced with aluminum storm door

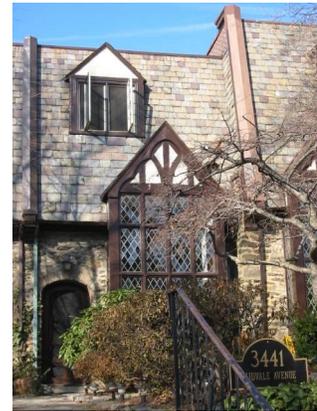
Front - Lamp: Replaced

Front - Storm/Screen Door: Replaced with storm/screen door

Front - Second Floor Casement Surround: Aluminum clad sill

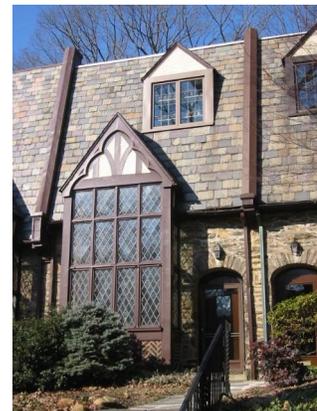
Front - Second-Floor Steel Casement: Replaced with two casement leaves, artificial divided lights

Front - Door Leaded Glass Pane: Leaded facsimile or original, damaged

Front - Storm/Screen Door: Replaced with aluminum storm door

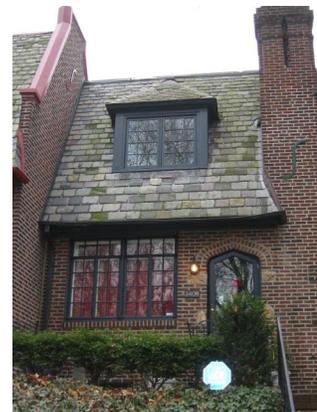
Front - Lamp: Replaced

Front - Second-Floor Steel Casement: Replaced with two casement windows, artificial divided lights

Front - Storm/Screen Door: Replaced with wood storm door

Front - Second Floor Casement Surround: Aluminum clad

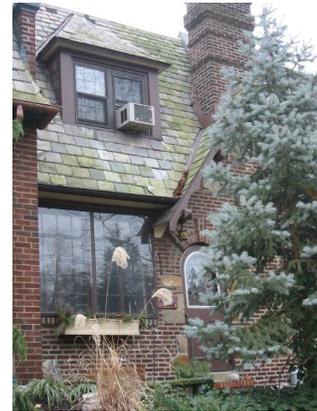
Front - Second-Floor Steel Casement: Replaced with one/one double-hungs, artificial divided lights

Front - Storm/Screen Door: Replaced with aluminum storm door

Front - Second Floor Casement Surround: Aluminum clad

Miscellaneous: Second floor window air conditioning unit added through window

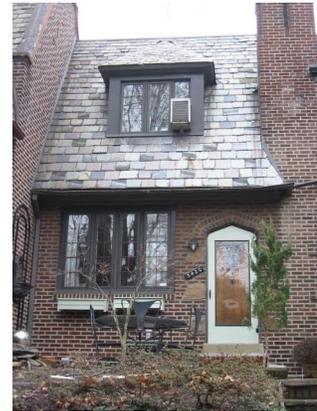
Front - Lamp: Replaced

Front - Second-Floor Steel Casement: Replaced with three casement windows, artificial divided lights

Front - Door Leaded Glass Pane: Replaced with solid pane

Front - Storm/Screen Door: Replaced with aluminum storm door

Front - Second Floor Casement Surround: Aluminum clad

Miscellaneous: Second floor window air conditioning unit added through window
