# Ellen Phillips Samuel Memorial–Central Terrace Conditions Assessment

## Final Report

Prepared for the City of Philadelphia by the  
Fairmount Park Historic Preservation Trust

April 2007

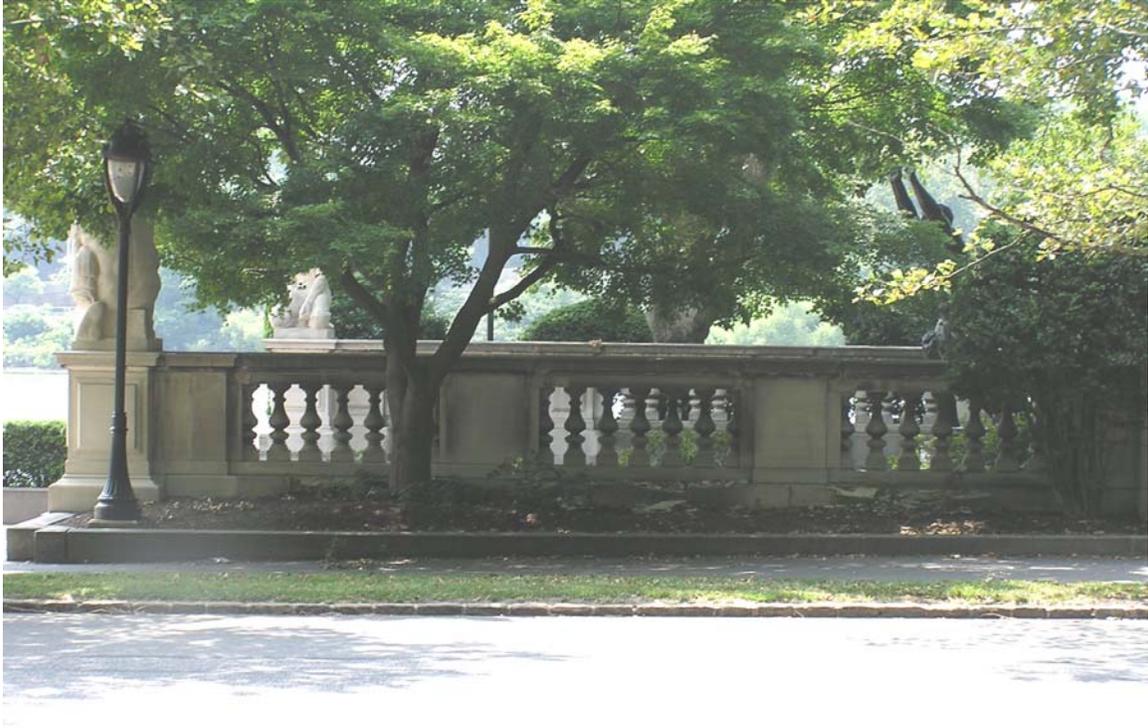
View of N-X-E Note the heavy shade causing biological growth and the mulched garden bed adjacent to the memorial.

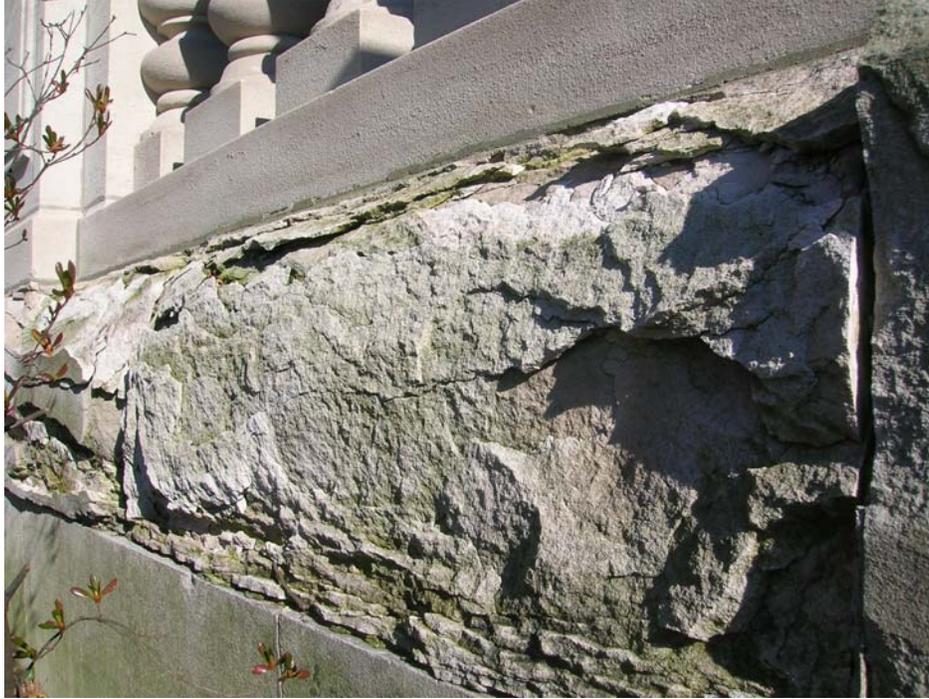
N-I-E 54 Example of a Crumbling piece of Pennsylvania Sandstone slated for replacement

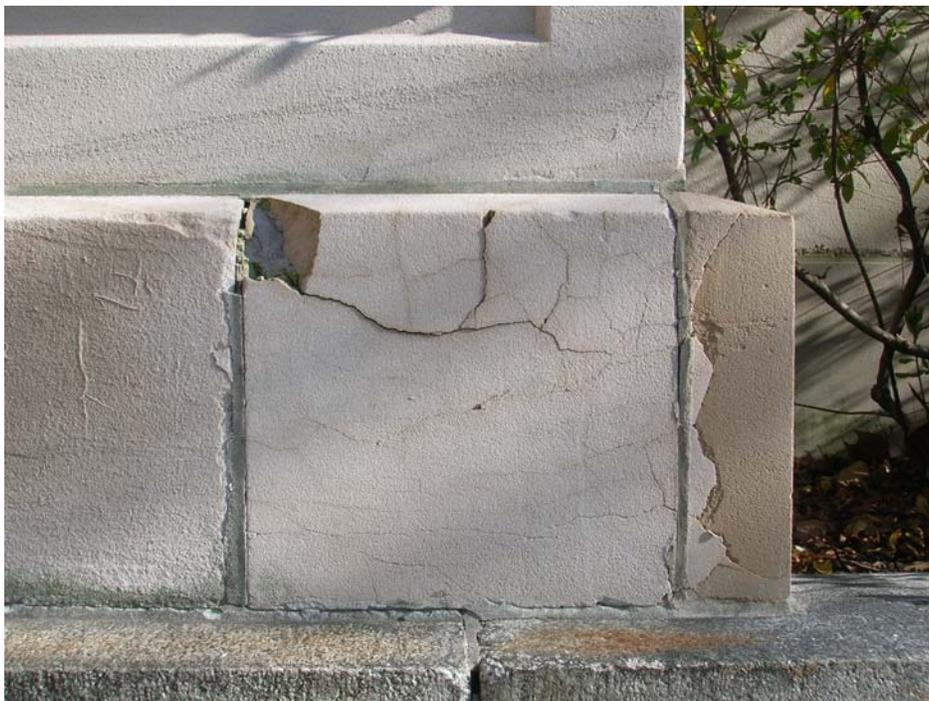
N-I-E 57 Inappropriate patch repairs that are beginning to fail

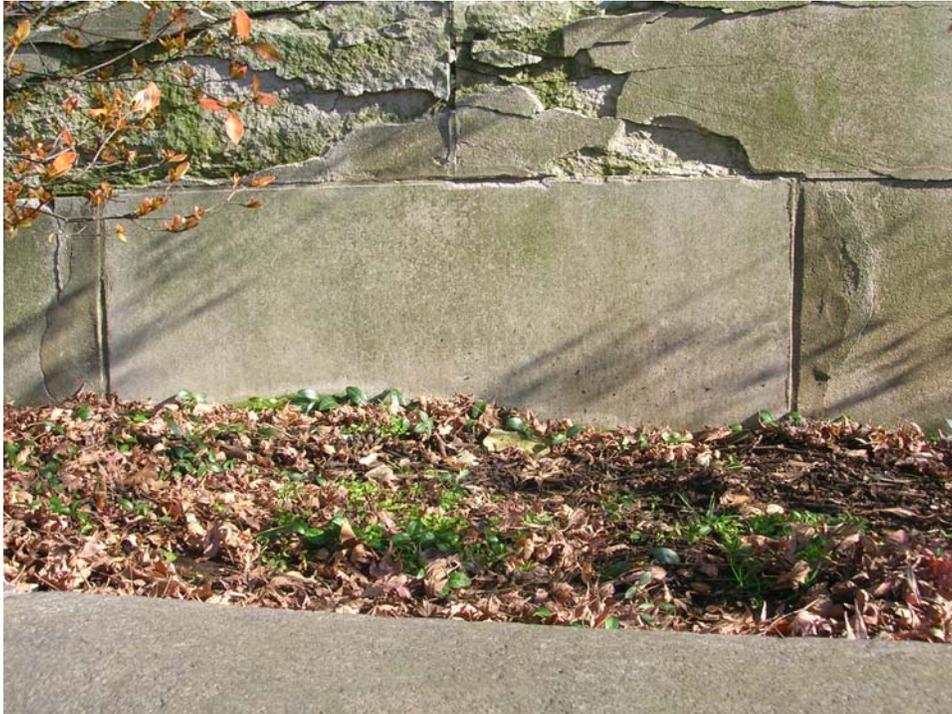
N-I-E 63. Composite stone replacement that matches in character and is weathering favorably

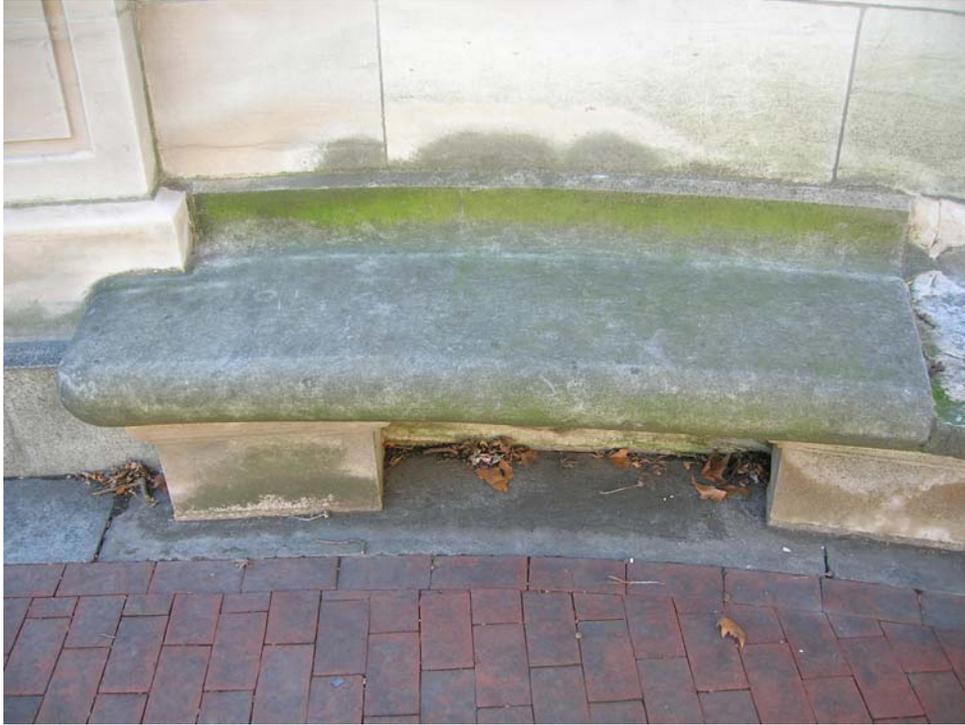
N-I-C 115 This stone exhibits severe biological growth and rising damp.

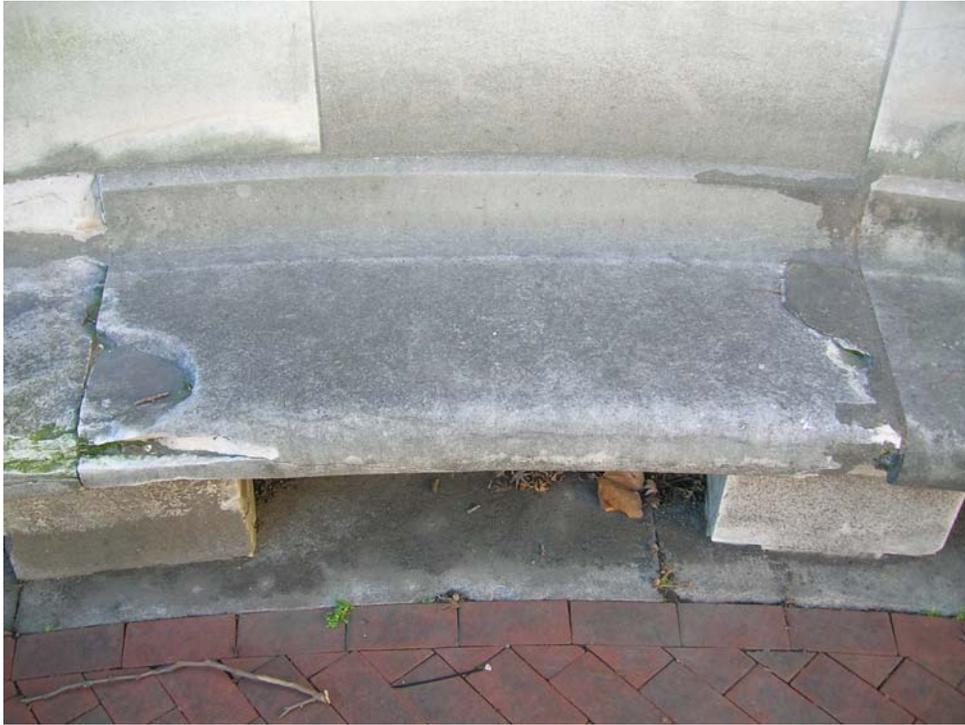
N-I-C 117

117	<b>N-C-117</b>	bench	chipping, cracking, inadequate patch, bio-growth	4 - poor	very soiled	Clean, Re-point, Patch, Fill Crack
118	<b>N-C-118</b>	bench	bio-growth	2 - good	very soiled	Clean, Re-point
119	<b>N-C-119</b>	bench	bio-growth	2 - good	very soiled	Clean, Re-point
120	<b>N-C-120</b>	bench	blistering, inadequate patch, bio-growth	3 - fair	very soiled	Clean, Re-point, Patch

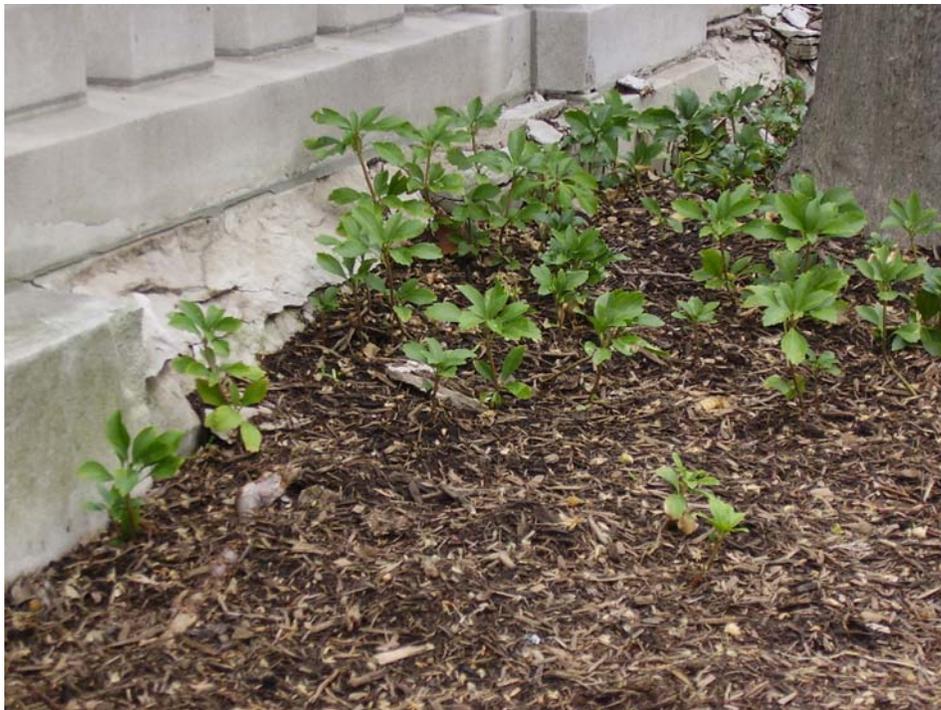
Prior to treating any of the damaged stone elements of the Central Terrace landscaping issues need to be resolved. Currently, mulch retaining moisture is piled adjacent to the stone in the planting beds. These areas are mulched on an annual basis and the beds continue to rise higher on the walls of the terrace. A design construction project engineer should be consulted to determine an appropriate drainage plan for these areas. In addition, many trees are planted close to the terrace. This is part of the intended landscape plan. When/if site drainage work is addressed possible root issues should also be discussed. Root barrier products can prevent roots from passing by a certain area. If the walls were surrounded by one of these products root damage could be prevented. Bio-barrier® is one product that could be used for this purpose. Throughout the landscape/drainage planning process a conservator should be consulted to ensure the treatment is appropriate for the stone.

Mulch Build-up on the  
Exterior, East side of the Central Terrace

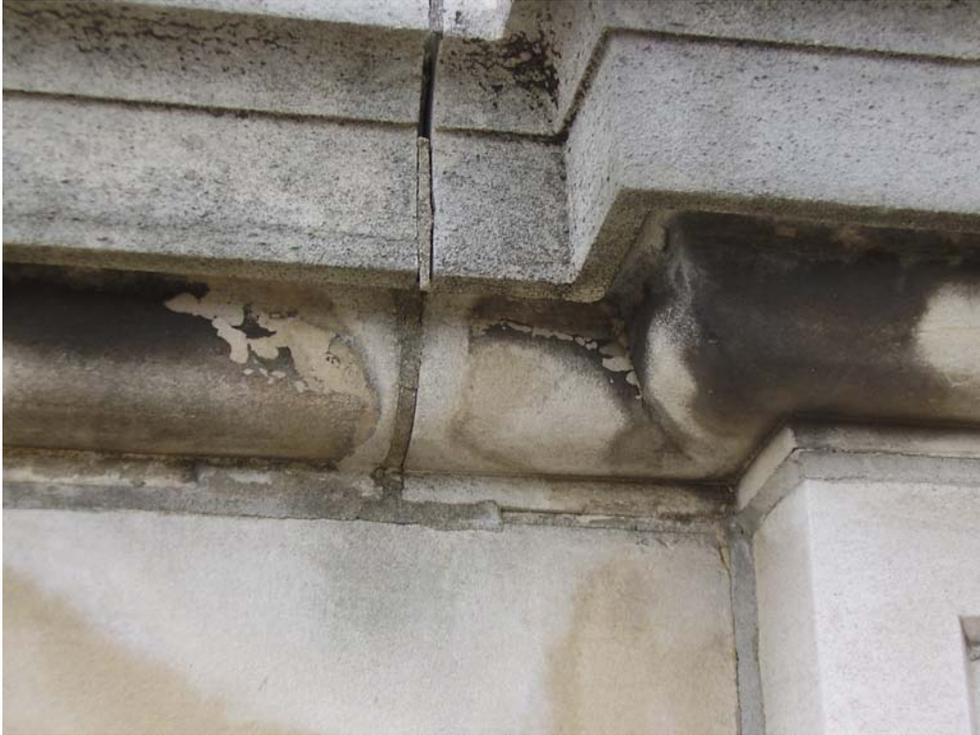
Surface Crusts on the underside of the capstones.

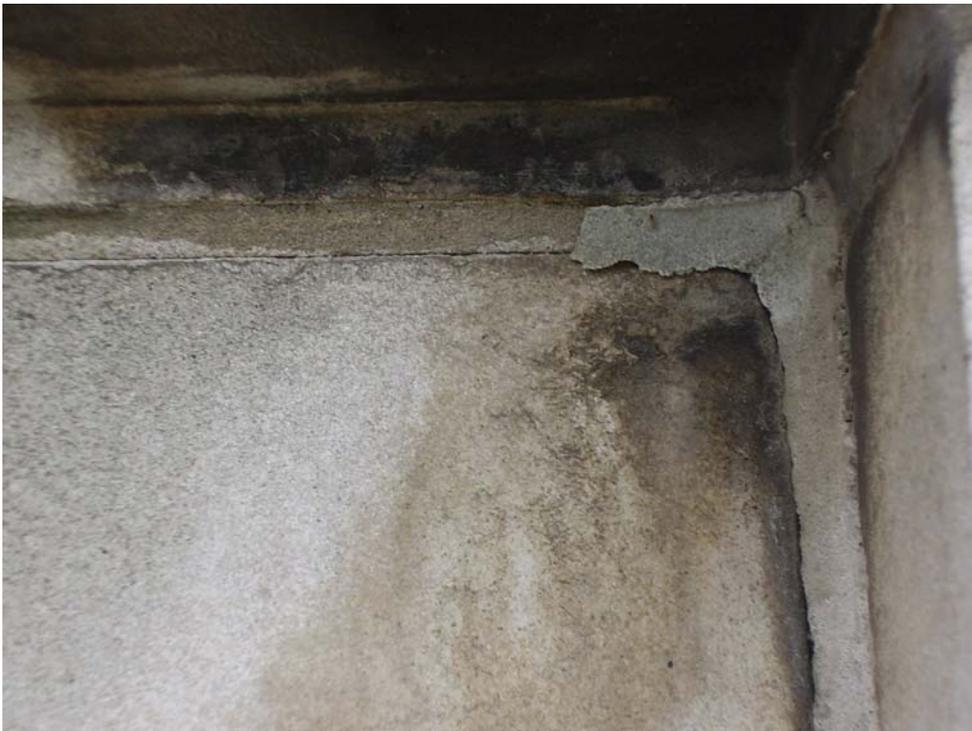
There are also a significant amount of open mortar joints throughout the terrace. In addition to open mortar joints, many joints have been “re-pointed” using inappropriate cement mortar. This mortar was installed on joints throughout the monument and in most instances the original mortar was not cut back prior to the installation of the new mortar. As a result, the cement mortar was installed over the edges of the joints of the stones. The cement mortar is beginning to spall off and is taking some of the sandstone and limestone with it. This is the cause of many of the small chips and stone loss on arrises of the stone.

Inappropriately applied Portland Cement mortar on a joint.

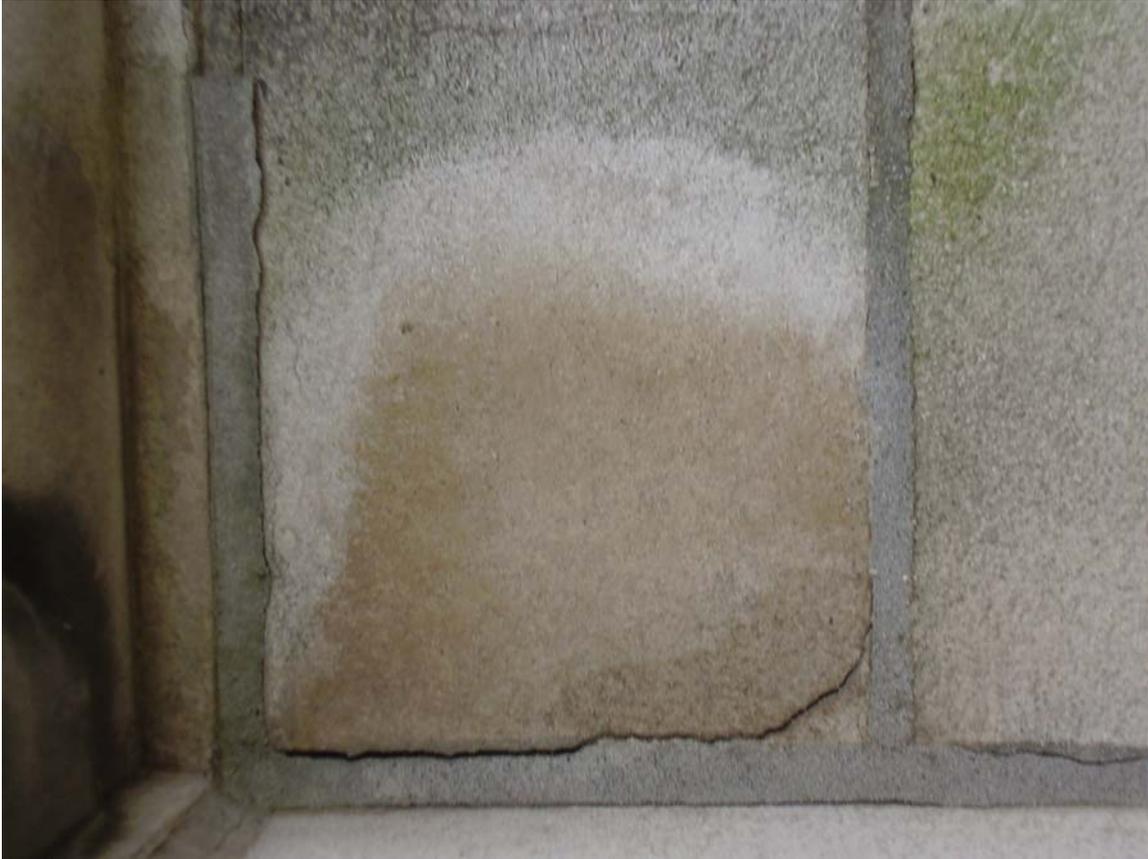
Portland Cement Mortar pulling away from the stone and taking some of the stone with it.
