# **PHILADELPHIA FIRE DEPARTMENT**

## **INVESTIGATIVE REPORT**

**BOX 6542 WOOLSTON AVENUE AND MIDDLETON STREET**

**LINE OF DUTY DEATH**

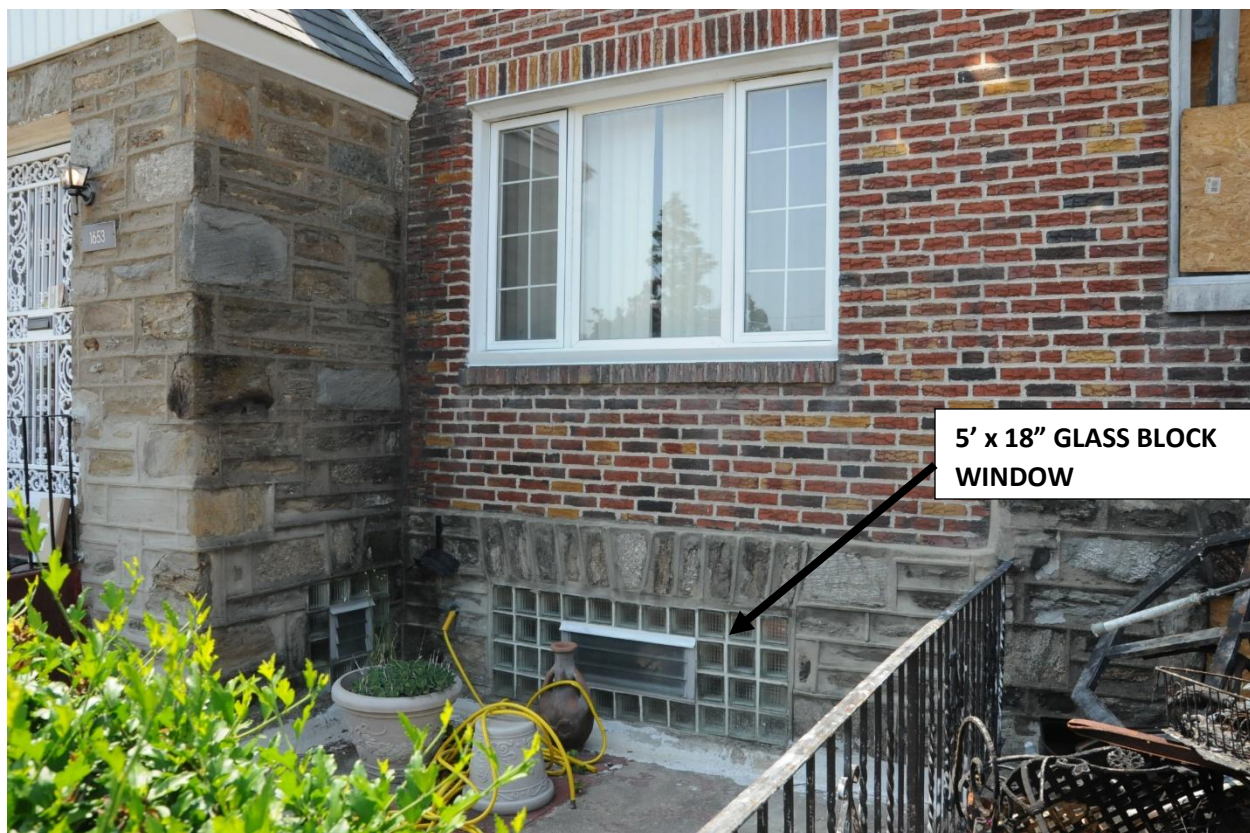
**PHOTO 3**

**5' x 18" GLASS BLOCK  
WINDOW**

**Front of 1653 Middleton Street - Bravo Exposure with similar 5' x 18" glass block front basement window.**

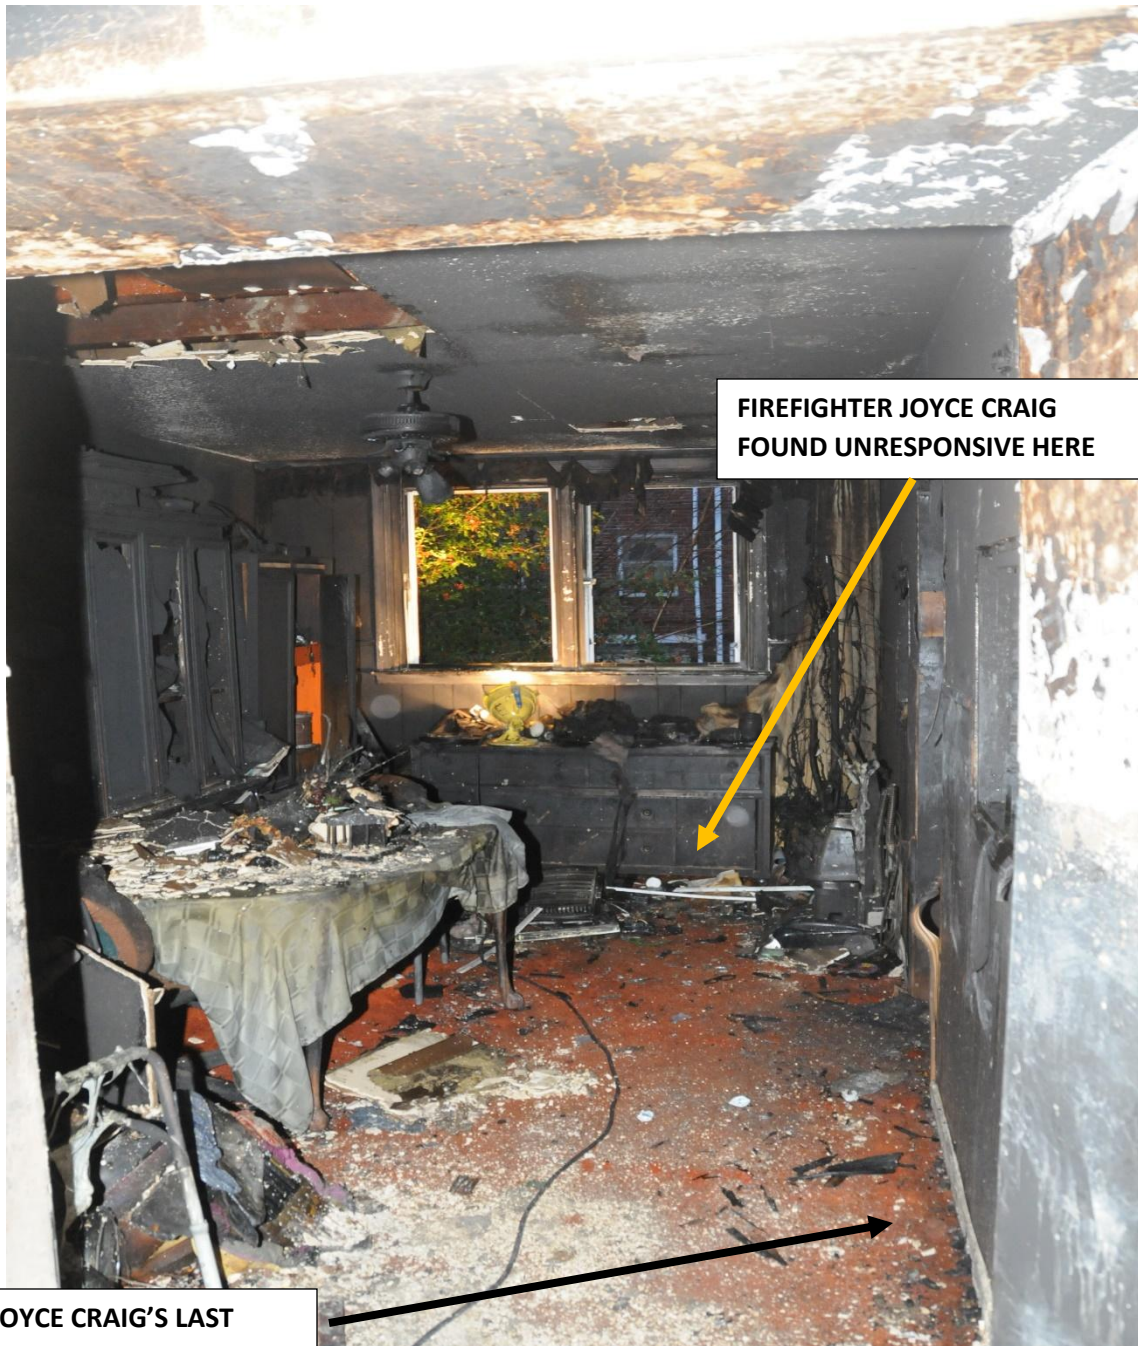
**PHOTO 7**

**FIREFIGHTER JOYCE CRAIG  
FOUND UNRESPONSIVE HERE**

**FIREFIGHTER JOYCE CRAIG'S LAST  
CONFIRMED LOCATION**

**Looking west from living room at entrance to dining room.**

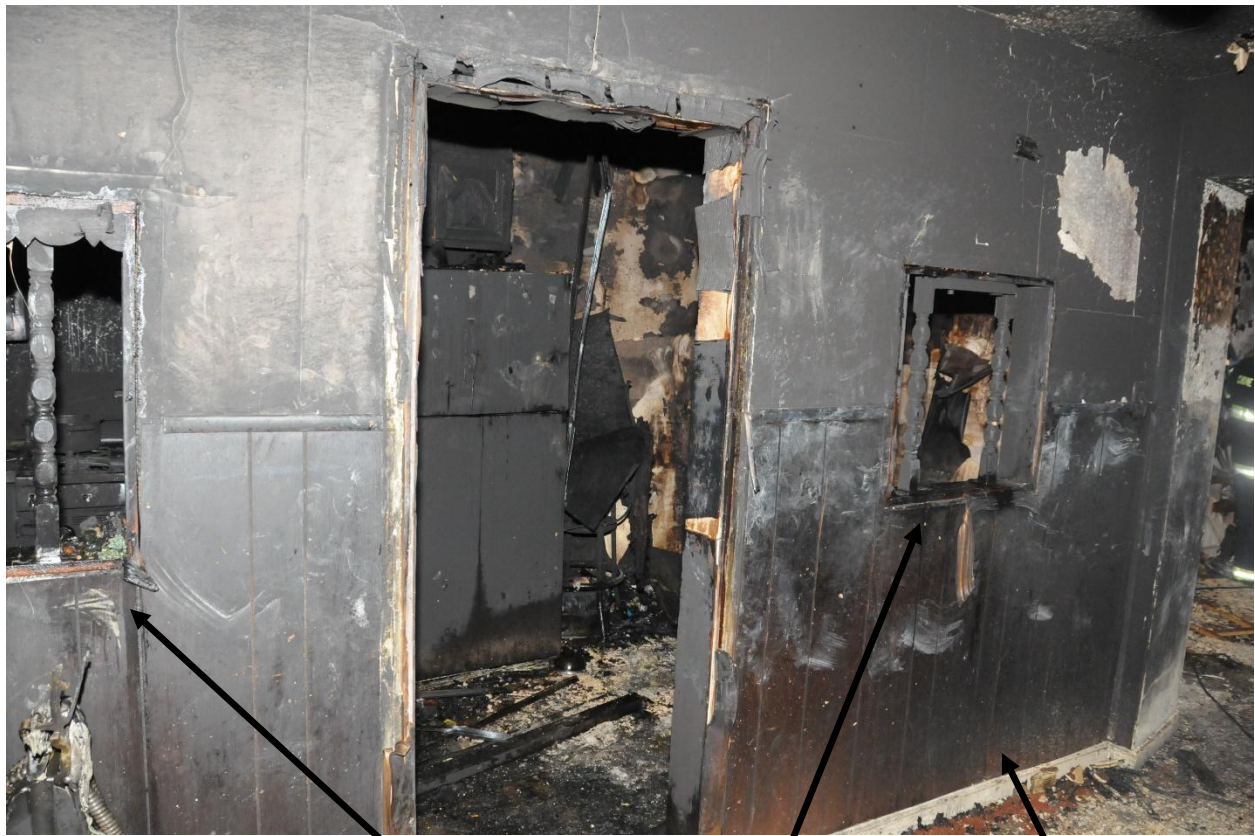
PHOTO 10

Dining room looking into kitchen.

DECORATIVE CUT OUTS  
IN KITCHEN / DINING  
ROOM WALLS

FIREFIGHTER JOYCE CRAIG'S  
LAST CONFIRMED LOCATION

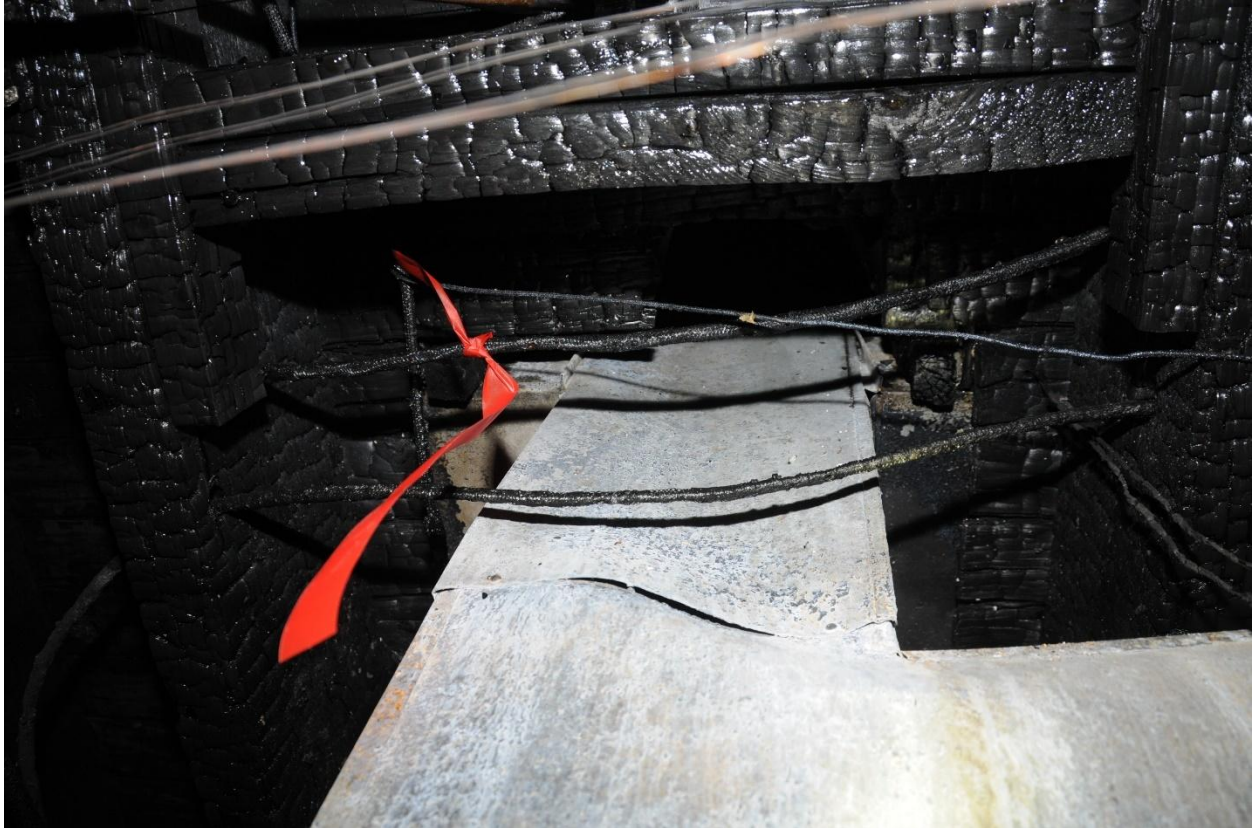
**PHOTO 16**

The fire grew to fully involve the entire recreation room. The fire then extended up the basement stairs and into the 1st floor kitchen, dining room, and living room. The 1st floor was heavily damaged by the fire. The fire spread via an interior ventilation shaft to involve and damage the ceiling / roof void space, or cockloft, as well.

**Heating Ventilation Air Conditioning (HVAC) shaft way to 2<sup>nd</sup> floor ceiling / roof void space (cockloft).**

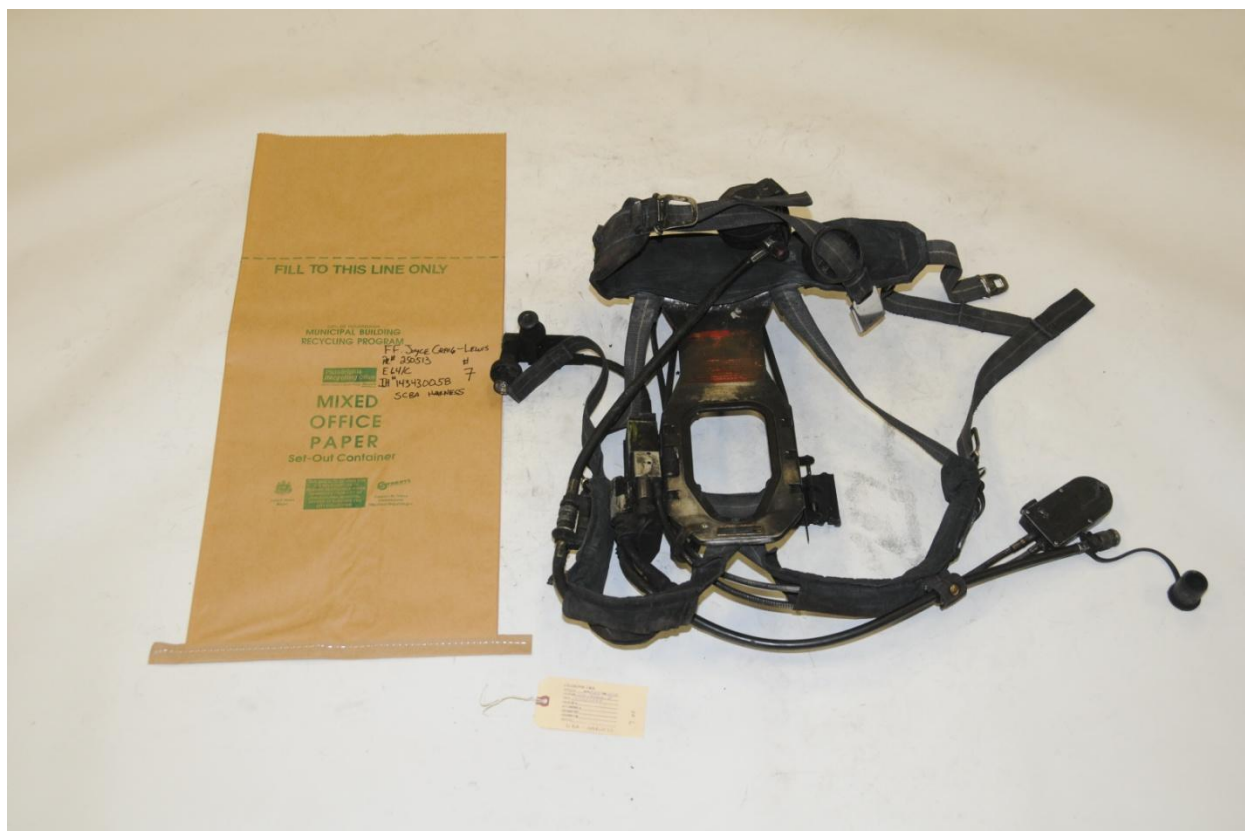
**PHOTO 17**

**Firefighter Joyce Craig's Self Contained Breathing Apparatus Harness.**

low pressure buddy breathing hose being burnt through, and she lost consciousness.<sup>3</sup> (See Photos 17 through 21)

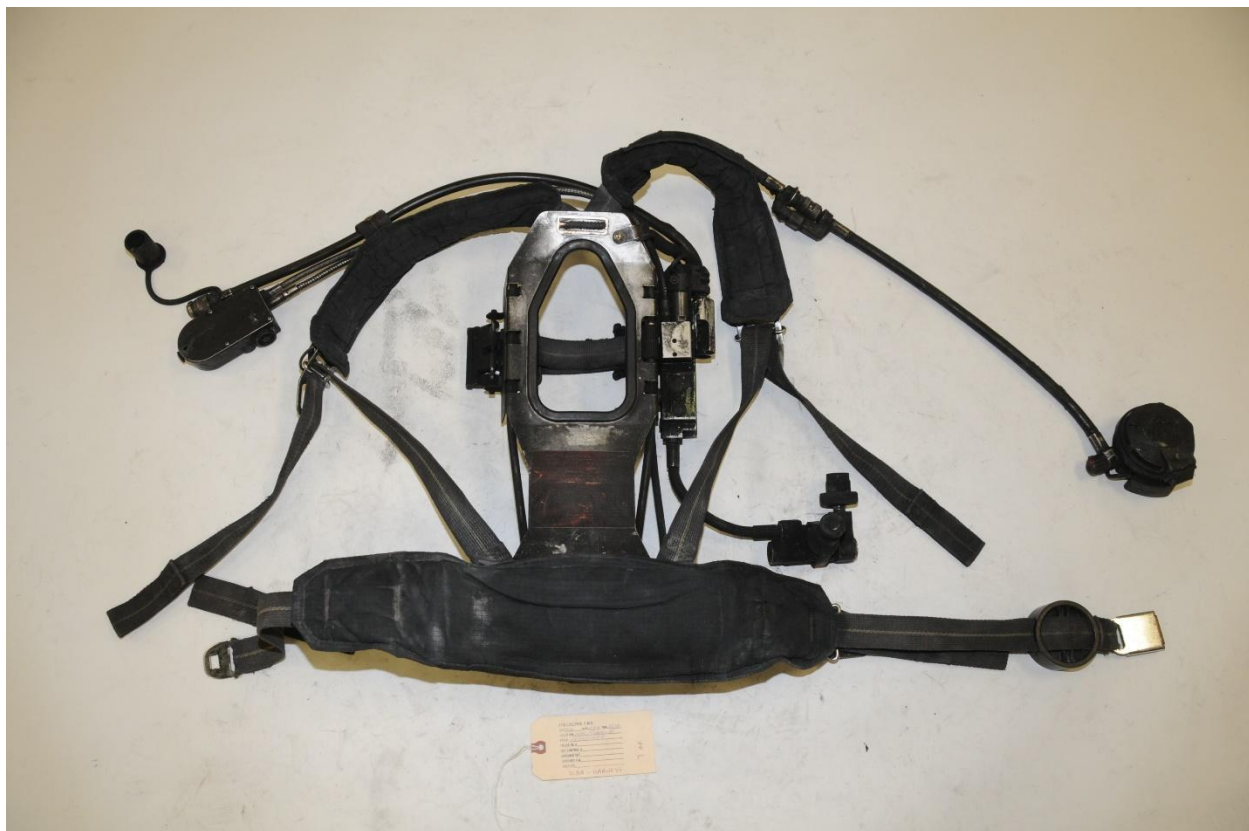
**PHOTO 18**

**Firefighter Joyce Craig's Self Contained Breathing Apparatus Harness. (Open)**

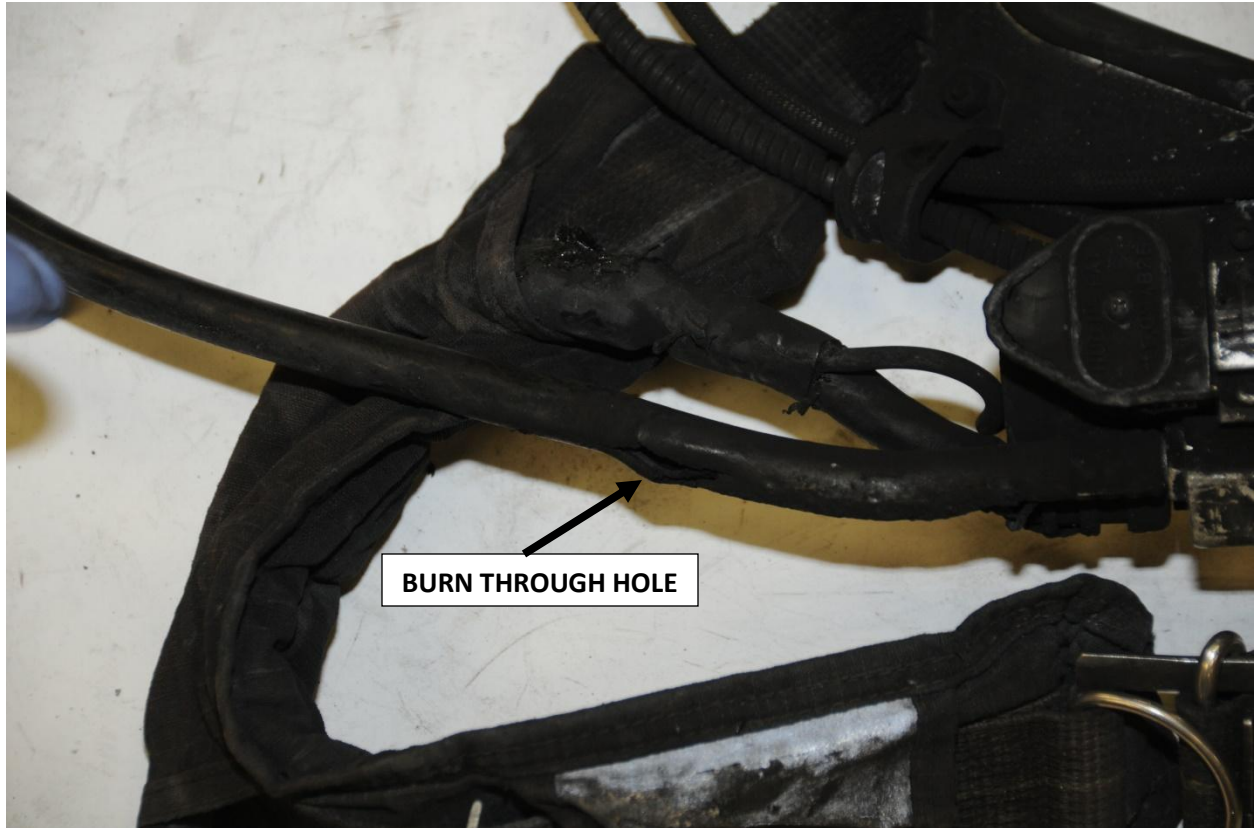
**PHOTO 19**

**Burn through hole in the low pressure buddy breathing hose on Firefighter Joyce Craig's Self Contained Breathing Apparatus Harness.**

The low pressure buddy breather hose was burnt through on Firefighter Joyce Craig's Self Contained Breathing Apparatus (SCBA)<sup>1</sup>. This caused a loss of Firefighter Joyce Craig's air supply, which led to Firefighter Joyce Craig running out of air in an Immediately Dangerous to Life or Health (IDLH) environment.

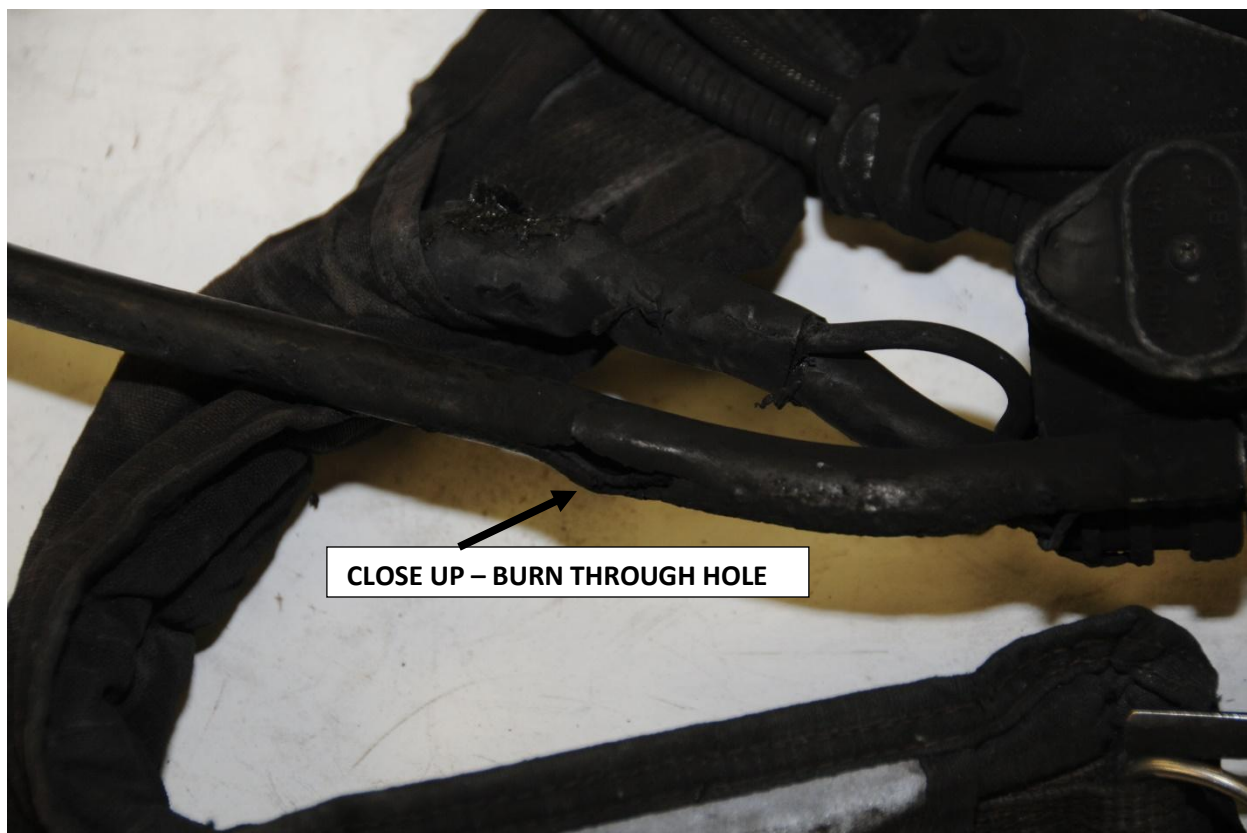
**PHOTO 20**

**Burn through hole in the low pressure buddy breathing hose on Firefighter Joyce Craig's Self Contained Breathing Apparatus Harness. (Close up)**

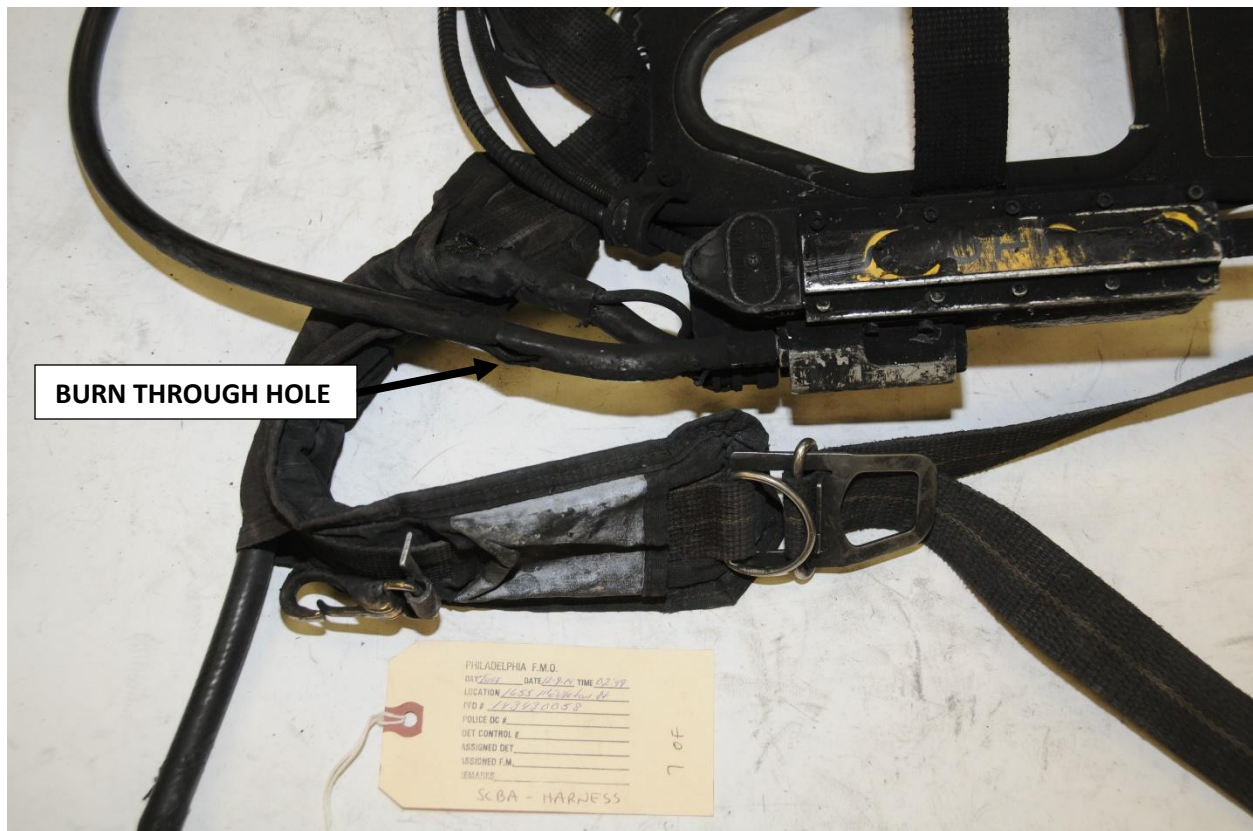
**PHOTO 21**

**Burn through hole in the low pressure buddy breathing hose on Firefighter Joyce Craig's Self Contained Breathing Apparatus Harness.**

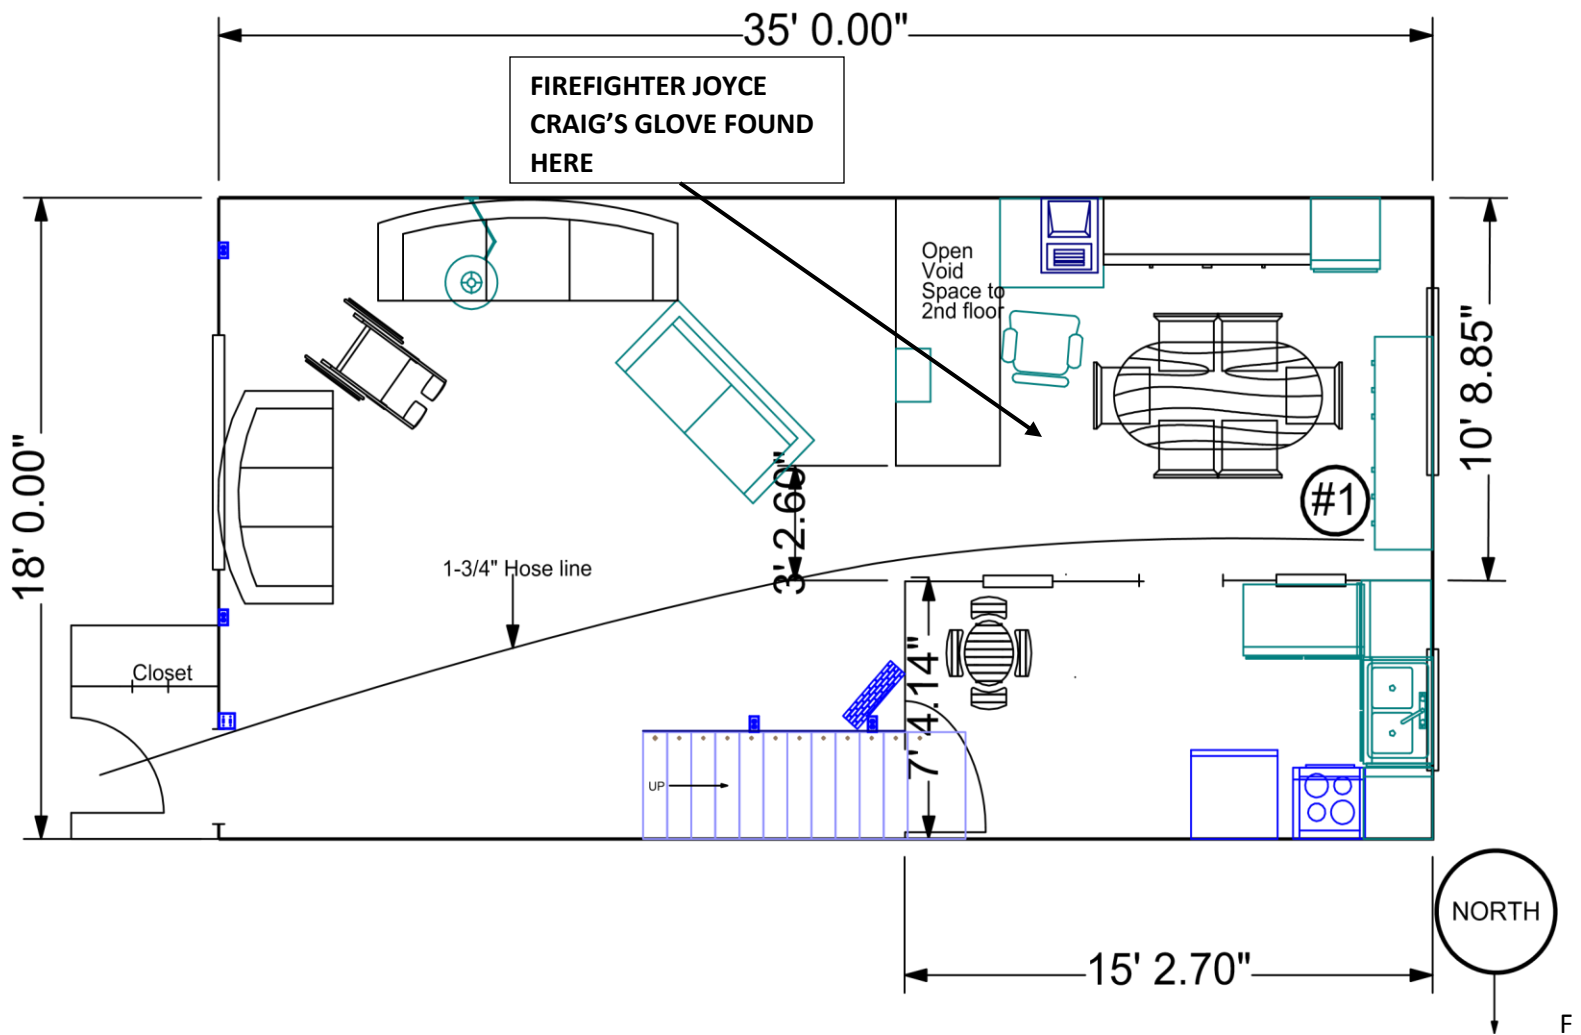
**DIAGRAM 6**

**1655 Middleton Street 1<sup>st</sup> floor.**

**Time: Approximately 0315.**

**#1 - Firefighter Joyce Craig found unresponsive at this location.**
