Factual Update

October 16, 2019

U.S. Chemical Safety and
Hazard Investigation Board

Fire and Explosions at Philadelphia Energy Solutions Refinery Hydrofluoric Acid Alkylation Unit

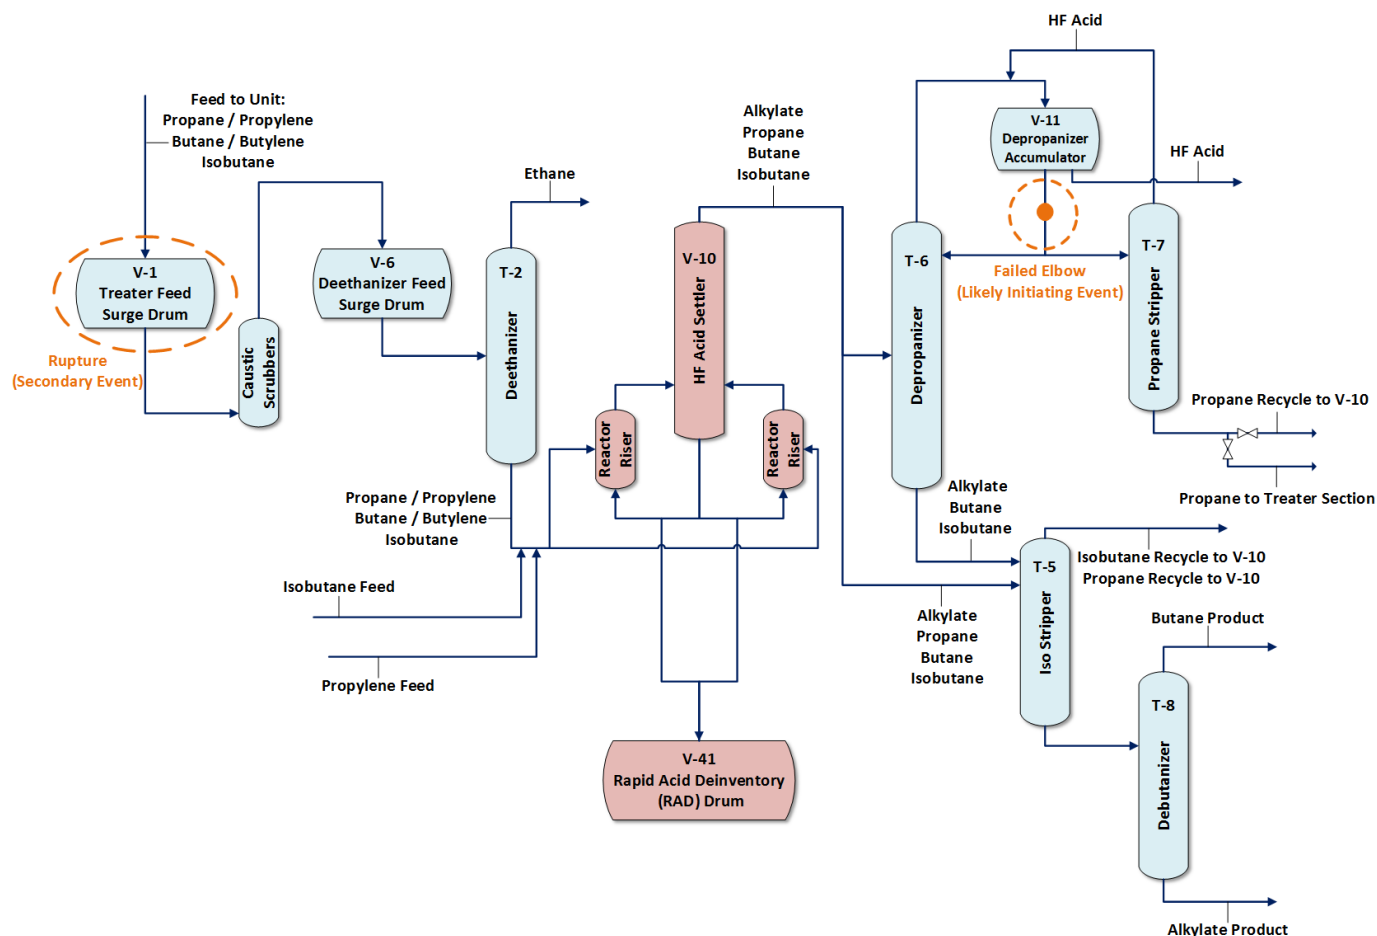
- A process flow diagram of the PES hydrofluoric acid alkylation unit is shown in Figure 2. Indicated on the process flow diagram in orange are two equipment failure locations of interest. These identified failures are discussed below.

Figure 2. Process flow diagram of PES hydrofluoric acid alkylation unit. The equipment shown in red is the hydrofluoric acid alkylation reaction section and the Rapid Acid Deinventory (RAD) drum, to which the hydrofluoric acid can be routed. (Credit: CSB).

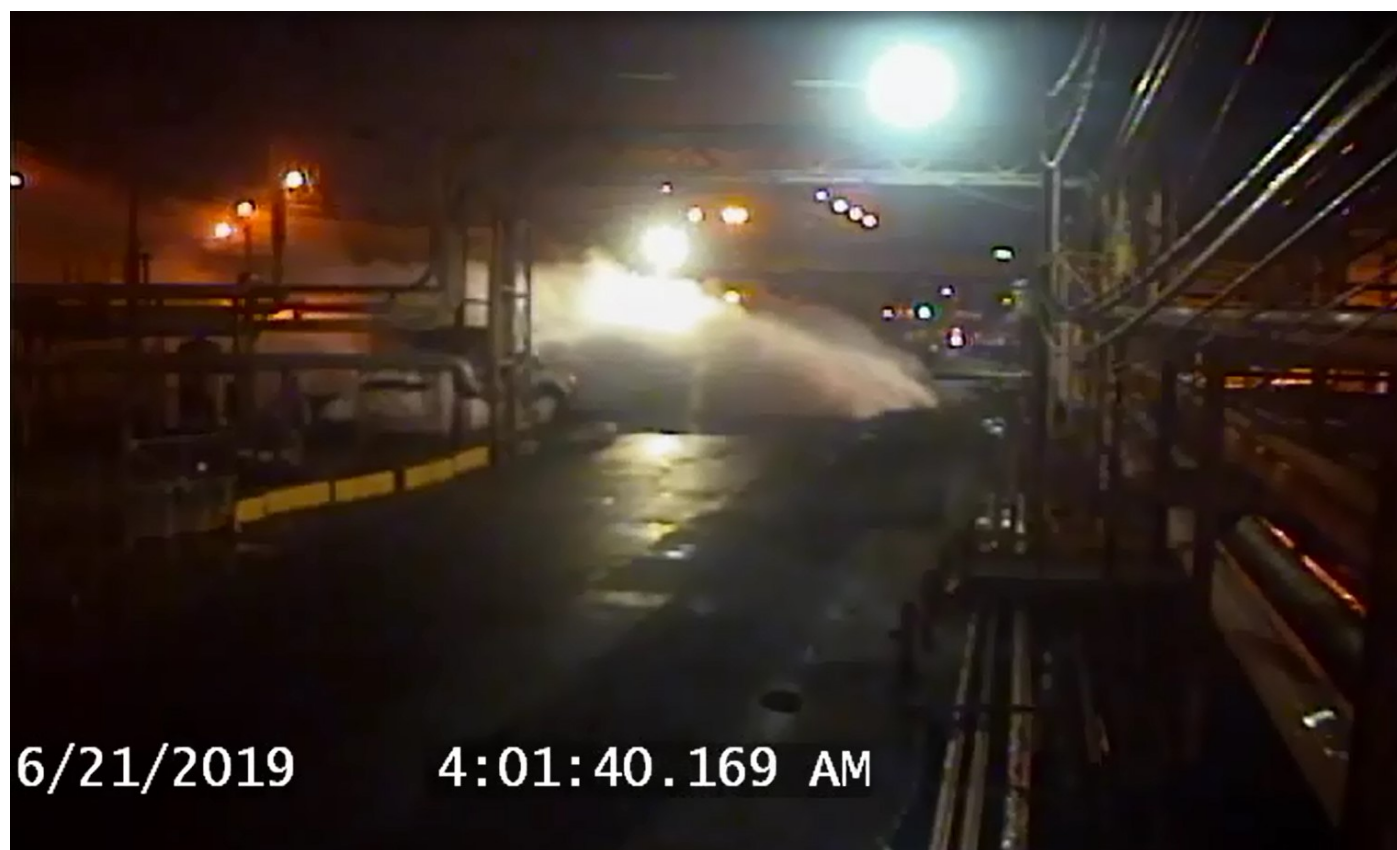
- During the early hours of Friday, June 21, 2019, the HF alkylation unit was reportedly operating normally.
- At 4:00:16 am, there was a sudden loss of containment causing flammable process fluid containing hydrofluoric acid to release from the PES alkylation unit, forming a ground-hugging vapor cloud (Figure 3).

Figure 3. Security camera footage of leaking process fluid. It formed a large ground-hugging vapor cloud that surrounded some sections of the unit. (Credit: PES).

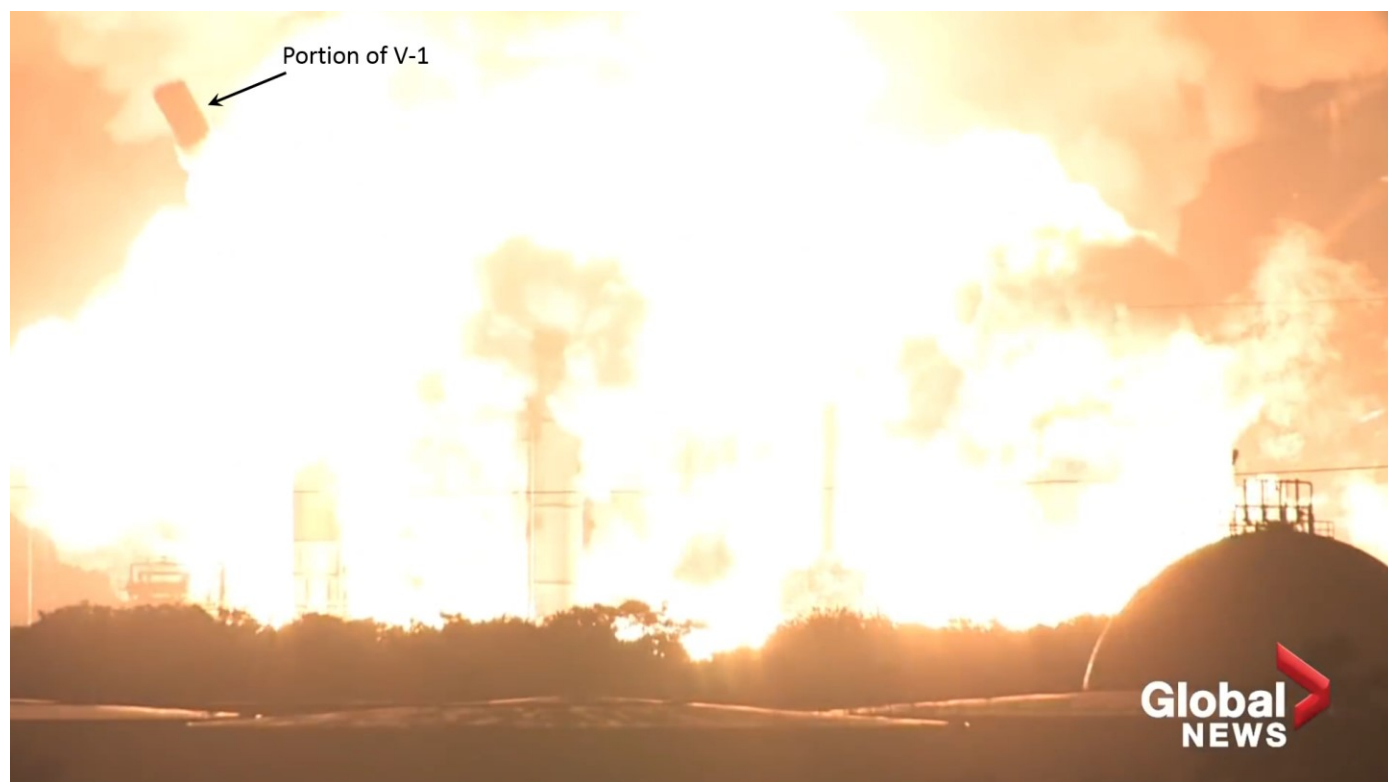
- At 4:15 am, during the ongoing fire, an explosion occurred in the alkylation unit. A second explosion in the unit then occurred at 4:19 am.
- At 4:22 am, a third, and the largest, explosion occurred when the V-1 Treater Feed Surge Drum, containing primarily butylene, isobutane, and butane, violently ruptured (Figure 4, Figure 5). A fragment of the vessel weighing approximately 38,000 pounds flew across the Schuylkill River, and two other fragments, one weighing about 23,000 pounds and the other 15,500 pounds, landed in the PES refinery (Figure 6). This appears to be a secondary event caused by the fire.

Figure 4. Video still of V-1 explosion. (Credit: Global News^a).

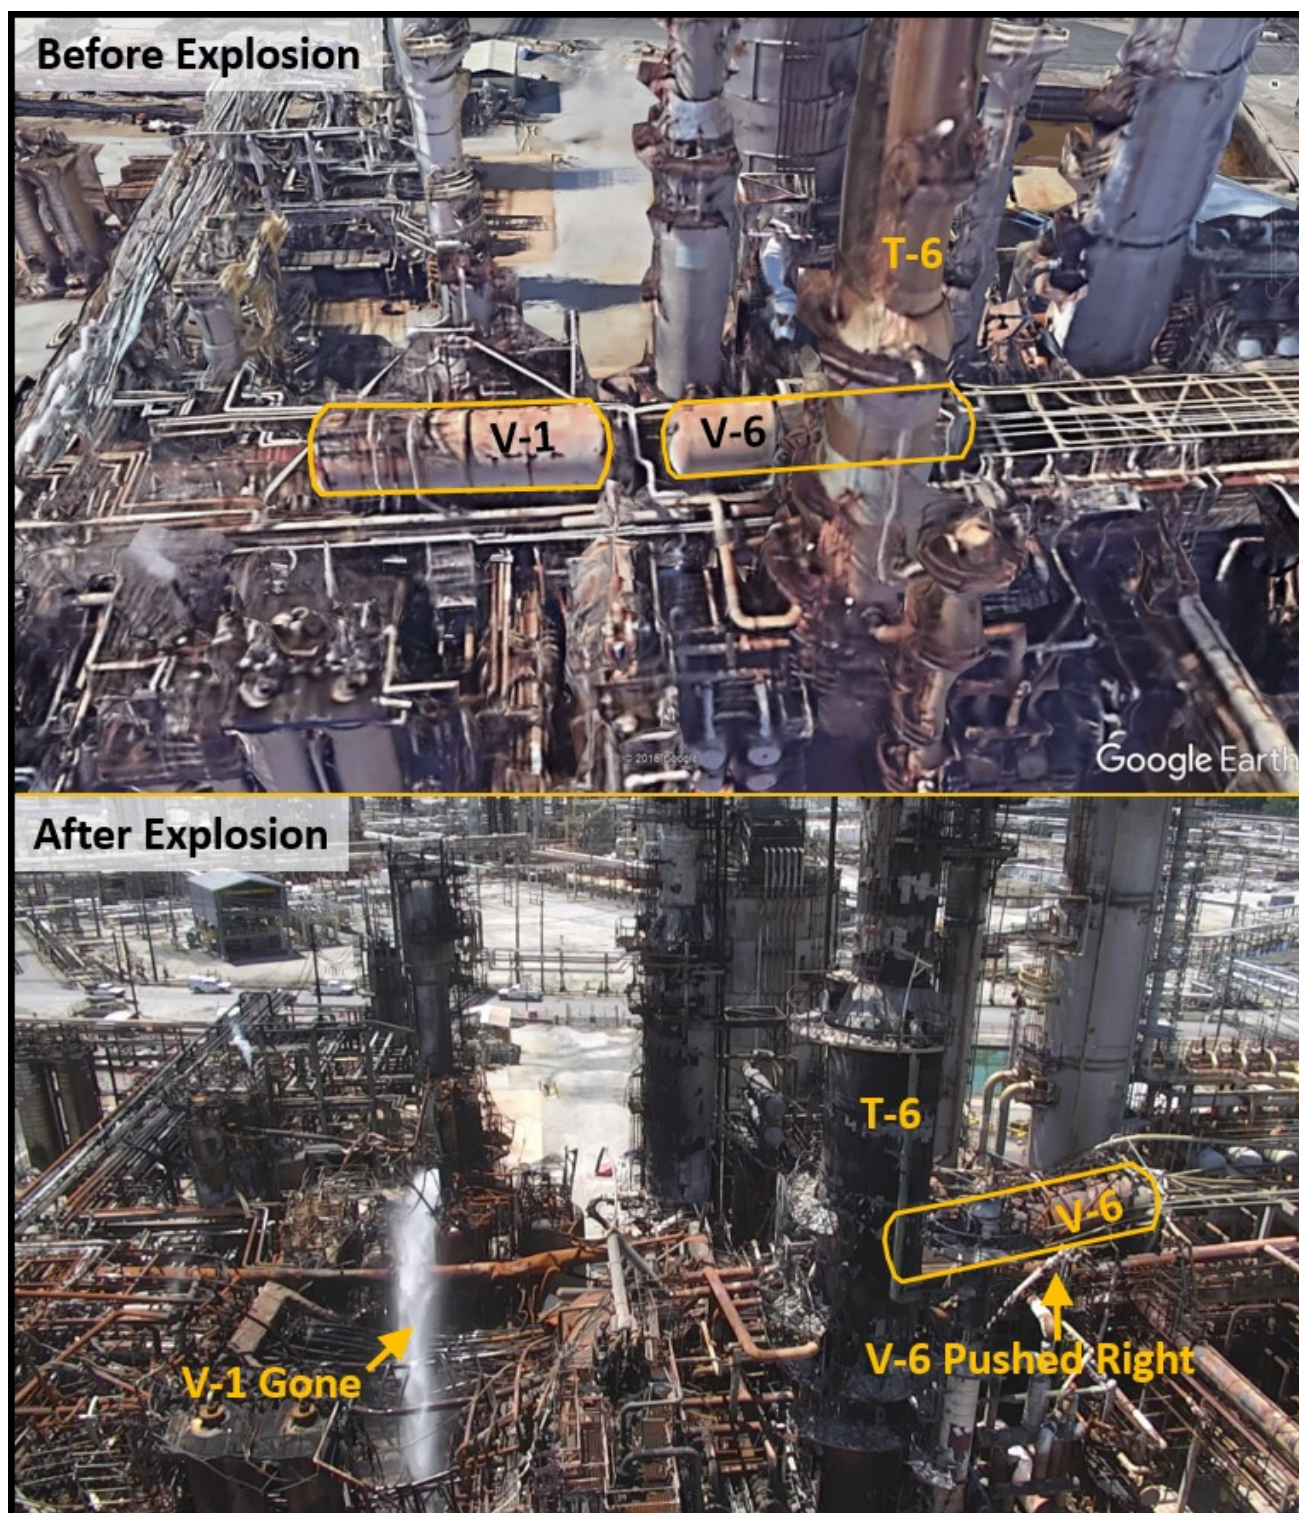
Figure 5. Comparison of incident scene pre-and post-incident. (Top photo credit: Google Earth. Bottom photo credit: PES. Modifications by CSB).

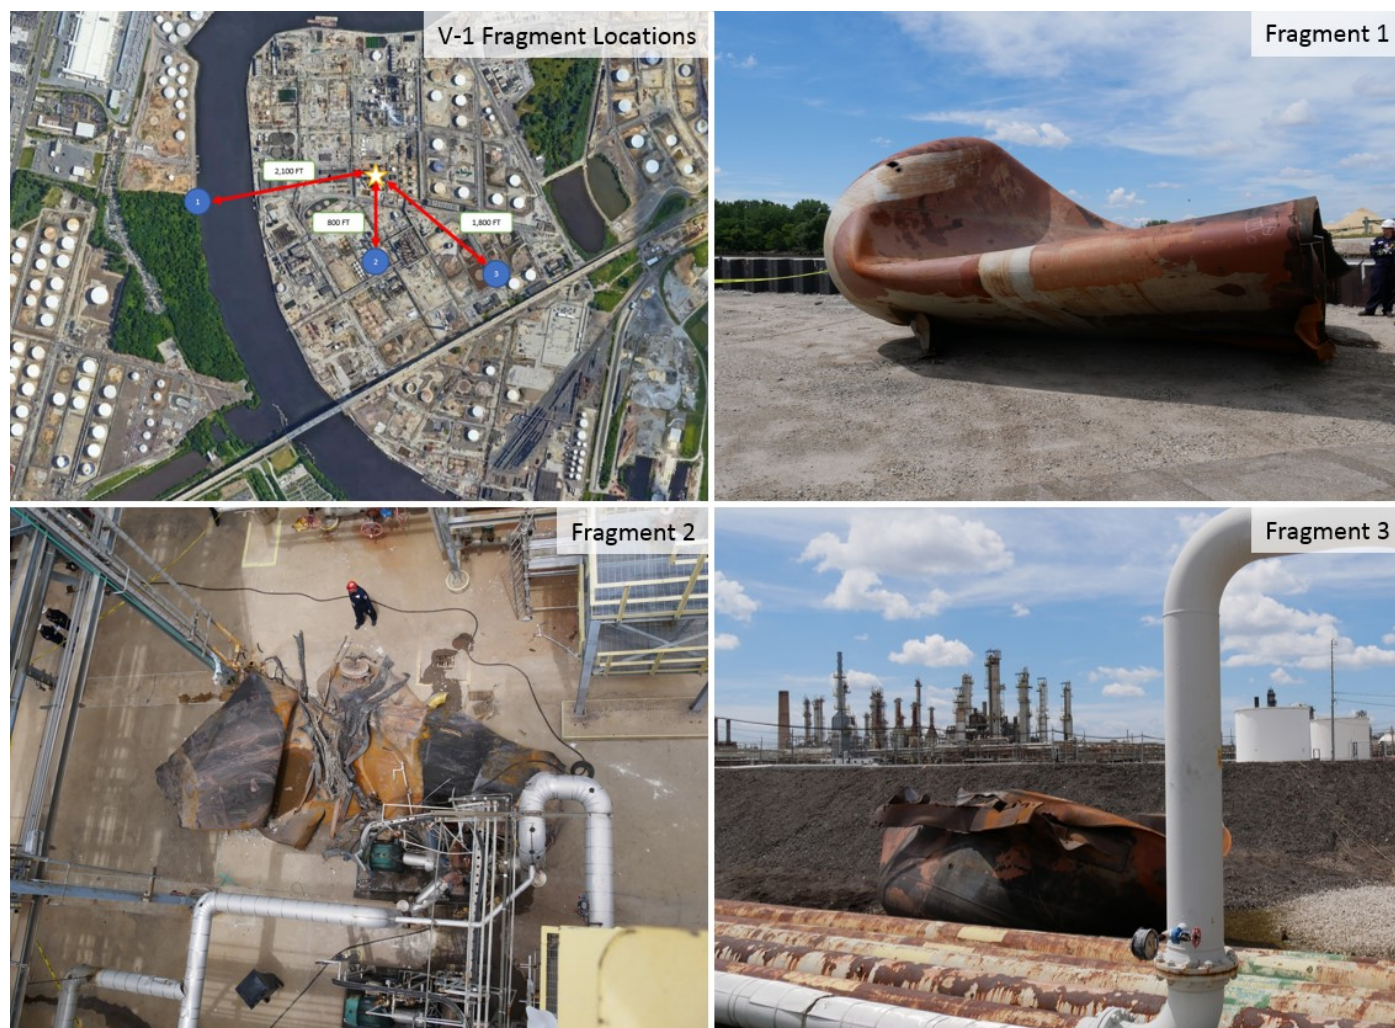
Figure 6. Locations and photos of the post-incident V-1 vessel fragments. The fragment 1 photo was taken after the fragment was recovered from the bank of the river and relocated to the PES refinery. The deformation of fragment 1 was likely caused by impact with the river bank. (Top left photo credit: Google Earth with modifications by CSB. Credit for other photos: CSB).

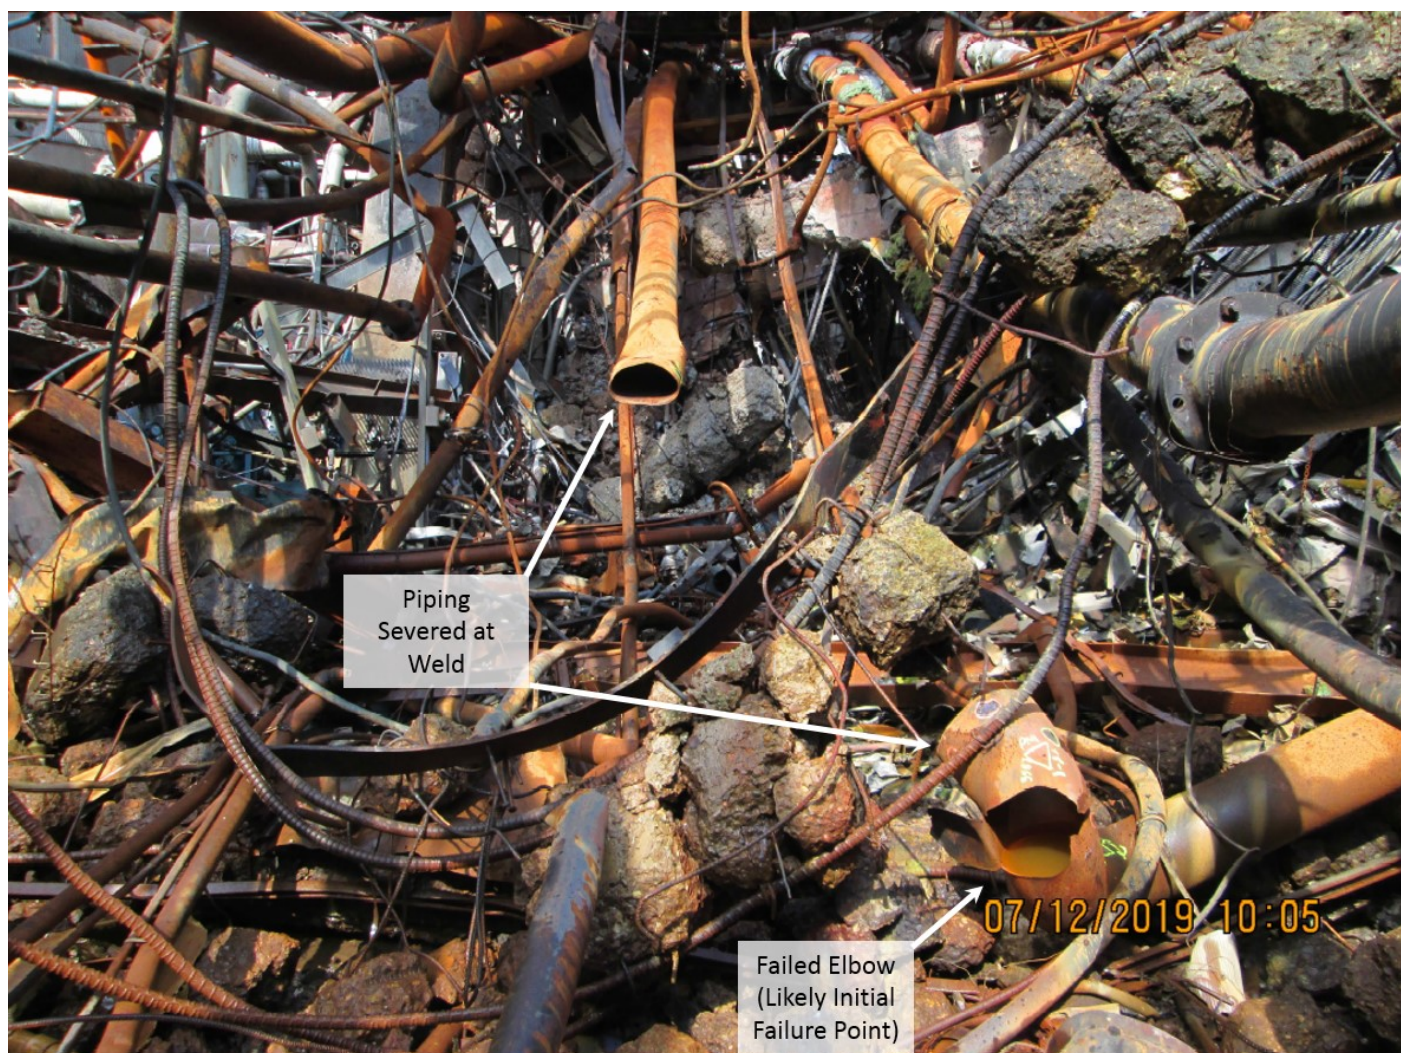
- A ruptured pipe elbow was found in the unit post-incident (Figure 7). The rupture of the elbow appears to be the initiating event causing the process fluid release. The elbow was part of the piping between V-11, the depropanizer accumulator, and T-6, the depropanizer distillation column. The elbow was on the discharge (outlet) piping from a pump (one of two pumps in this system) that was not operating at the time of the incident. At the time of the event, this piping was operating at a pressure of about 380 psig and a temperature of about 100 °F. The approximate design composition of process fluid in the piping was:

Figure 7. Photo of ruptured pipe elbow found post-incident. (Credit: PES).

- A CML was not located on the ruptured elbow, so the thickness of this elbow was not monitored. The thinnest measurement taken of the ruptured elbow post-incident was 0.012 inch.^{b,c} This value is less than 7 % of the PES default retirement thickness.

- The piping circuit containing the ruptured elbow was installed in about 1973. As of this Factual Update, this piping appears to be the original piping. Both the elbow that failed and the adjacent elbow are stamped “WPB”, indicating they were constructed to meet the ASTM A234 WPB material specifications.

- The 1965 version of ASTM A234 *Standard Specification for Factory-Made Wrought Carbon Steel and Ferritic Alloy Steel Welding Fittings*, the applicable version at the time of the pipe installation, required that Grade WPB pipe “permissible raw materials” composition meet the A106 Grade B chemical composition specifications. The 1972 ASTM A106 standard did not specify nickel (Ni) and copper (Cu) composition requirements. In 1995, ASTM A234 began specifying nickel and copper composition, as well as compositions of other elements.^a The WPB composition requirements in 1972 and 1995^b are shown below. The chemical composition of the ruptured elbow and the adjacent elbow are also shown. The nickel and copper content of the ruptured elbow exceeds the updated A234 WPB chemical composition requirements.

- API RP 751 *Safe Operation of Hydrofluoric Acid Alkylation Units* states: “HF corrosion has been found to be strongly affected by steel composition and localized corrosion rates can be subtly affected by local chemistry differences. NACE Paper 03651 indicated that the combination of carbon (C) content and residual element (RE) content (Cr, Ni, Cu) could increase non-uniform corrosion by up to five-fold compared to baseline measured corrosion rates.”^c
- The investigation is ongoing. At the conclusion of the investigation, the CSB will publish a final investigation report discussing findings, analysis, and issuing recommendations.

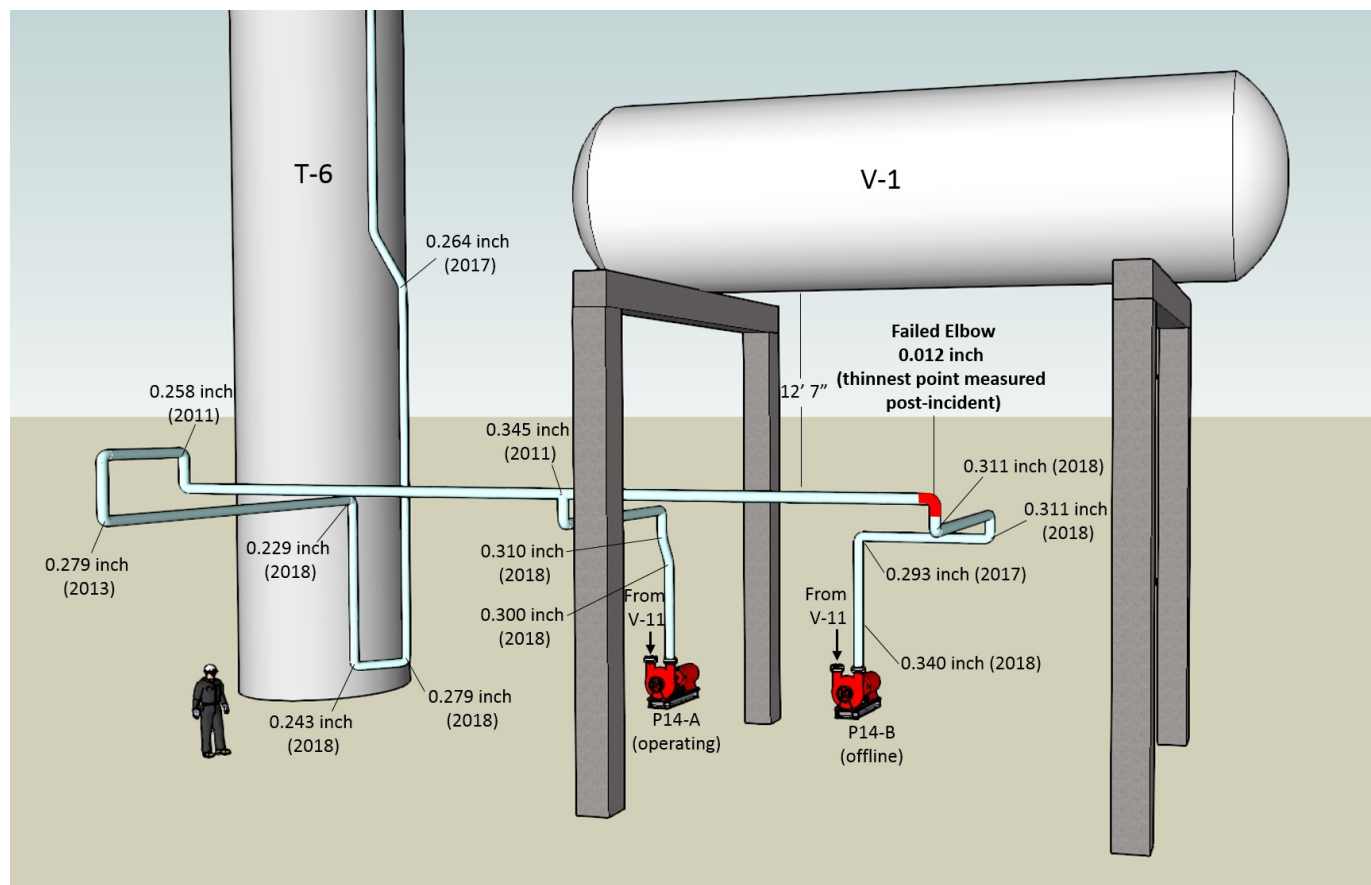
- The piping circuit that includes the ruptured elbow was subject to regular ultrasonic thickness measurements at designated condition monitoring locations (CMLs),^a as part of the PES inspection program to monitor the rate of piping metal loss due to corrosion. Locations of CMLs and the most recent thickness measurements are

shown in Figure 8. The default retirement thickness^a of this piping in the PES inspection database is 0.180-inch. The most recent CML measurements did not indicate thin pipe.

Figure 8. Model of the piping circuit containing the ruptured elbow. The most recent thickness measurements at designated Condition Monitoring Locations (CMLs) are shown. The year of each measurement is shown in parentheses. This figure also illustrates that V-1 was directly above the ruptured elbow. (Credit: CSB).
