**Re: Proposed Creation of Automobile Row Tagmatic Historic District (the “District”)  
/142-144 North Broad Street (the “Property”)**

Site visit to 142 N. Broad

142 North Broad Street  
Philadelphia, PA

## FAÇADE REVIEW

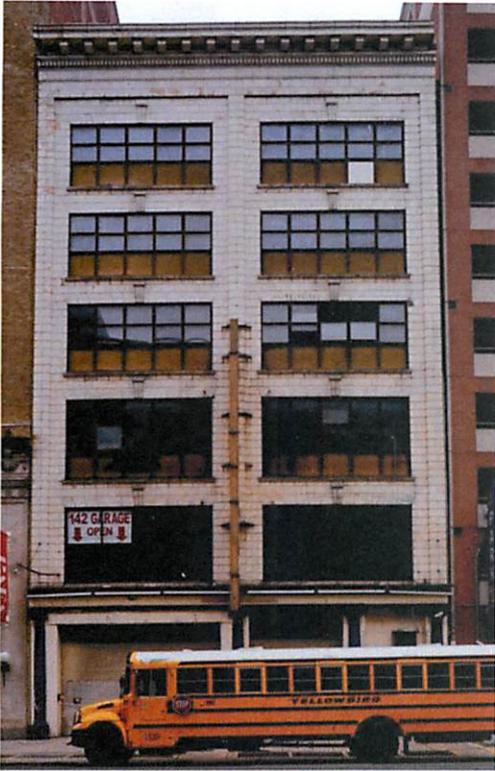
Fig. 1) Broad St. Façade

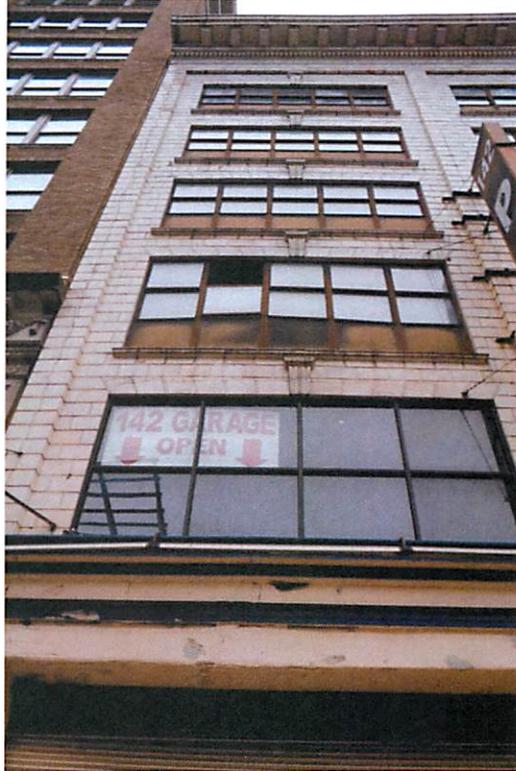
Fig. 2) Detail, south bay of Broad St. Façade

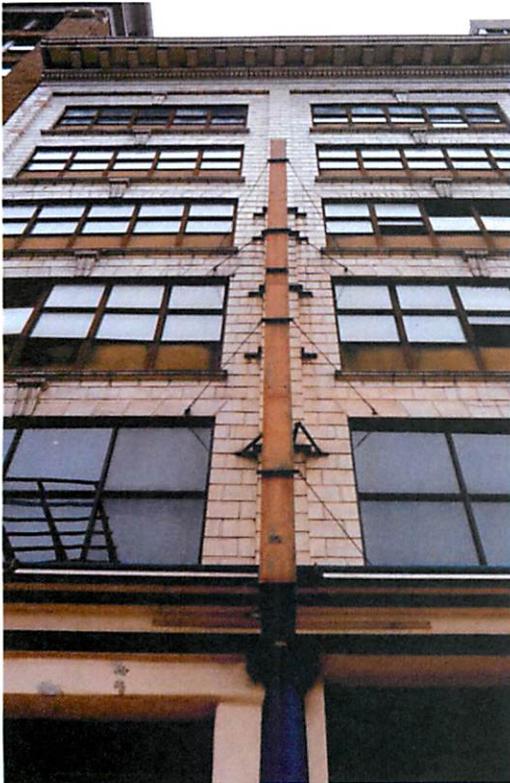
Fig. 3) Central Pier, Broad St. Façade

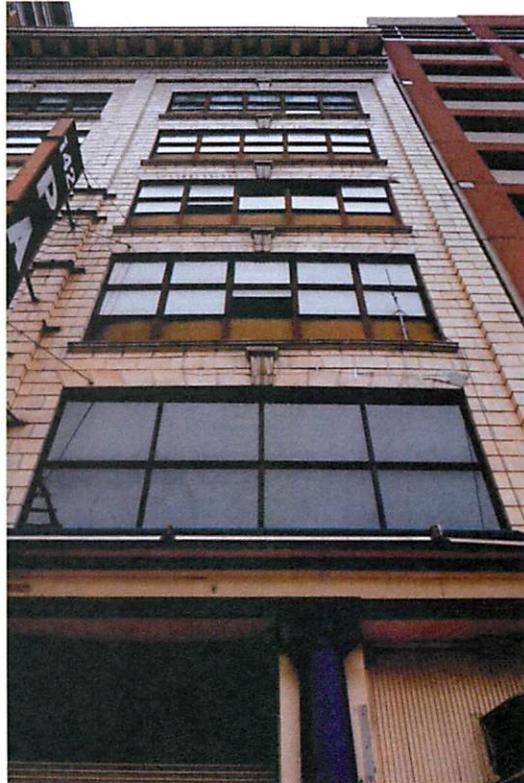
Fig. 4. North bay Broad St. Façade

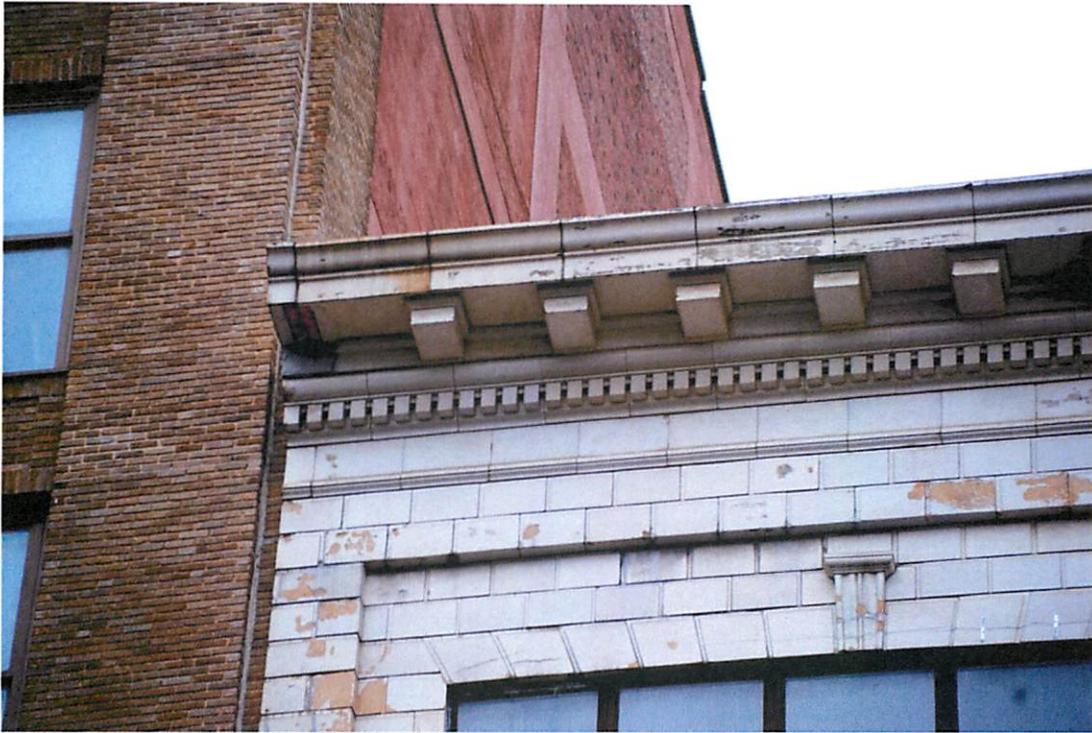
Fig. 5 Deglazed terra cotta, cracked terra cotta, missing terra cotta bracket in cornice, dark staining marks areas of water infiltration

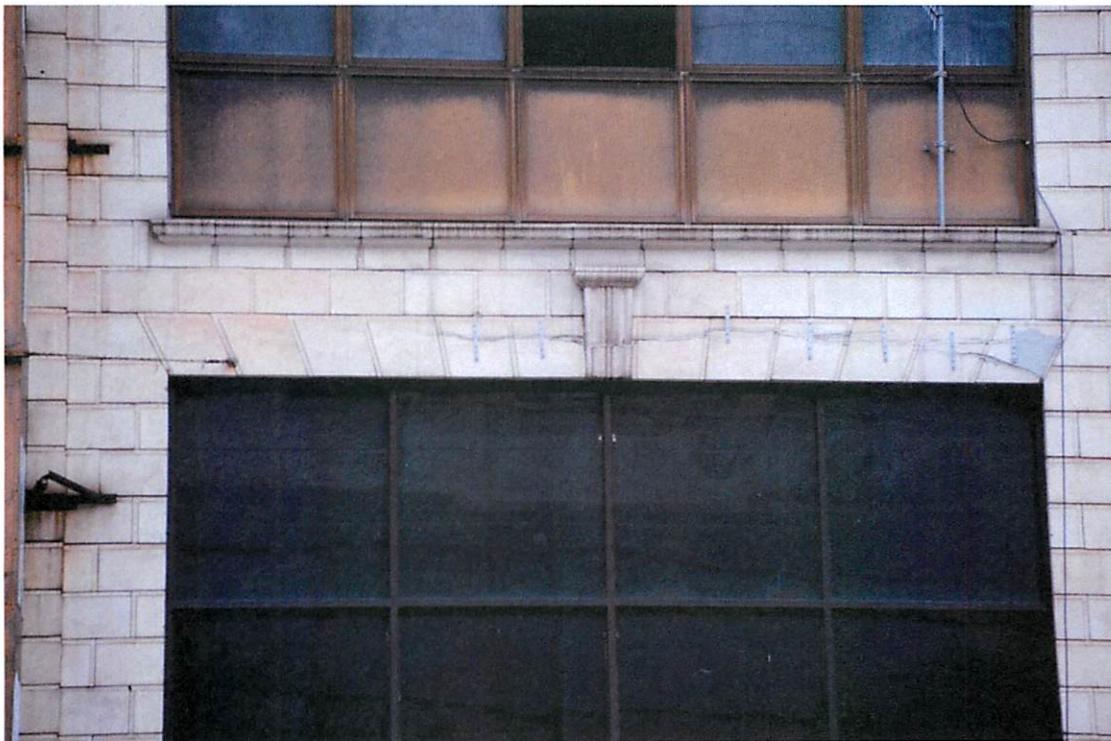
Because Philadelphia has a façade inspection regulation, the building façade has been regularly inspected and short-term repairs have been made that protect the public but which do little to maintain the integrity of the original materials. Fractured jack arch pieces have been sutured together with metal plates; cracks have been repaired with caulking to keep out water. But the underlying problems – water penetration from above and behind the terra cotta, caused in part by lack of heat in a garage building, which permits water to condense on exterior walls and then work its way into the rear, unglazed portions of the front terra cotta and the rear brick have damaged both facades. (Figs 1-8)

Fig. 6) Typical repaired jack arches, loss of glazing, water staining showing infiltration at sills

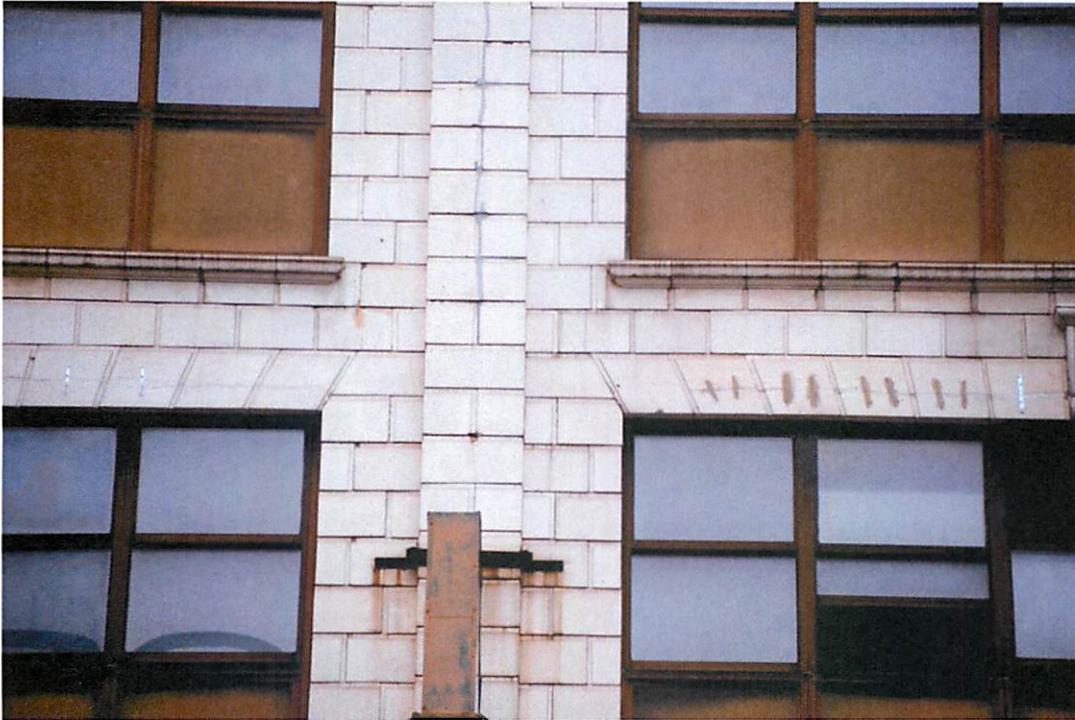
Fig. 7) Center Pier, fourth level, damage to jack arches, cracking of central pier (gray caulk), dark water stains below sills

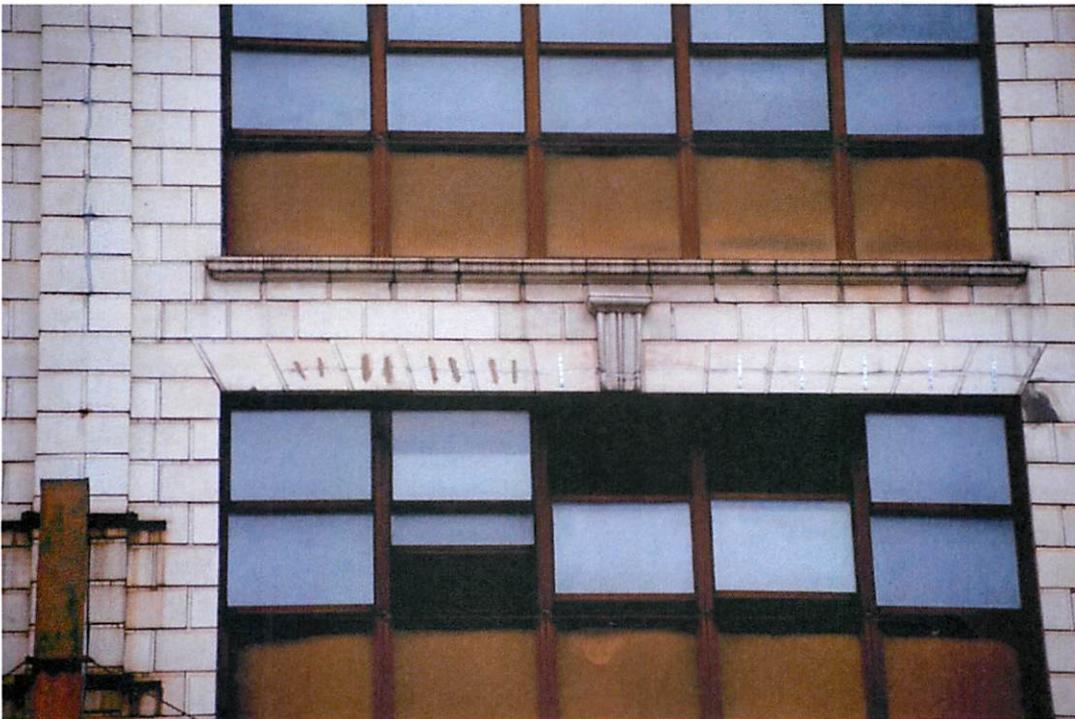
Fig. 8) Fourth level window, north bay, cracked jack arch, damage at impost on right, cracking of piers, etc. This damage is typical at all openings and piers.

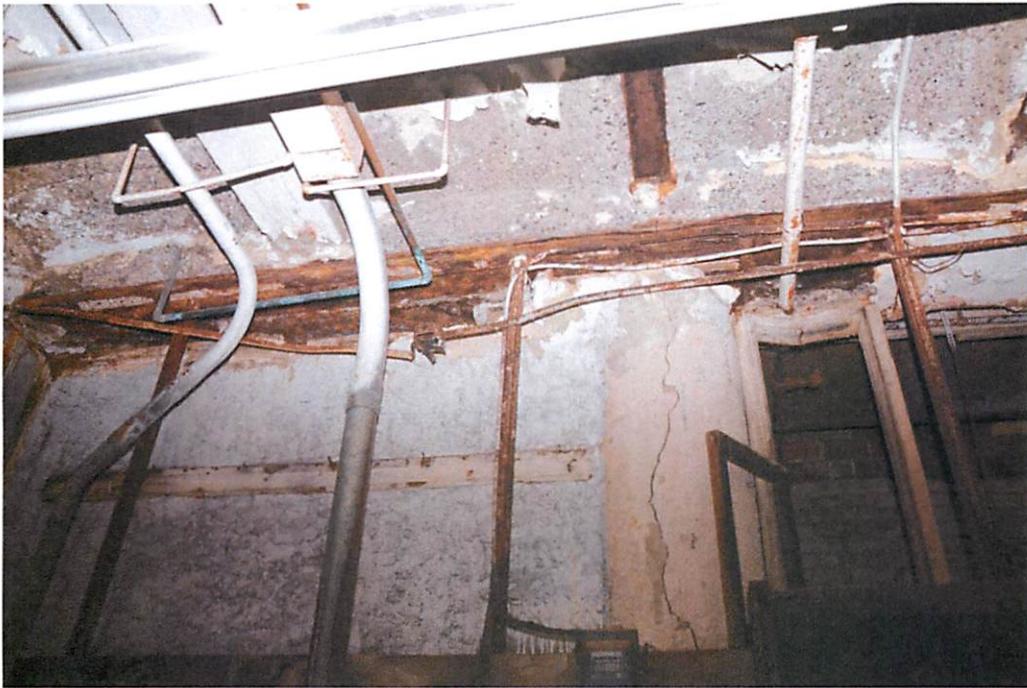
Neither system is surviving in reasonable condition. The basement structure, which receives the greatest amount of tire-born water and salt has extensively damaged the eastern structural bays toward Broad Street. Because cars were stored on the upper levels using elevators to lift them, the upper levels toward Broad Street are similarly extensively damaged with lessening damage on the upper stories presumably reflecting the decreasing number of wet automobiles stored at higher levels.

Fig. 9) Basement deterioration of steel set into concrete, front of building

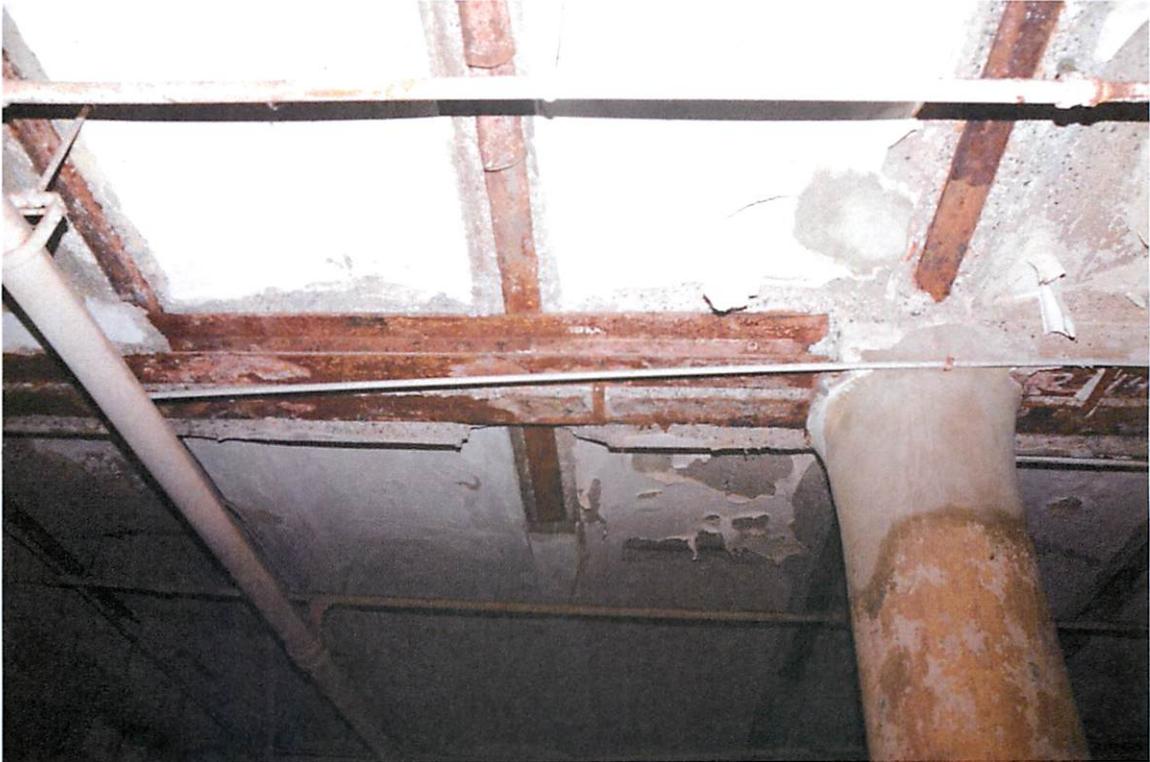
Fig. 10) Basement, delaminating steel beams and girders

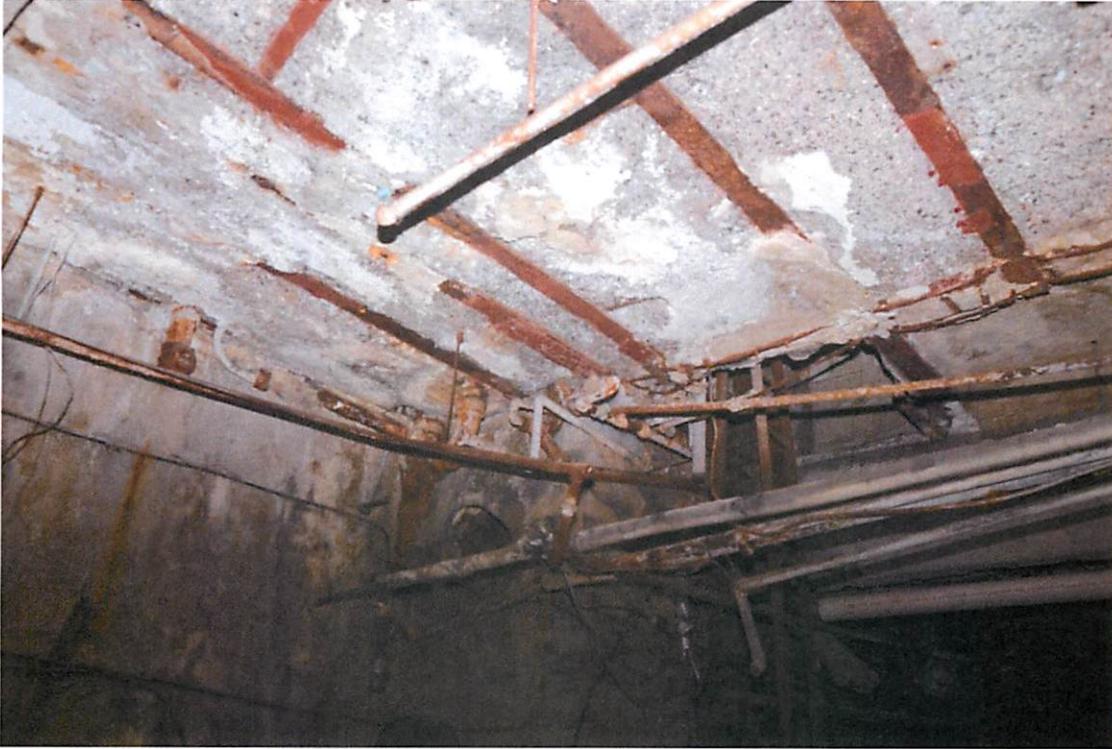
Fig. 11) Basement rear, delaminating steel beams carrying reinforced concrete of first floor

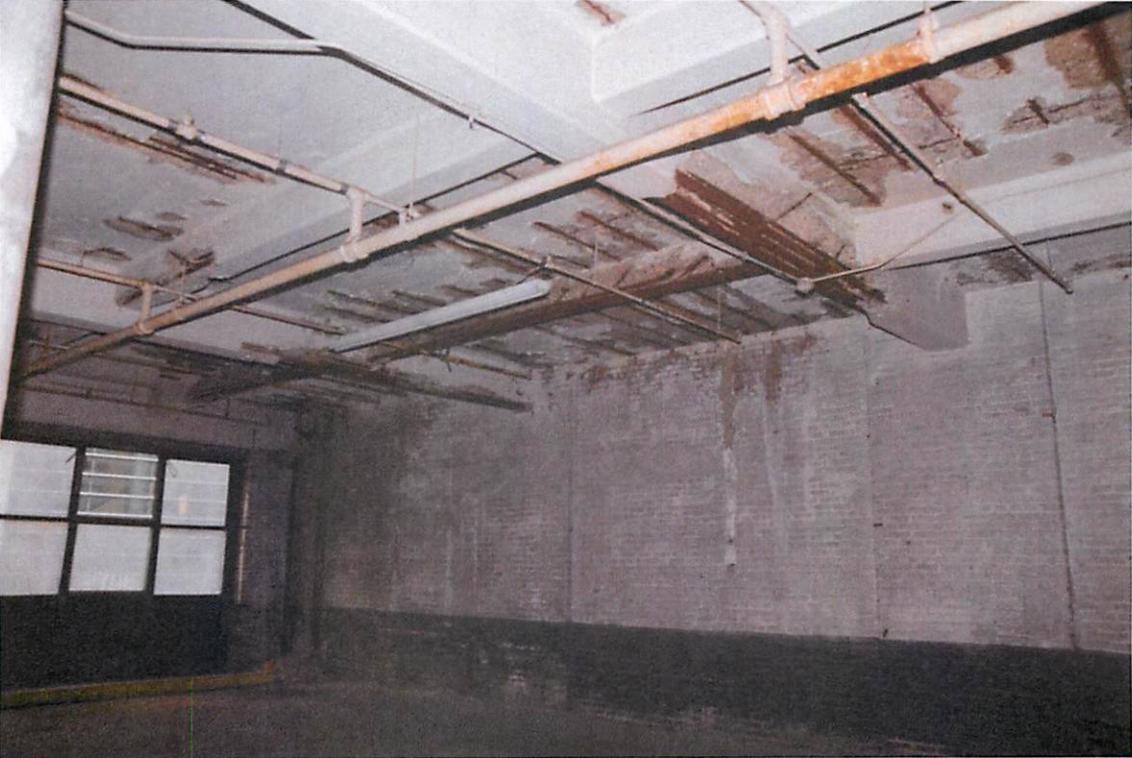
Fig. 12) Massive damage to first three bays of 2<sup>nd</sup> floor ceiling (3<sup>rd</sup> floor)

The condition of these bays should be evaluated by the engineer. If they are sufficiently damaged to require reconstruction, the process would also affect the stability of the front façade and would dramatically increase the cost of a project that, because of historic designation, is required to preserve the Broad Street façade. Given that more than half of the terra cotta elements of the façade have been damaged, in the end it would be beneficial to reconstruct the entire façade because blocks that have yet to fail will likely fail in the future as their iron hangers rust and fail.

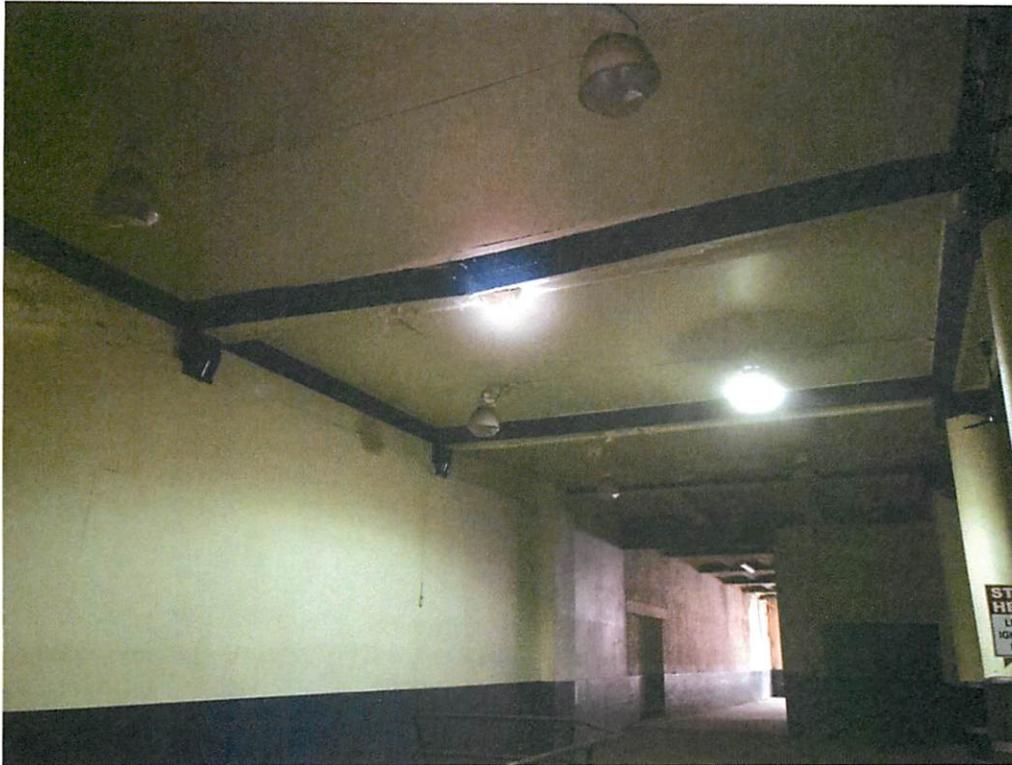
The first floor ceiling is not visible because it has been sheathed in plaster – presumably on wire lath as part of the more public interior with tapered columns and cast Ionic capitals. However, one of the girder covers is suspiciously lower (Fig. 15) suggesting that there are problems concealed by the sheathing. In the case of the front bays visible from the second, third, and fourth stories, massive deterioration is visible on the three eastern-most bays with loss of concrete cladding that has been forced off by rusting of the steel and with the steel itself reduced to little more than powder in many instances. (Figs 8-16)

Fig. 15) Depressed beam cover, first floor ceiling

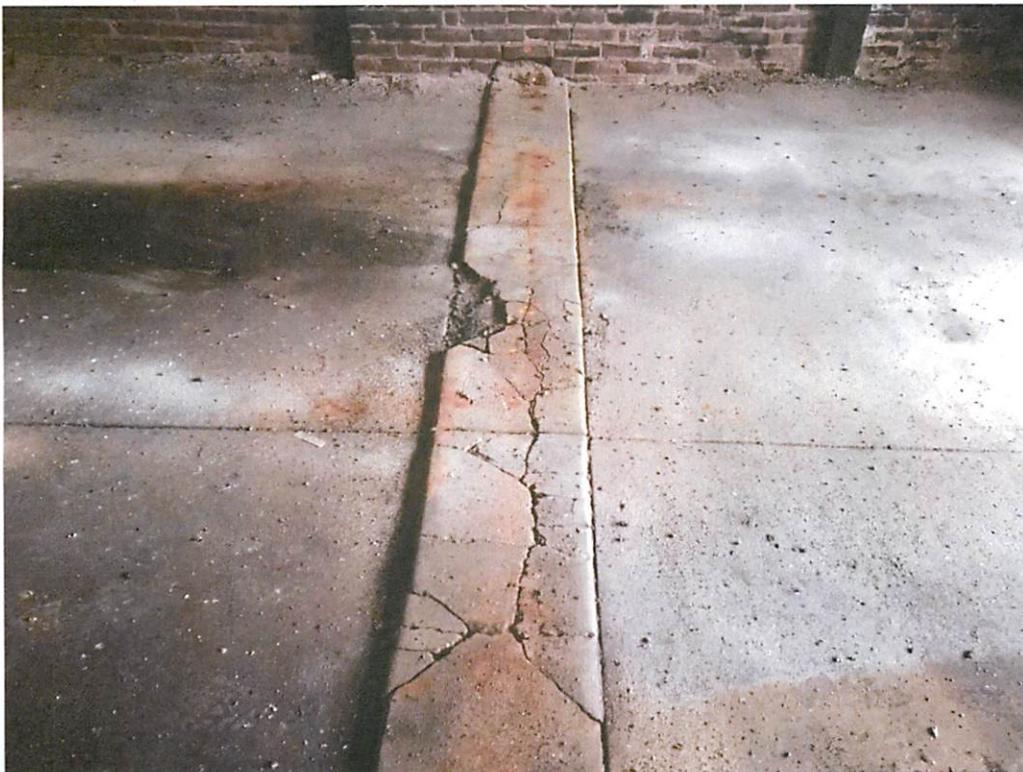
Fig. 16) Typical beam cover, floor, upper level, rear steel frame section

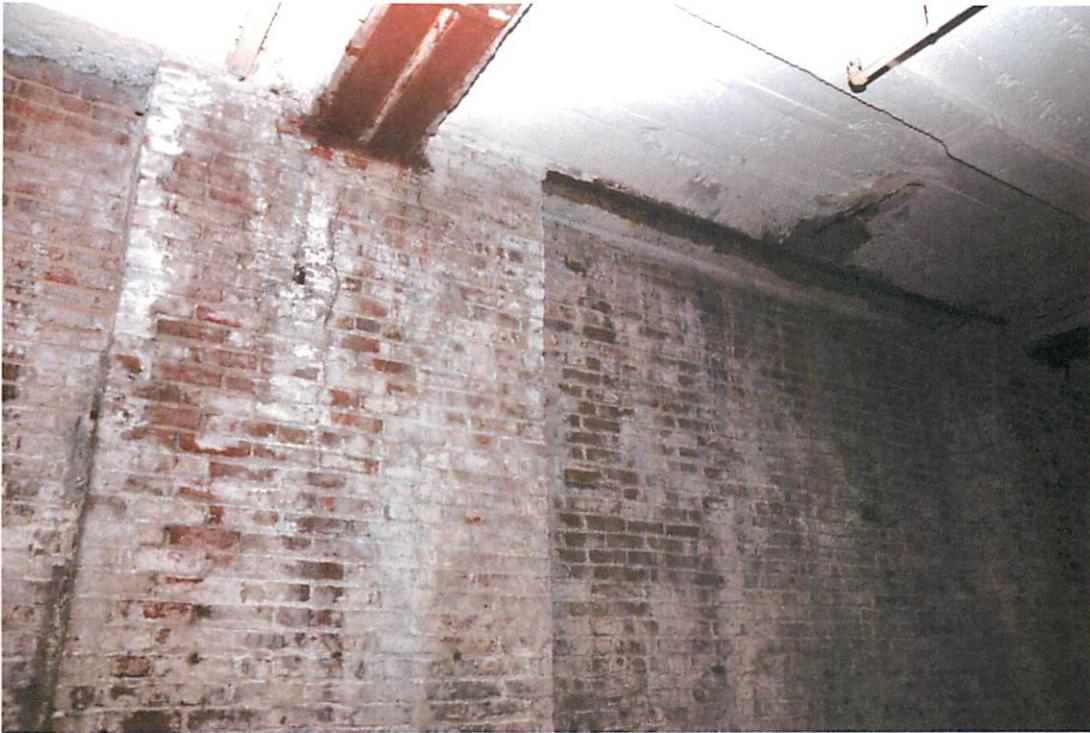
One other note is worth reporting. The south interior wall shows a significant crack that suggests that the front façade started to pull out to the east. Work in 1975 on the restoration of the Pennsylvania Academy of the Fine Arts, to the south discovered major movement of the main stair that pushed east and began to collapse apparently as a result of the open trench for the Broad Street Subway. It is possible that the same work damaged 142 N. Broad Street.

Fig. 13) Vertical cracking, 2<sup>nd</sup> floor rear, south wall

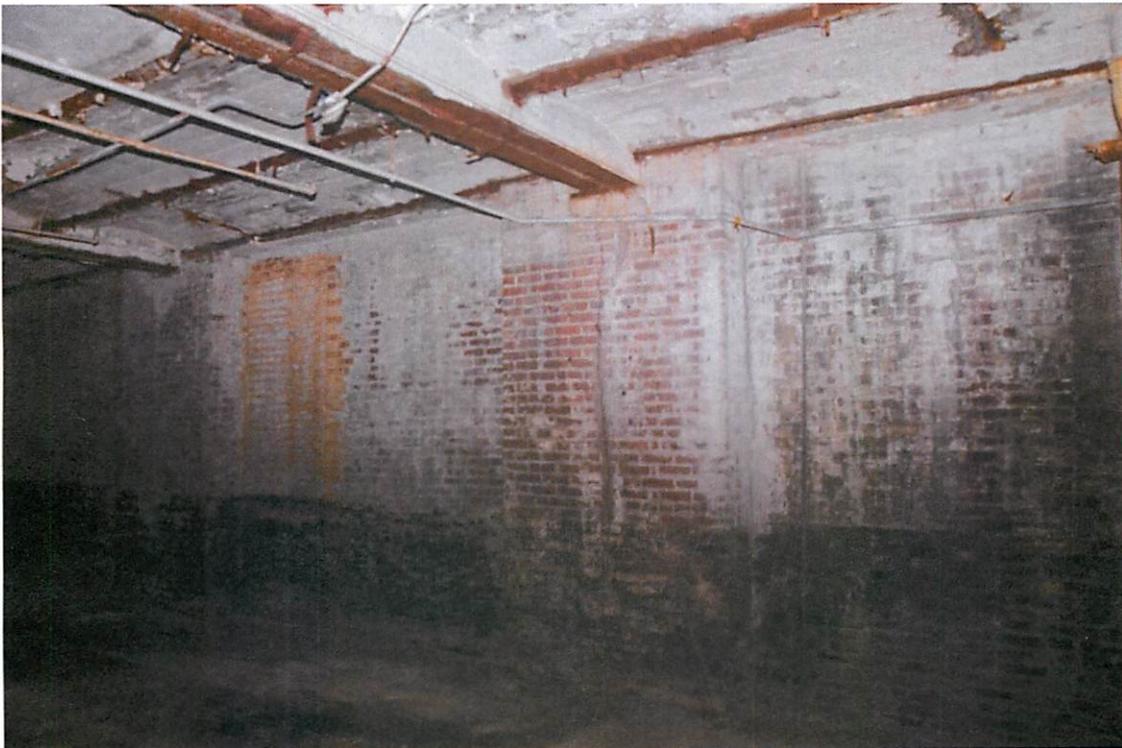
Fig. 14) Vertical cracking 4<sup>th</sup> floor pier, south wall

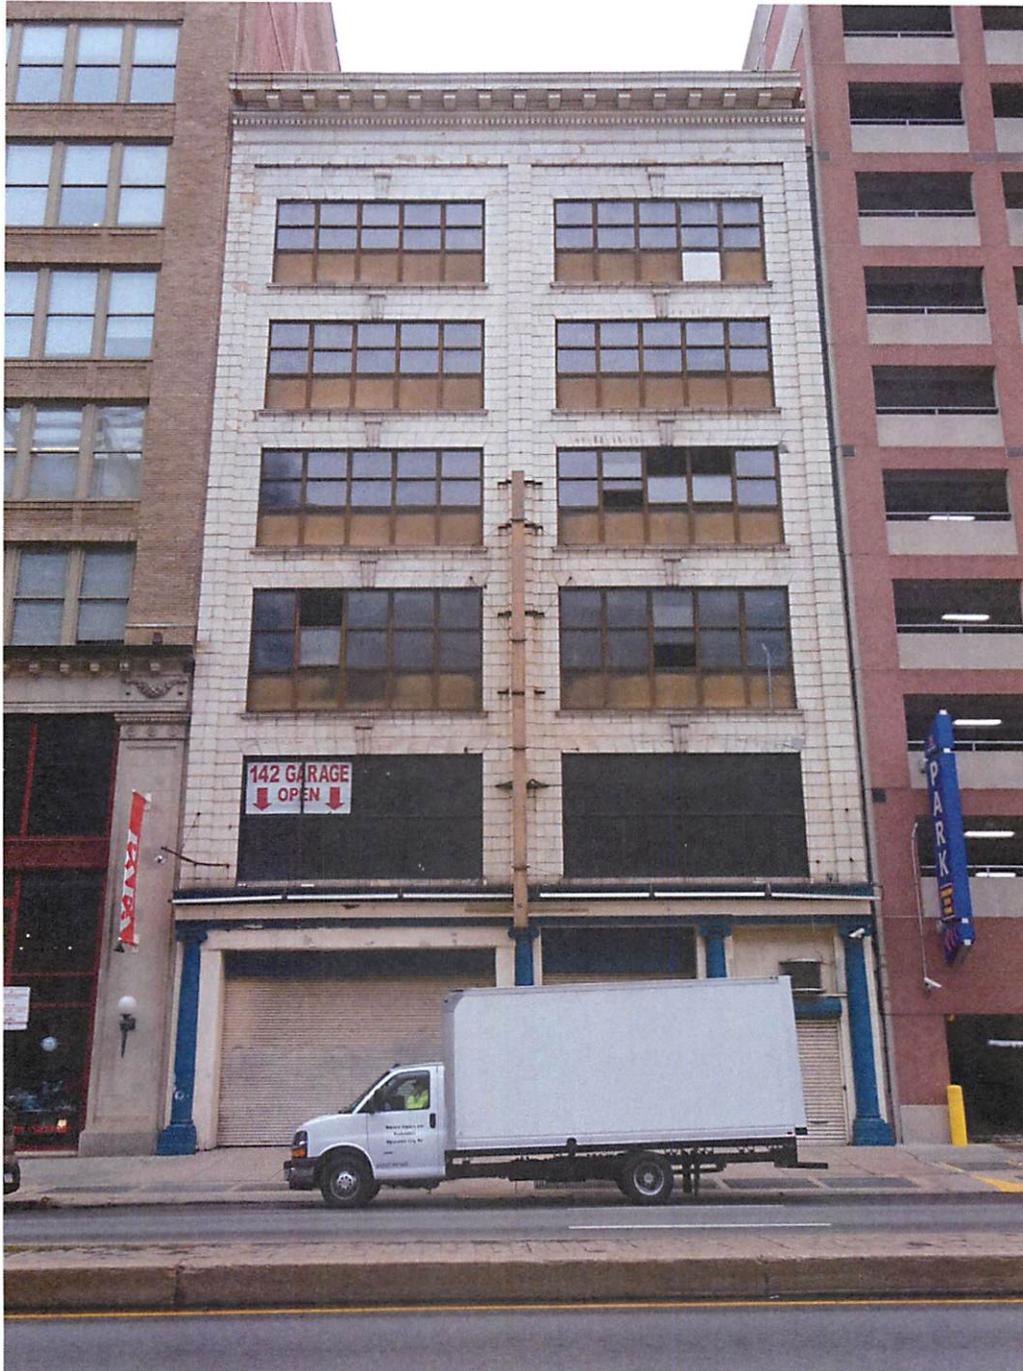
Figure 1: East Elevation

The terra cotta is in poor condition. Over twenty percent (20%) of the units have lost some of their face glazing, which is the only protection against moisture intrusion and resulting freeze-thaw degradation. About sixty percent (60%) of the the “column cover” units have a vertical split, which again allows water intrusion. This is particularly obvious on the southern column cover, where the units are trapped against the adjacent building and thus have split due to flexure (outward bending). One hundred percent (100%) of the jack arch units have a horizontal split, including right through the keystone units, indicating advanced corrosion of the supporting steel elements. These cracks have been crudely addressed with caulk and plates but the deterioration is obvious. There are quite a few terra cotta units that are out of place either vertically (some of the jack arch units have slipped downward) or horizontally (moved out of plane relative to the surrounding units). It was also noted that the entire southern bay bulges outward at the fourth floor level, and there is a vertical tension crack in the southern party wall near the front corner.

Because terra cotta is a relatively brittle material, good repairs in place are difficult and expensive. Often when there is extensive damage such as this, the units are removed and replaced. Replacement of the terra cotta is even more warranted for this building because the interior structure consists of cast-in-place concrete beams and slabs which have become severely deteriorated and must be replaced in several locations. A large portion of the front bays for levels 2-5 need to be replaced. Since the wall is braced and supported by the floors, removal of the floor for reconstruction will require disassembly of the façade for several levels. The owner may consider replacement of all the terra cotta units below the cornice dentil band.

The east façade can continue to be patched together for a few more years but is nearing the point of rapid deterioration. The blade sign should be serviced or removed as soon as practical. The west façade is in fair condition and with appropriate attention should serve adequately for the foreseeable future.

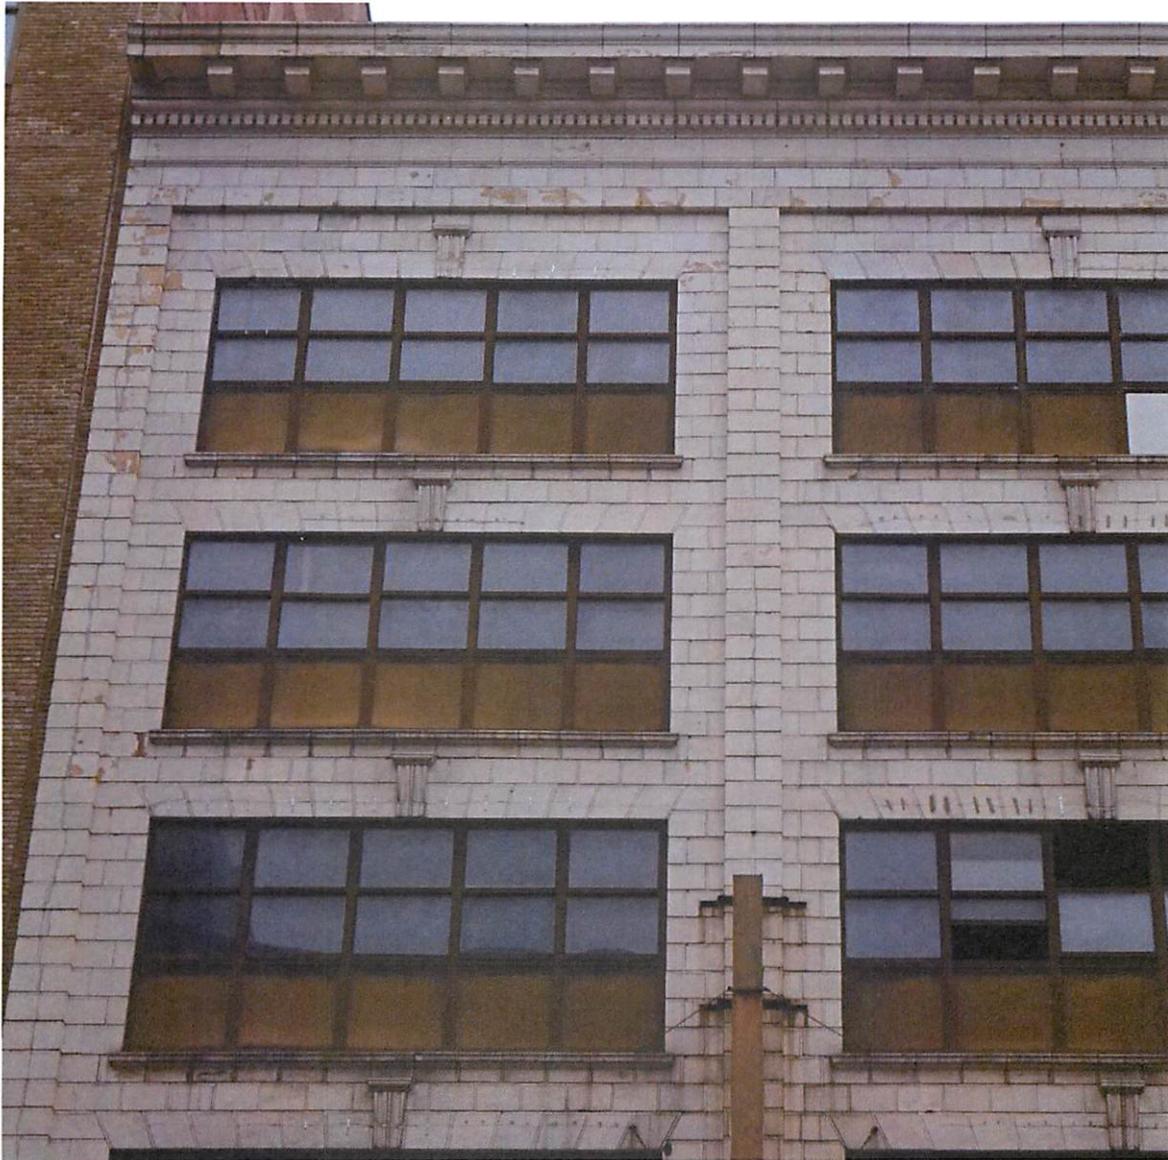
**Figure 2:** Detail view showing spalled shell glazing, cracked jack arch units with aluminum straps, cracked column cover units, and corroded sign supports (one is fractured).

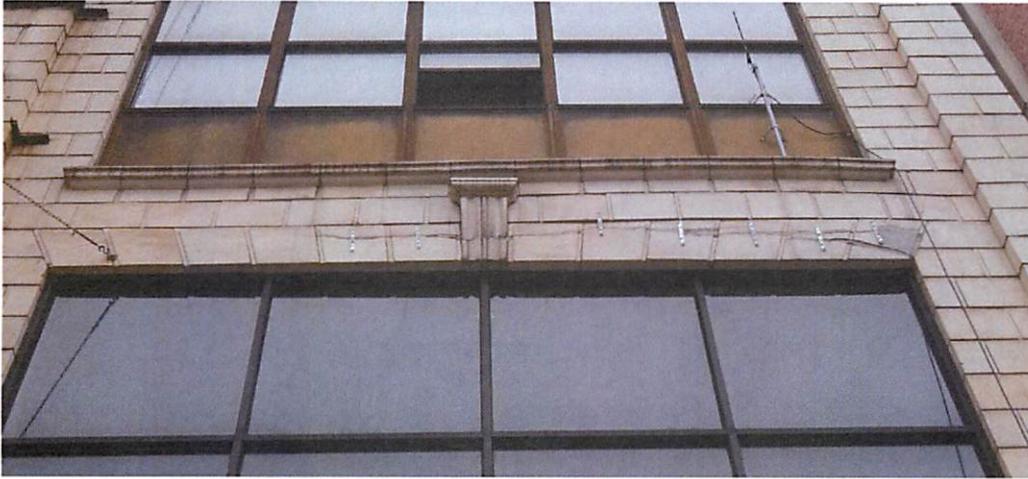
**Figure 3:** Detail showing the “repair straps” nailed into the terra cotta. The “waviness” of the sill line is not an optical illusion.

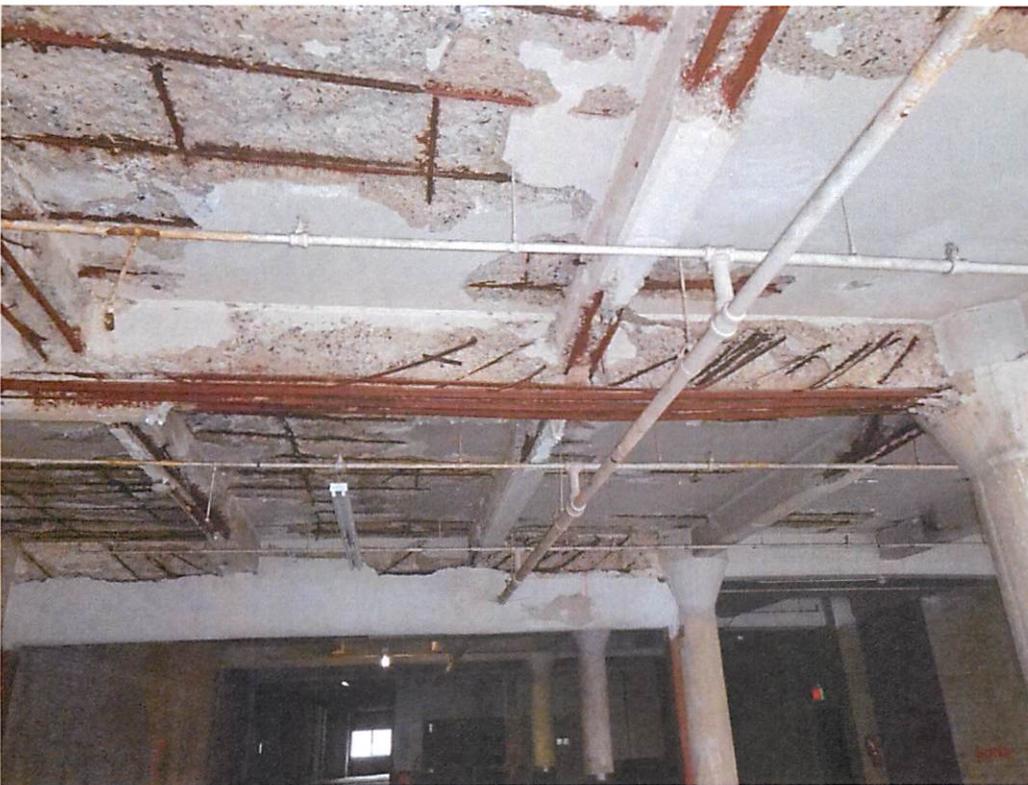
**Figure 4:** Example of the severely spalled concrete and corroded reinforcing in some bays at the front of the building. Some major bars were painted to stop further corrosion but the missing concrete makes this beam unable to support loads.

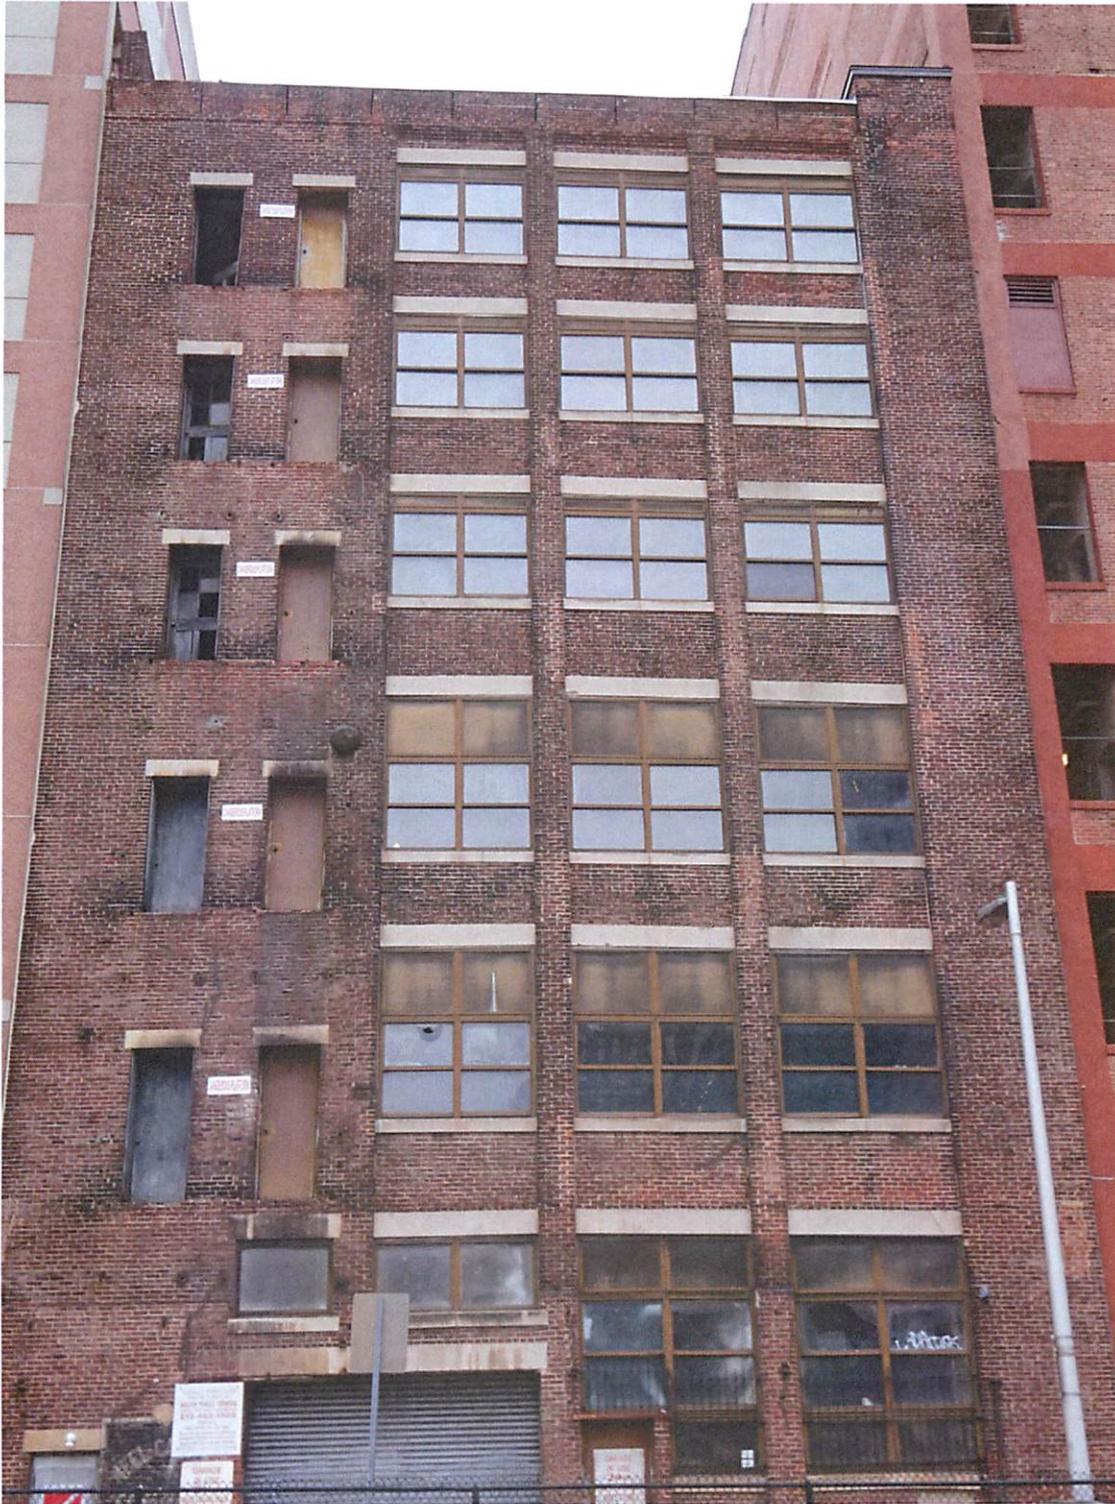
Figure 5: West elevation.

The rear elevation of the building consists of multi-wythe brick construction with limestone “lintels” (supported by steel) and window sills. The general field of the brick wall is in fair (serviceable) condition. There are various generations of mortar and crack repairs throughout. The limestone elements exhibit some minor cracks and spalls. The supporting steel has some visible corrosion; the condition of the parts buried in the masonry is unknown.
