ADDRESS: 107 CHESTNUT ST

Proposal: Complete demolition of Unsafe building

Structural Condition Assessment 107 Chestnut Street, Philadelphia, PA

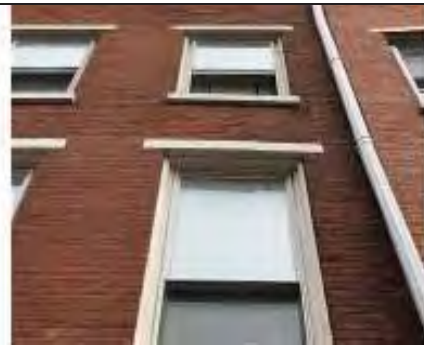
1. The front brick wall has moved laterally towards Chestnut Street. There is cracking and spalling, or pieces of it are breaking off, of the front wall at the third and second floor levels. This movement results in the load no longer being applied concentrically at the center of the wall. The eccentric load also furnishes a driving moment which will result in further movement of the wall outwards. Due to the movement the capacity of the wall is reduced. This condition is not repairable unless the wall is reconstructed. As such, the historical nature, aspects and/or fabric of the building would be altered.

The picture above shows movement below the window. The brick joints are open. This reduces the ability of the brick to transfer load due the reduced surface area. The walls are deteriorated. The picture to right shows a opening that has failed at the second floor. This opening is approximately 12 inches wide by 18 inches tall. This results in a reduced capacity of the pier to carry load. This condition is not repairable without complete reconstruction. Thus, the historical nature, aspects and/or fabric of the building would be altered.

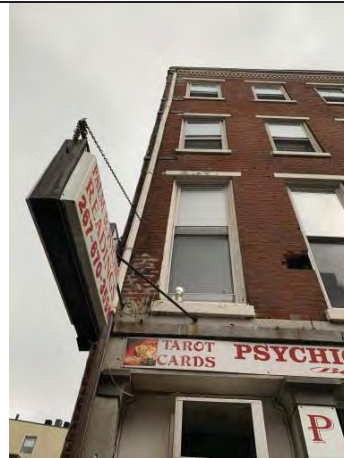
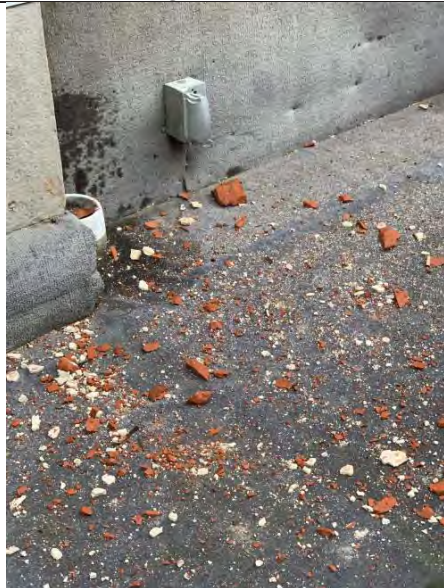
2. A portion of the front brick wall has fallen as shown in item #1. This opening is approximately 12 inches wide by 18 inches tall. This condition reduces the cross sectional area that the wall can use to support the loading. As such, the load carrying capacity of the wall is reduced. At my original inspection, the masonry was intact and no holes existed. This condition worsened over time. This condition is not repairable without complete reconstruction. Thus, the historical nature, aspects and/or fabric of the building would be altered.

The picture to the left shows the fallen debris on the ground on the front sidewalk of the structure. At the time of my original inspection, the hole and fallen debris did not exist. This condition is not repairable without complete reconstruction. Thus, the historical nature, aspects and/or fabric of the building would be altered.

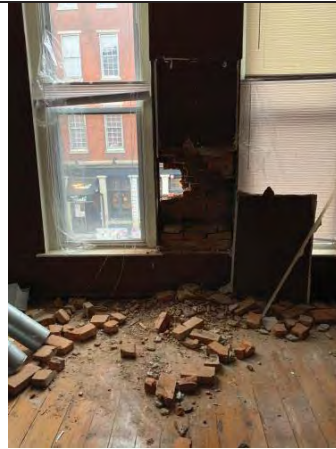
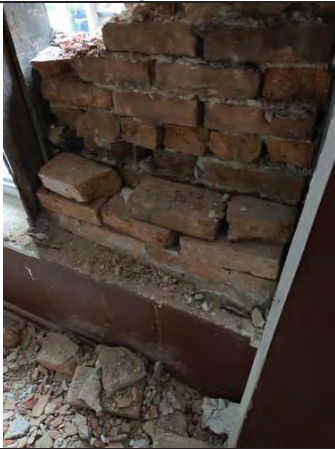
3. The front pier that has collapsed onto the side walk has deteriorated. This is a picture taken from within the second floor. The bricks have collapsed onto the second floor. The brick are loose and easily removed by hand. They are no longer mortared together. They are a stack of cards and cannot carry load. The mortar has completely deteriorated. This pier is no longer carry loading. In order to repair this condition, the loading above would have to be shored and the pier completely removed and reconstructed. This would negatively impact the historical nature, aspects and/or fabric of the building.

This condition was not present at the time of my initial inspection.

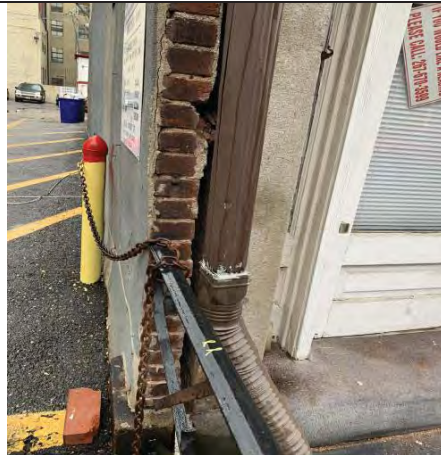
4. There is a large vertical crack that has widened on the front Southwest corner. The crack extends vertically up the entire height of the wall. It has been repaired on at least two occasions. This crack varies in width. It is approximately $\frac{3}{4}$ of an inch wide. The movement of these walls will only continue to worsen as water can now freeze in the crack. This condition shows that the walls have delaminated. In effect, the walls are two 4 inch thick walls rather than one 8 inch thick wall. The second portion of the wall is behind the downspout. This results in reduced load capacity of the wall. The crack has widened over the course of my inspections. This condition is not repairable without complete reconstruction. Thus, the historical nature, aspects and/or fabric of the building would be altered.

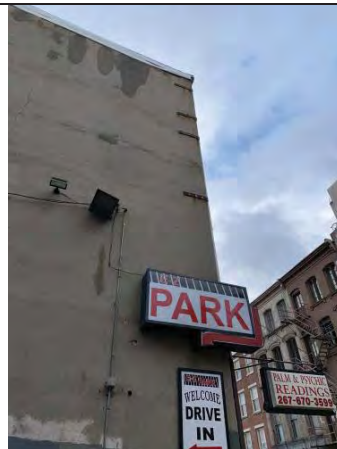
5. There is steel strapping present at the top of the front west corner. These straps indicate a previous repair completed at the top of the wall. The repair is approximately 10 years old. There are four straps that appear to be 3 inches wide by 3 feet long. The repair indicates that the building corner was moving and is no longer in its original condition. The masonry is not properly integrated together. While the strapping is working, it is unattractive and negatively impacts the historical nature, aspects and/or fabric of the building.

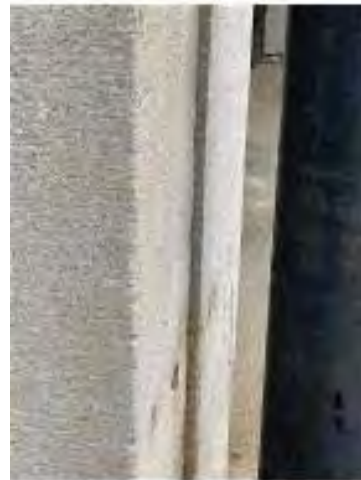
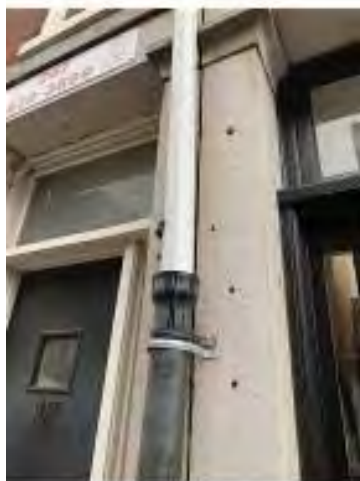
6. The front wall where it adjoins the building to the east also shows separation, shifting and lateral movement. The movement indicates that the building has sifted relative to the neighboring east building and has gotten larger over the time of my inspections. The movement noted is approximately $\frac{3}{8}$ of an inch. The joint exists for the full height of the structure along the east side. Due to movement, the loading above is now eccentric to the wall. This results in the wall continuing to laterally move and the condition to worsen over time. In order to repair this condition, the wall would have to be removed, reconstructed and properly secured to the floors behind. This would negatively impact the historical nature, aspects and/or fabric of the building.

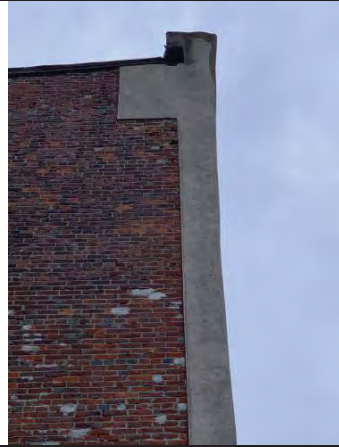
7. The upper parapets are not water protected. There is no cap flashing and the top of the wall is water stained. As such, water is entering into the wall resulting in further movement. The water infiltration is visible on the upper parapet of the structure.

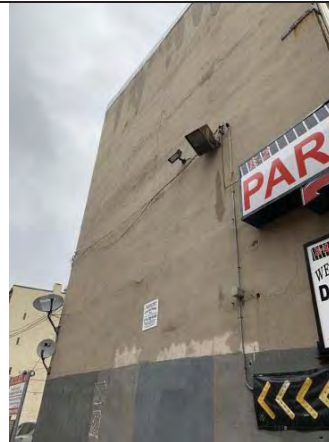
8. The west wall is pulling away from the building to the west. This is indicated by the cracking and spalling of the stucco. Please note that the wall has bulged and rolled. This movement results in the load no longer being applied concentrically at the center of the wall. The eccentric load also furnishes a driving moment which will result in further movement of the wall outwards. Due to the movement the capacity of the wall is reduced. The joists are dislodged from their original bearing condition. With the floor removed, the wall becomes more slender and longer. The load carrying capacity of the wall is reduced. This condition is not repairable without complete reconstruction. Thus, the historical nature, aspects and/or fabric of the building would be altered.

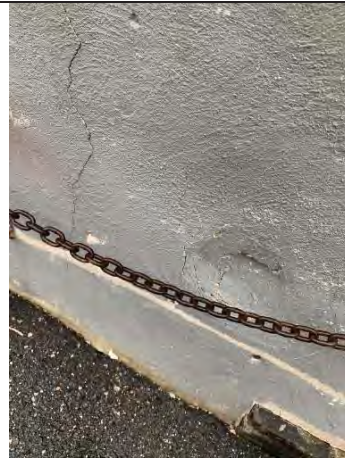
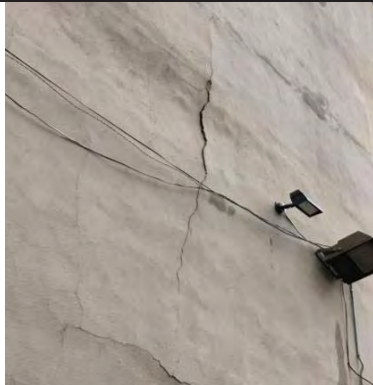
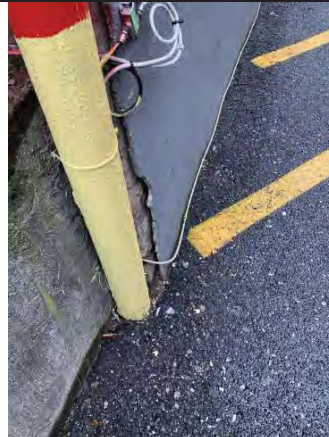
9. There are numerous areas where the stucco coating has delaminated and moved away from the exterior walls. The stucco is cracked and bulging. The cracks vary in thickness from 1/8 to 3/8 of an inch in width. Some cracks are small other are over 8 feet in length. The impact on the picture to the right shows that the stucco has delaminated over 3 inches away from the face. The movement also is visible at the ends of the stucco where it adjoins the brick face. This is visible within the lower right picture. The stucco presents a dangerous condition because pieces are falling to the ground. These conditions have worsened over the time of my inspections. This condition is not repairable without complete removal and reconstruction of the stucco. Thus, the historical nature, aspects and/or fabric of the building would be altered.

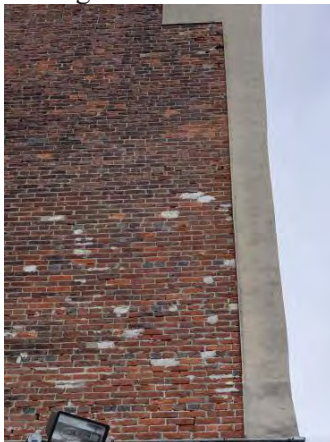
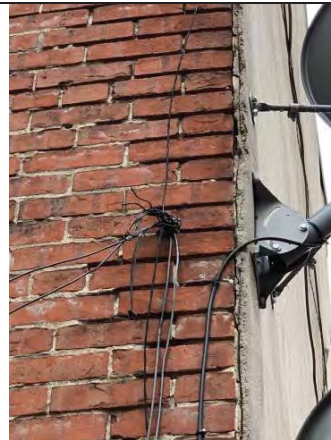
10. Several bricks are missing or have been infilled on the rear east corner. This is indicated by the holes in the picture below. The infilled bricks are white. The bricks have further deteriorated over the time of my inspections. Additional brick faces have spalled or deteriorated. This condition is indicative of deterioration of the brick and reduced load carrying capacity of the wall. This condition is not repairable without removal and replacement of the damaged brick. Thus, the historical nature, aspects and/or fabric of the building would be altered.

This picture shows missing mortar within the brick joints. This missing mortar indicates that the wall has deteriorated. This results in a reduced load carrying capacity of the wall. The mortar joints have deteriorated further over the time my inspections. This condition is not repairable without replacement of the mortar. The mortar composition and color would not match the original construction. Thus, the historical nature, aspect and/or fabric of the building would be altered.

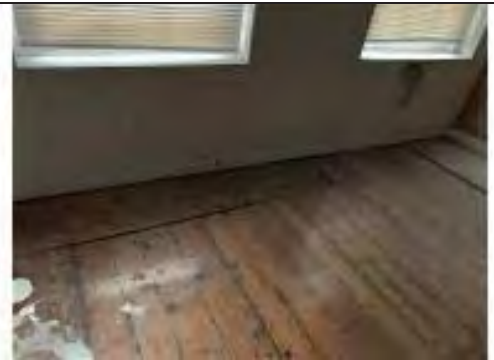
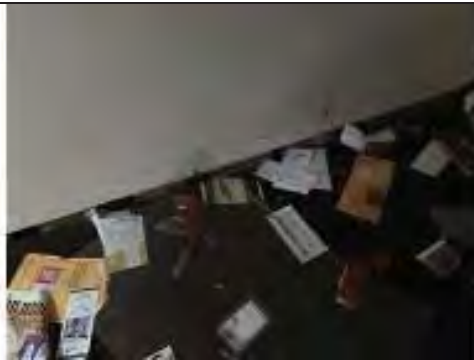
11. All floors are loose and not level. The picture to the right shows an increased gap between the baseboard and the floor. The gap is over $\frac{1}{2}$ of inch wide. The gap on the left side is larger than the gap on the right. This indicates that the front wall has moved laterally forward. This condition has worsened over the time of my inspections. In order to level the floor, the floor boards would have to be removed. Thus, the historical nature, aspects and/or fabric of the building would be altered

This picture to the left shows the movement downward on the first floor. The floor was originally at the bottom of the white wall. The movement downwards is a maximum of 4 inches. This indicates that the joists are not laterally supporting the wall and that the wall will continue to move. The floor joists have deteriorated and require complete replacement. Thus, the historical nature, aspects and/or fabric of the building would be altered. This condition has worsened over the time of my inspections.

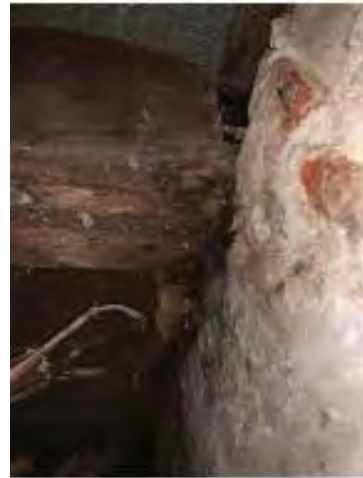
12. The west end of the joists are almost completely out their pockets on the first floor. This condition had and will continue to worsen. The joists have moved further out of the pockets and floor has moved downwards. There is no bearing contact of the joist to a minimal 1 inch bearing contact of the joist to the wall. The joist ends are rotted. The load carrying capacities of these members are compromised. The first floor is unstable and potentially can collapse. The floor no longer provides lateral support for the wall.

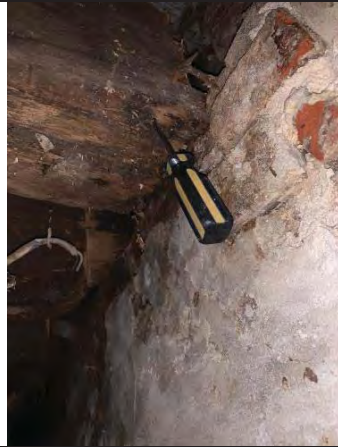
13. The first floor joists on both the east and west ends are rotted. These members are easily penetrated by a screw driver under normal hand pressure. This condition has worsened over the time of my inspections. The deterioration indicates that the member is structurally compromised and can no longer sustain its required loading without removal or repair. This would result in negatively impacting the historical nature, aspects and/or fabric of the building.

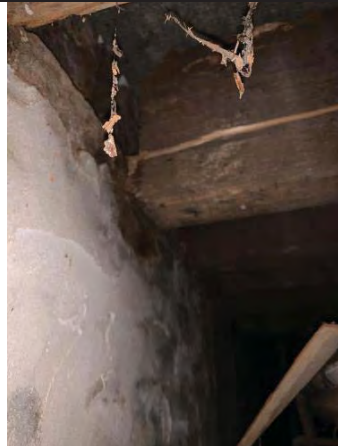
14. There are cracked joists within the first floor visible on the east end. The crack is approximately $\frac{1}{4}$ of an inch in width and extend 6 feet long. The crack reduces the member available to carry loading. Its load carrying capacity is reduced. The deterioration indicates that the member is structurally compromised and can no longer sustain its required loading without removal or repair. This would result in negatively impacting the historical nature, aspects and/or fabric of the building.

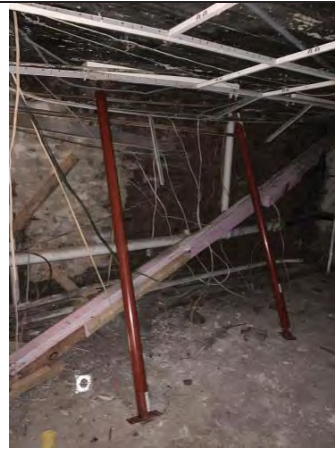
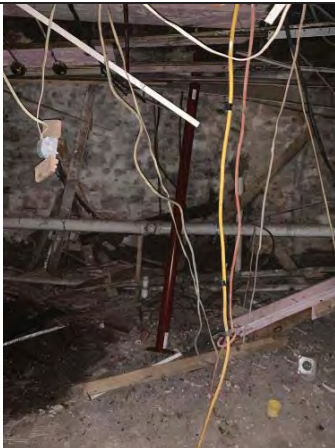
15. The temporary supports for the first floor joists have shifted. The supports are no longer plumb or supporting. During my original inspection these members were plumb. The shifting indicates that the floor has moved downwards and outwards. It indicates that the building is continuing to move. In order to repair this condition, the entire floor and wall have to be reconstructed. The joists immediately must be removed and replaced. The wall has to be reconstructed to eliminate the water infiltration.

Any repair/reconstruction would result in negatively impacting the historical nature, aspects and/or fabric of the building.

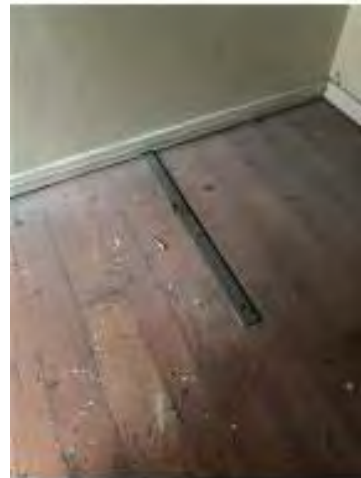
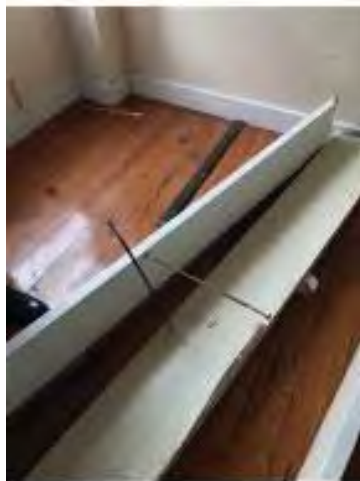
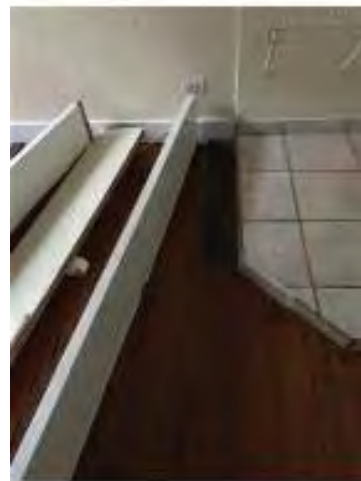
16. There is steel strapping present at the second and third floor level that attaches the floor to the rear wall. This indicates a prior repair. This repair is over 10 years old. The repair indicates that the building was moving. While the strapping is working, it is unattractive and negatively impacts the historical nature, aspects and/or fabric of the building.

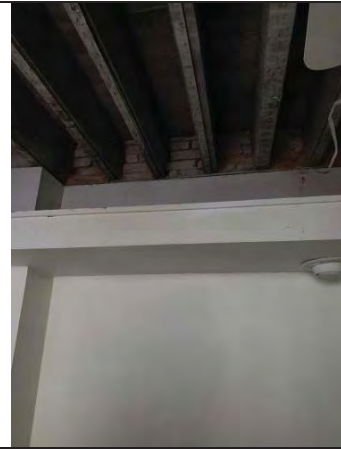
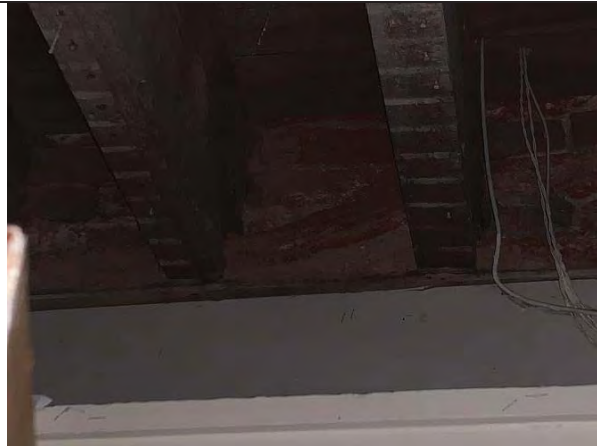
17. Several joists are loose in the joist pockets on the upper levels. This is evidence by the creaking and movement when walking on the floors above. These joists are no longer secured in the pocket due to deterioration of the brick and the mortar. This picture shows the condition of the brick and pockets at the third floor. There is missing mortar within the brick joints in the picture at the left.

The picture to the left shows deteriorated brick dust on the insulation. This indicates that the bricks are crumbling due to water infiltration within the building. This reduces the load carrying capacity of the brick. In order to repair this condition, the bricks would require removal and replacement. This would negatively impact the historical nature, aspects and/or fabric of the building.

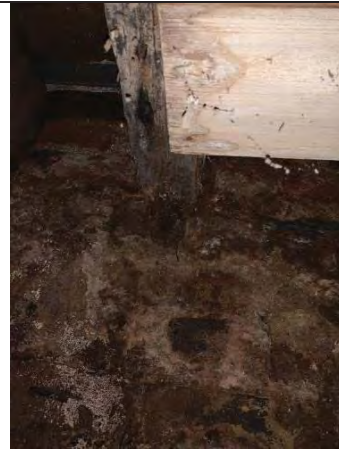
18. The basement is damp and wet. This condition has been present on all inspections. There is standing water present. There is mold present. Water infiltration is due to the site drainage, the lack of parapet flashing, and through the wall itself resulting in deterioration of wood member and the stone walls. The water causes further deterioration and reduced capacity of the members to carry load. In order to eliminate the water, the wall above requires removal and replacement. The site drainage should be set to drain water away from the foundation. Further, damproofing and drainage systems would be required. This would negatively impact the historical nature, aspects and/or fabric of the building.

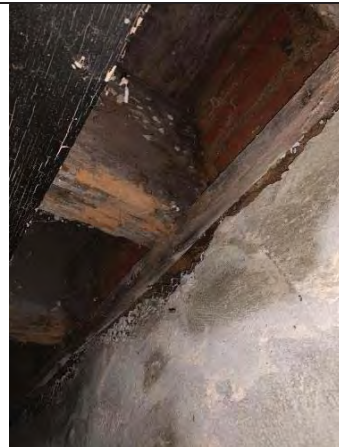
19. There is evidence of a past fire within the basement area. The ceiling and some members show substantial charring and smoke damage. A fire indicates that the building has suffered past trauma. It is no longer constructed in its original condition. Due to the presence of a past fire, I recommend that all members to inspected to assure a proper repair was completed and no damaged members exist.

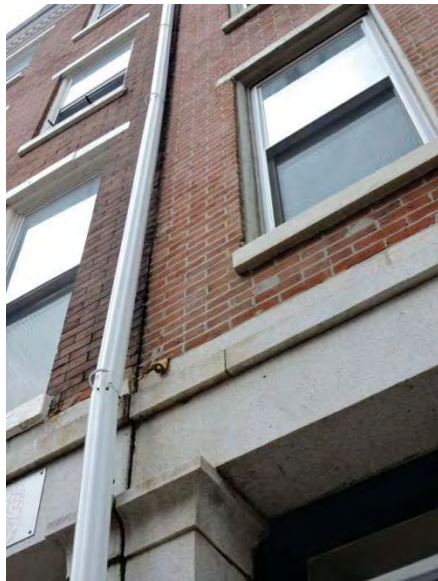
The vertical lines indicated in the *Baxter's Panoramic Business Directory* conform to the visual evidence of the physical site. Mr. Baumert's photograph reveals a cold joint with no interlocking of brick in the facades between 105 and 107 Chestnut Street, indicating their separate construction. Together with their shared proportions, window sizes, lack of shutters, similar shop fronts and cornices noted above, this evidence suggest that 107 and 109 were almost certainly a single project. Both depended on each other for stability, essentially resisting lateral dynamic forces in the masses of each building. The demolition of 109 Chestnut Street prior to 1942 thus would have negatively affected the stability of 107 Chestnut Street.

Fred Baumert, Photograph of cold joint behind drain line, between 105 and 107 Chestnut Street, May 11, 2020

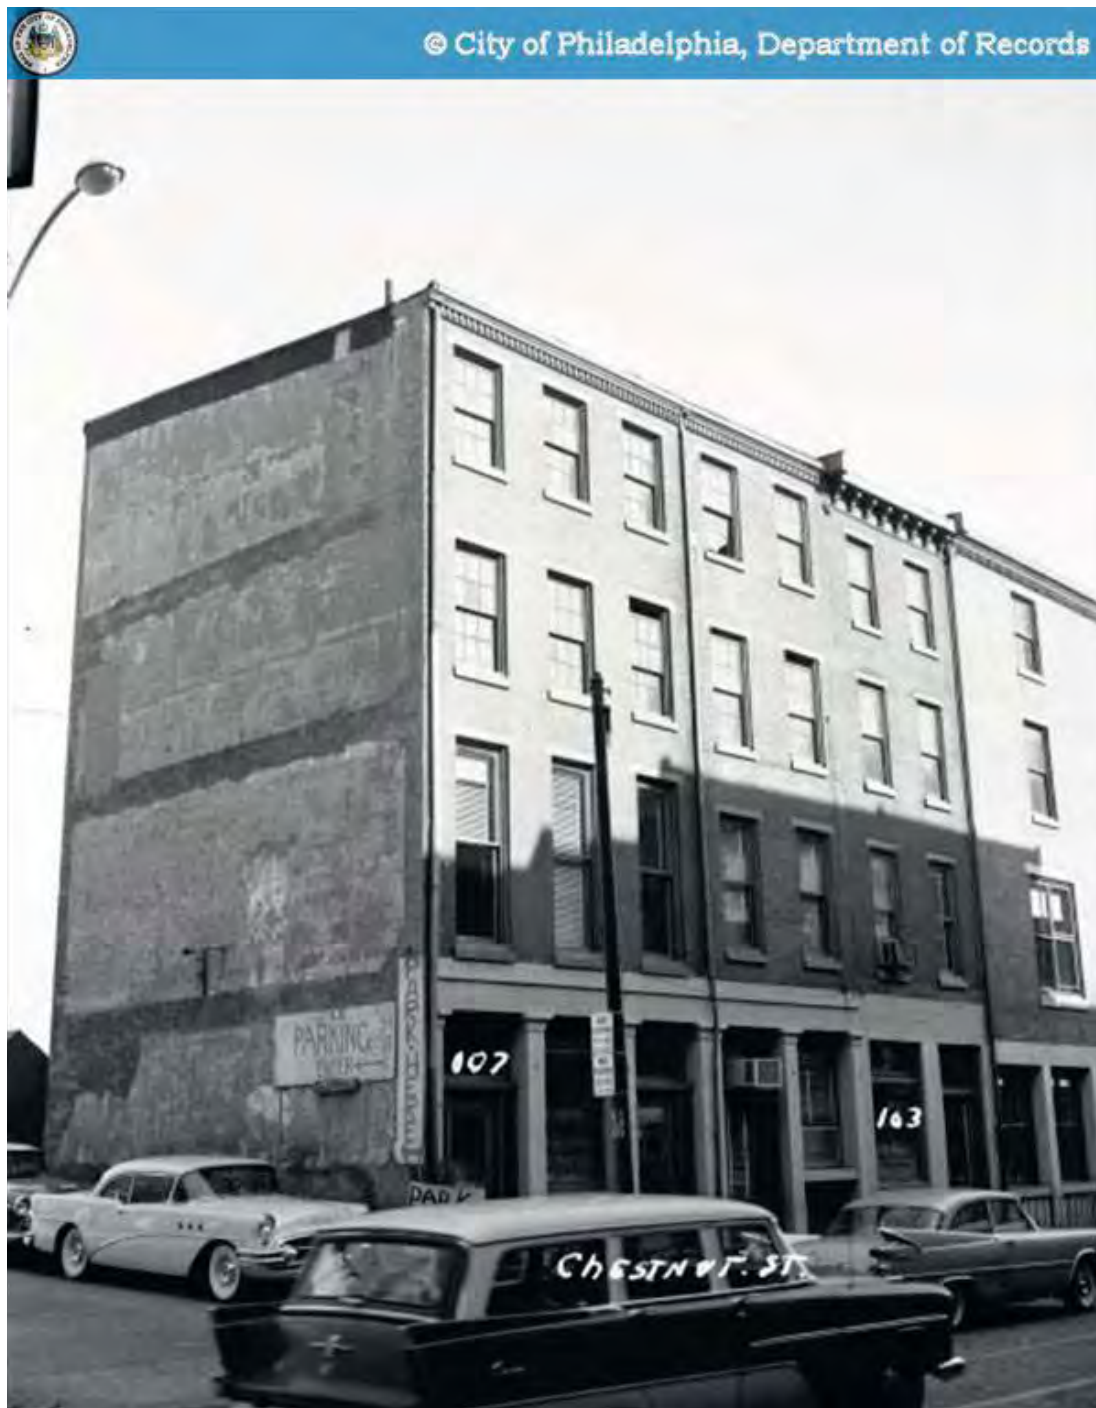
Department of Records: Chestnut Street, 103, 107 showing parking on the site of 109 and remaining plaster on its former party wall (1959 Photograph) This clearly shows the slope of the roof toward Chestnut Street as well as the different cornices, window sizing, and breaks in the façade evident in the *Baxter Panoramic Business Directory* engraving that further corroborate the separate builds of 103, 105, and 107.

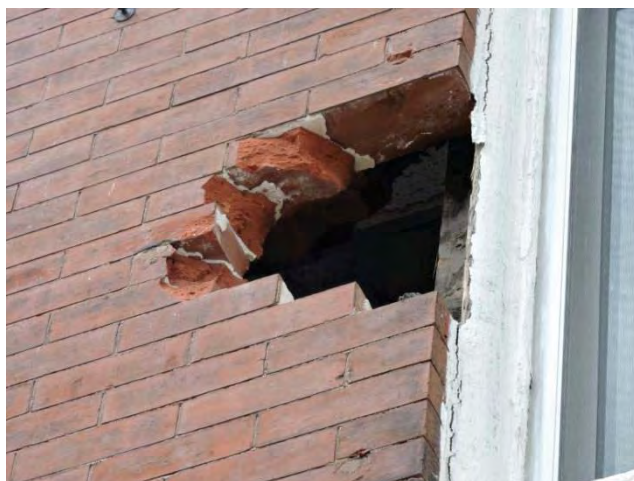
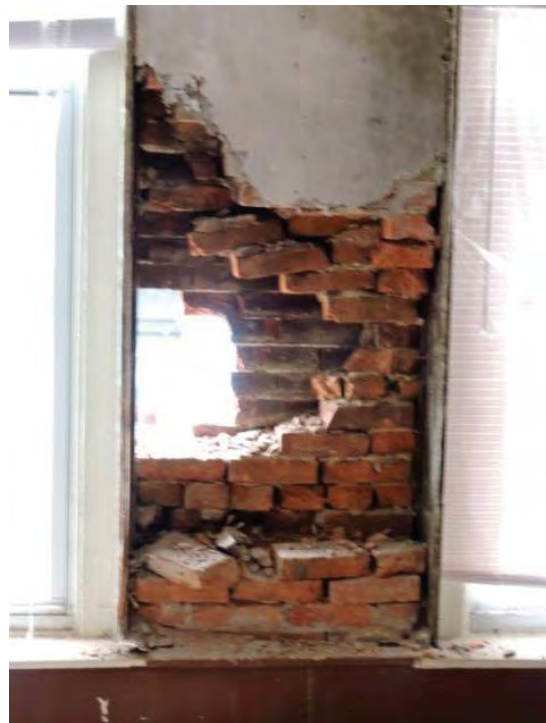
Left: Detail of south façade 107 Chestnut Street, showing failure of middle left pier of the front wall adjacent to second floor window, photograph, Fred Baumert, Keast & Hood, May 11, 2020.; Right three wythes of brick, two inner layers of salmon brick filling out wall to depth of window frame with outer pressed brick facing Chestnut Street. The collapse suggests failure of a bond course in the salmon brick between the layers (or this may have been where the mason laid cut brick ends); photograph, Fred Baumert, Keast & Hood, May 11, 2020.

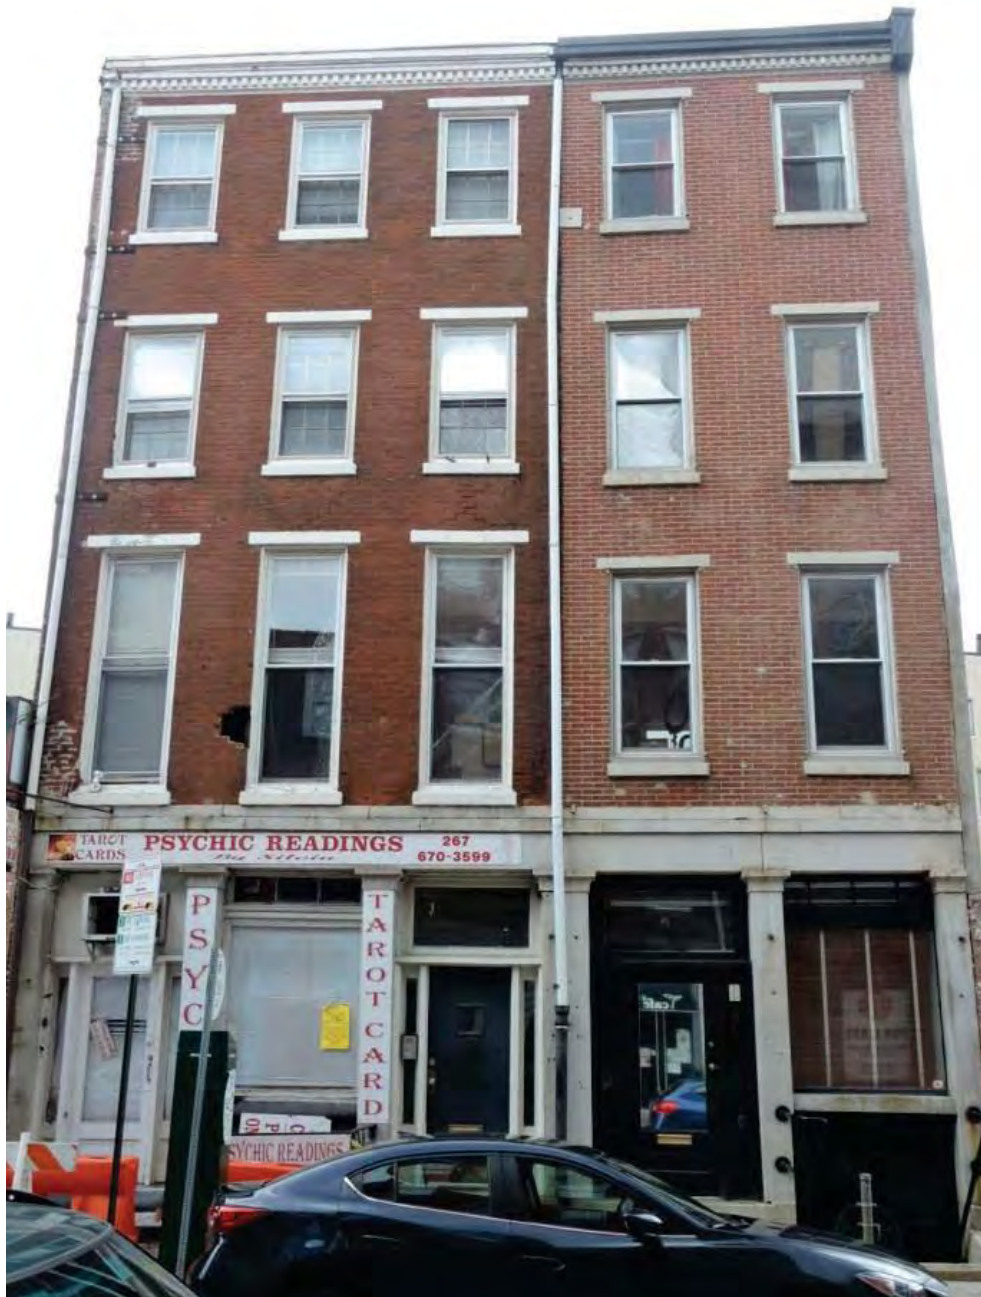
No bond courses or headers are visible in the entire main façade. Large settling cracks in the façade between the second and third floor show additional stresses in the façade. Note that the window sizes and locations are different than in 105 to the right, making clear that they are separate buildings. Photograph Fred Baumert, Keast & Hood, May 11, 2020

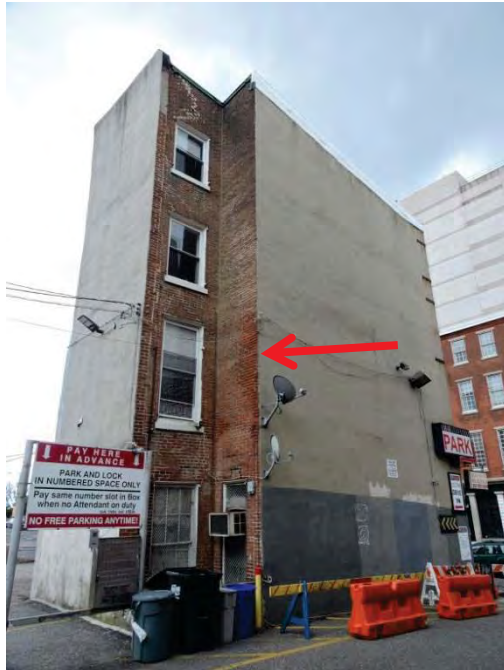
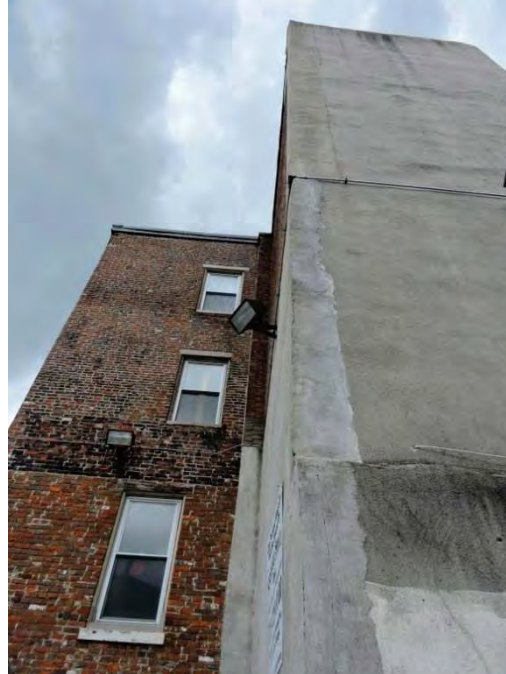
Left photo: rear of 107 Chestnut Street showing medium hard exterior grade brick with extensive weathering (arrow) at the northwest corner. Right photo: Rear of 105 Chestnut with fired redder brick below showing the one story wing of 48 S. Front Street that originally covered that portion of the wall. The darker brick above is smoke darkened from exposure to the industrial city air. Stuccoed areas were formerly covered by other buildings and are presumably salmon brick. Photographs Fred Baumert, Keast & Hood, May 11, 2020.
