ADDRESS: 1600-06 E BERKS ST

Proposal: Demolish building owing to necessity in the public interest

STRUCTURAL CONDITION APPRAISAL

ST. LAURENTIUS CHURCH
1608 EAST BERKS STREET
PHILADELPHIA, PA

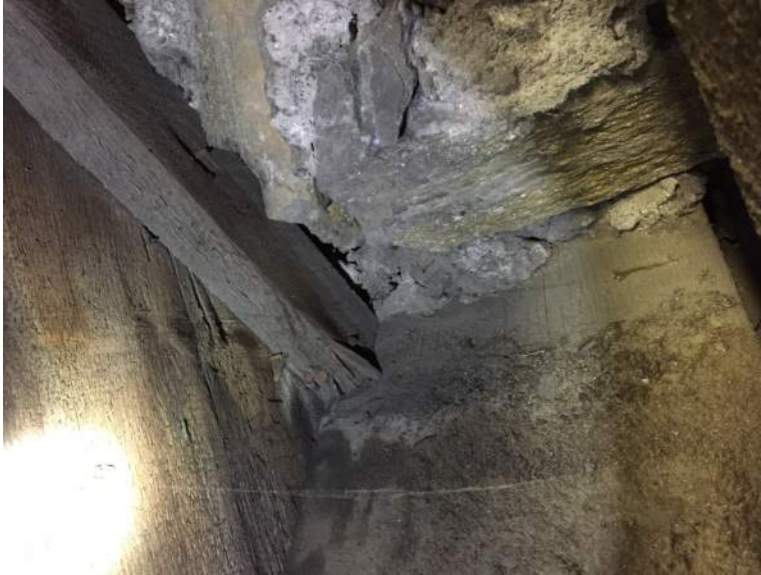
Corner masonry infills supported by timbers at the Lower Bell level

Structural Issue #	Title	Description	Impact on Stability of Northern Towers
#1	Geometry	All weight of steeples (50,000 pounds each) is supported on 2 primary timber girders resting on the lower bell level, northern and southern walls only; all gravity and lateral loads from the steeple are supported at this level.	Moderate impact. No stability gained between masonry and steeple; stability/bracing from timber girders gained on northern and southern walls only. Eastern and western walls rely on the corners for stability.
		Corner rounded turrets gain no bracing from corner masonry infills; Cracking evident	Significant impact. No stability of masonry at corners due to cracking.
		Steeple additionally supported on corner masonry infills	Moderate impact.

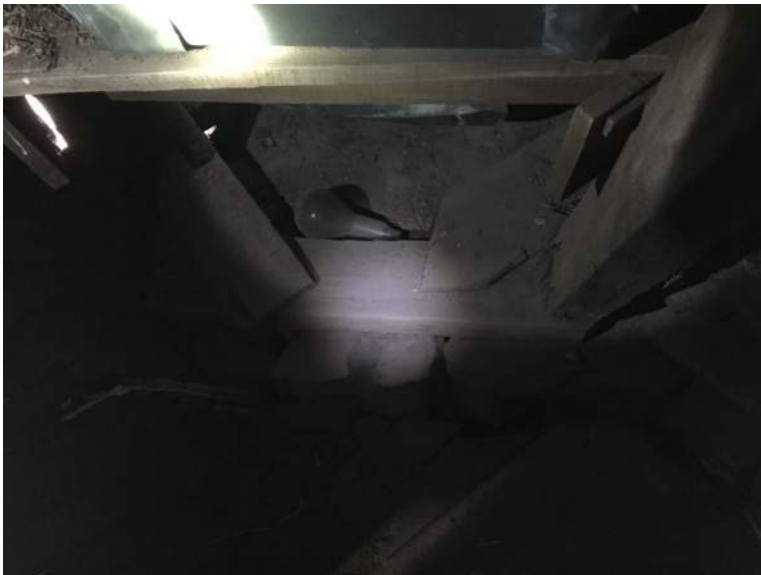
Corner steeple support supported on corner masonry infills

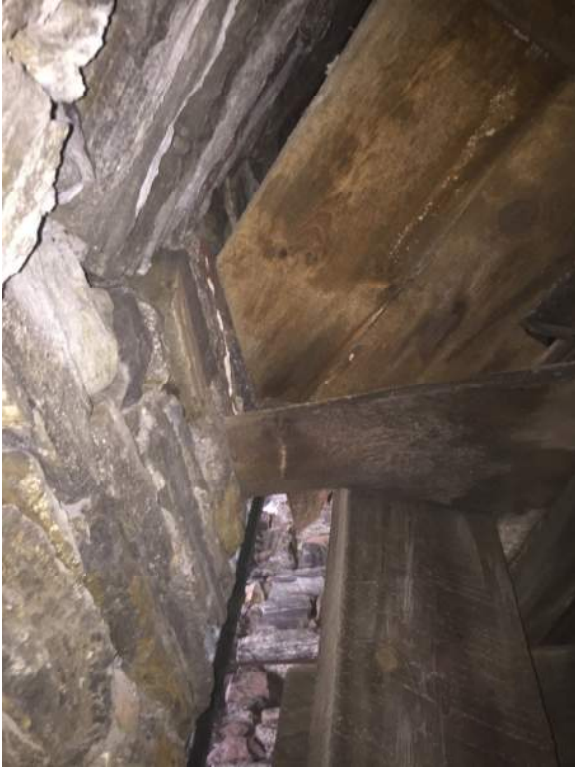
Gap between timber framing and masonry above the lower bell level; no anchors between timber framing and masonry above the lower bell level

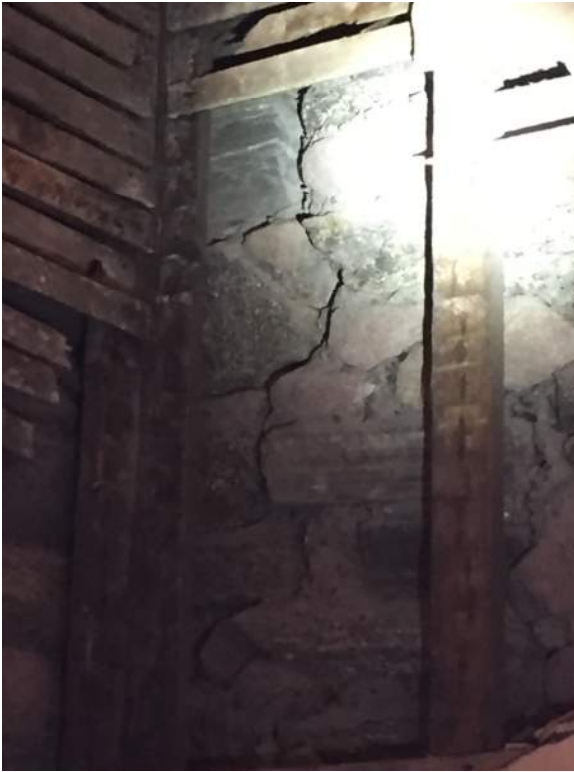
**INTERIOR THROUGH CRACK –
CHOIR TO MID-LEVEL NE TOWER**

The through crack reflects that the corners of the masonry walls have become disconnected from each other. There is no structural integrity at the corners due to this cracking.

#2	Masonry Movement - Mid-level	Up to 2" outward movement evident at northeastern and northwestern tower	Significant impact. Cracking creates lack of masonry continuity and lack of stability of the towers

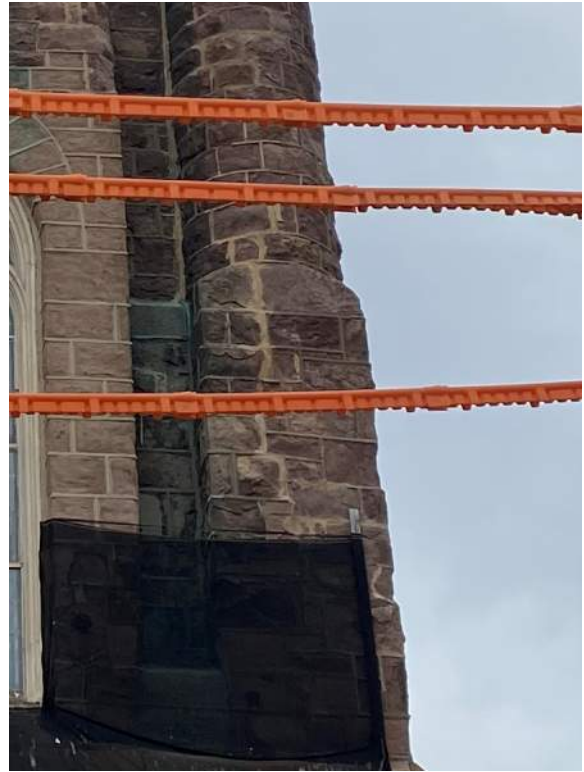
EXTERIOR VIEW OF SAME CRACK

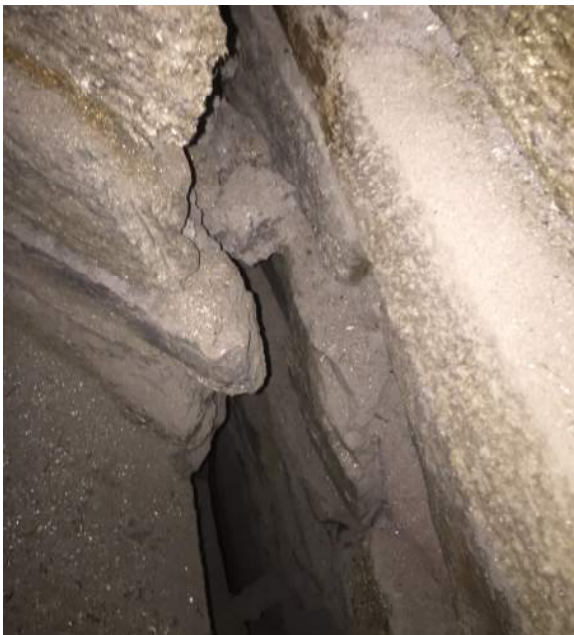
Open 2" gap between diagonal infill masonry and eastern wall indicating movement.

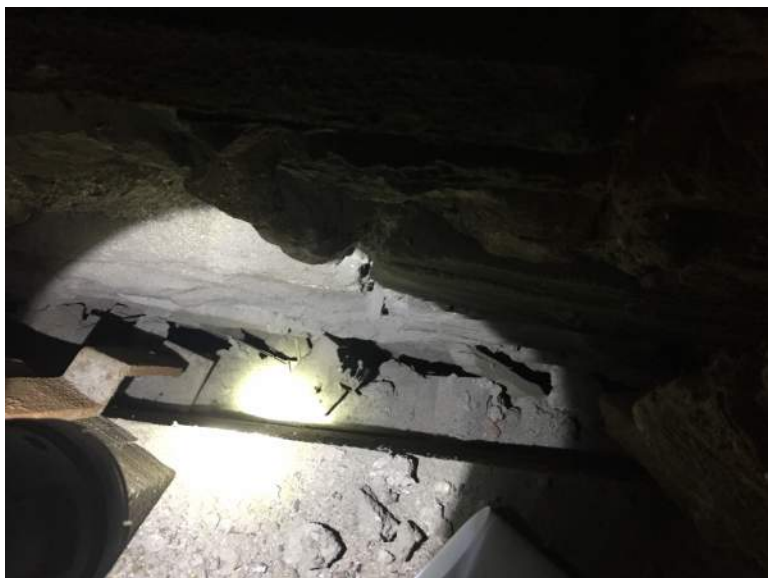
Open 2" gap between wood framing and eastern wall further indicating movement of the eastern wall.

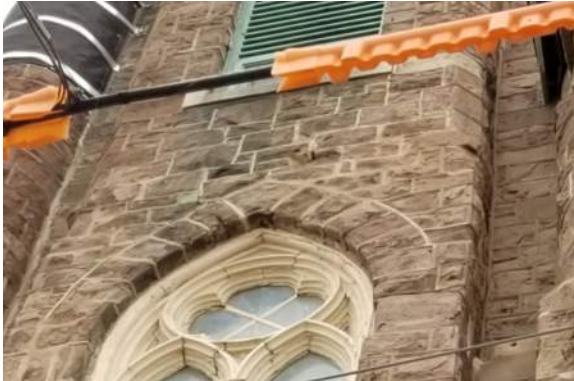
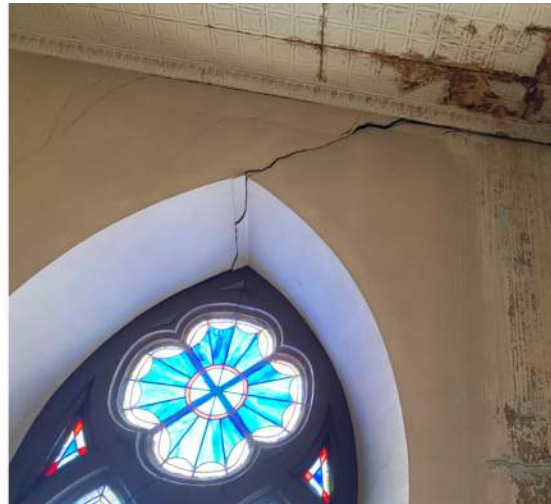
Northern wall eastern tower below mid-level (wood window frame cracked)

#3	Failure of arches	Although the interior of the plaster was not removed, it appears apparent that the head of most of the monumental windows have failed	Failure may cause movement of the masonry noted in #2 or vice versa

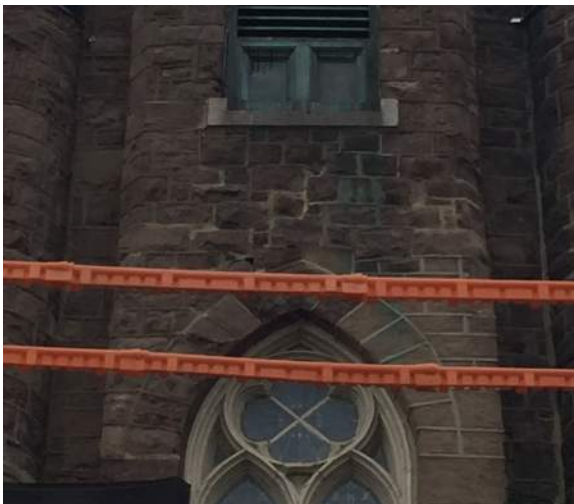
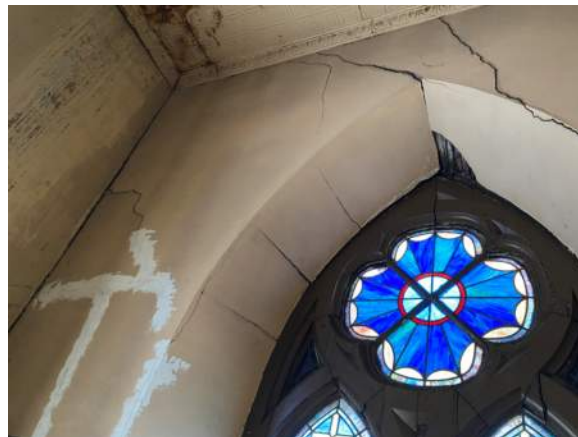
Eastern wall eastern tower below mid-level (wood window frame cracked)

Notice that the plaster (and masonry) cracking indicates that the corner is pulling away from the tower.

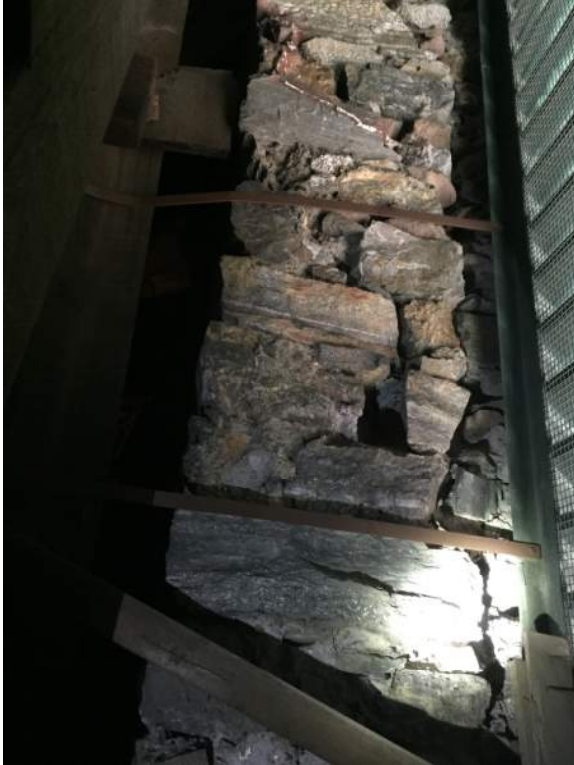
Note smaller stones, lack of mortar

#4	Schist backup quality and degradation of mortar	Original construction of the schist stone backup was smaller stones. The mortar has been impacted through age and freeze thaw.	Significant impact. Smaller stones create extra reliance on mortar. Mortar has significantly degraded between turrets and corner masonry infills. Cracking evident. Lack of maintenance has allowed increased impact from moisture penetration and freeze thaw. Poor quality of backup stone has allowed for geometry (#2) to have a greater impact on the masonry movement and the arch failure. We do not believe pointing is a viable option.

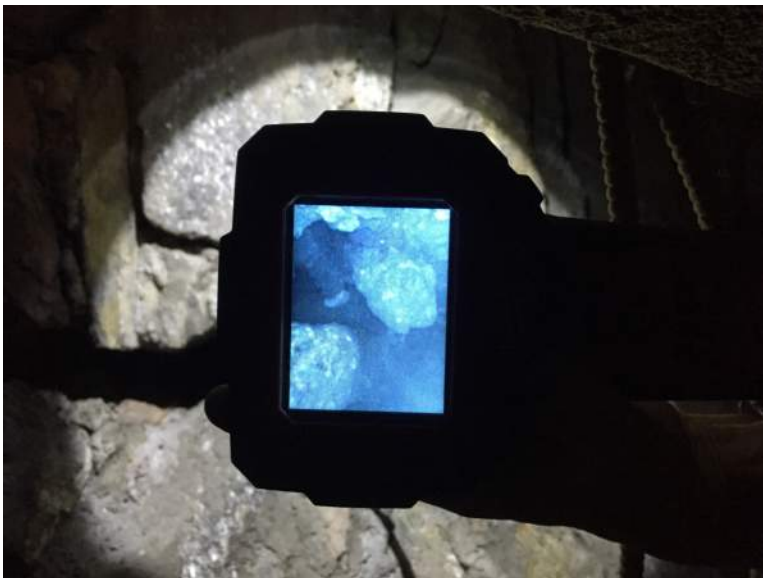
Boroscope readings behind the diagonal infill wall indicates a void originally built. Based on the boroscope readings, the void was filled with dust, remnants of former mortar (damaged through age and freeze/thaw).
