**Philadelphia (PA) Fire Department
Health and Safety Office
After Action Review**

**Line of Duty Death
Lieutenant Matthew LeTourneau
January 06, 2018**

2240 N. Colorado Street
Box 7743: 18th Street and Dauphin Street

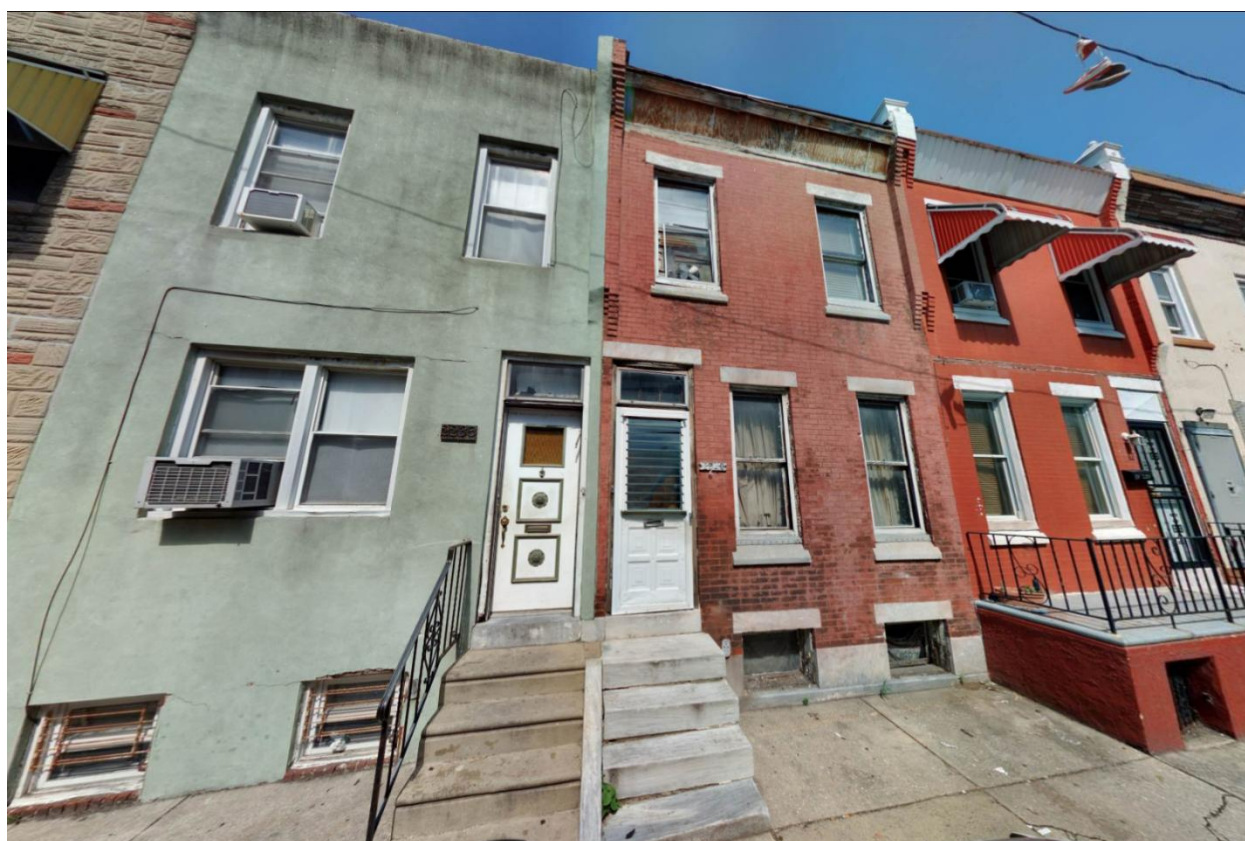
3: Pictured from Left to Right: Bravo Exposure (green dwelling with white door); Fire dwelling (red dwelling with white door); Delta Exposure (red dwelling with red/white window awnings on the second floor). (Source: www.streetsmart.cyclomedia.com)

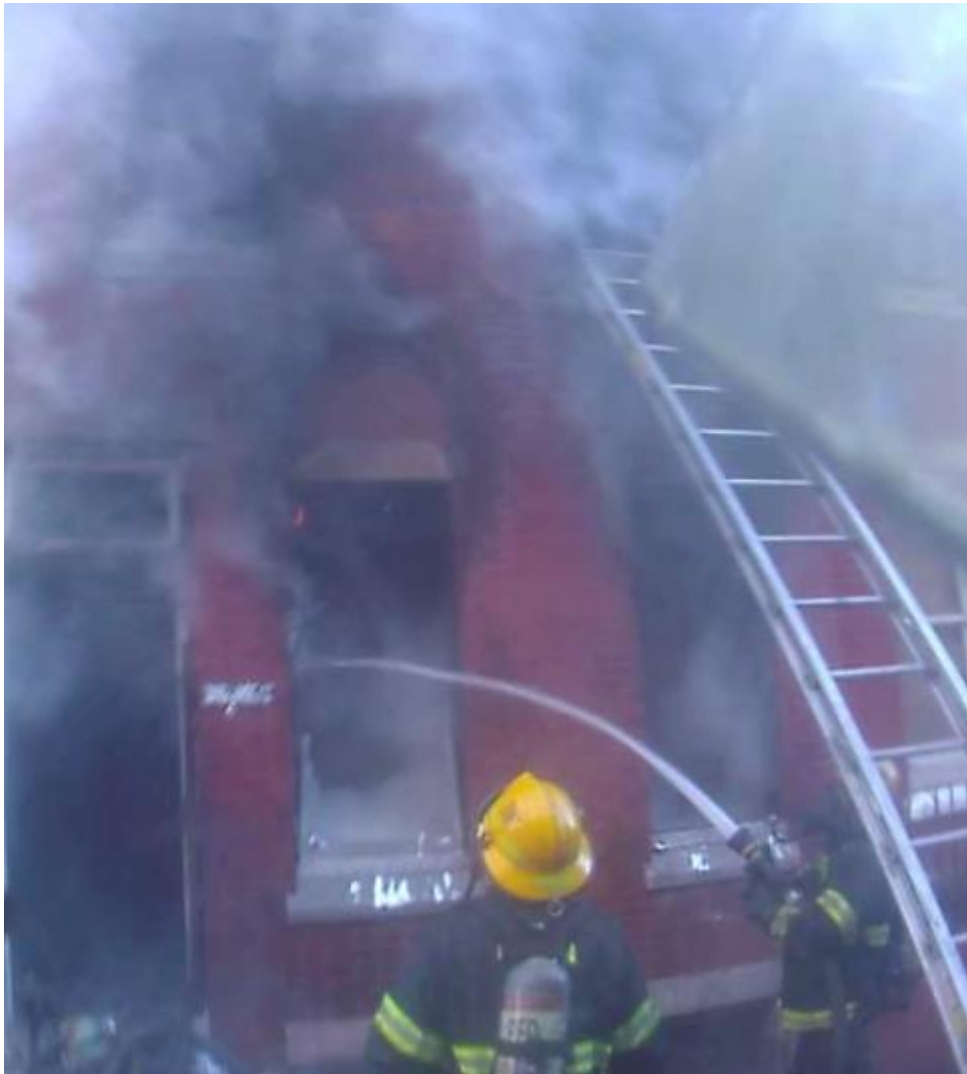
15: Exterior operations. Hose stream demonstrates the water supply problems. (09:10:26 Hrs.)

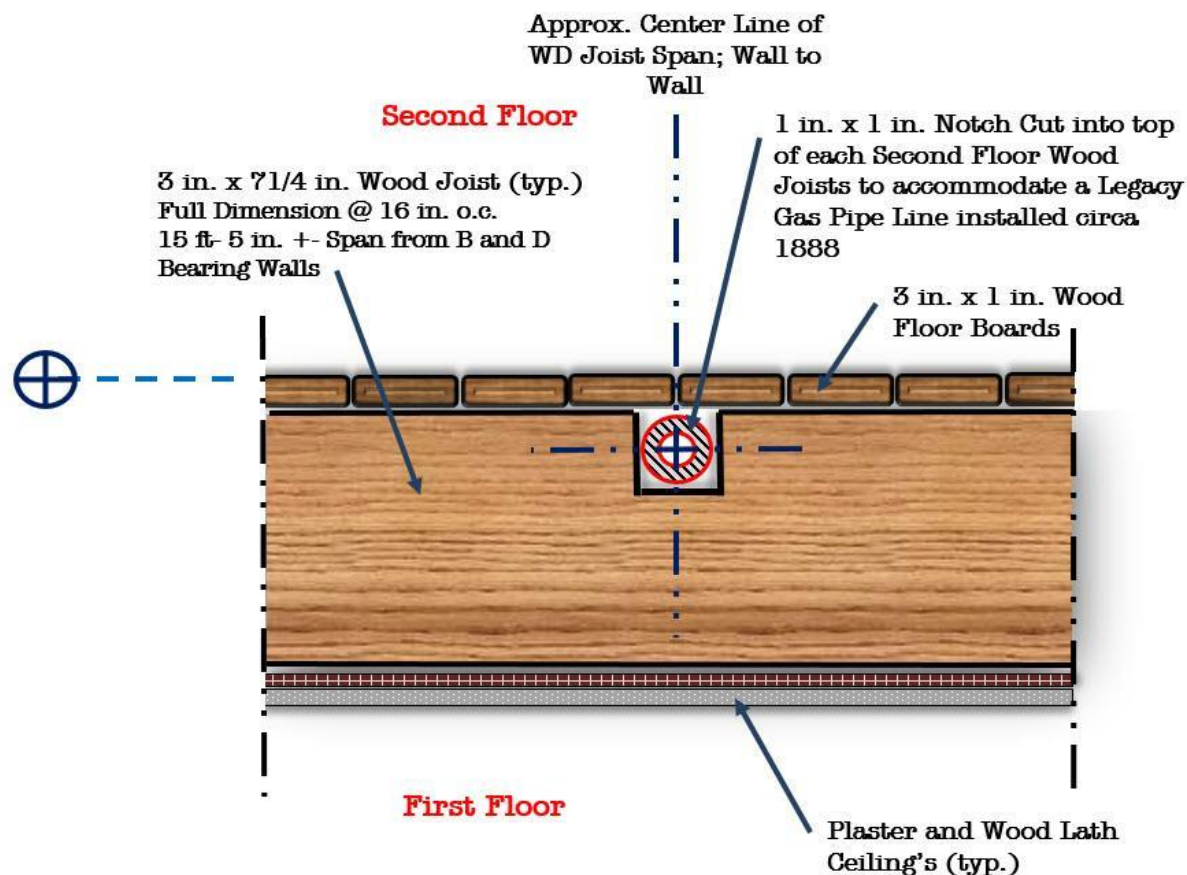
Diagram #5
Floor Joist Plan-Second Floor; Gas-line & Notch
Graphic Courtesy of Buildingsonfire.com | C.J. Naum (Naum, 2018)

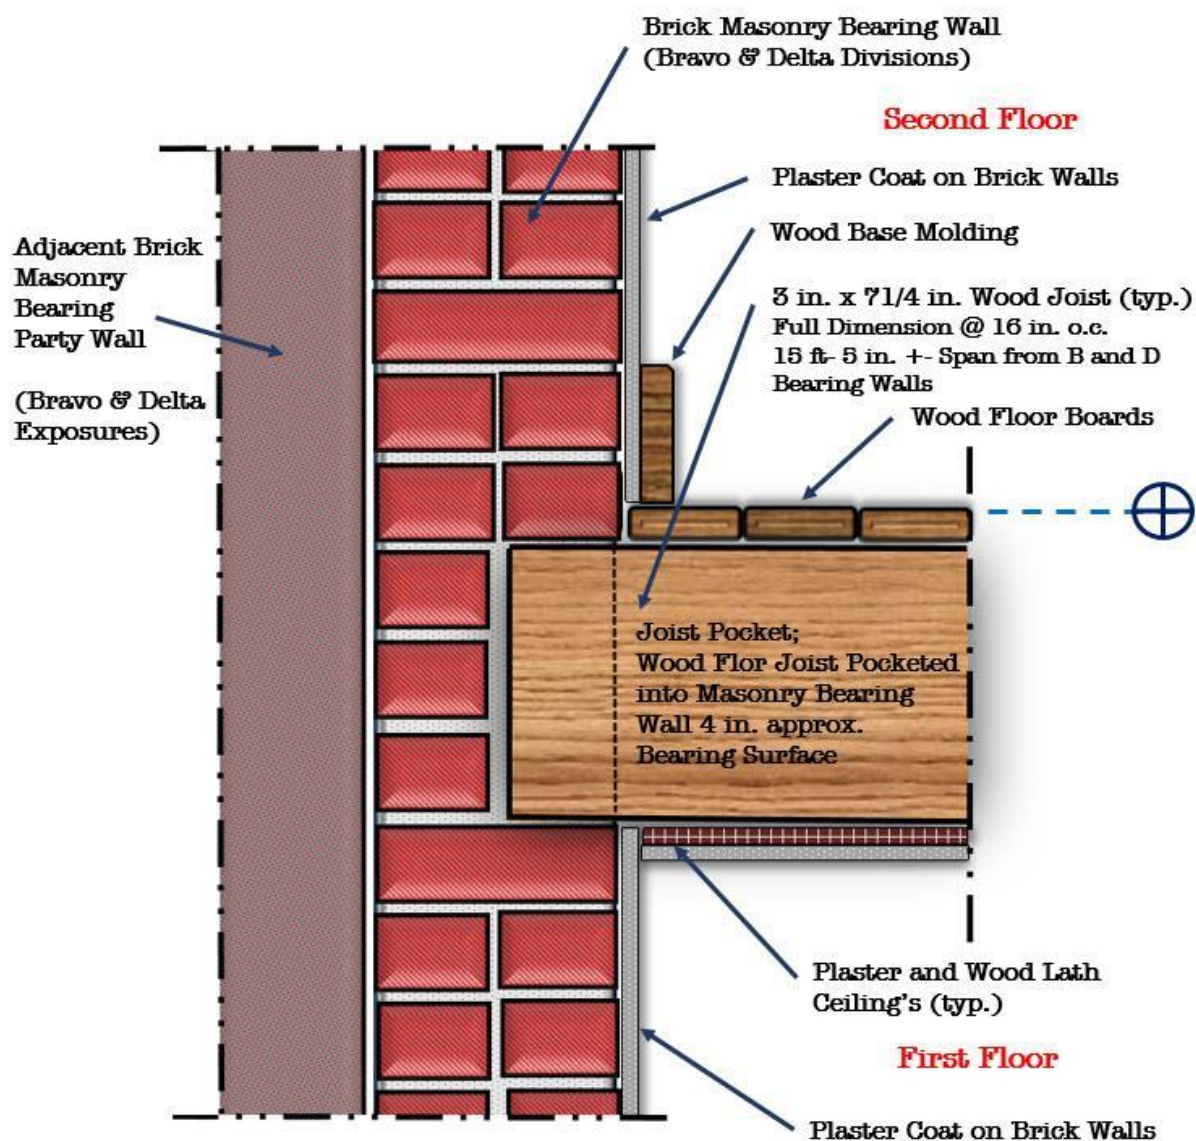
Diagram #6
Masonry Party Wall and Floor Joist Section
Graphic Courtesy of Buildingsonfire.com | C.J. Naum (Naum, 2018)

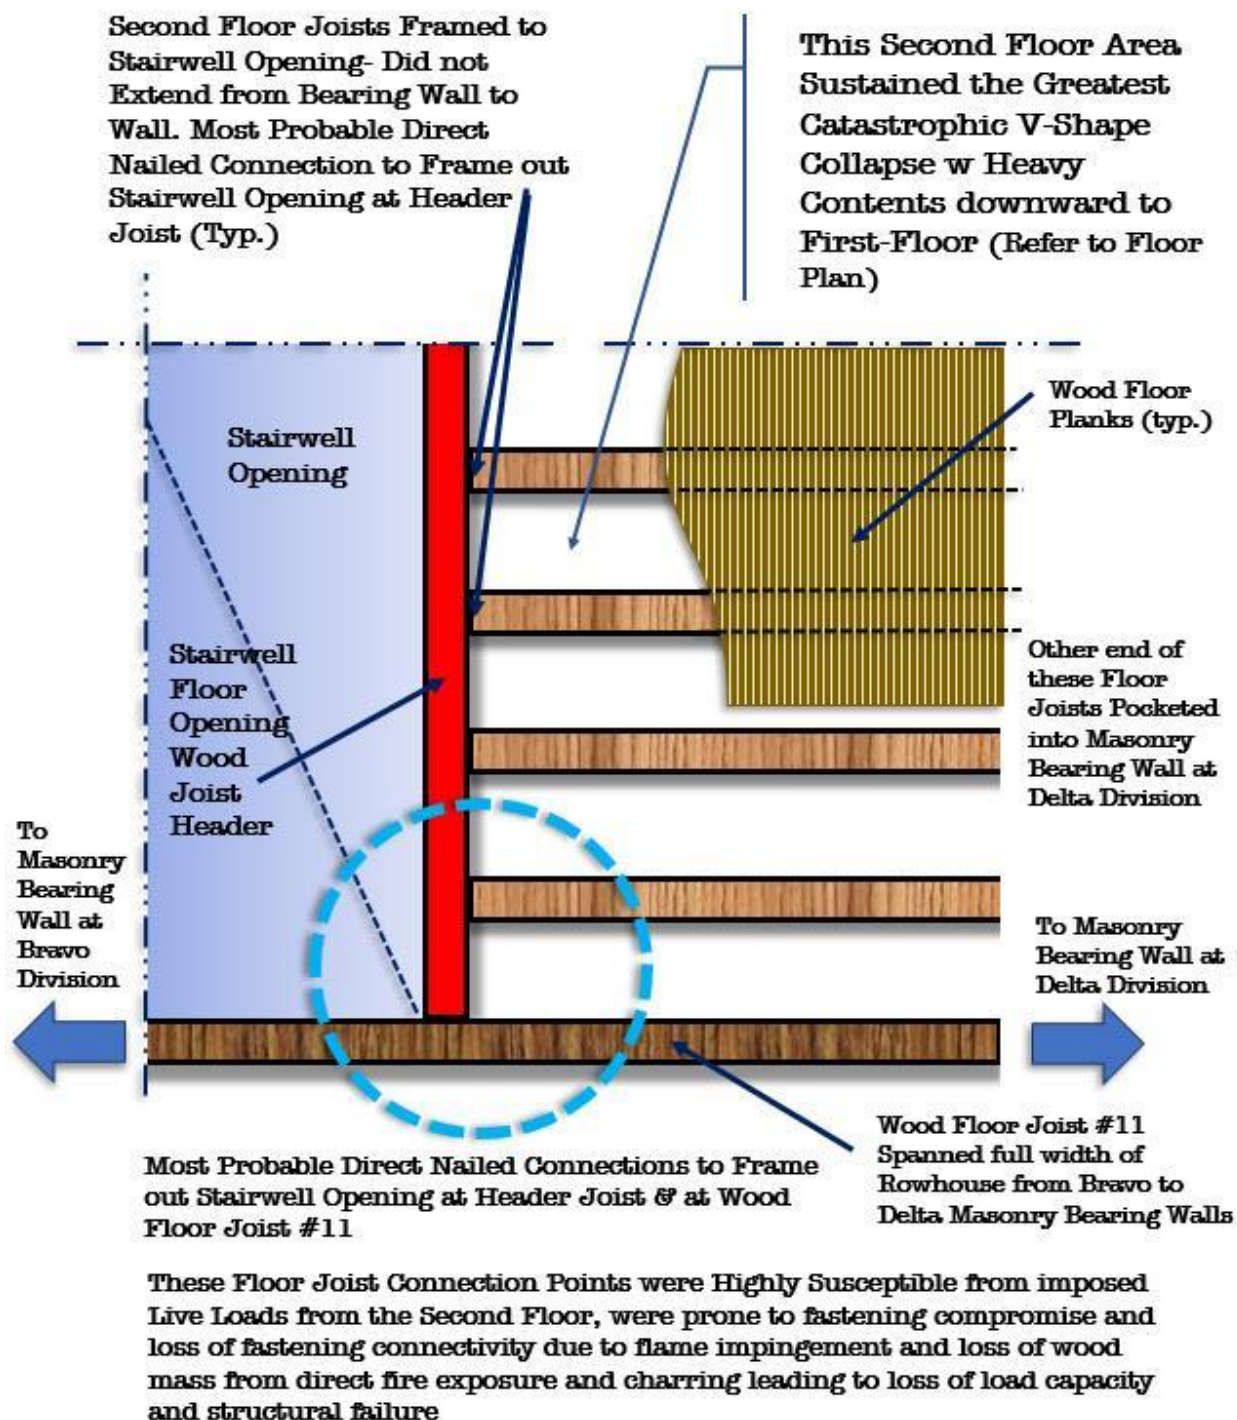
Diagram #7

Stairwell Opening Framing and Second Floor Joists
Graphic Courtesy of Buildingsonfire.com | C.J. Naum (Naum, 2018)

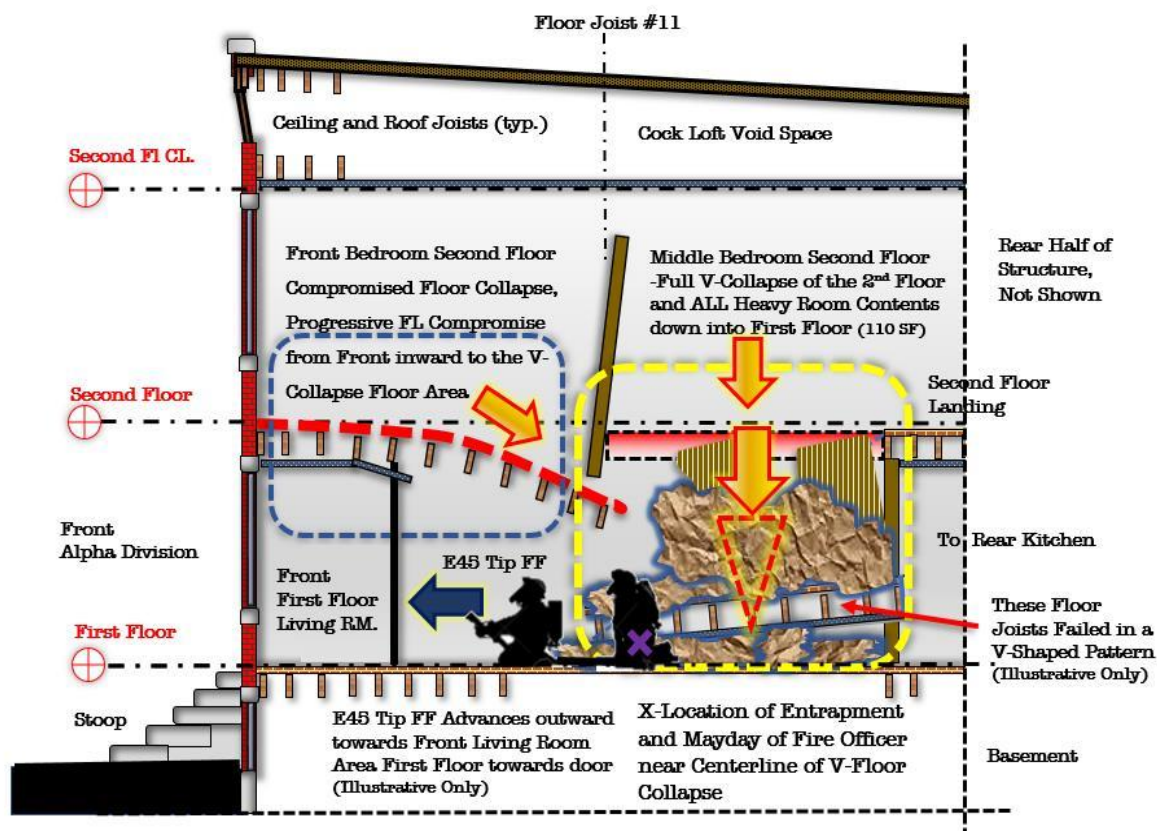
Diagram #9
Cross-Section of Second Floor Collapse Configuration
Graphic Courtesy of Buildingsonfire.com | C.J. Naum (Naum, 2018)

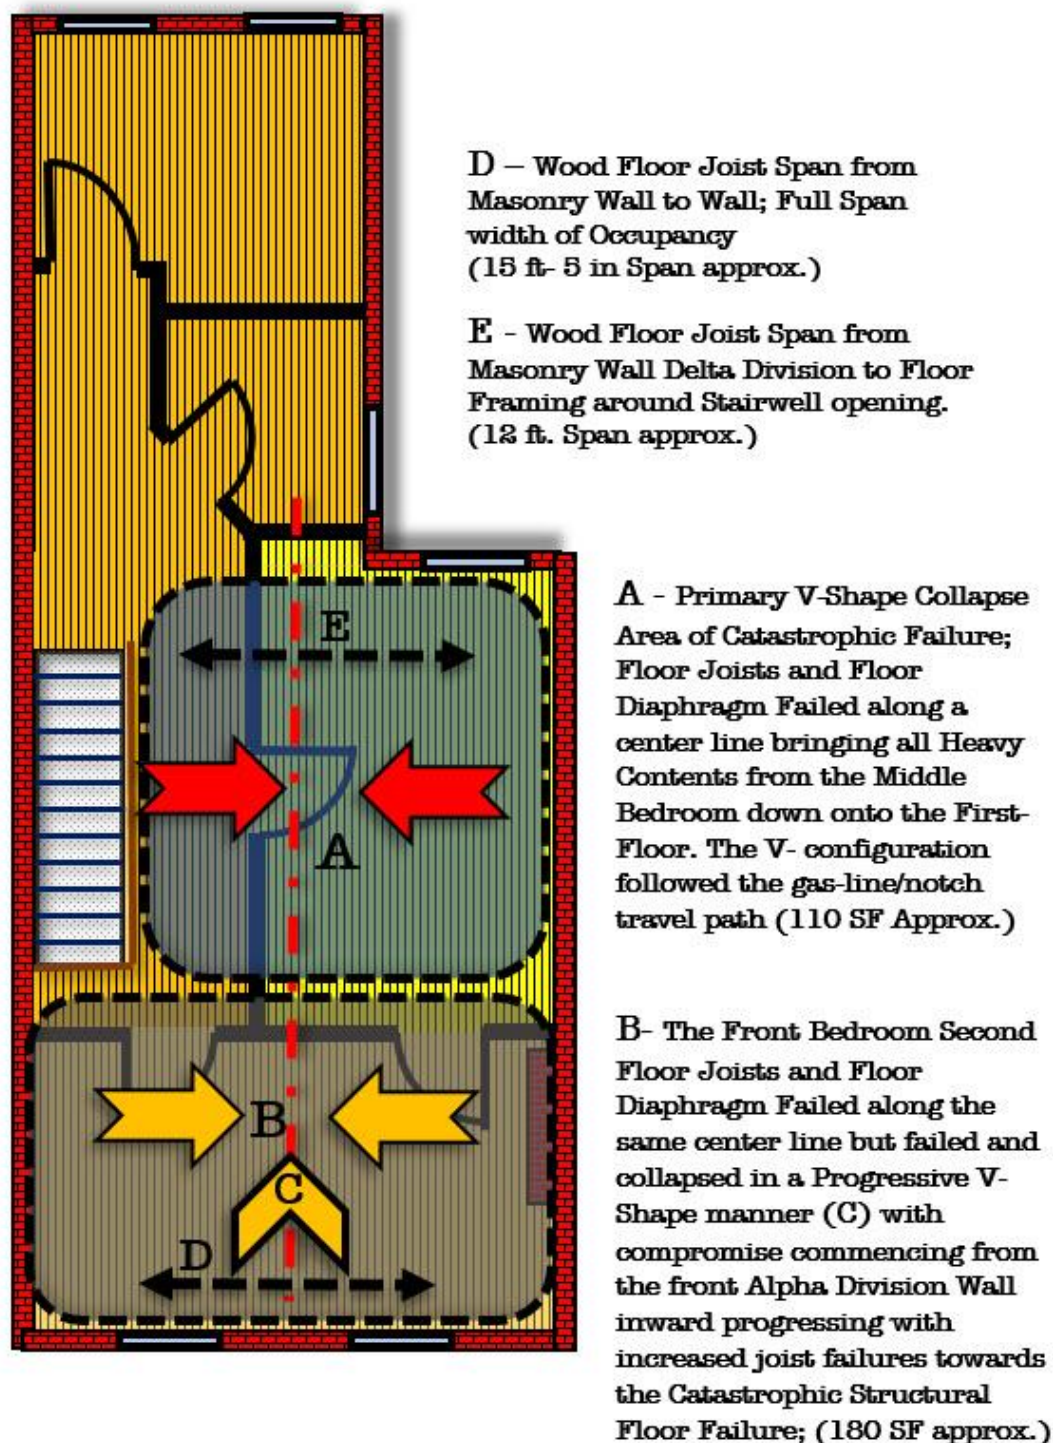
Diagram #10
Second Floor Collapse Areas
Graphic Courtesy of Buildingsonfire.com | C.J. Naum (Naum, 2018)

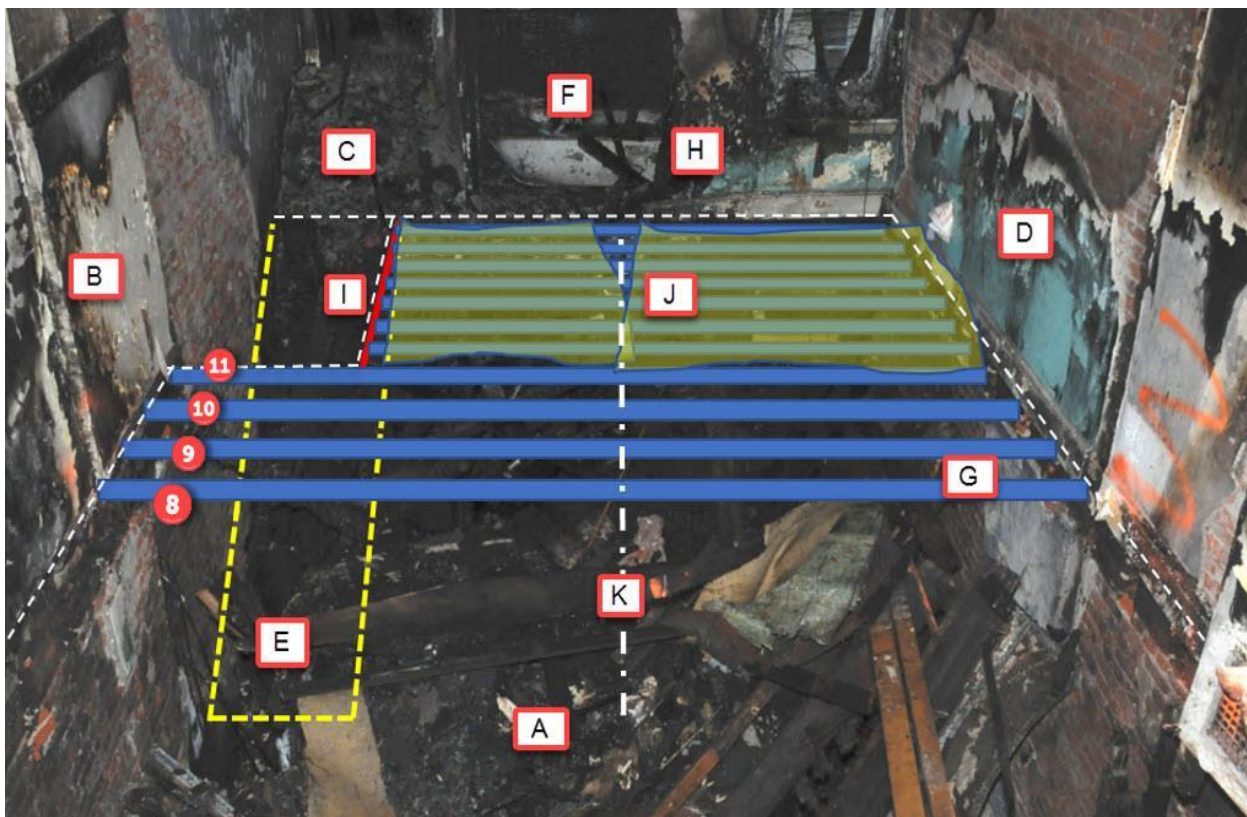
Diagram #11
Second Floor Joist Reconstruction and Collapse Area
Looking inward from the Alpha Division
Analysis Courtesy of Buildingsonfire.com | C.J. Naum (Naum, 2018)

- J. Second Floor Bathroom
- K. Approximate Centerline of the Rowhouse floor-span & approx. CL of the Second Floor V-Collapse Profile
- L. Depiction of the directional movement of the second-floor assembly and floor diaphragm failing approx. mid-span resulting in a V- Collapse profile

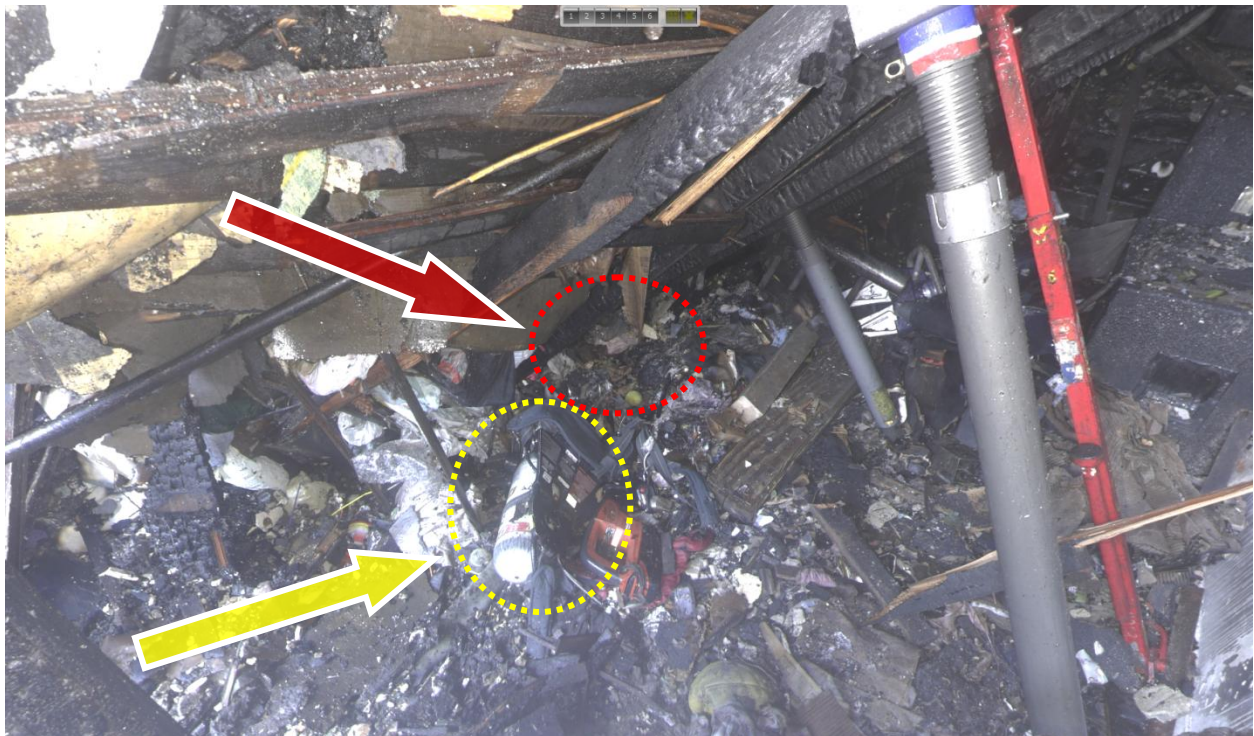
Photograph #2

The red circle indicates the approximate location where Lt. LeTourneau was located. The yellow circle shows Lt. LeTourneau's SCBA. This picture was taken from approximately the middle of the living space, along the Delta side wall looking towards the Bravo side of the dwelling.

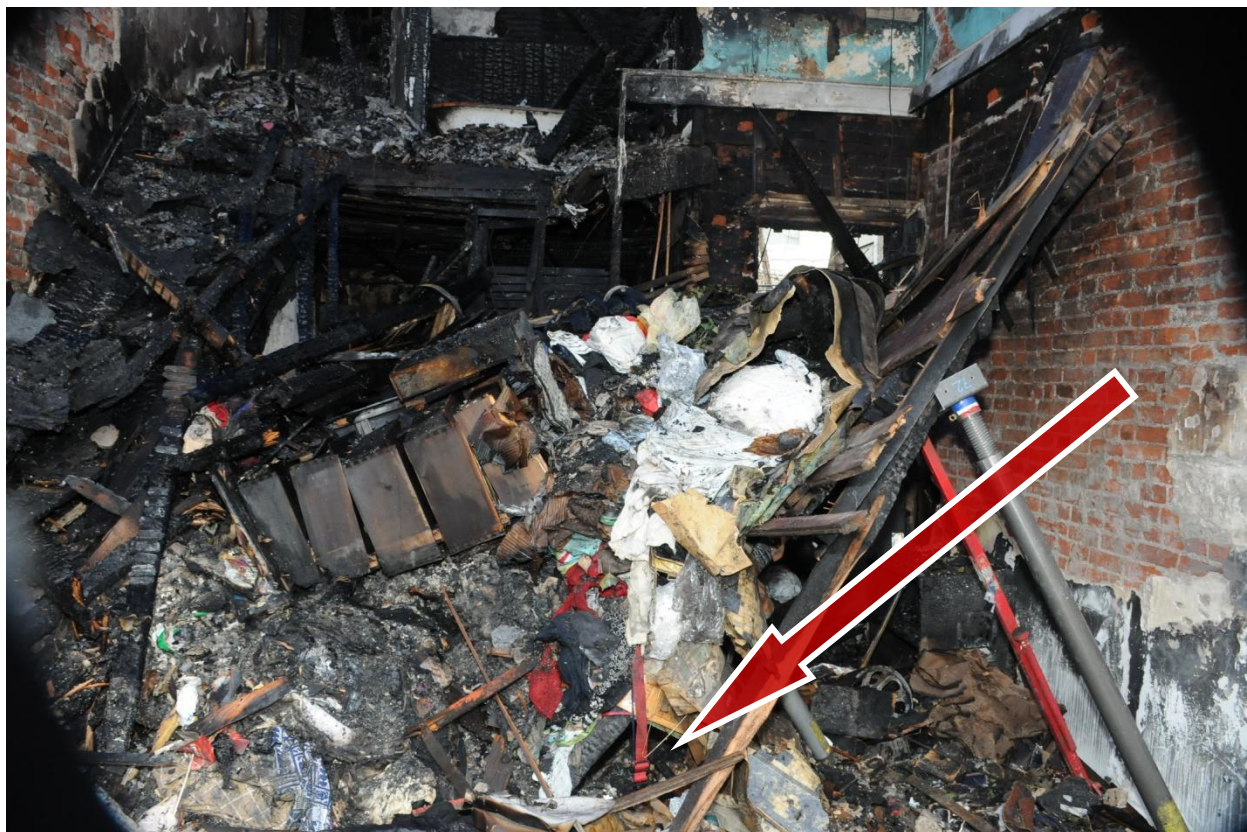
Photograph #3

This picture is taken from near the Alpha wall looking towards the Charlie wall. Lt. LeTourneau was located under the debris approximately where the arrow points. The steps to the second floor are to the far left of the picture.

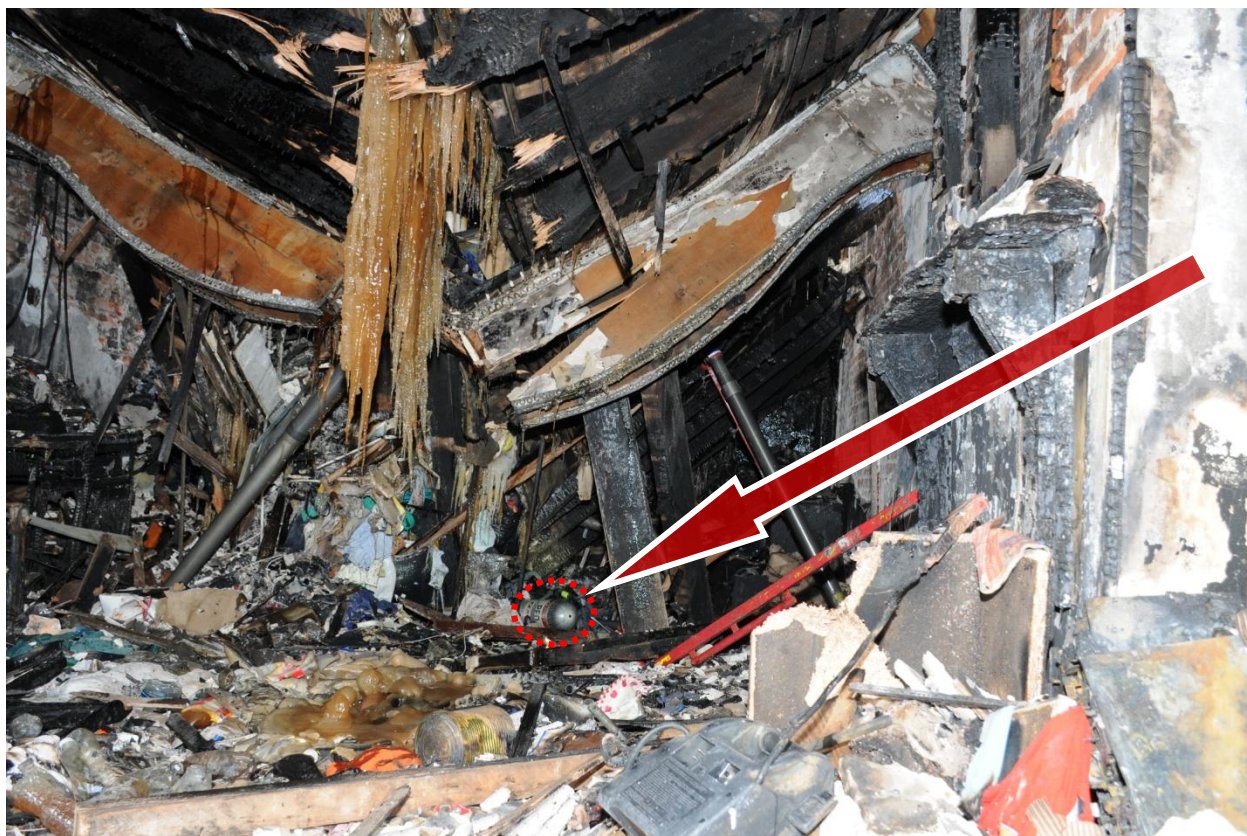
Photograph #4

This picture is taken from near the Alpha/Delta corner looking towards the Charlie wall. Lt. LeTourneau's SCBA is circled in the picture where the arrow points.

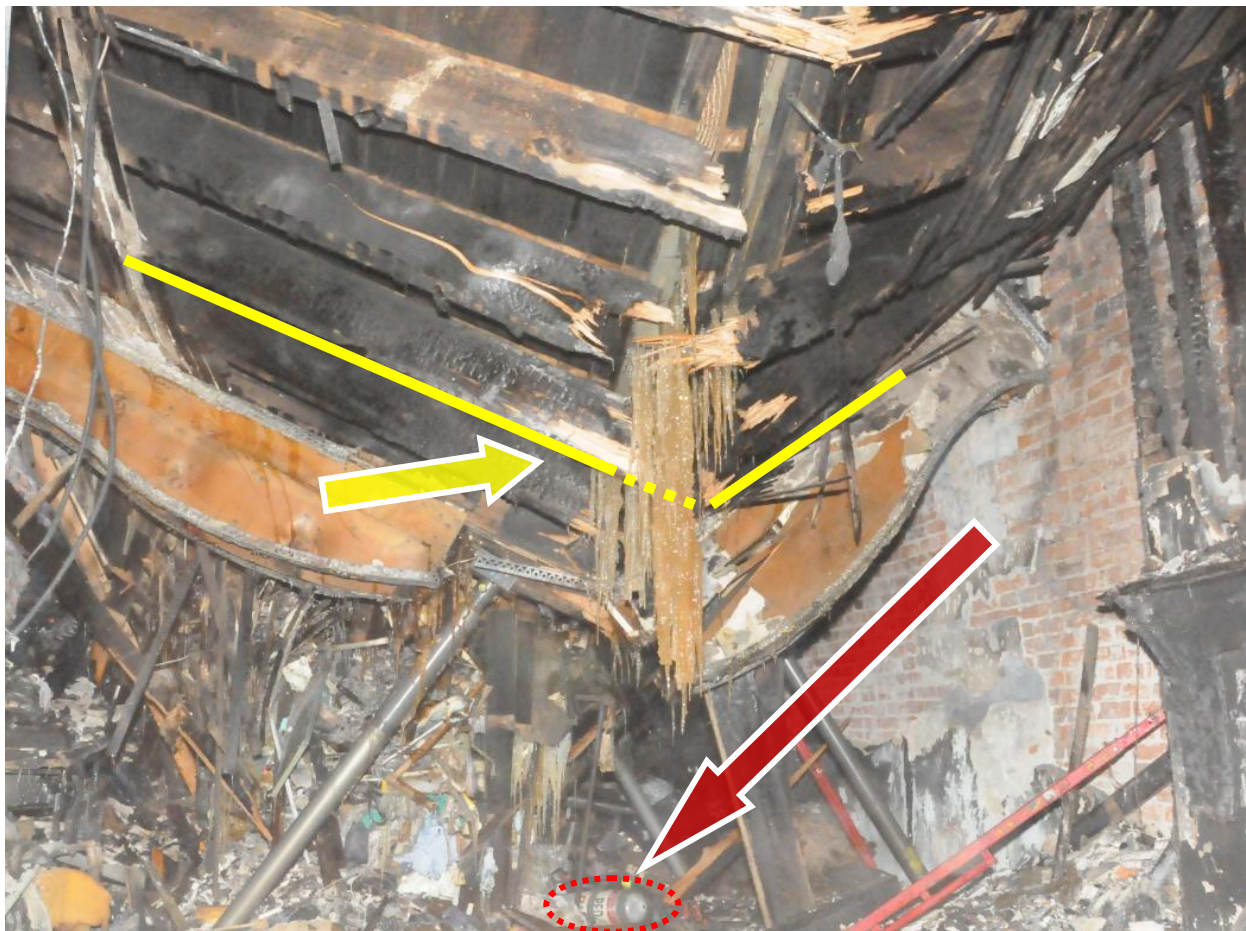
Photograph #5

“V” shaped collapse looking from near the Alpha/Bravo corner towards the Charlie wall. The “V” shape is highlighted below a floor joist by the yellow lines where the yellow arrow points. Lt. LeTourneau’s SCBA is circled in the picture where the red arrow points.
