STRUCTURAL CONDITION ASSESSMENT

1106-14 SPRING GARDEN STREET
PHILADELPHIA, PA

**THE HARMAN GROUP
STRUCTURAL ENGINEERS
150 South Warner Road
Suite 100
King of Prussia, PA 19406**

FEBRUARY 20, 2021

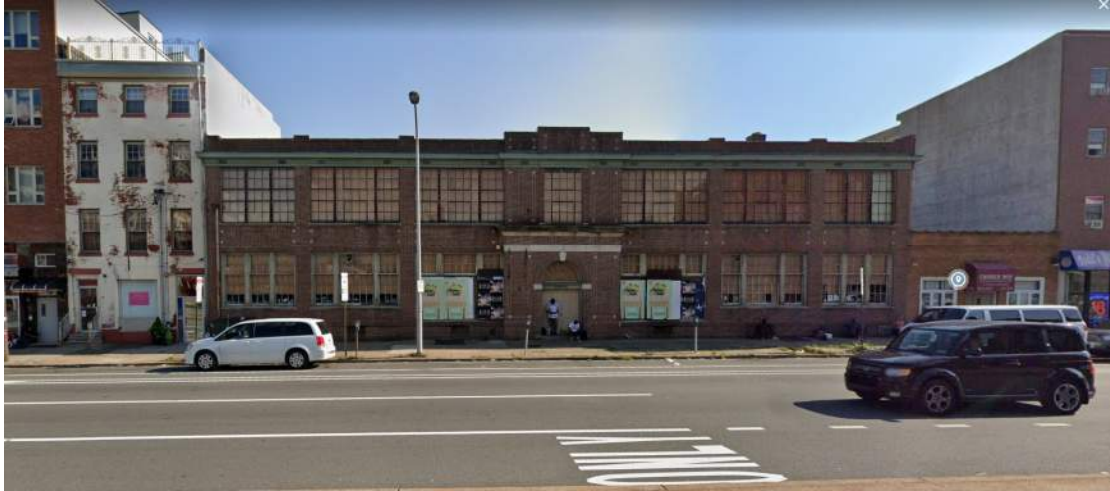
The remaining portion of the partially demolished building was originally a two (2) story structure constructed between 1920 and 1930 (see overall photographs #1 and #2). The existing brick party walls from the 1800's residential row houses were salvaged in the basement and used to support new wood framing (since partially demolished). The overall remaining structure is steel frame with wood purlins and flooring. The steel vertical columns were cut into the former brick party walls and enclosed with brick. The front remaining façade was constructed on the original rubble stone foundation wall from the original row houses. None of the brick walls are load bearing.

Photograph #1: Front Elevation

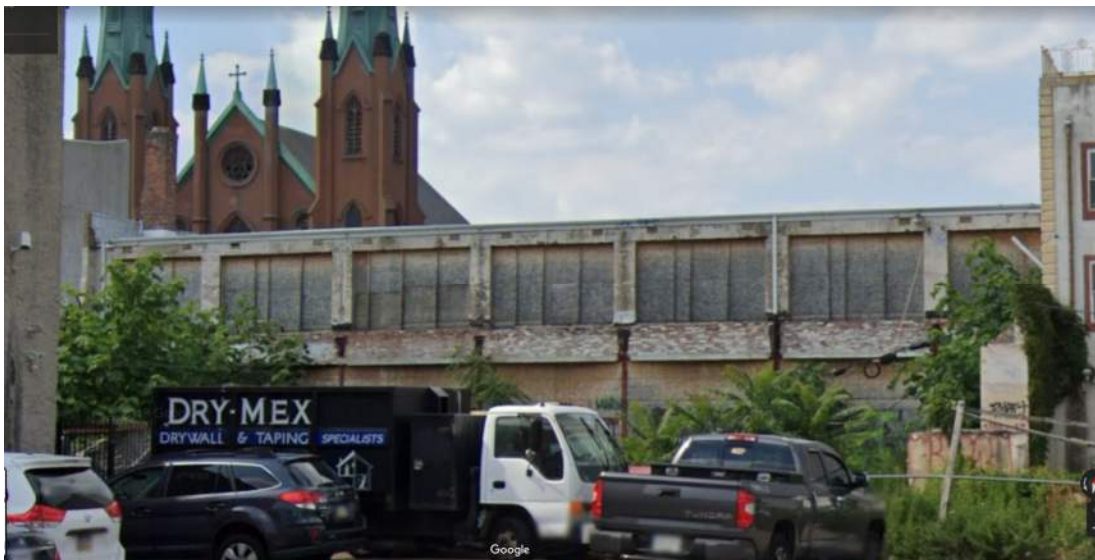
Photograph #2: Rear Elevation

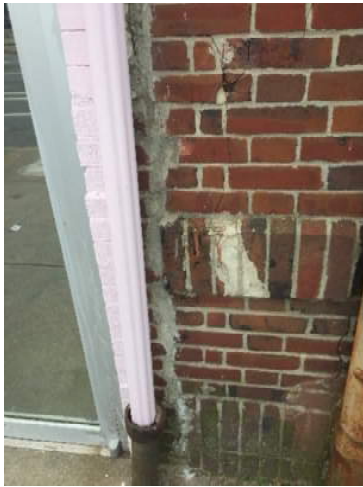
There is excessive cracking at the northeast corner. This could be due to water infiltration, rusting of the embedded steel column, settlement, or poor construction. See photographs #3,4 and 5. Additionally, when the building was built in the 1920's, a portion of the remaining party wall was removed to wrap around the new brick. This is in poor condition (see photograph #3).

Photograph #3: NE Corner brick cracks

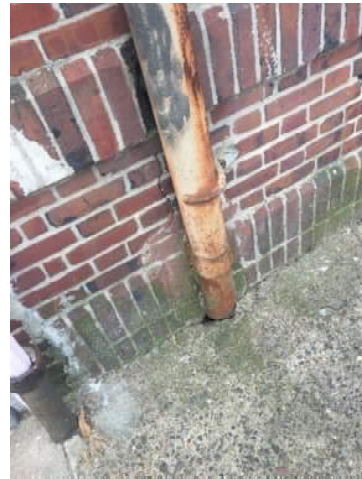
Photograph #4: NE Corner brick cracks at broken storm pipe

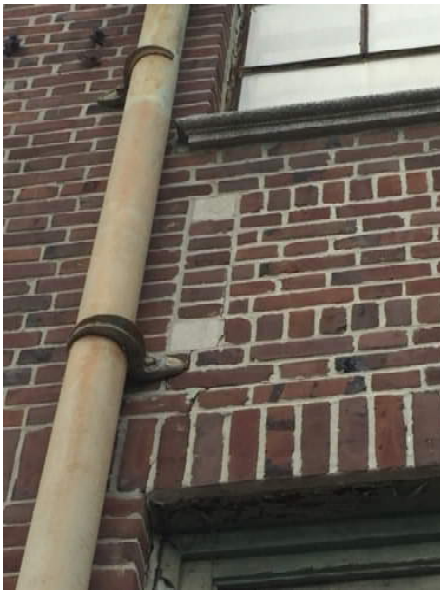
Photograph #5: Front brick cracks at jamb NE corner

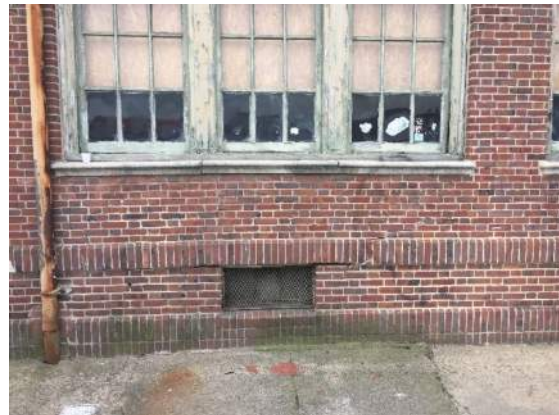
At the ground level, all lintels for the basement windows are significantly rusted and must be entirely replaced (see photographs #6 and #10). The rust jacking of these lintels has failed and displaced the brick above the basement window. The rust jacking has pushed up the window mullions and caused rotation of the brick above the 1st floor windows. (see photograph #7 and 8).

Photograph #6: Typical rust jacking at ground level windows with excessive cracking

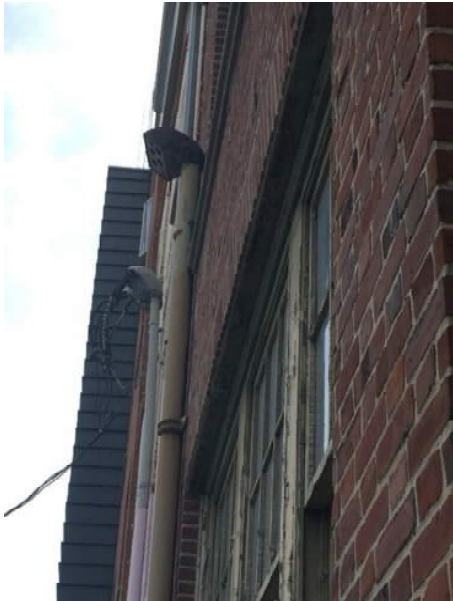
Photograph #7: Bowing of brick

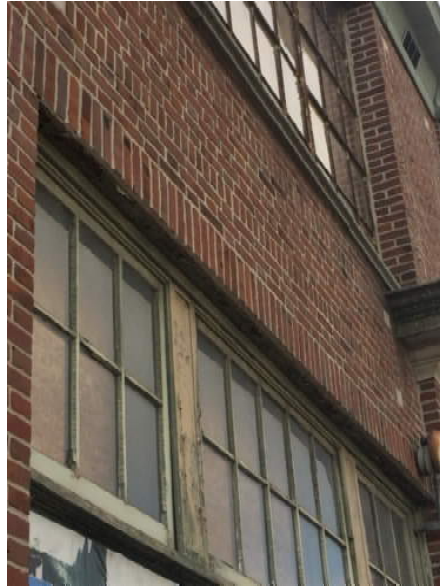
Photograph #8: Bowing of brick and leaning of wall

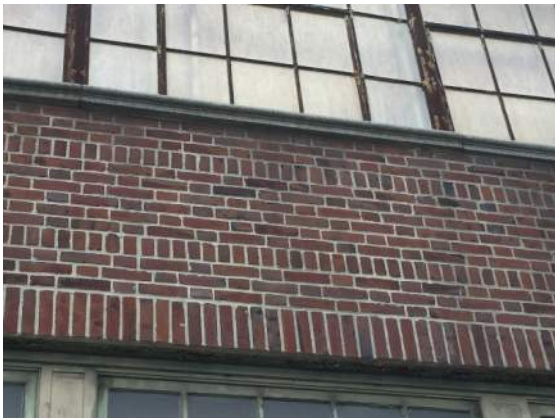
Photograph #9: Cracking and distress at 2nd floor sill

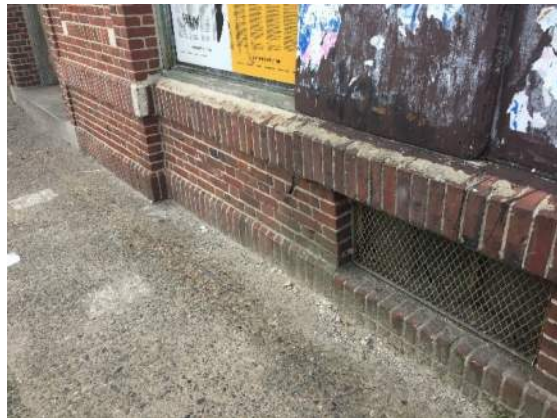
Photograph #10: Additional rust jacking at ground level window

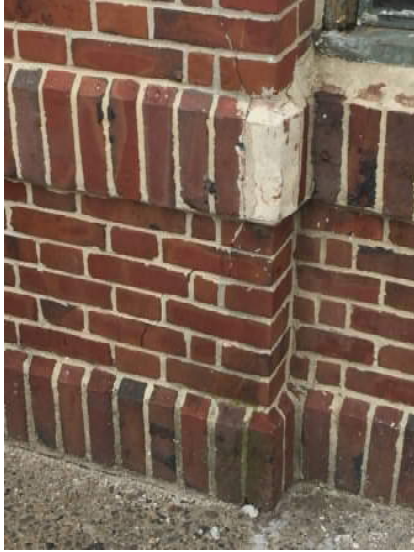
The front pier at the entrance is cracked (see photograph #11). This could be due to rusting of the embedded steel column.

Photograph #11: Cracked front pier; implies rusting steel column within

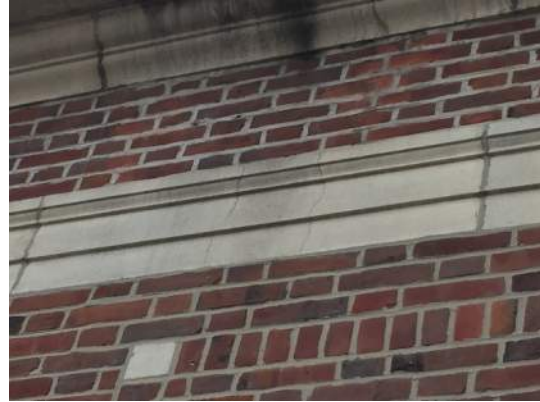
There are stress cracks in the entablature (see photograph #12).

Photograph #12: Stress cracks in entablature

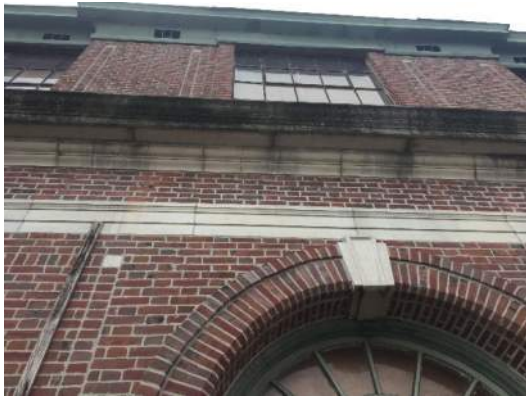
There is water and distress through the cornice at the entry. (see photograph #13).

Photograph #13: Water infiltration and cracking through joints

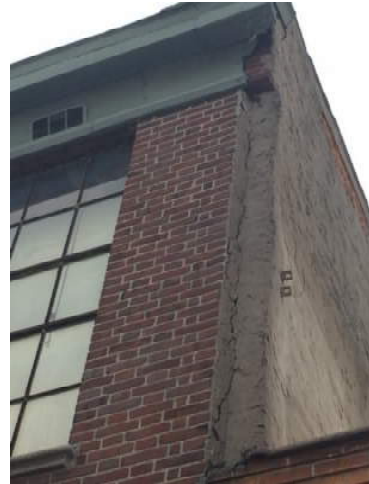
The western party wall original to the 1800's row houses is detached from the structure. Its structural integrity is questionable.

Photograph #14: Western existing party wall

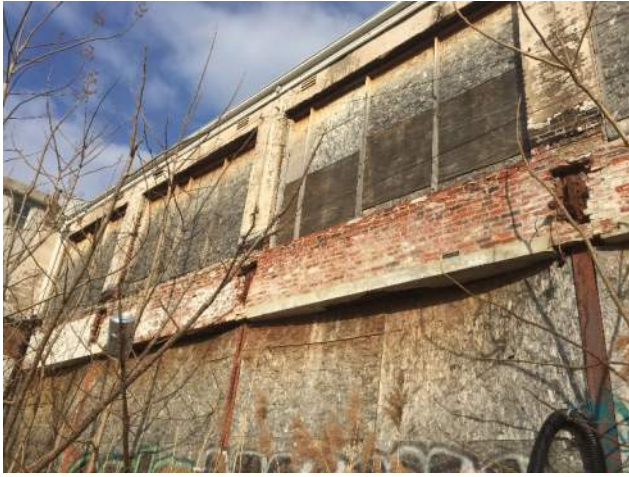
The rear wall, formerly the interior of the building, was damaged during the demolition process. Additionally, the 2nd floor brick is in poor condition (see photograph #15). This wall is exposed to the elements and is deteriorating.

Photograph #15: Rear wall

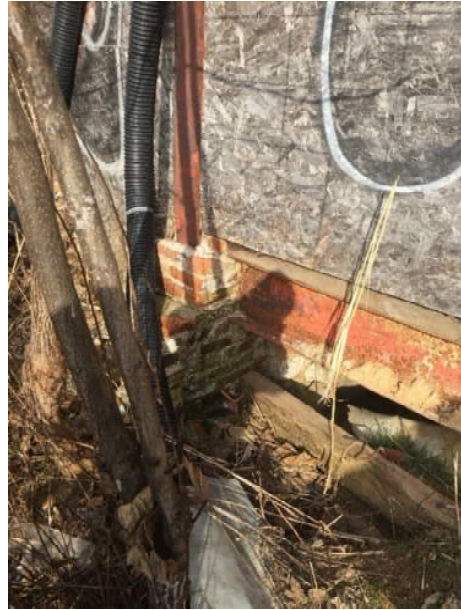
The exposed steel columns are embedded in brick (see photograph #16). These are now exposed due to the demolition of the back half of the building. Water infiltration is rusting the embedded steel columns.

Photograph #16: Rear encased steel columns

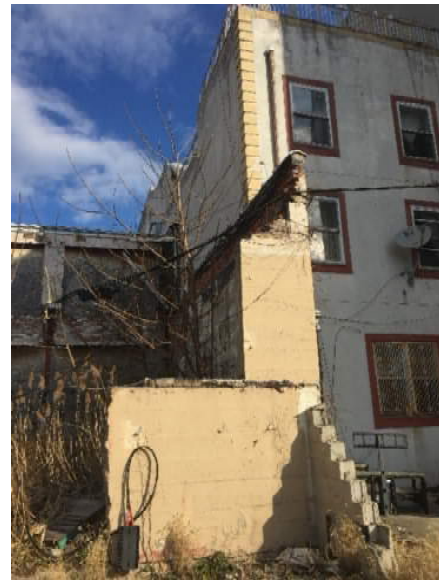
The original east party wall was left when the building was constructed (see photograph #18 and #22) and remains after the partial demolition. The condition of this old party wall is poor.

Photograph #18: Southeast corner

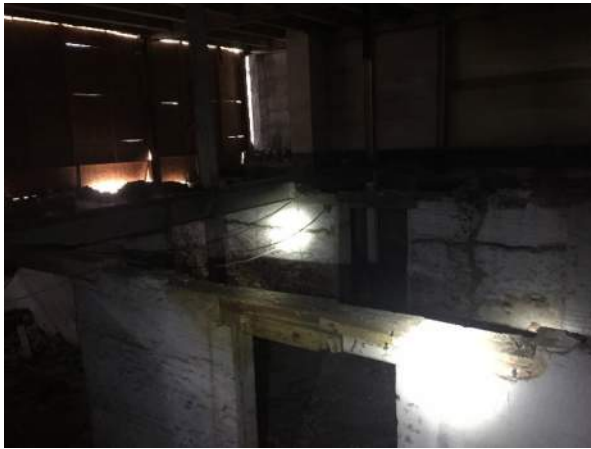
The ground floor construction has been partially demolished leaving it un-usable. It appears that this framing was originally supported on the original row house party walls. We are uncertain if this condition exists for the eastern half also as there was no access to the basement(see photograph #19) due to the partial demolition.

Photograph #19: Interior Ground Floor

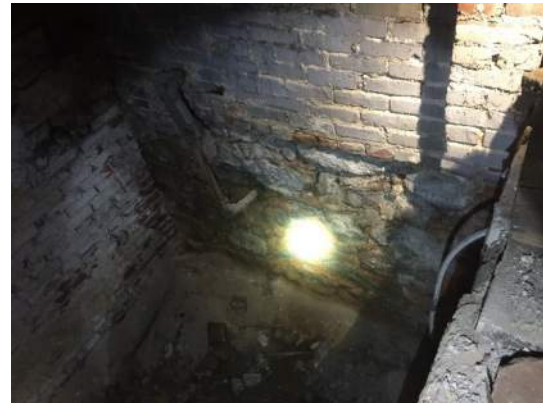
The remaining north wall is a multi-wythe brick wall constructed on the existing 1800's row house rubble stone foundation wall (see photograph #20). The foundation wall is in poor condition and based on structural calculations, cannot support the soil pressure.

Photograph #20: Front Wall Foundation

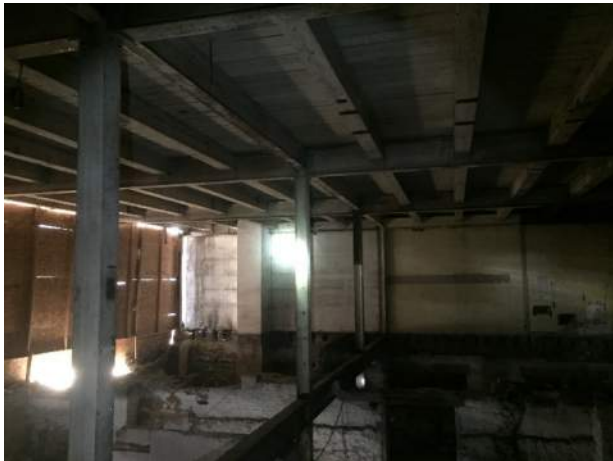
The remaining wood purlins and flooring at the second floor are in good condition (see photograph #21).

Photograph #21: Second Floor Framing

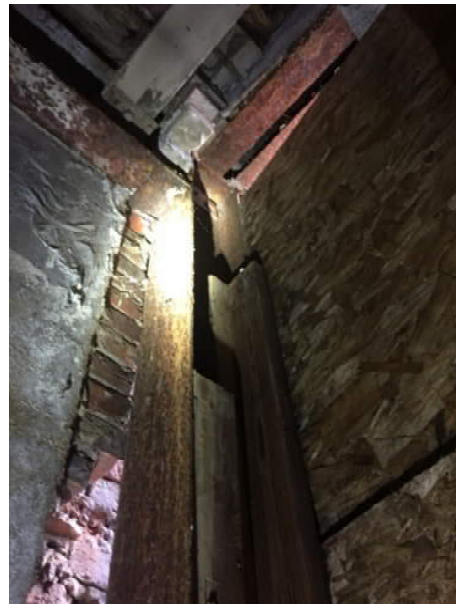
Photograph #22: Joint to Eastern party wall

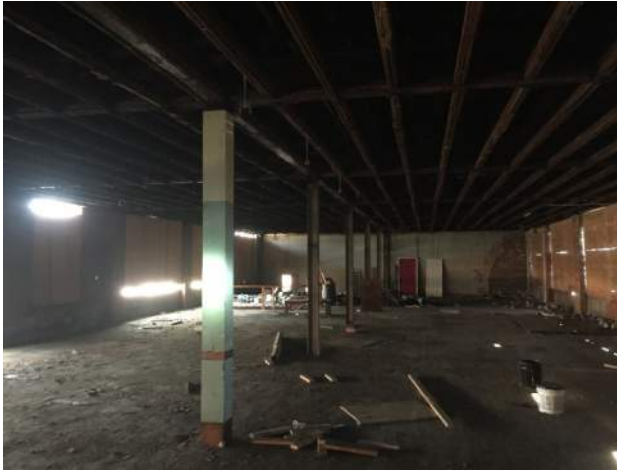
The roof construction, with steel beams and girders on the column lines with timber purlins, is in good condition (see photograph #22) with the exception that there is water damage at the north end near the drains. See photograph #23.

Photograph #22: Overall Roof structure

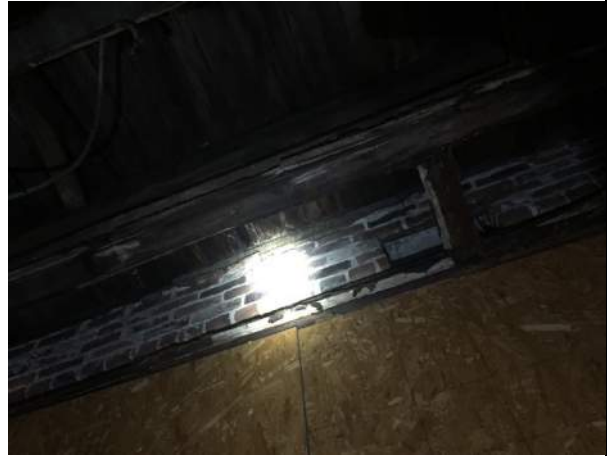
***Photograph #23: Deteriorated roof structure
NW corner***
