Project+ Front St Renovation 305 N Front St Philadelphia, PA 19106

Scope of Work (SOW): Analysis of the front and rear walls to determine the feasibility of restoring the walls.

This document is to discuss the feasibility of restoring the existing front and rear walls for 305 n Front St, Philadelphia, PA.

STRUCTURAL REPORT

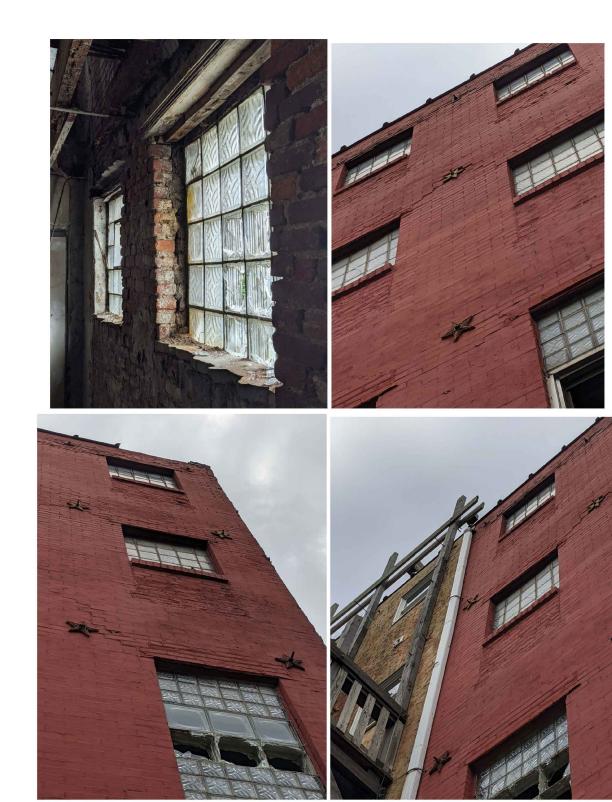
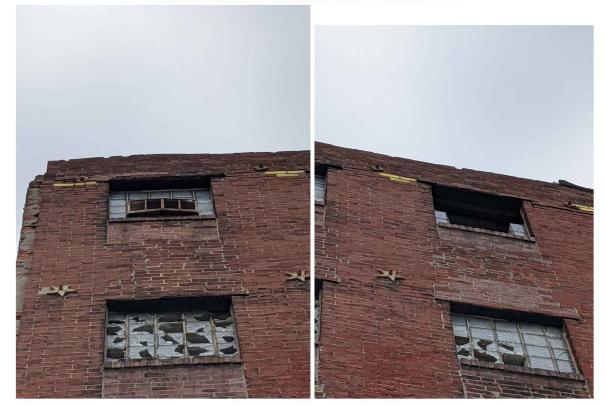
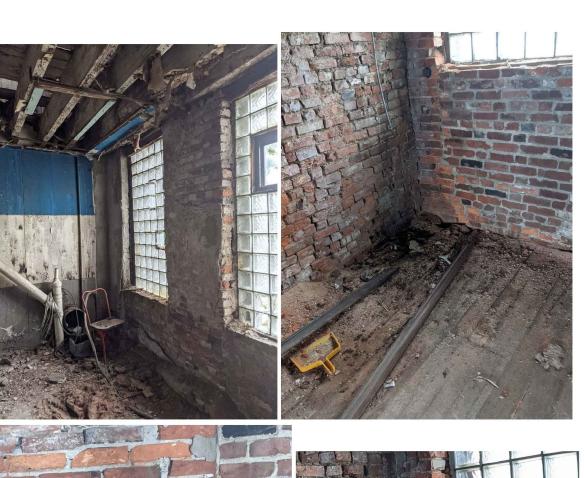
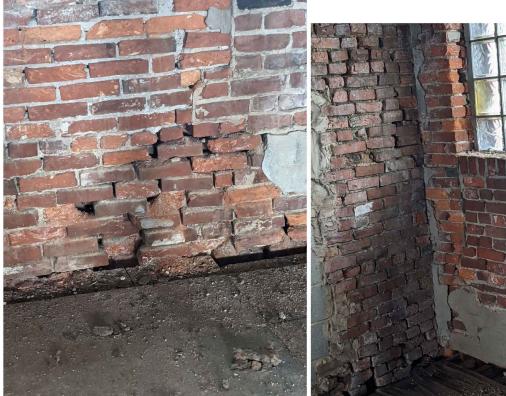
Foundation Deflection. The foundation for the front and rear of the building are deflecting. This deflection is most commonly the result of voids created around and under the foundation walls. These voids are created by water infiltration as the result of broken or cracked underground pipes that either sleeve through or run adjacent to the foundation walls. These voids affect the lateral stability of the foundation walls allowing them to deflect.

Double Wythe Construction. The brick walls for the front and rear are double wythe brick. As a result of the deflection in the foundation walls the layers of brick are coming apart and water is beginning to infiltrate between the bricks. During the winter months the water between the bricks will freeze and expand, pushing the bricks further from each other. This ultimately results in the appearance of a bowing wall.

Previous Reinforcement. There was a previous reinforcement completed on the deflecting brick walls. This reinforcement consisted of steel plates on the front and back of the building between the floors. This reinforcement is typically referred to as star bolts and is tied back into the wood framing on the interior of the building. Since the star bolts were installed, the star bolts are now "punching" through the brick wall. This punching is evidence that the wall is still moving despite the previous reinforcement.

Adjacent Building. The front and rear facade for the adjacent building is also deflecting. This building was reinforced with wooden 6"x6" posts running vertically and anchored into the building's interior framing between the floors. The 6"x6" posts are deteriorating and will eventually fail. Because the brick walls are connected a failure of those posts may result in a failure of the wall at 305 N Front St.

Conclusion. Given the evidence gathered onsite it is recommended that the brick walls be demolished and rebuilt.

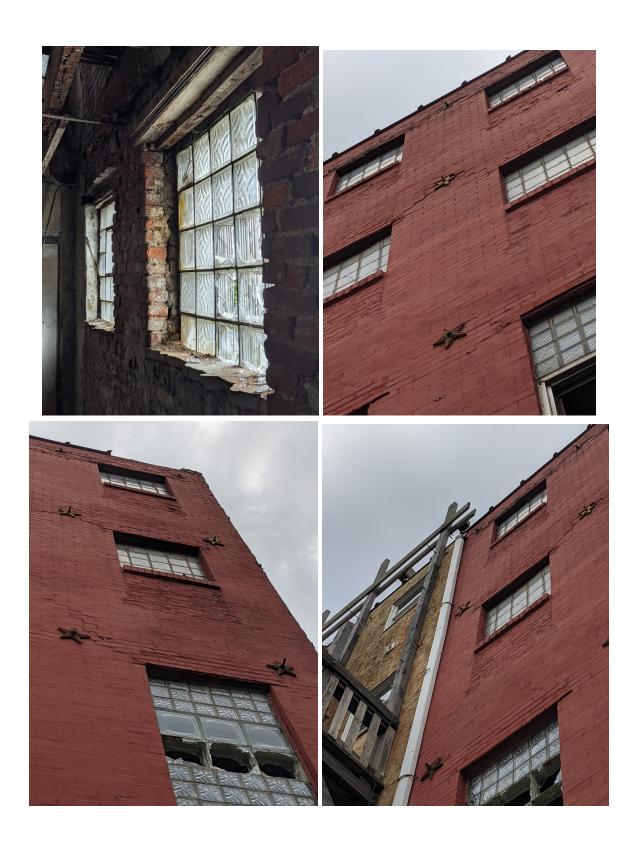
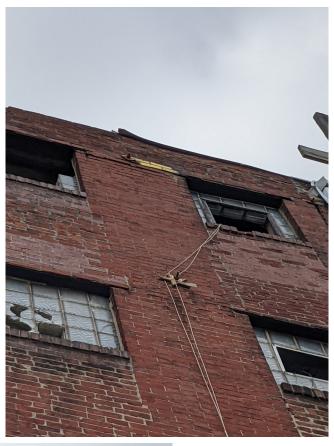
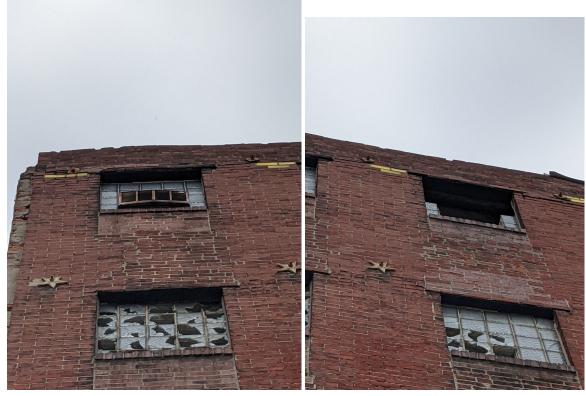
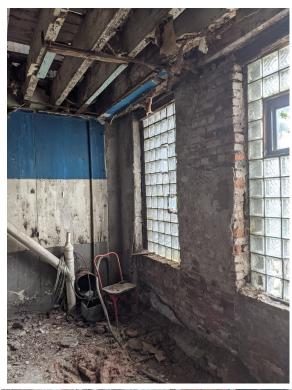
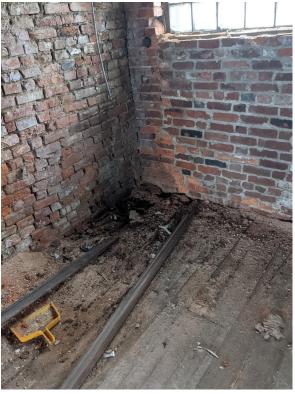
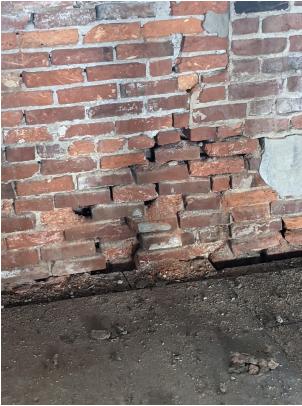
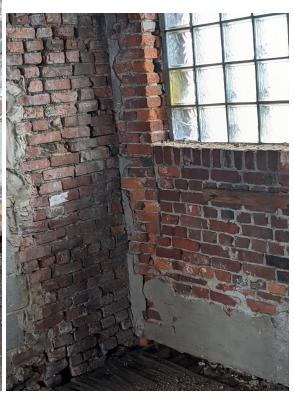
Foundation Deflection. The foundation for the front and rear of the building are deflecting. This deflection is most commonly the result of voids created around and under the foundation walls. These voids are created by water infiltration as the result of broken or cracked underground pipes that either sleeve through or run adjacent to the foundation walls. These voids affect the lateral stability of the foundation walls allowing them to deflect.

Double Wythe Construction. The brick walls for the front and rear are double wythe brick. As a result of the deflection in the foundation walls the layers of brick are coming apart and water is beginning to infiltrate between the bricks. During the winter months the water between the bricks will freeze and expand, pushing the bricks further from each other. This ultimately results in the appearance of a bowing wall.

Previous Reinforcement. There was a previous reinforcement completed on the deflecting brick walls. This reinforcement consisted of steel plates on the front and back of the building between the floors. This reinforcement is typically referred to as star bolts and is tied back into the wood framing on the interior of the building. Since the star bolts were installed, the star bolts are now "punching" through the brick wall. This punching is evidence that the wall is still moving despite the previous reinforcement.

Adjacent Building. The front and rear facade for the adjacent building is also deflecting. This building was reinforced with wooden 6"x6" posts running vertically and anchored into the building's interior framing between the floors. The 6"x6" posts are deteriorating and will eventually fail. Because the brick walls are connected a failure of those posts may result in a failure of the wall at 305 N Front St.

Conclusion. Given the evidence gathered onsite it is recommended that the brick walls be demolished and rebuilt.
