ADDRESS: 1631 ARCH ST

Proposal: Remove cornice rosettes

**RE: Verizon – 1631 Arch Street Façade Repairs – Terra Cotta
Philadelphia, PA 19103
File No. 3168.0007.00**

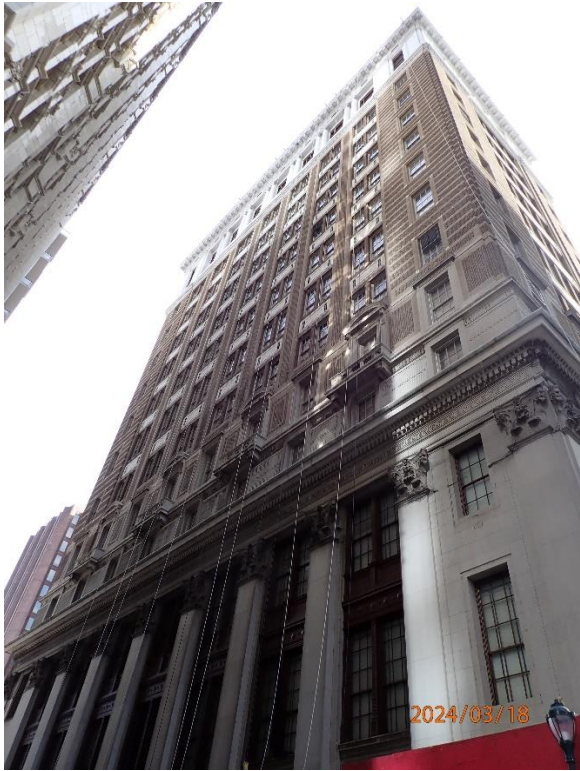
Photograph 1 – Overview of west elevation.

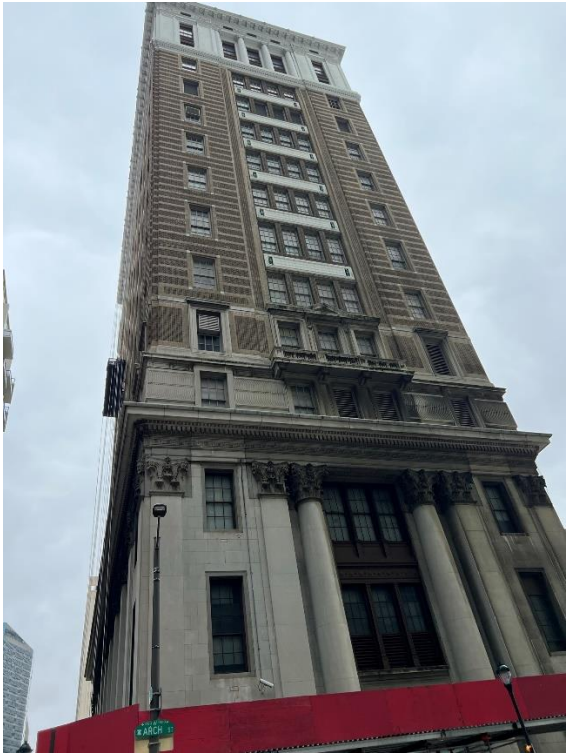
Photograph 2- Overview of south elevation.

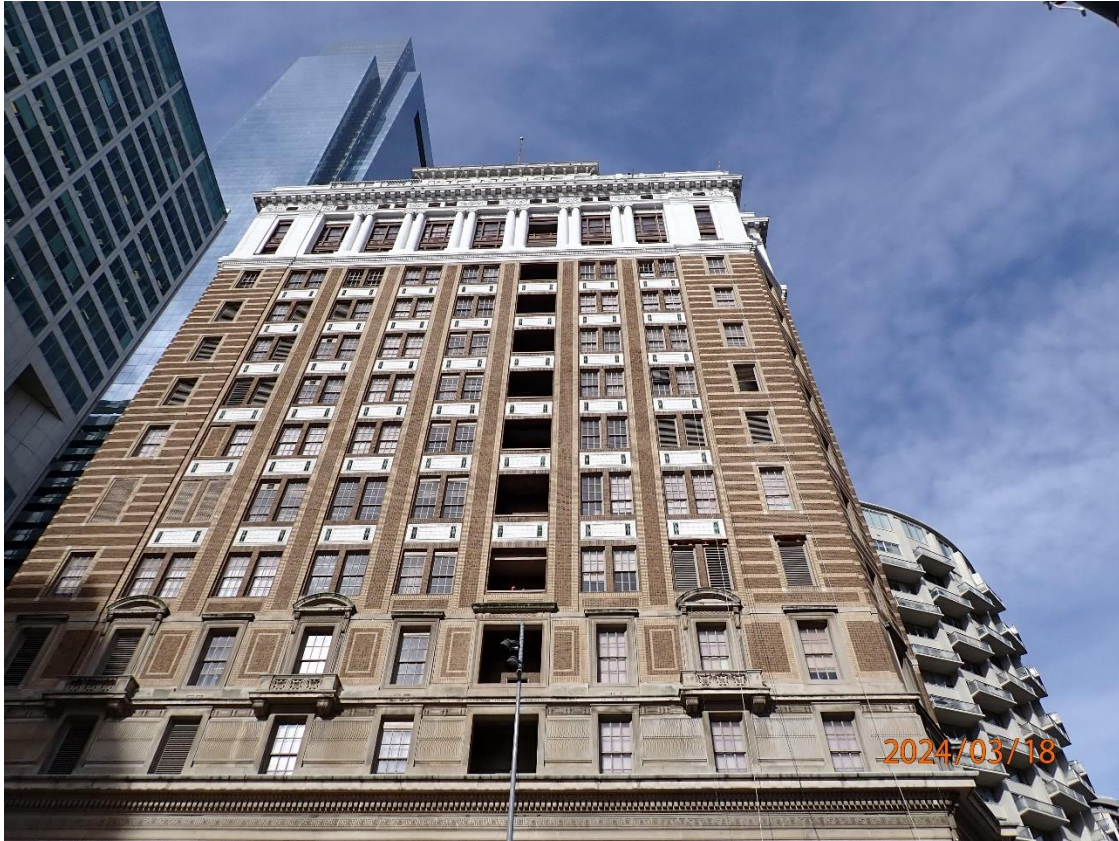
Photograph 3 – Overview of east elevation.

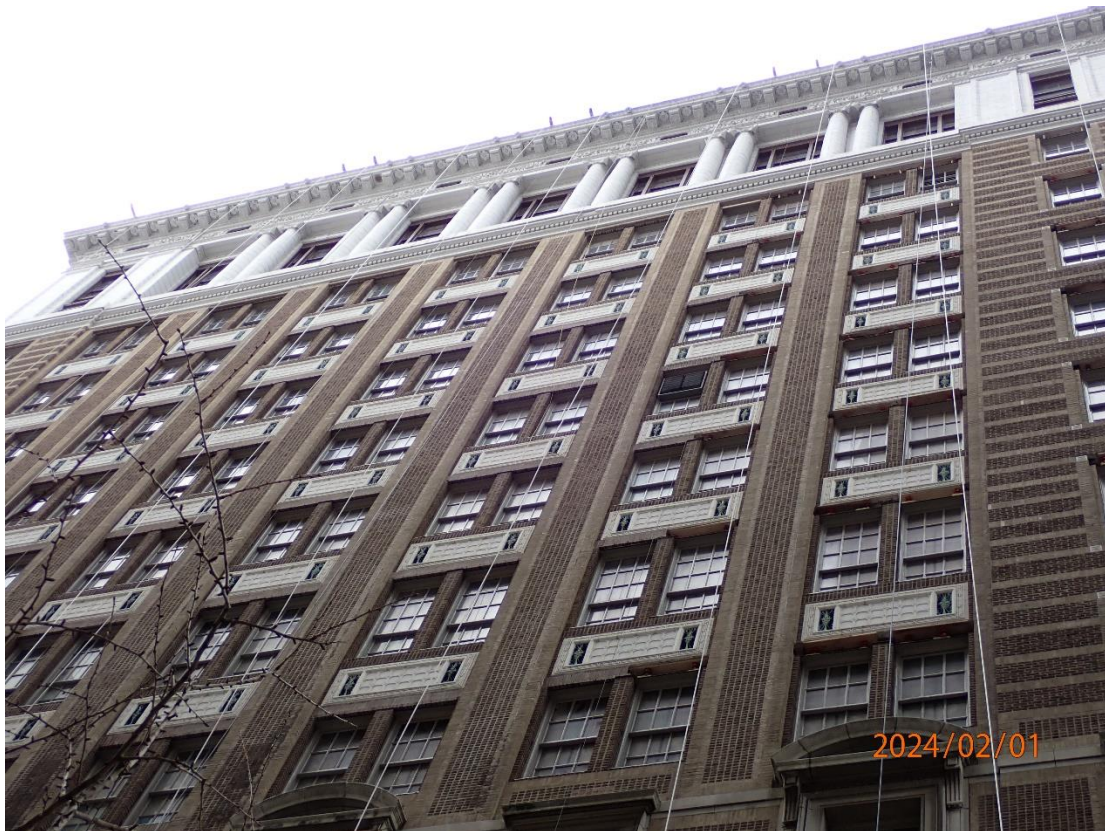
During the ongoing façade repairs O'Donnell & Naccarato (O&N) performed a review of the existing hung terra cotta flower units at the underside of the cornice at the sixteenth floor (See Photographs 4-6). During the ongoing façade repairs at the west elevation a hung terra cotta flower unit became dislodged from the cornice and fell onto the scaffold below. Upon further investigation and sounding of the units, O&N identified two additional terra cotta flower units at the west elevation that appeared to be dislodged. During the attempt to re-secure one of the dislodged units it became loose and required removal (See Photograph 7).

Photograph 4 – Overview of terra cotta flower details from grade (zoomed in).

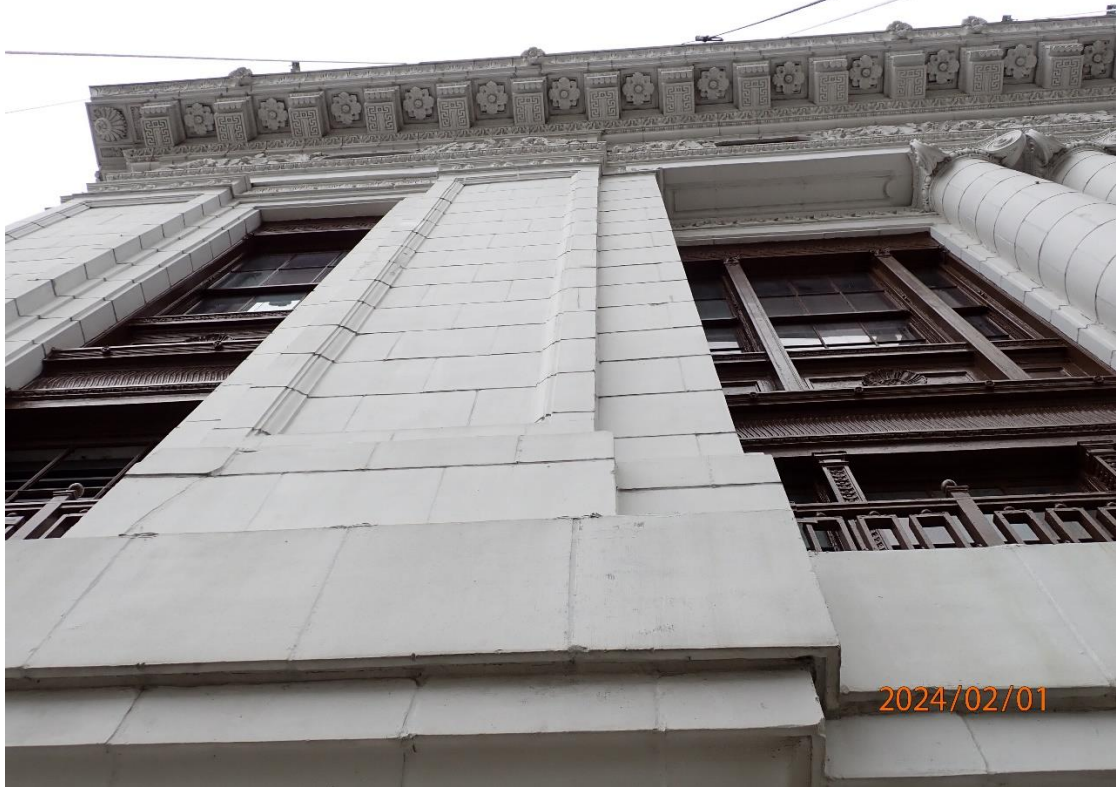
Photograph 5 – Overview of terra cotta flower units from 14th floor.

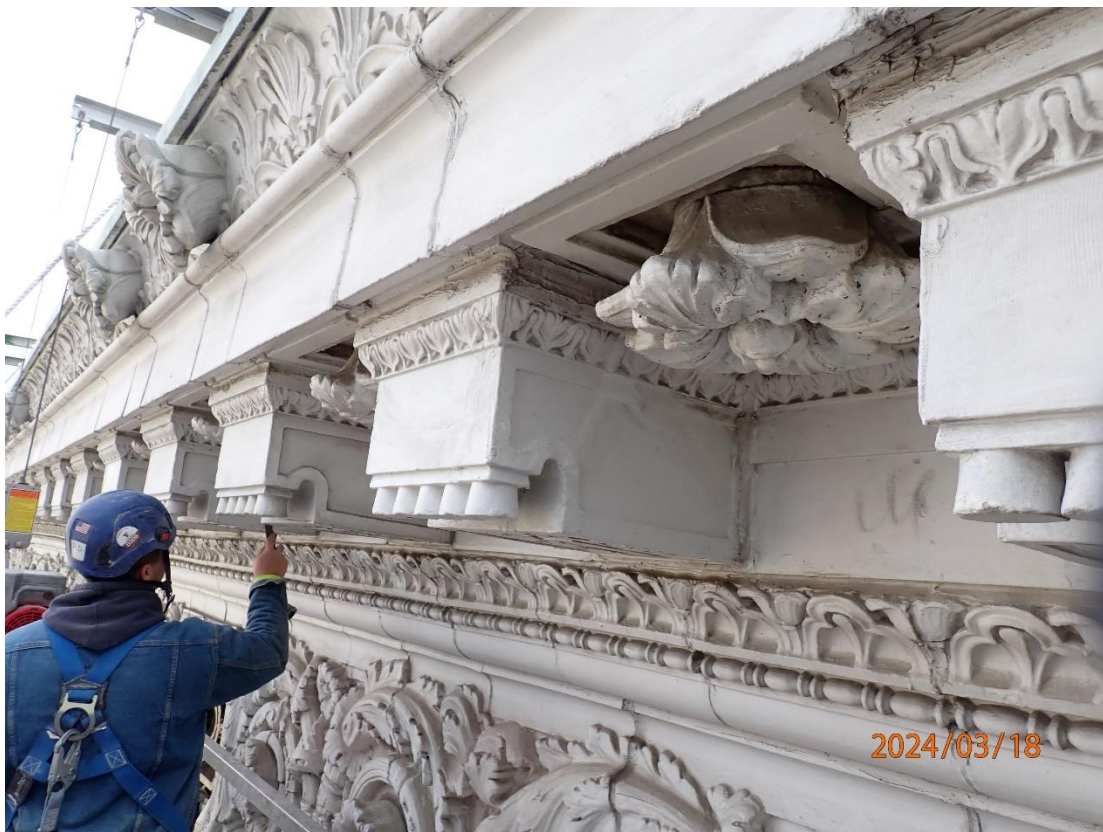
Photograph 6 – Close-up view of terra cotta flower units between dentil units.

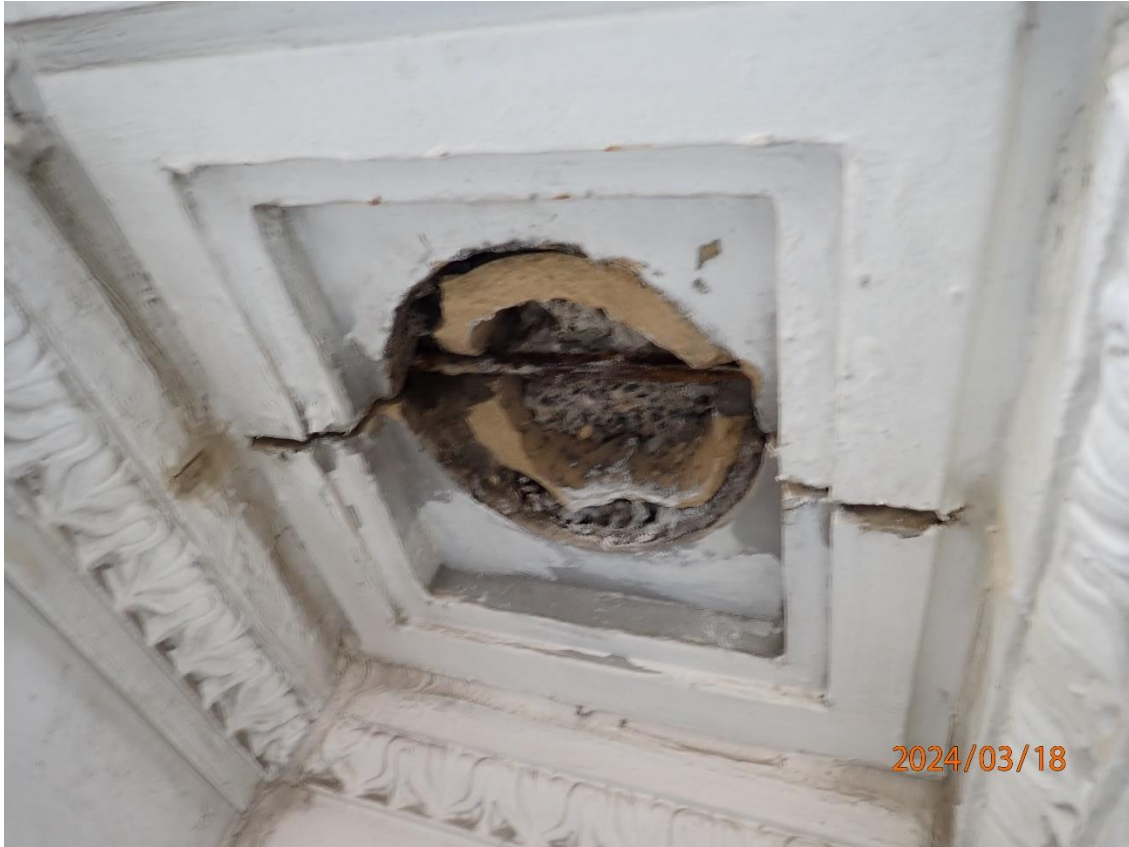
Photograph 7 – Overview of removed/fallen terra cotta flower unit.

Based on the findings at the probe locations, O&N recommends that the hung terra cotta flower units be removed wholesale at each elevation. The terra cotta flower units are supported by a single steel bar that is experiencing significant corrosion and section loss. The condition of the steel bar at the remaining terra hung terra cotta units is unknown. While sounding of the remaining units at the west elevation was performed, O&N cannot guarantee that the remaining units will remain sound.

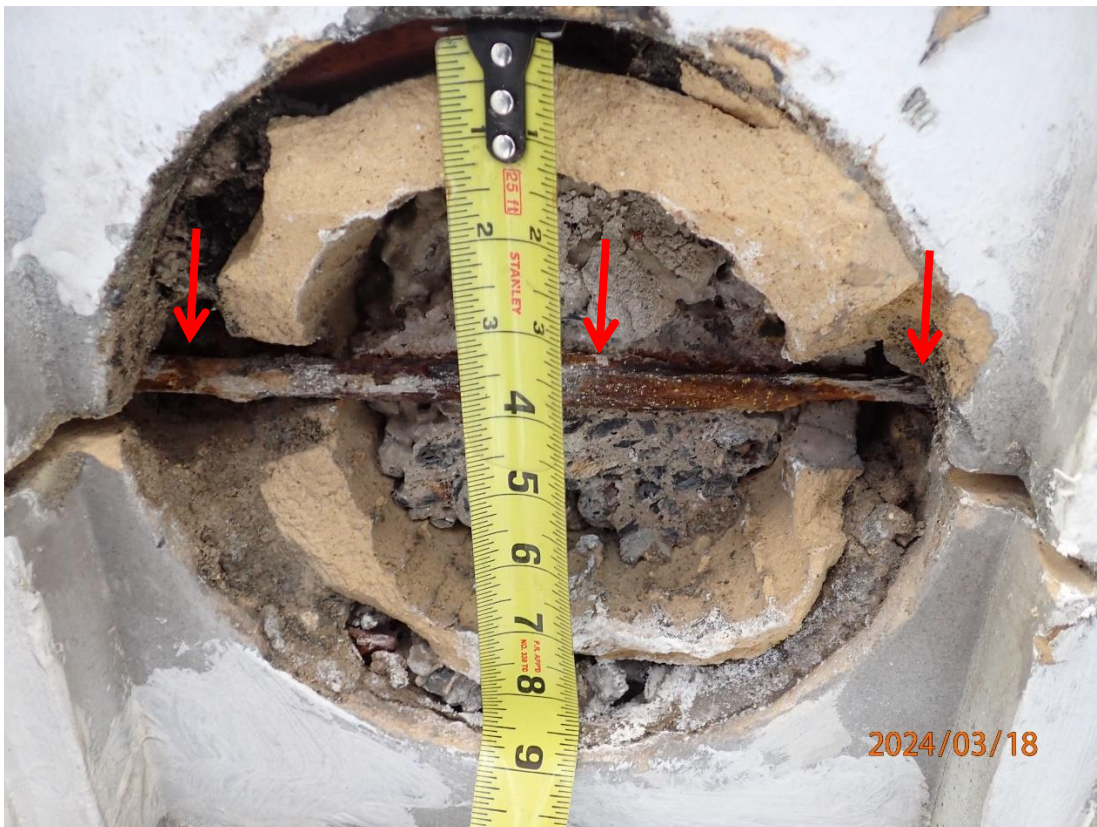
O&N and the contractor performed exploratory probes at the location of the two hung units that were removed. The unit is supported by a single 1/2" diameter by +/-14" long steel bar that bears on the adjacent terra cotta soffit detail units (See Photograph 8). The terra cotta hung flower units have two holes cored into the neck of the flower unit that the 1/2" diameter steel bar is slotted through (See Photograph 9). The terra cotta flower unit is filled with a concrete slurry that extends into the adjacent terra cotta soffit detail units. At both probe locations the existing steel bar was corroded with up to 50% section loss observed (See Photograph 10).

Photograph 8 – Overview of terra cotta flower unit support, steel bar shown with red arrow.

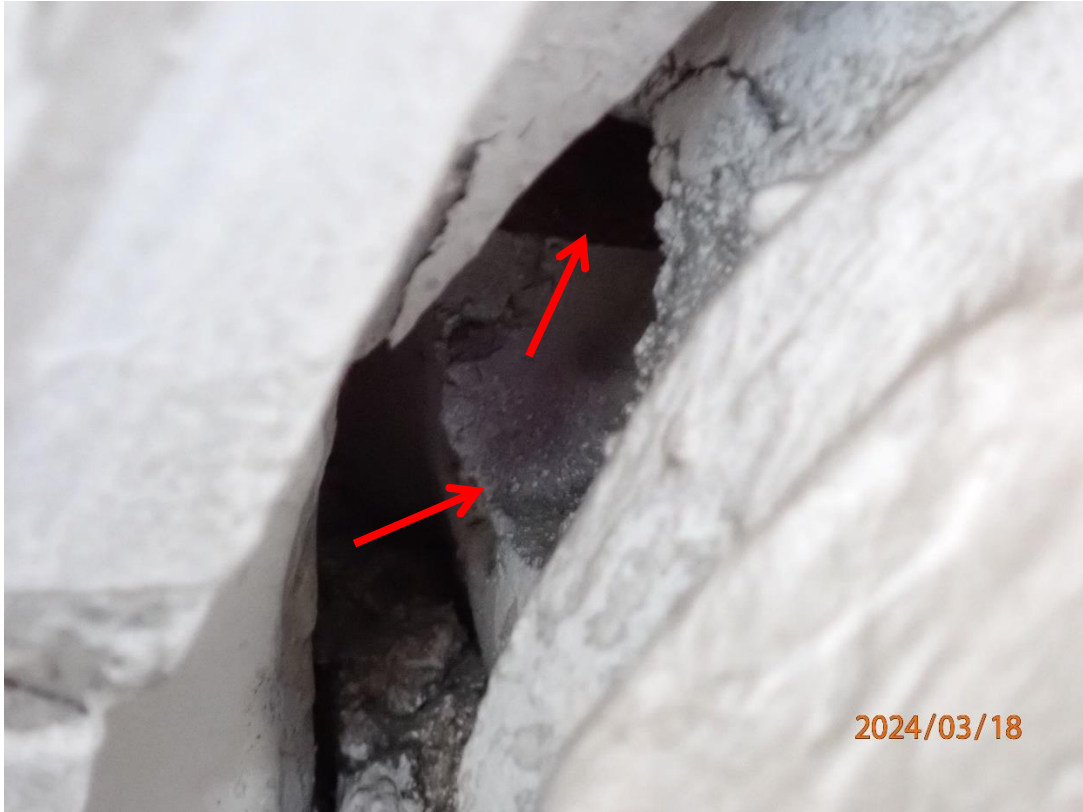
Photograph 9 – Cored hole in terra cotta flower unit and steel bar.

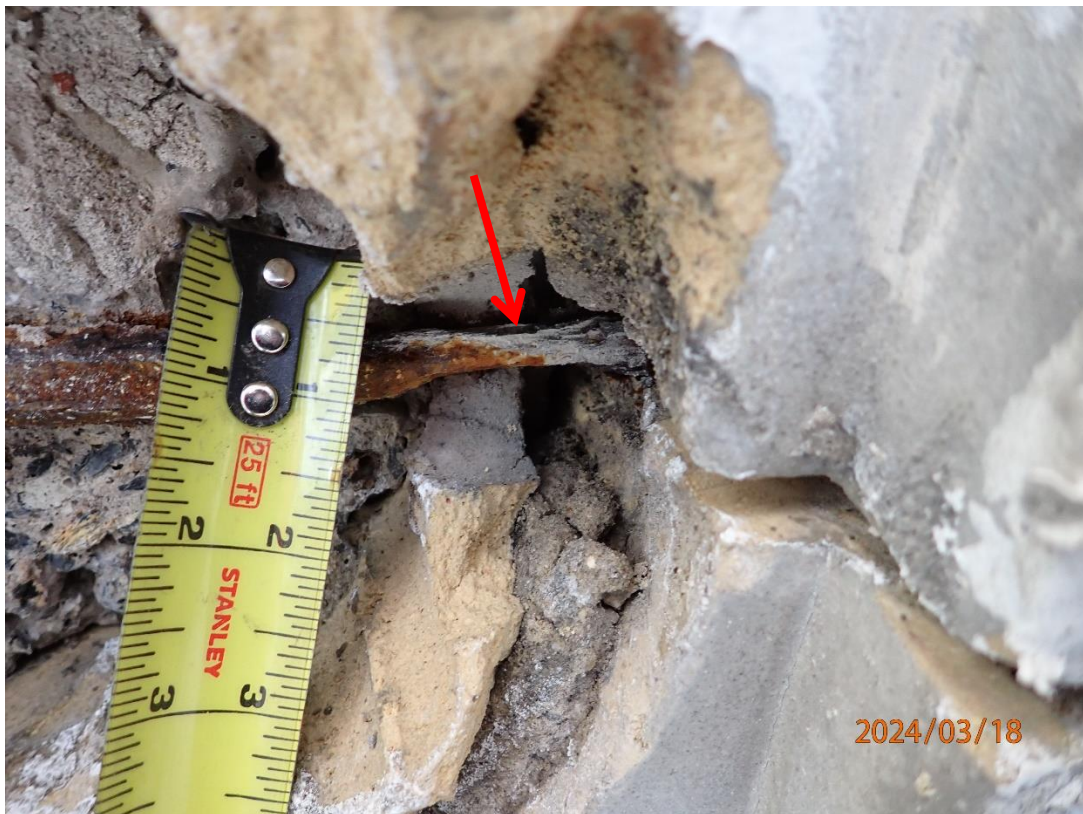
Photograph 10 – Corroded steel bar with 50% section loss.

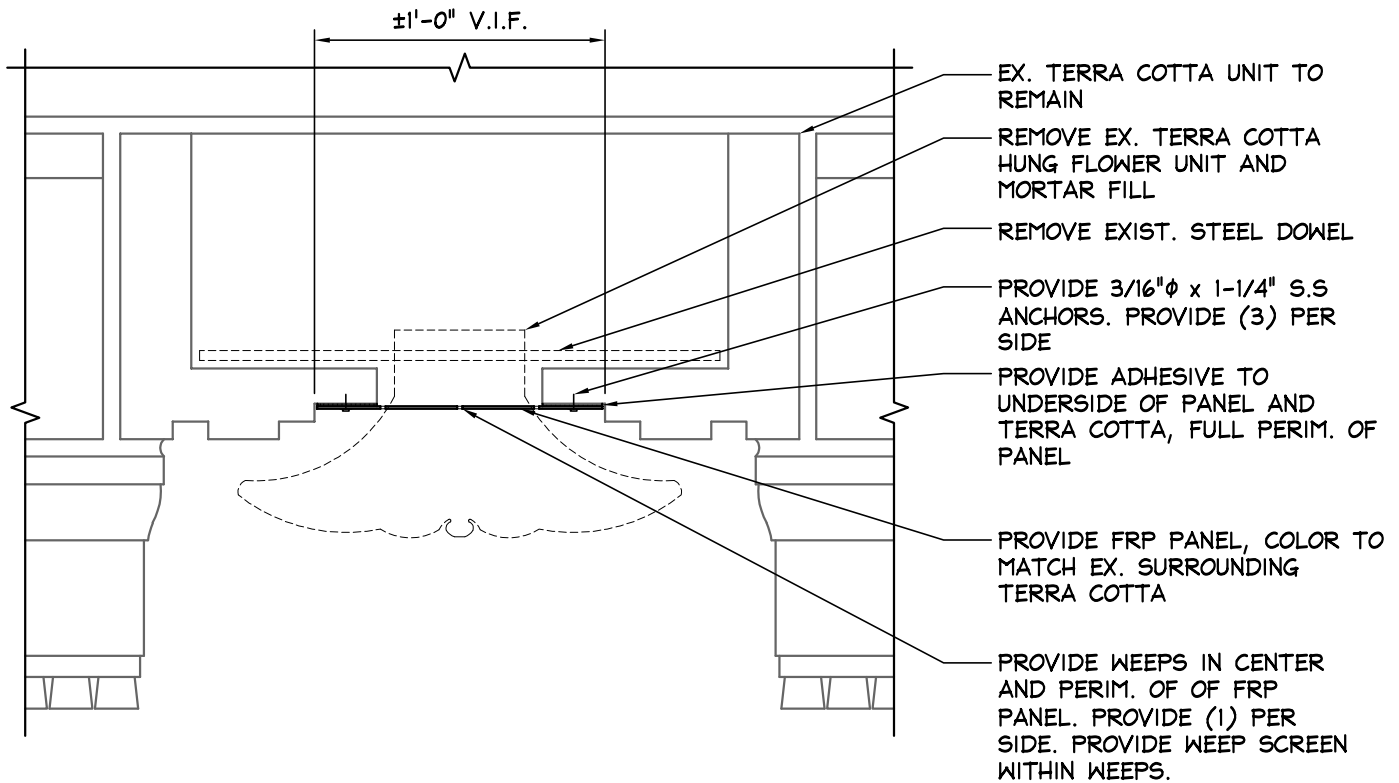
1
SK02

It appears that replacement of the terra cotta hung flower units is not feasible without the de-construction and re-construction of the terra cotta cornice. Additionally, the original detail places the load of the hung flower unit on the joint between the terra cotta soffit units. O&N does not recommend re-installing the hung flower units utilizing the same or a similar original construction detail.

HUNG TERRA COTTA FLOWER UNIT

We are proposing the removal of the hung flower units and replacement with a lightweight weather protective cover, coated to match the existing surrounding terra cotta, be installed within the terra cotta soffit units at the location of the removed flower units (See SK-02).

REMOVE TERRA COTTA UNIT & PATCH
