# Additional Information for 2147 and 2149 Ellsworth St

October 31, 2025

re: Mural & Party Wall Assessment  
Keith Haring Mural  
2147 Ellsworth Street  
Philadelphia, PA  
JBCI Proj. No. 257403

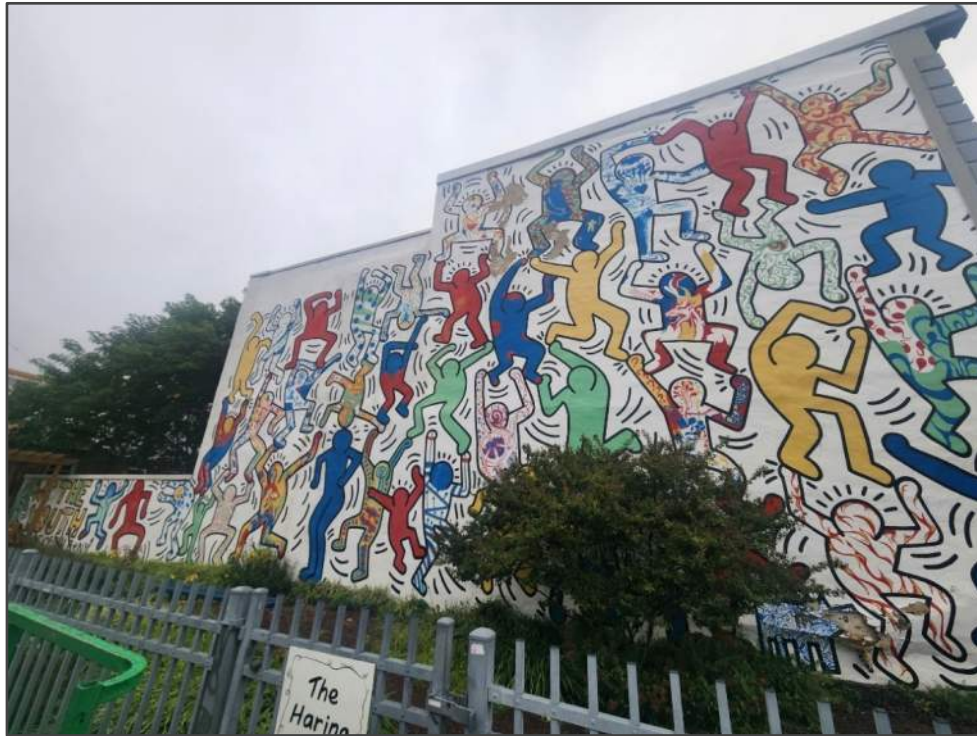
Photo No. 1: The Mural

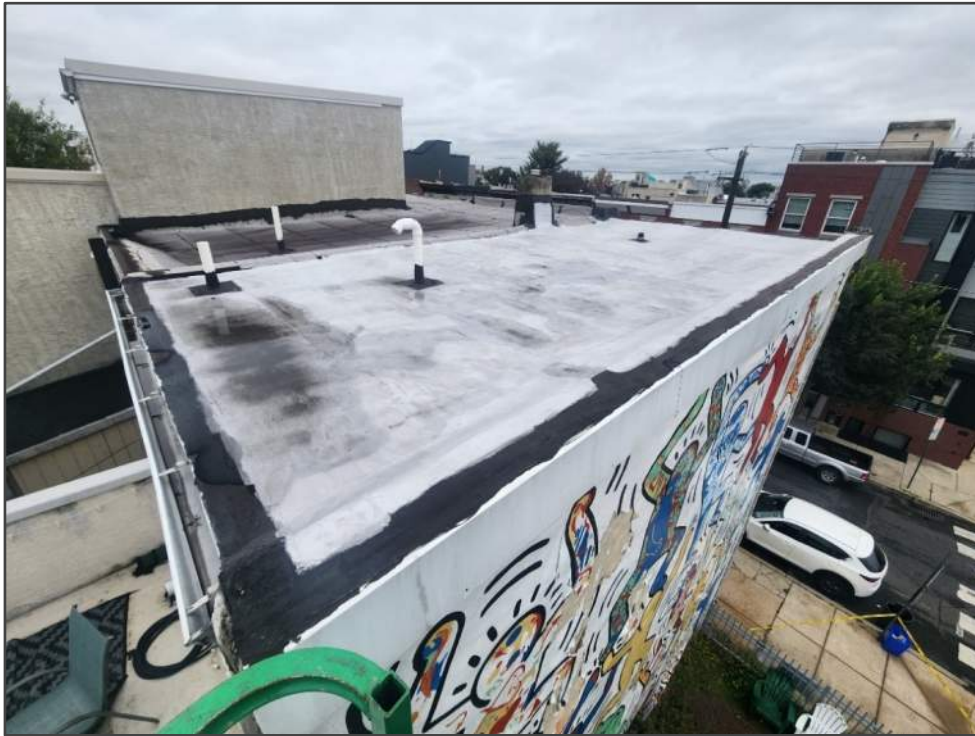
- Roofing appears to have a recently applied silver coat, and the roofing cement termination on the metal edge fascia appears to be recently applied. Based on historic satellite imagery, it appears these repairs were completed in May 2023.

In order to prevent water intrusion into the wall, the top of wall condition must be water-tight. The existing roofing termination at the main roof appears to have been recently re-sealed, but based on the condition of the wall, it was likely open for some time and was a significant source of water/moisture intrusion leading to the delamination of the stucco. At the roof deck, there is a metal cap over wood blocking at the top of the wall. The section of the Mural below is in generally good condition, much better condition than the wall below the main roof.

Photo No. 2: Main roof/top of wall condition

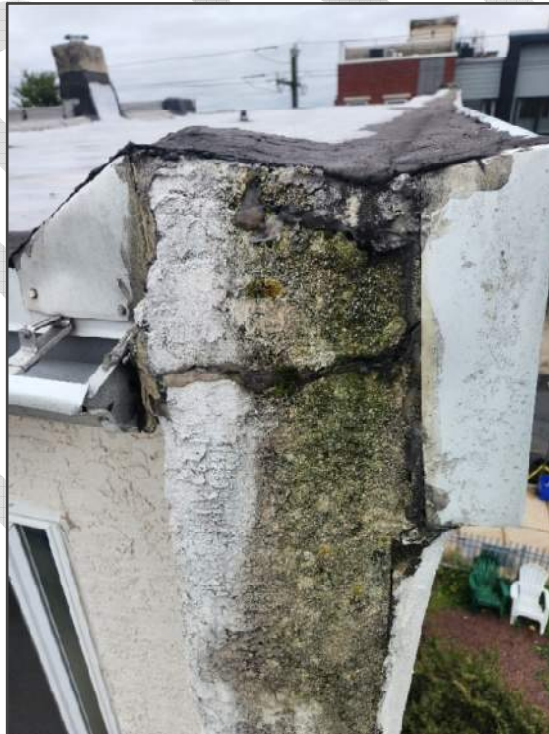
Photo No. 3: Top of 3<sup>rd</sup> floor wall condition

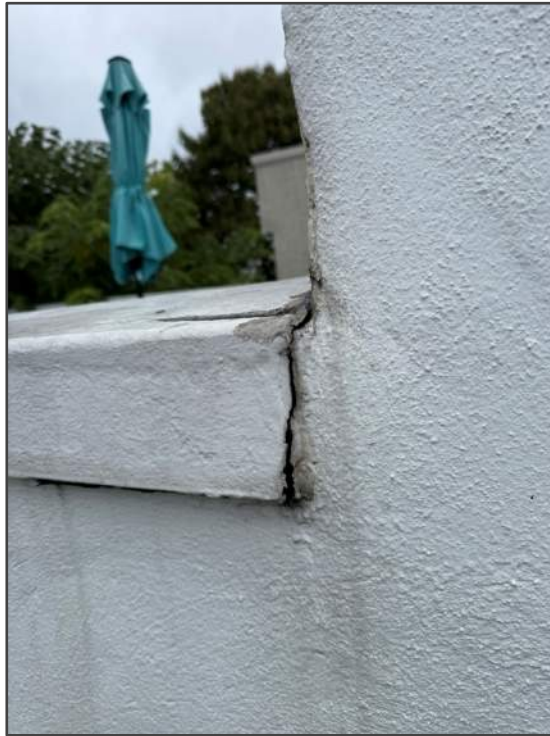
- At the roof deck, the coping is in fair condition. The edge of the wood blocking is exposed on the underside and the coating is flaking off.
  - The wall steps down on the north end from the main roof down to the roof deck. The vertical transition for the elevation change is poorly detailed. The metal edge fascia stops, there is no fascia covering the return edge, and there does not appear to be flashing present at the bottom of the transition. The joint between the roof deck coping and the rising wall is open.

Photo No. 4: Bottom of vertical transition – joint open at end of roof deck coping

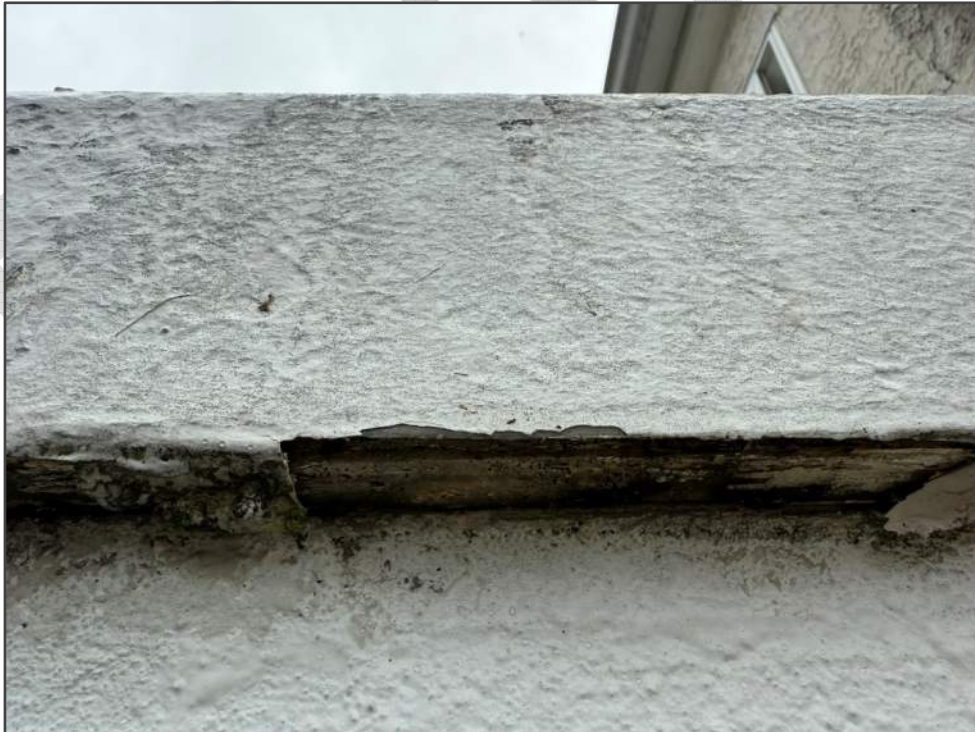
Photo No. 5: Coating flaking off underside of wood blocking at roof deck coping

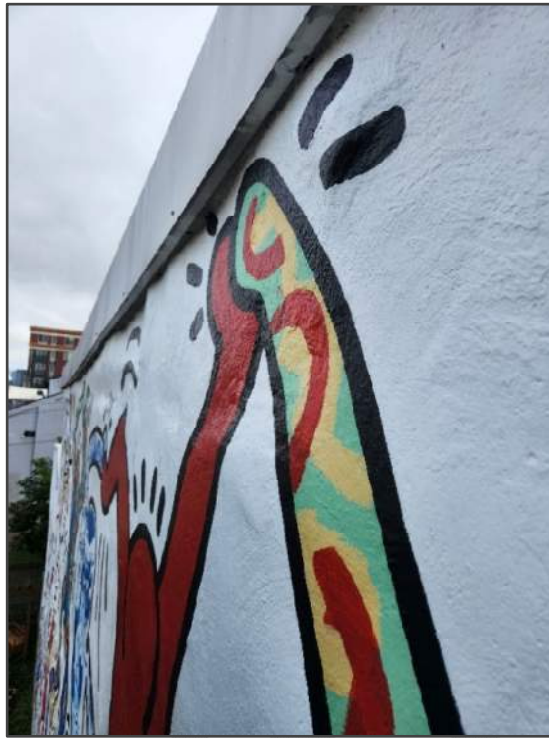
Photo No. 6: Bulging at top of wall

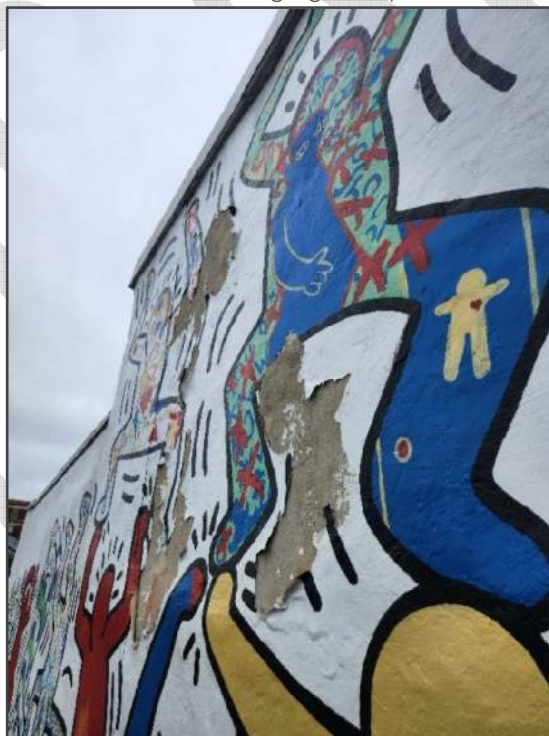
Photo No. 7: Delaminated, missing paint

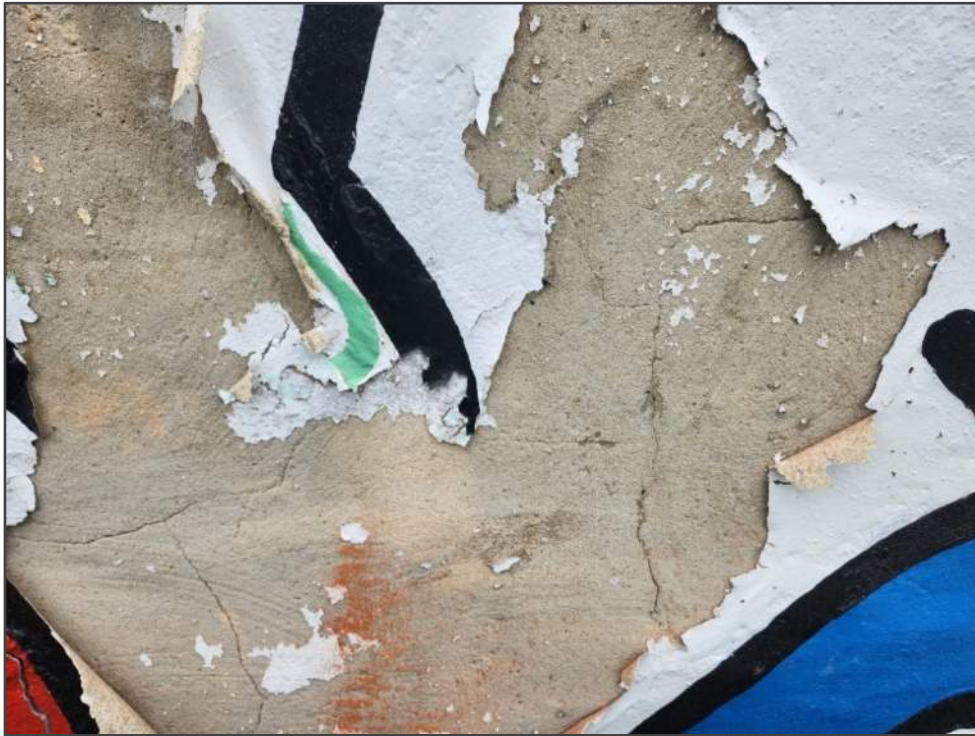
Photo No. 8: Delaminated, missing paint, cracks in stucco beyond

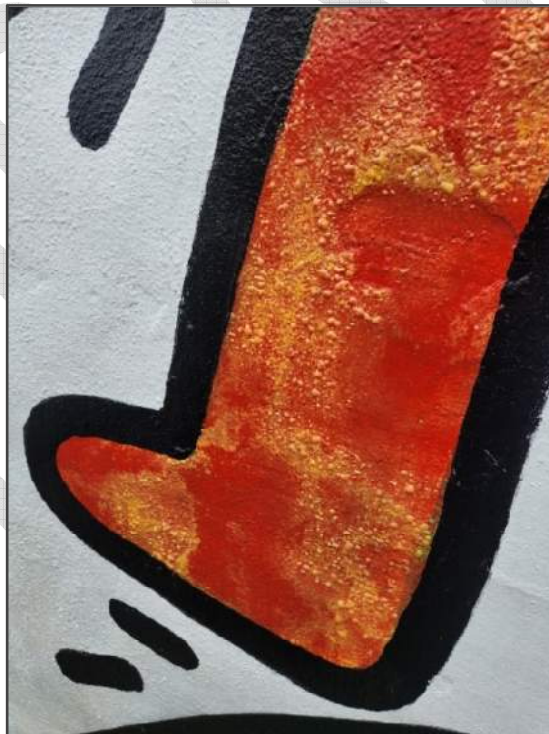
Photo No. 9: Bubbling paint

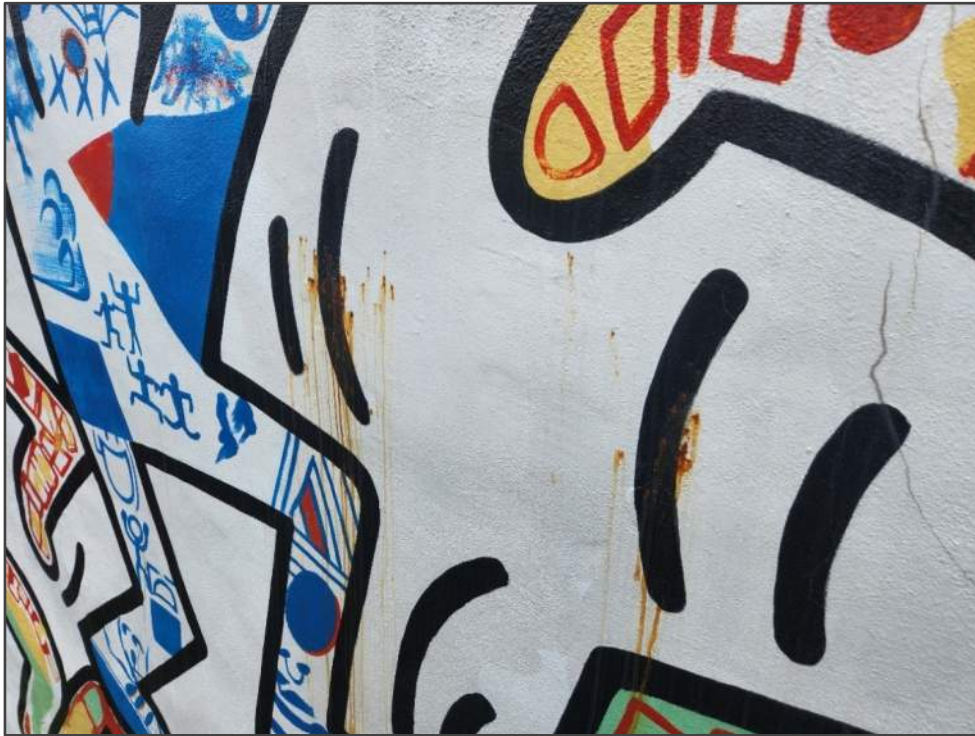
Photo No. 10: Rust staining, cracking

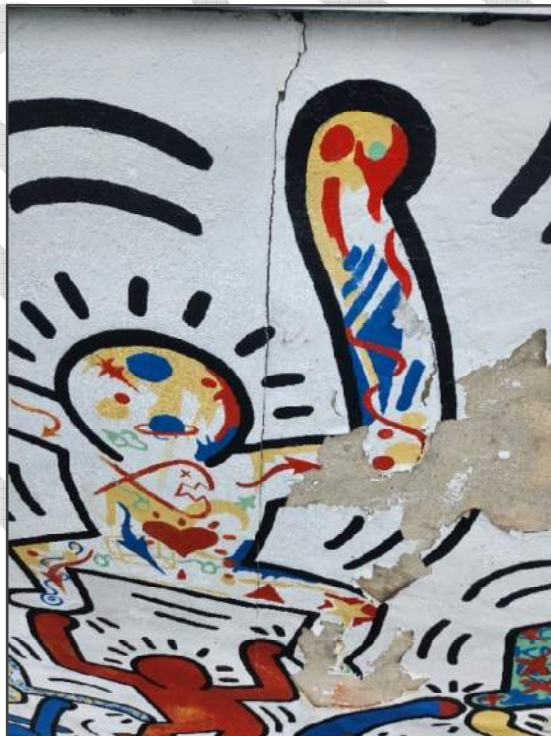
The open vertical crack through the stucco that extends generally the full height of the wall is also a contributing factor to the water infiltration issues. We were unable to determine if the crack translates through to the brick wall beyond, however, it is remarkably straight which suggests it is a cold joint in the stucco – a joint where new 2013 stucco was installed up against old stucco. If the new metal lath did not overlap the old lath, these two generations of stucco could easily separate as a result of water infiltration induced delamination, or thermal movement. To properly repair the stucco crack, the brick wall should be exposed to confirm the cracking does not propagate through. Depending on the condition, joint repair and/or reinforcing may be required prior to repairing the stucco.

Photo No. 11: Open vertical crack through stucco at top of wall; delaminated paint

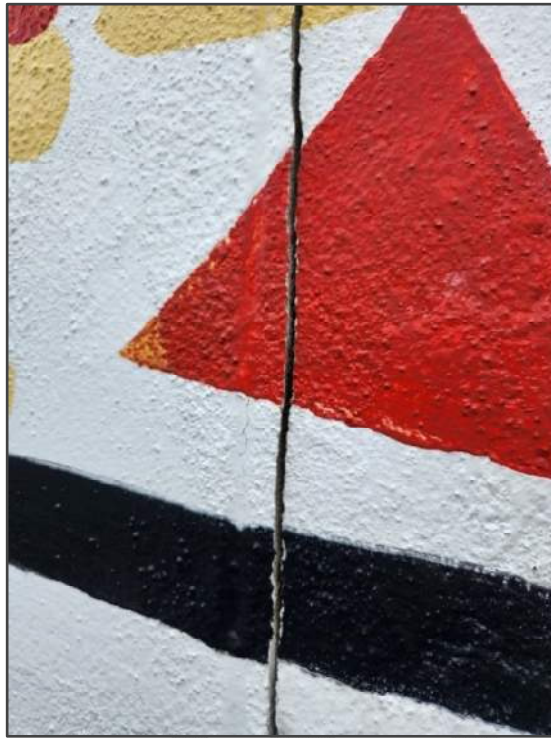
- Full height open vertical crack at center of wall

Photo No. 12: Open vertical crack through stucco

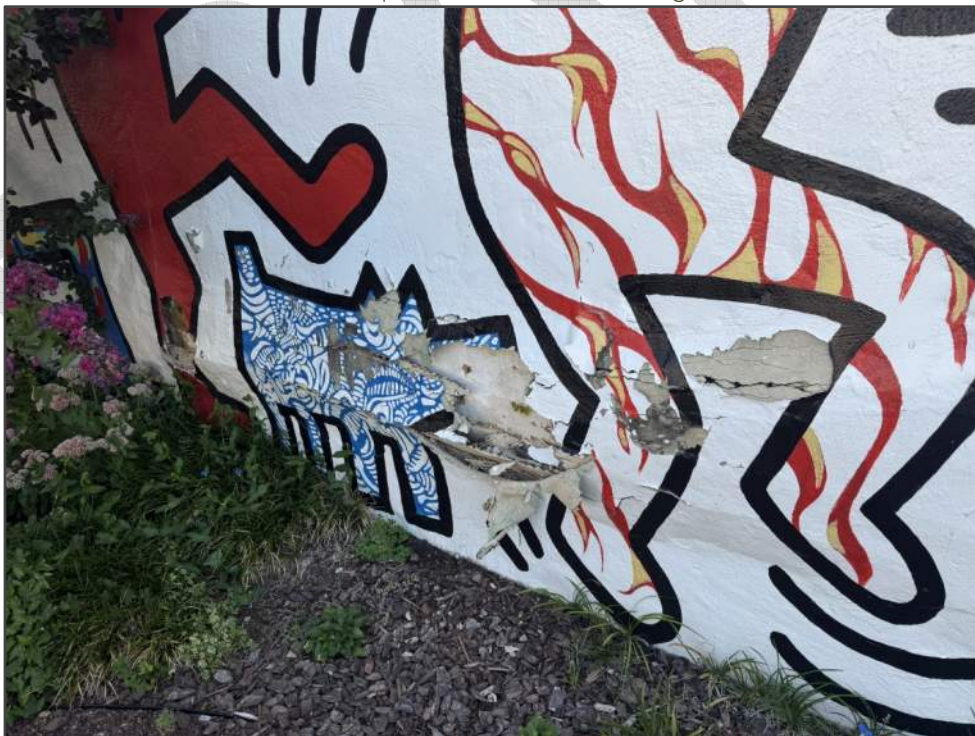
Currently the Mural extends down to grade at the adjacent garden area. Moisture from the ground and garden may wick up the wall, compromising the condition of the base of the stucco and cause the type of deterioration occurring at the bottom of the wall. A preferable termination would be to stop the stucco above the ground at a weep screed.

At the areas of spalled stucco at the base of the wall, it appears that the stucco was installed over the original interior plaster of the previous house on the property. If the plaster and/or brick wall conditions were not sound, the exterior stucco may have been

originally applied to poor substrate conditions. This can contribute to the bulging and delamination.

Photo No. 13: Cracked, spalled, delaminated stucco and paint; corroded metal lath at grade

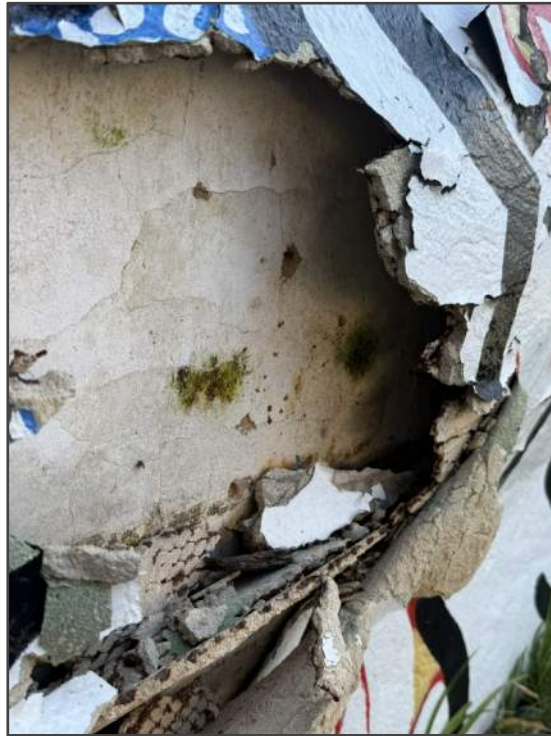
Photo No. 14: Cracked, spalled, delaminated stucco and paint; corroded metal lath at grade

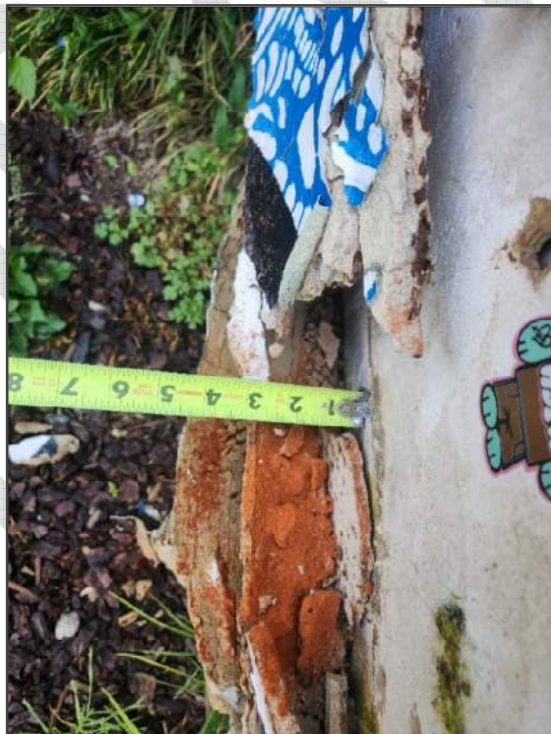
Photo No. 15: Cracked, spalled, delaminated stucco and paint; corroded metal lath at grade

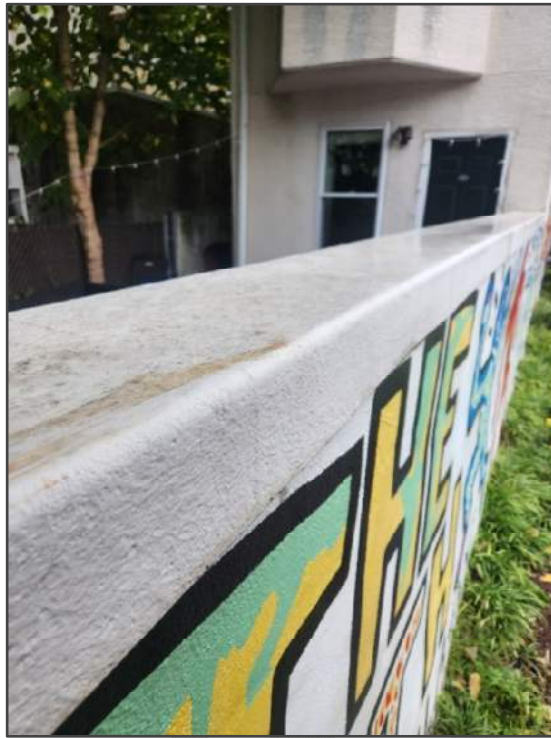
Photo No. 16: Top of site wall condition

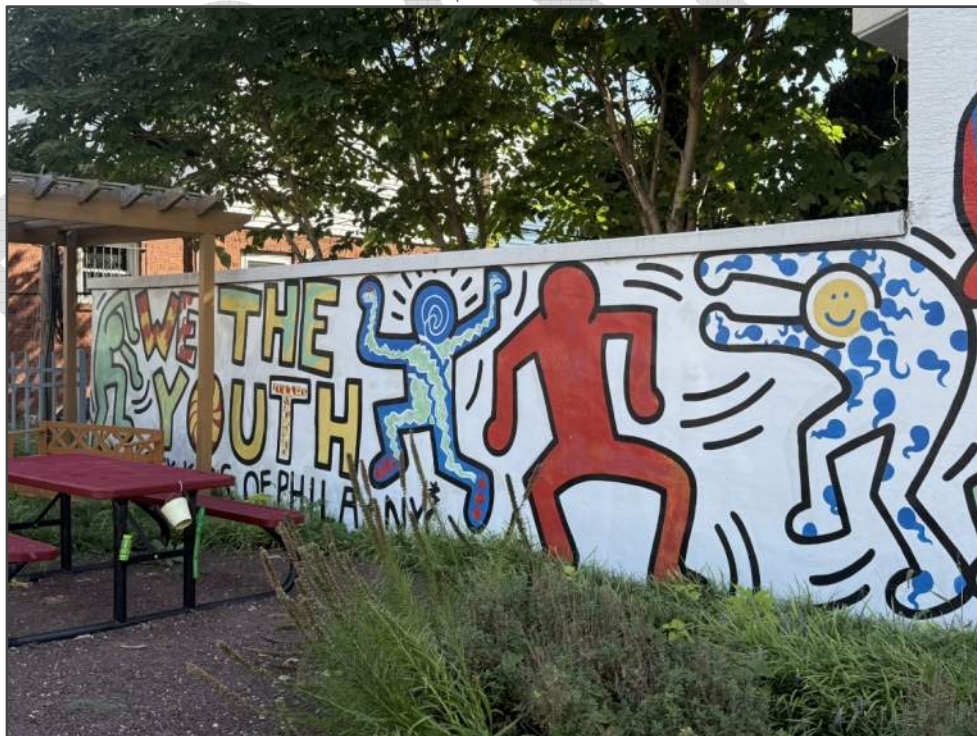
Photo No. 17: Site wall in good condition
