ADDRESS: 1416 DIAMOND ST

Proposal: Demolish front façade, the only remaining portion of the building

SUBJECT: Exploratory Removal and Laboratory Brick Analysis Report
1416 W. Diamond Street
Philadelphia, PA 19122
ARC No. 066-032-RC

Laboratory Testing of Brick Masonry Units

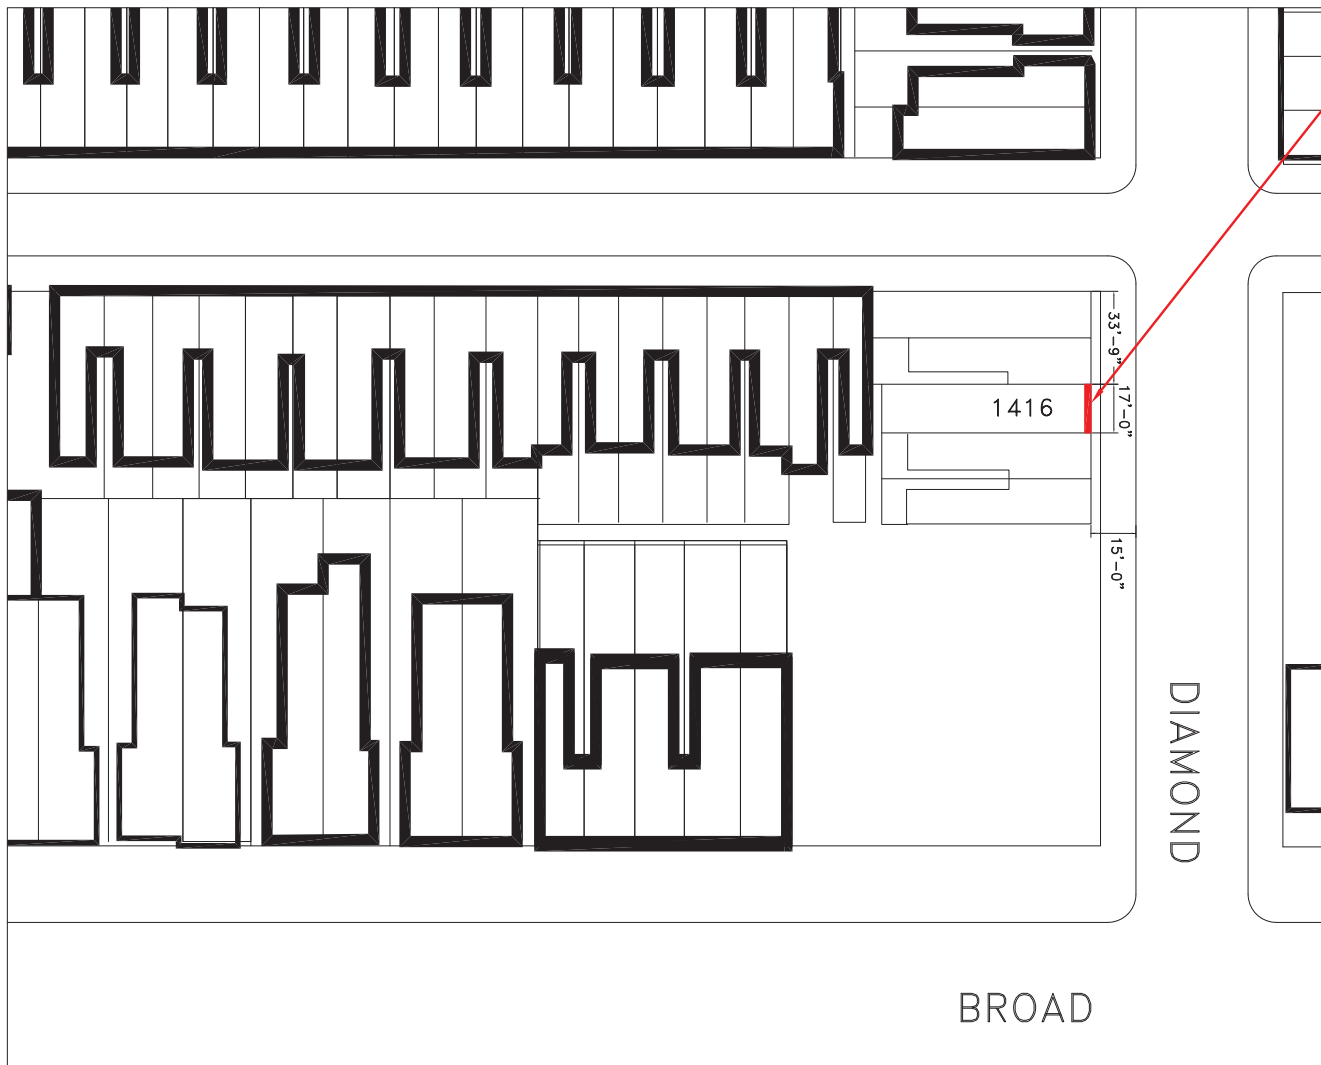
1416 DIAMOND STREET – EXISTING FACADE FRONT AND VACANT LOT BEHIND.

Free standing wall,brown stone de-laminating

FACADE TO BE DEMOLISHED.

PARGE EXPOSED WALLS OF ADJACENT PROPERTY AFTER DEMO.

LOT TO BE GRADED LEVEL AND STABILIZED USING PERMEABLE MEMBRANE AND STONE OR SEED.

INSTALL 6' CYCLONE FENCE WITH GATE ALONG DIAMOND STREET FRONTAGE AND REPAIR / REPLACE REAR FENCING AS NEEDED.

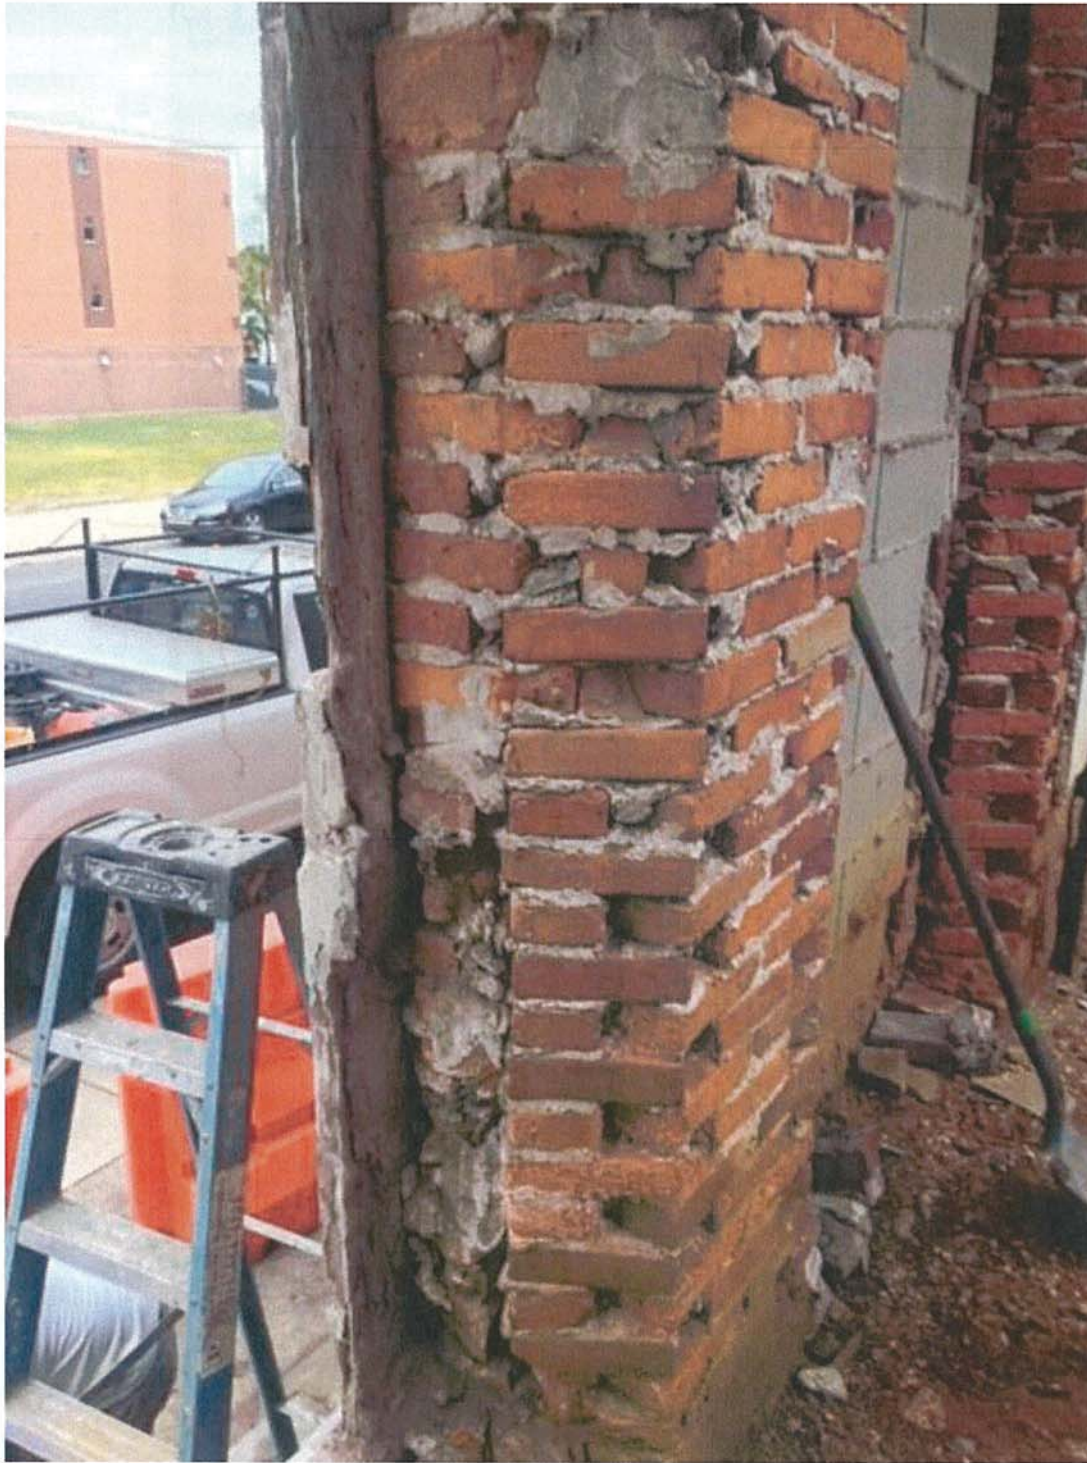
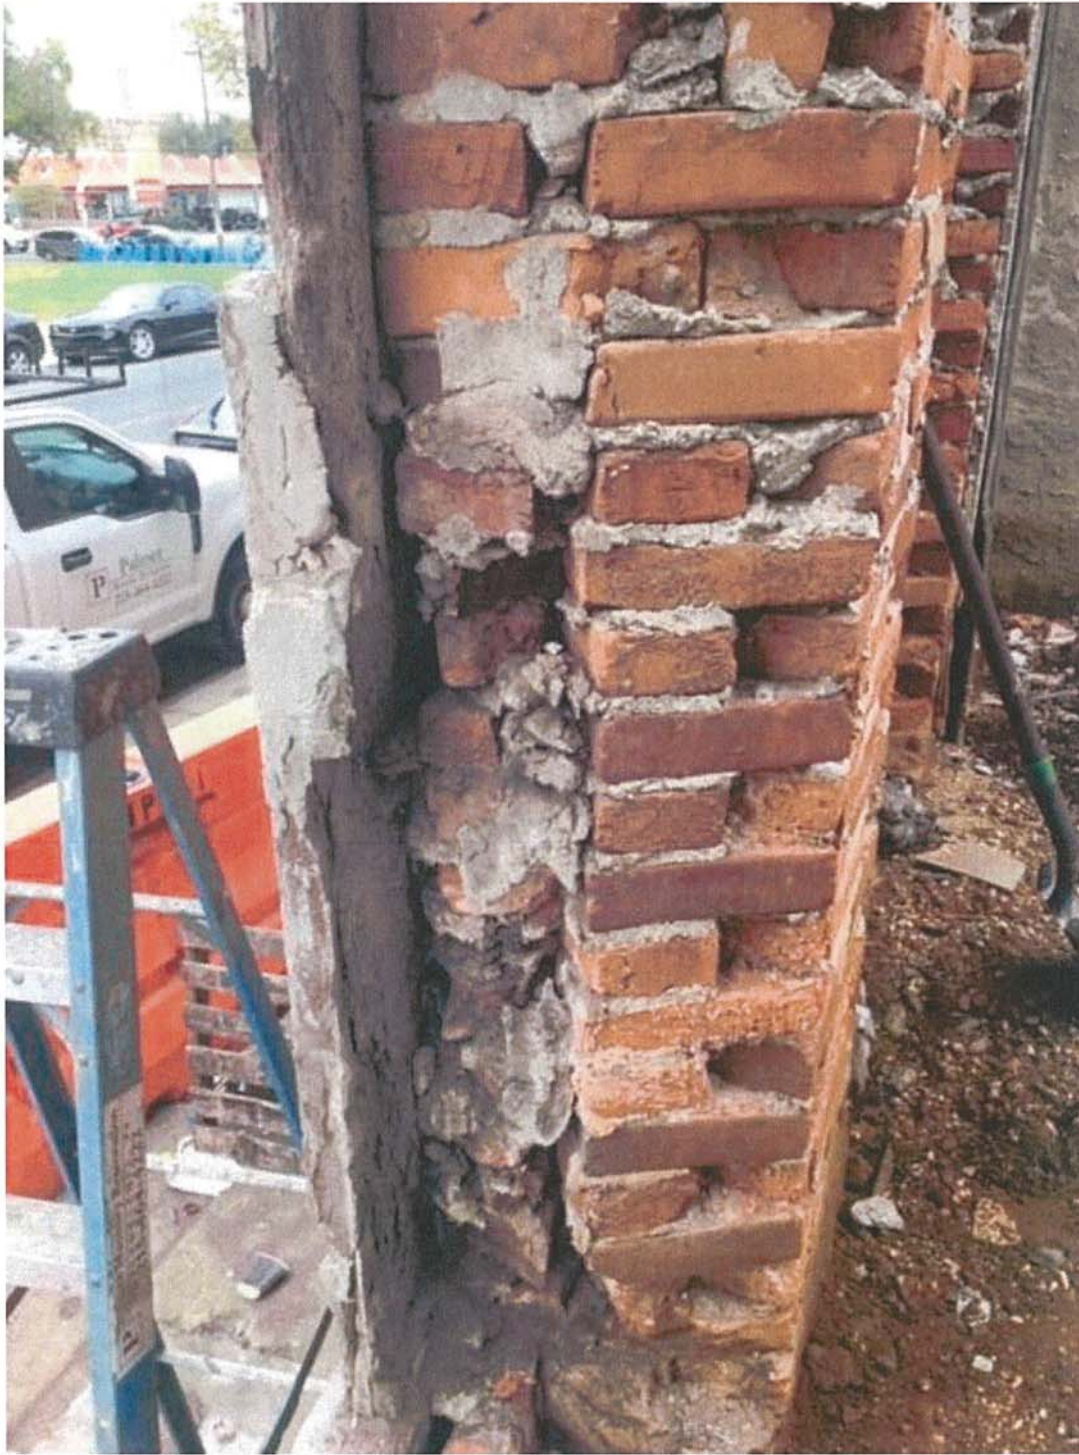
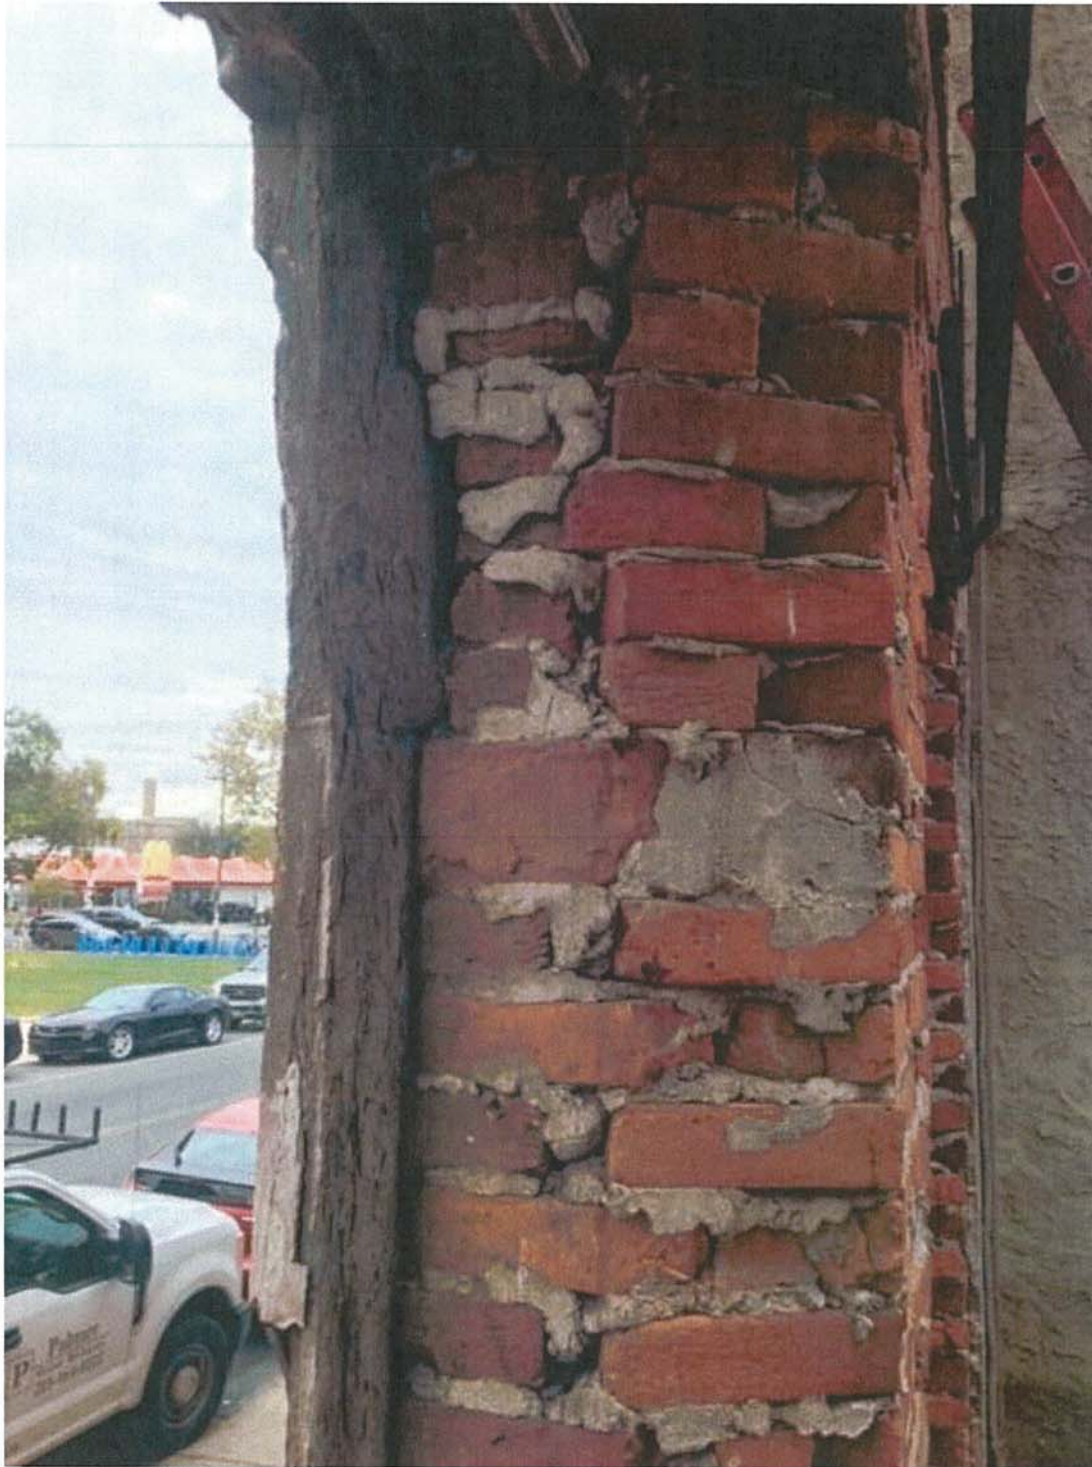
- We confirmed that the existing brick back-up wall is composed of three wythes of common brick. We observed indications of brick failure at exposed brick elements including section loss, erosion, cracks, and spalls. (Photos 1 – 3).

Therefore, we recommend demolition of the remaining masonry wall. Prior to demolition, the masonry of adjacent rowhomes must be reviewed by a Professional Engineer to determine the necessary protection and support required. Demolition must be completed by a qualified contractor in accordance with applicable standards. It is understood that the building is designated on the Philadelphia Register of Historic Places and approval would be required prior to obtaining a demolition permit from the City of Philadelphia Department of Licenses and Inspection.

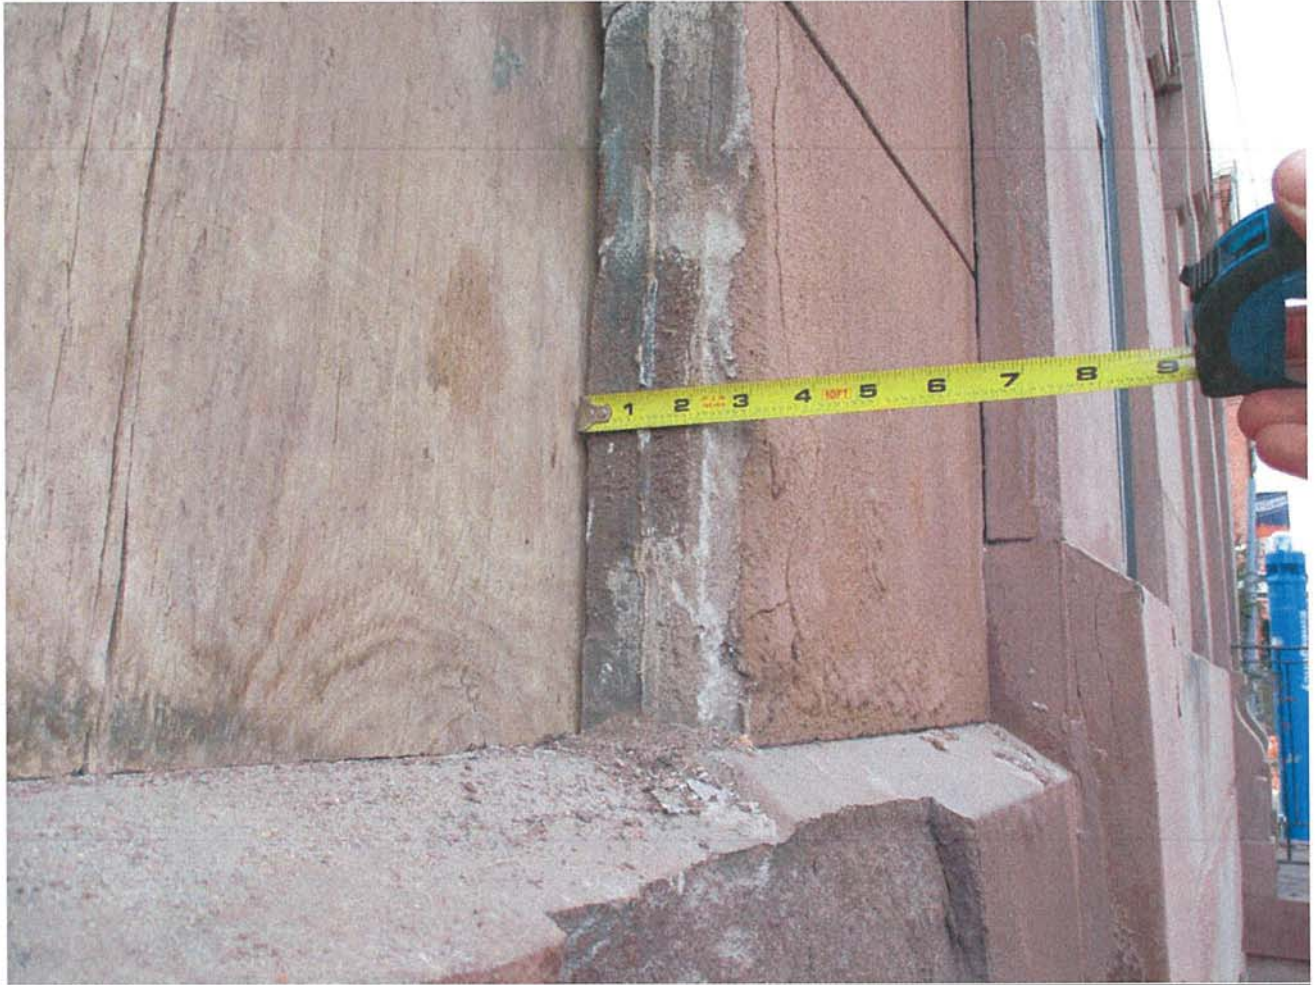
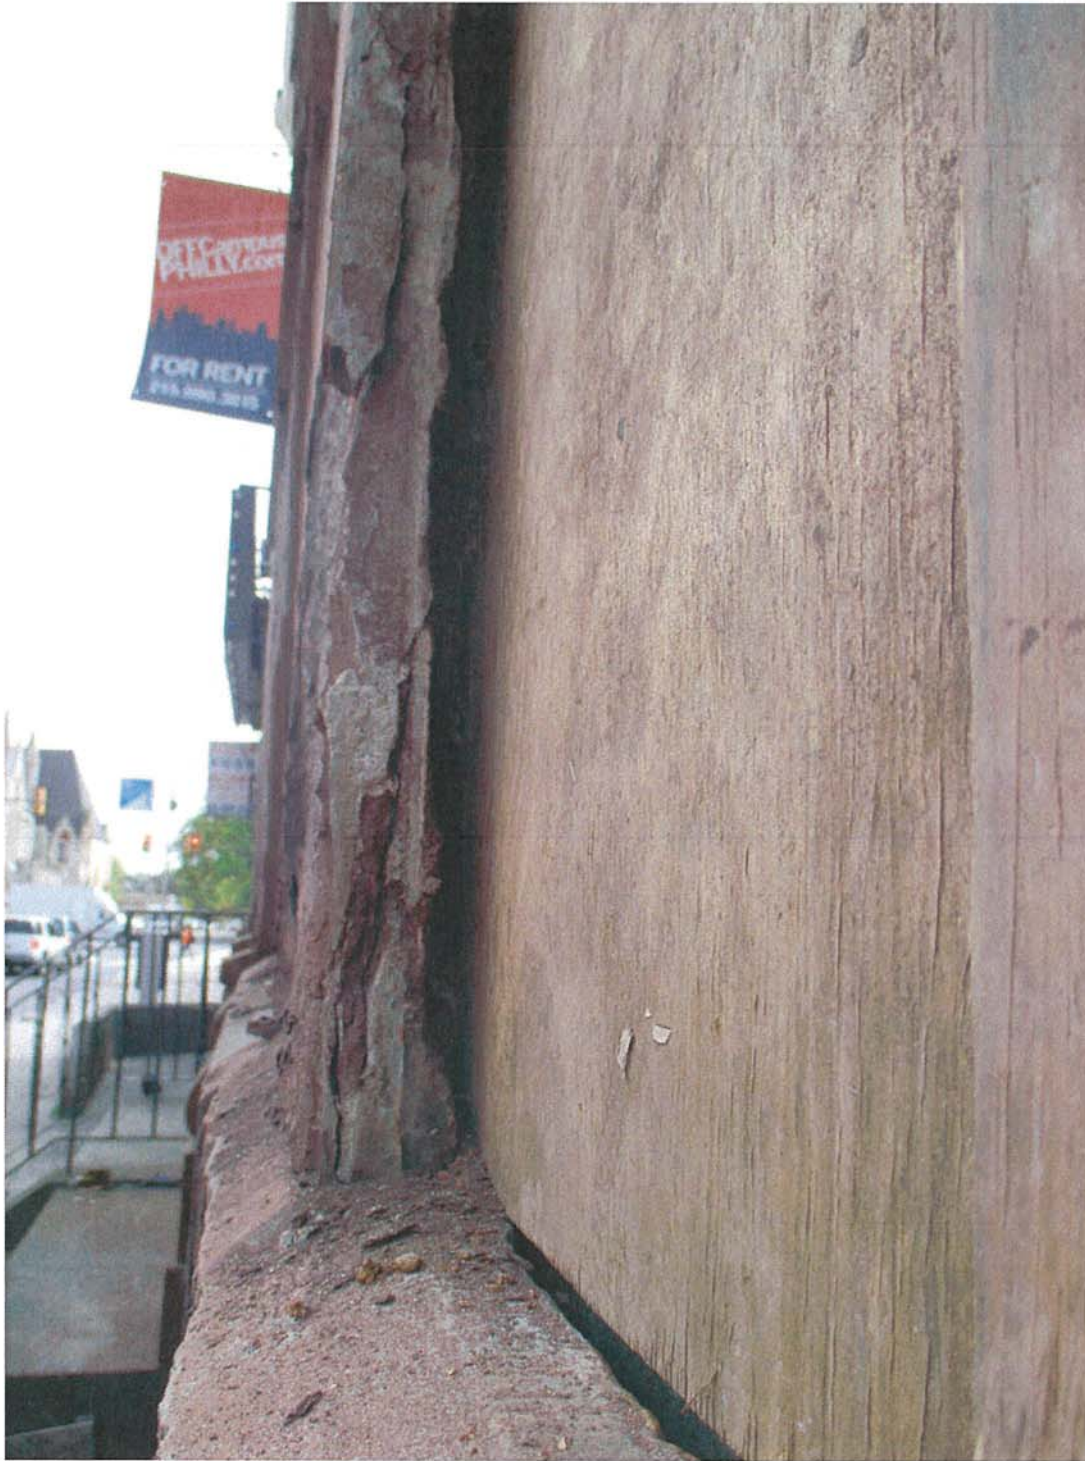
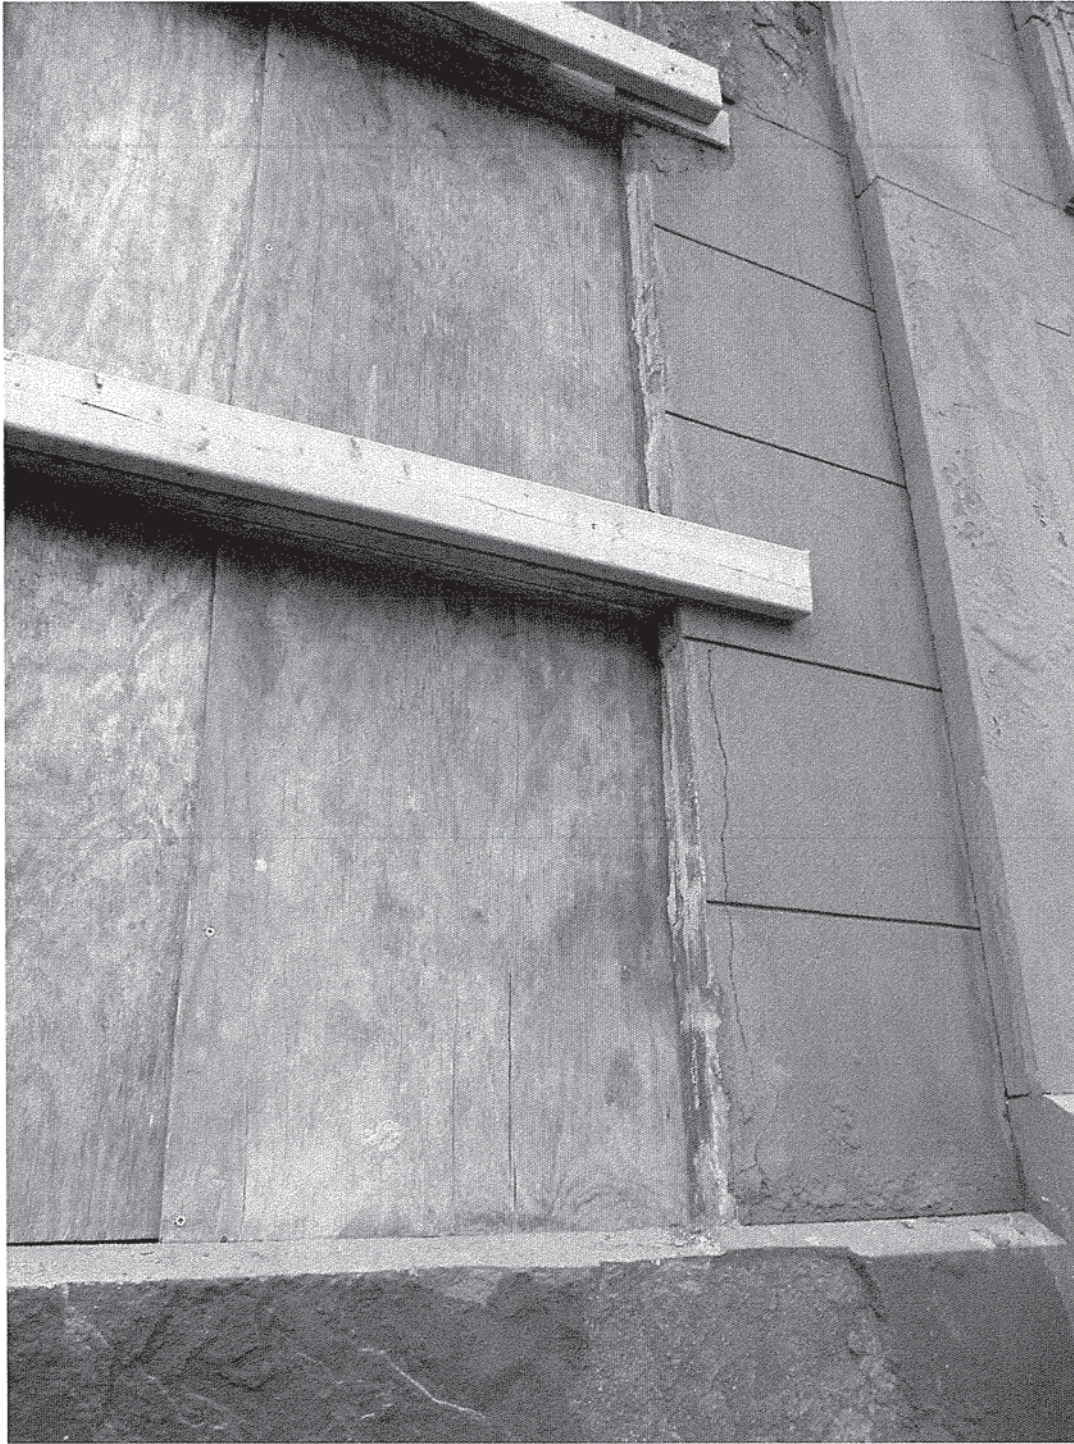
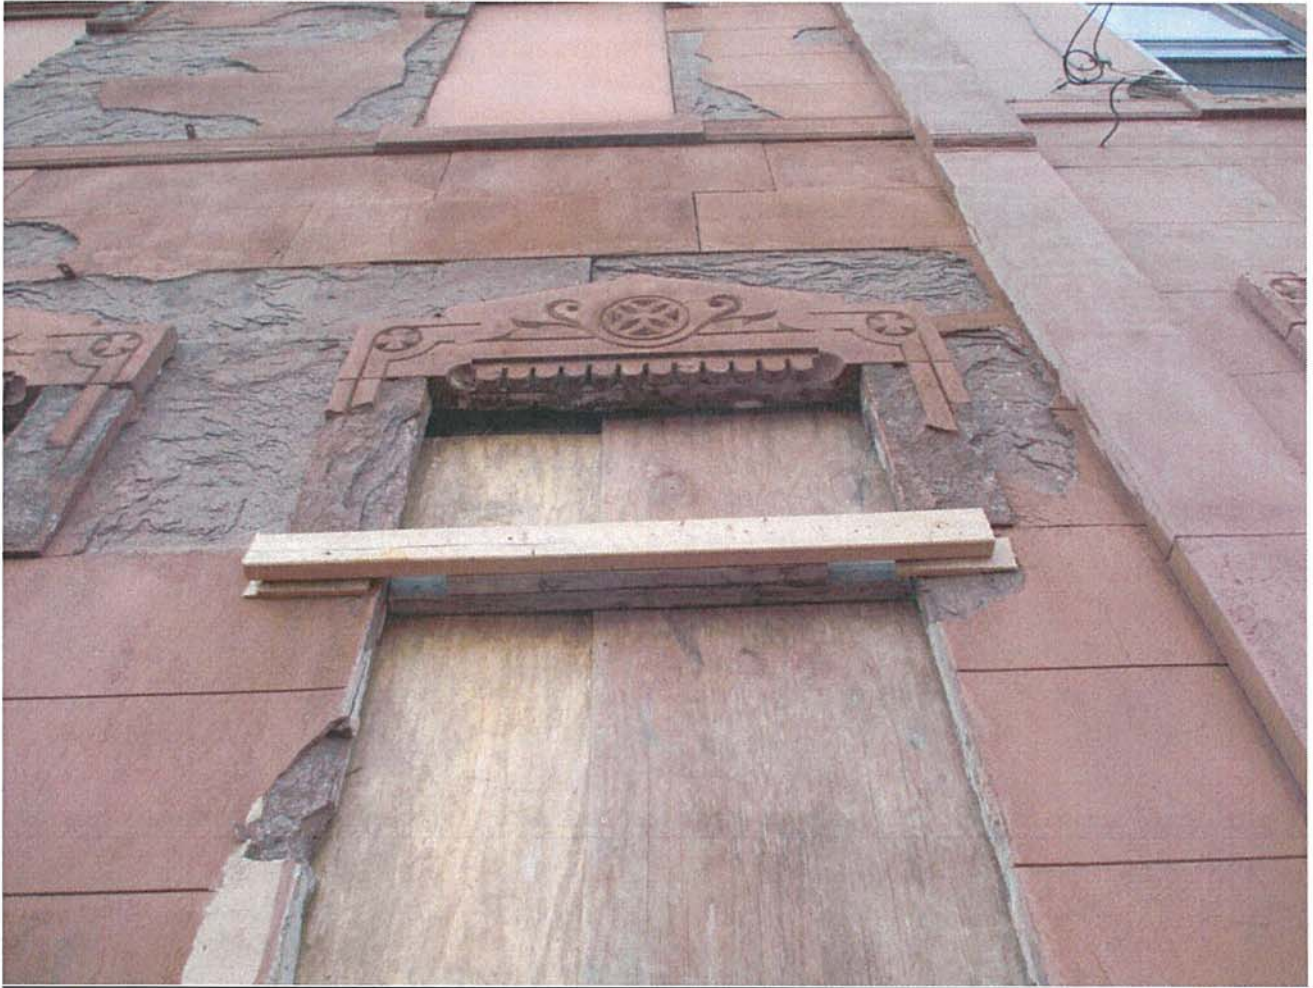
- Existing brownstone veneer is approximately 2" thick. The veneer panels showed evidence of previous repairs with a cementitious material applied to the exterior surface and coated with an unknown material (Photos 4 – 7).

- Parging and coating of existing brownstone may be contributing to the advanced deterioration of existing masonry material. Brownstone is a soft and porous sedimentary rock composed of feldspar, quartz, mica, and iron oxides. Weathering or erosion of brownstone surface are caused by several factors including water infiltration, residual moisture, acidic rain water, snow, temperature fluctuations (freeze/thaw cycles), wind exposure, and atmospheric pollutants. These factors may also contribute to small cracks or fissures in the stone allowing for water infiltration, promoting salt migration and corrosion of supporting elements. Brownstone was commonly installed with the bedding planes of the stone laid vertically, parallel to the façade, to ensure the color and texture was uniform. However, this installation method contributes to the higher frequency of deterioration in brownstone facades. As bedding planes begin to delaminate, the face-bedded brownstone flakes off in sheets leaving an uneven surface and section-loss in the façade (See Photos 6 and 7). Improper patching, parging, and coating of brownstone may create a vapor barrier; trapping residual moisture within the face of the stone and contributing to the deterioration of adjacent brick and brownstone.

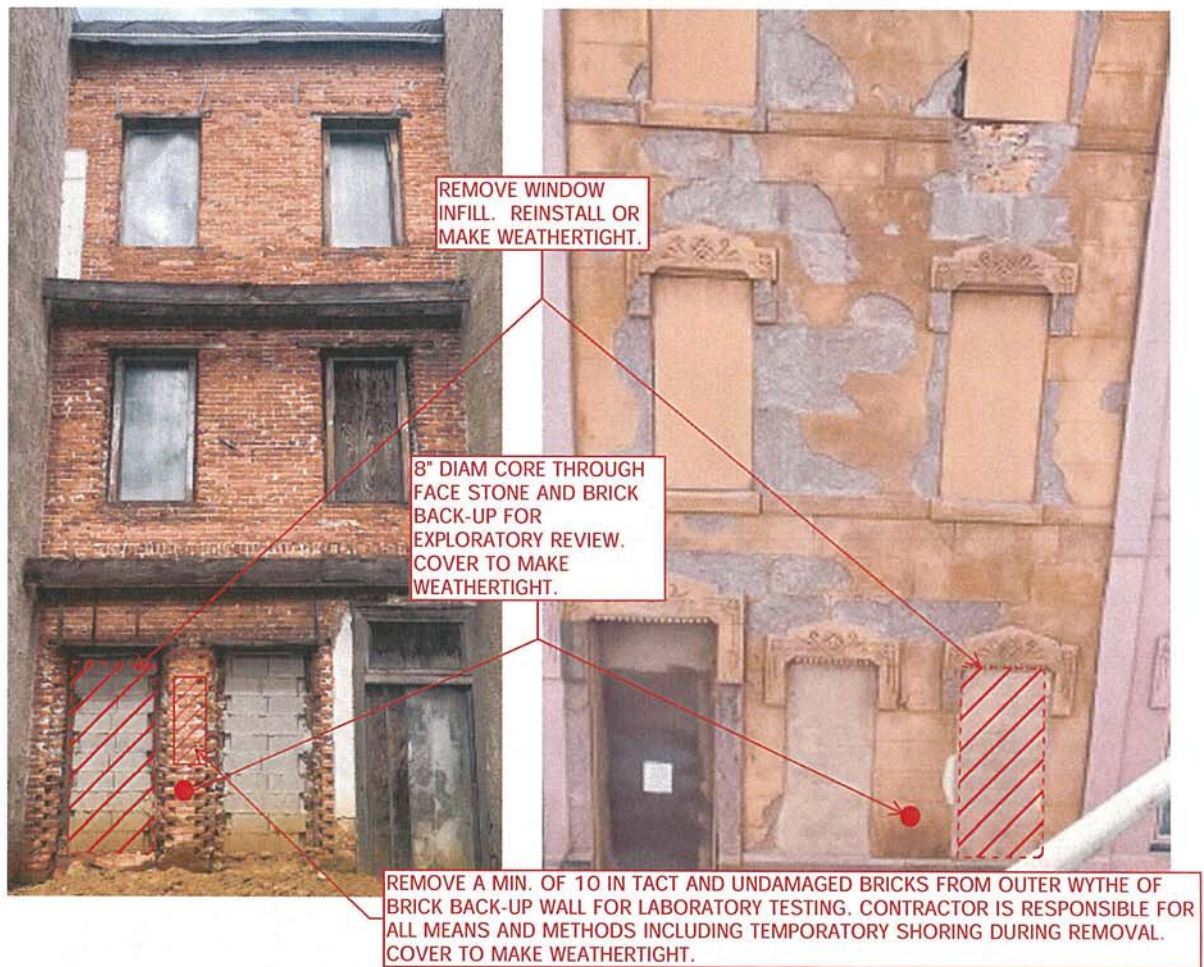
Figure 1: Photographs of the front and back of the building showing the location from which the samples were taken, and condition of the bricks in the field.

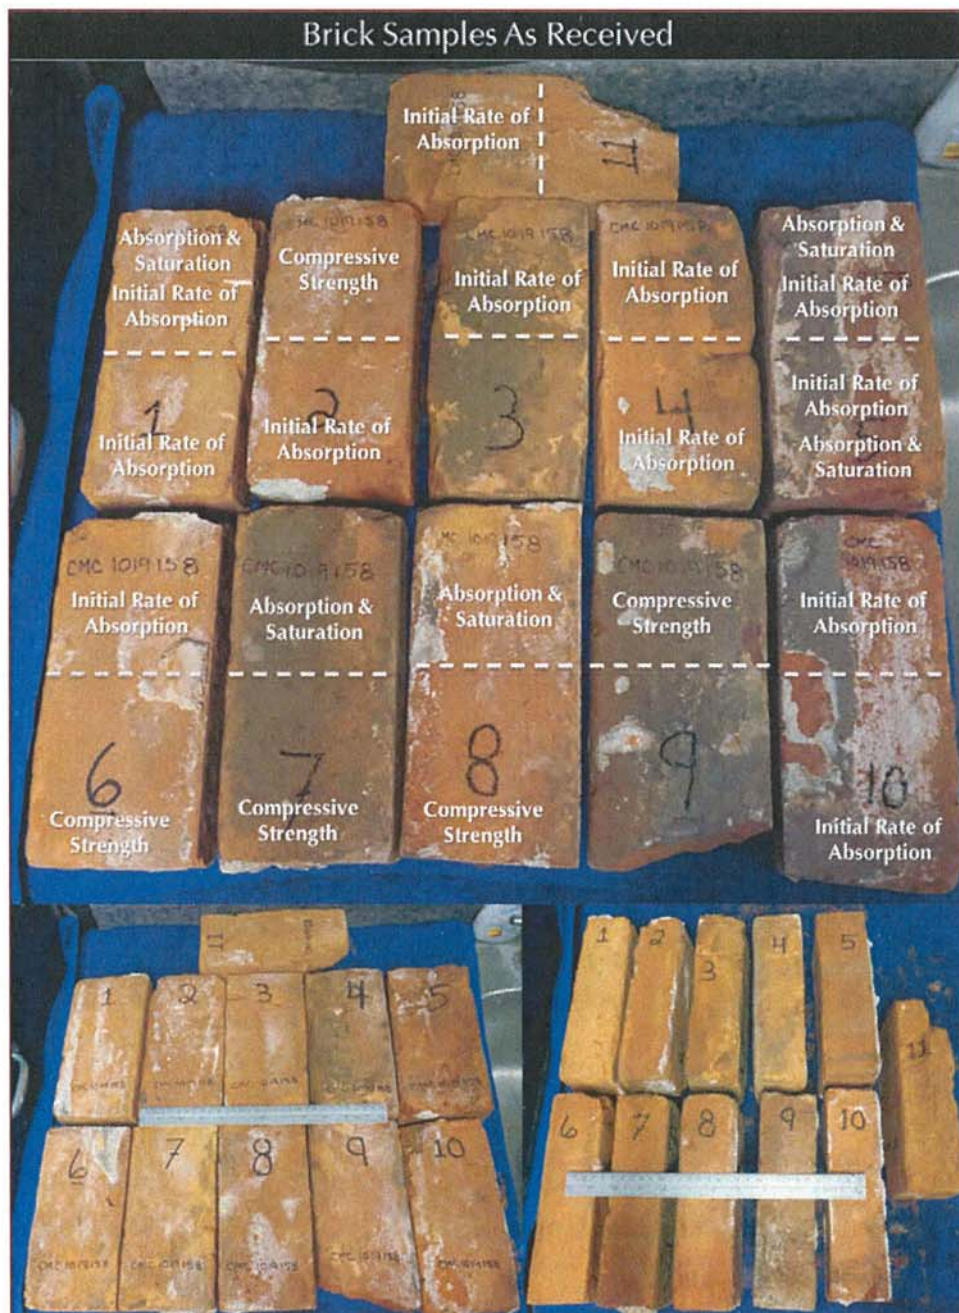
Figure 2: Shown are eleven brick units identified as Nos. 1 through 11. White dashed lines on bricks indicate locations to cut; portions were used for compressive strength testing, and the opposite portions were used for absorption, etc.

Table 1: Initial rate of absorption (suction), cold & boiling water absorptions, and saturation coefficients of bricks. All bricks have failed the requirement in saturation coefficient of ASTM C 216 facing bricks.

Table 2: Compressive strengths of bricks. Average strength results of five bricks are noticeably lower than the ASTM C 216 minimum strength of 3000 psi for facing bricks in a severe weather environment. Strengths of individual bricks are also lower than the ASTM C 216-recommended minimum strength of 2500 psi for facing bricks.
