#### ADDRESS: 1600-06 E BERKS ST

Proposal: Demolish building owing to necessity in the public interest Review Requested: Final Approval Owner: 1600 Berks LLC Applicant: Matt McClure, Esq., Ballard Spahr History: 1885-90, St. Laurentius Church, Edwin Forest Durang, architect Individual Designation: 7/10/2015 District Designation: None Staff Contact: Jon Farnham, jon.farnham@phila.gov

### STRUCTURAL CONDITION APPRAISAL

ST. LAURENTIUS CHURCH 1608 EAST BERKS STREET PHILADELPHIA, PA

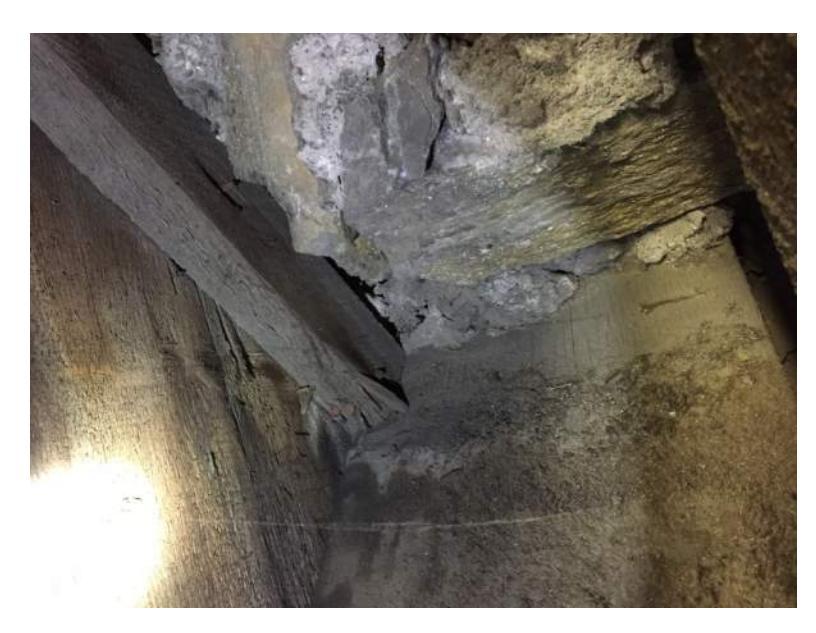
Corner masonry infills supported by timbers at the Lower Bell level

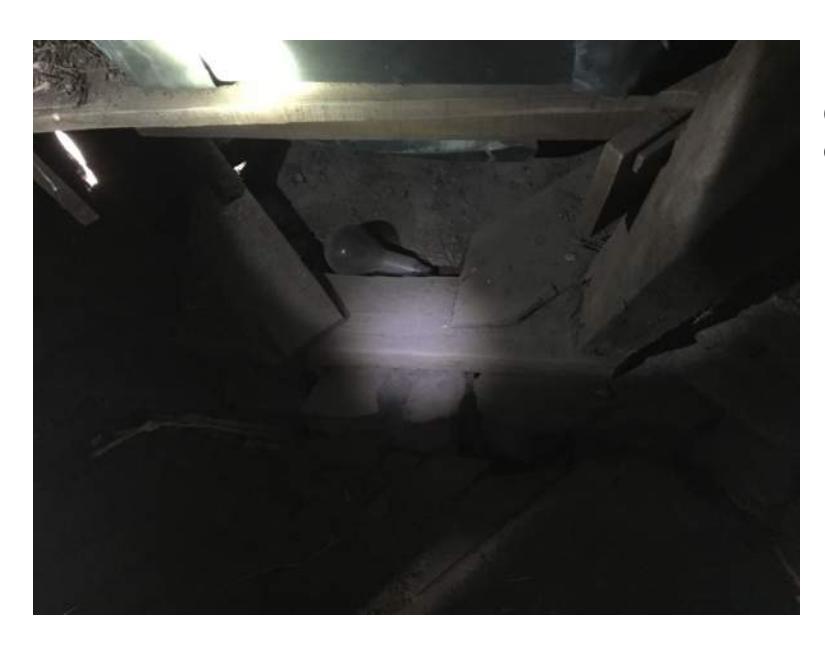
Corner steeple support supported on corner masonry infills

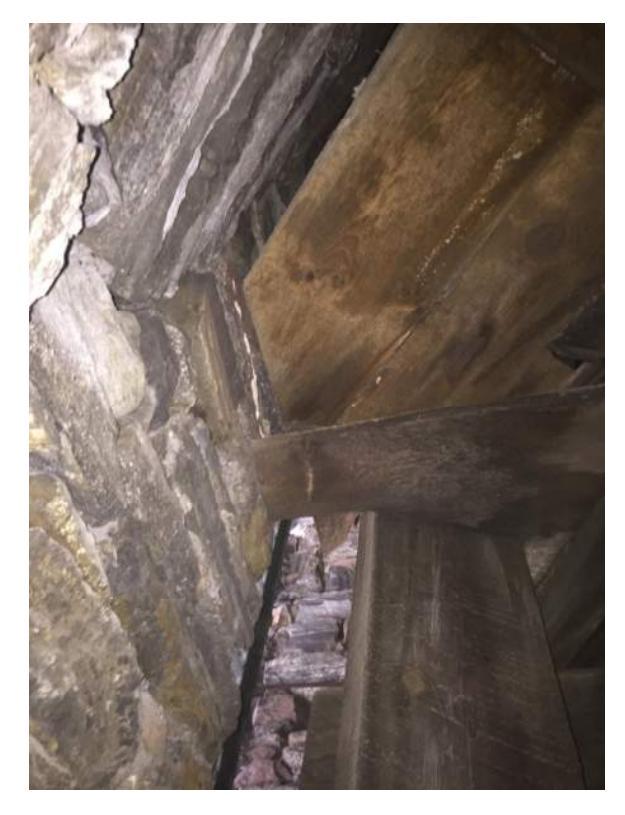
Gap between timber framing and masonry above the lower bell level; no anchors between timber framing and masonry above the lower bell level

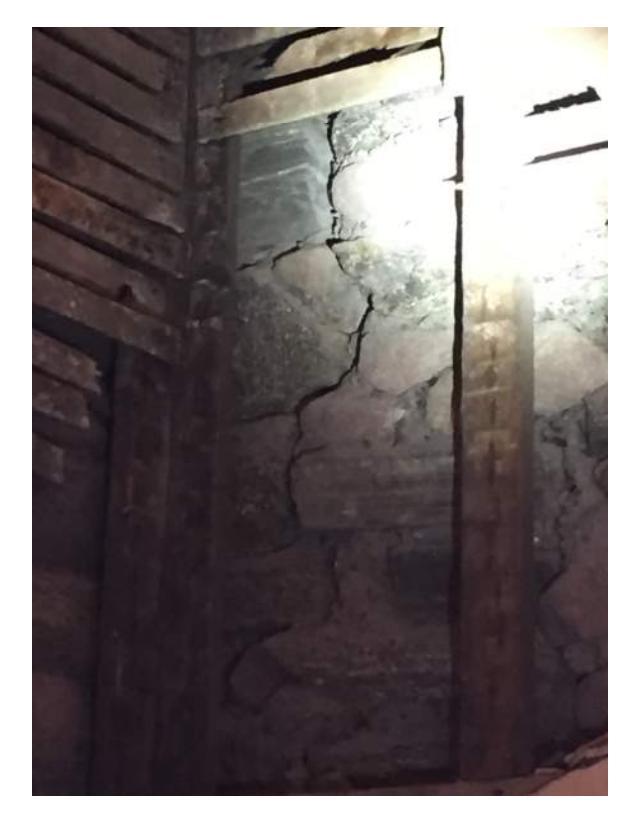
INTERIOR THROUGH CRACK – CHOIR TO MID-LEVEL NE TOWER

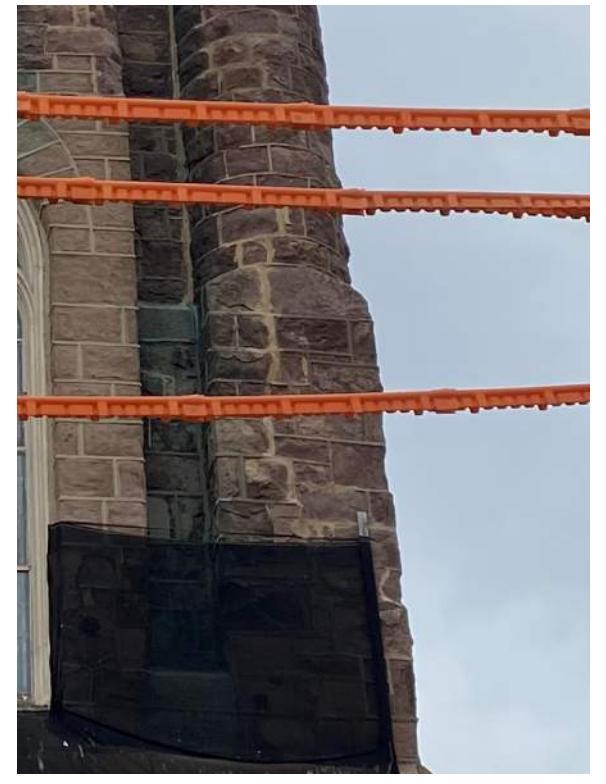
**EXTERIOR VIEW OF SAME CRACK**

The through crack reflects that the corners of the masonry walls have become disconnected from each other. There is no structural integrity at the corners due to this cracking.

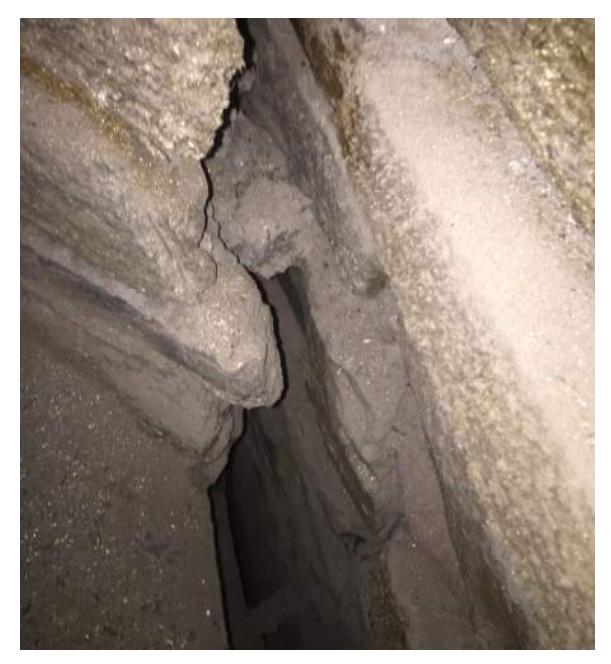
Open 2" gap between diagonal infill masonry and eastern wall indicating movement.

#2	Masonry Movement - Mid-level	Up to 2" outward movement evident at northeastern and northwestern tower	<b>Significant impact.</b> Cracking creates lack of masonry continuity and lack of stability of the towers

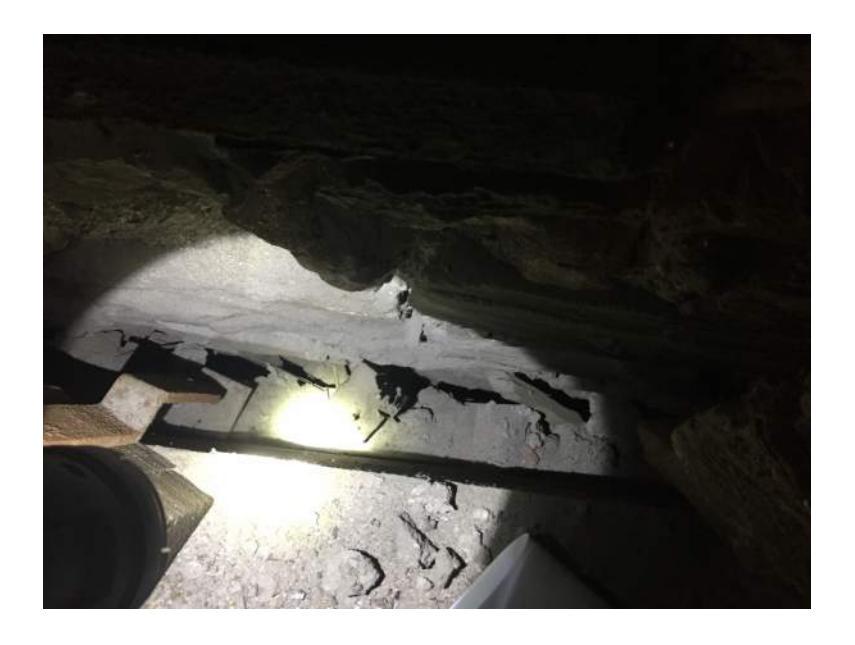
Open 2" gap between wood framing and eastern wall further indicating movement of the eastern wall.

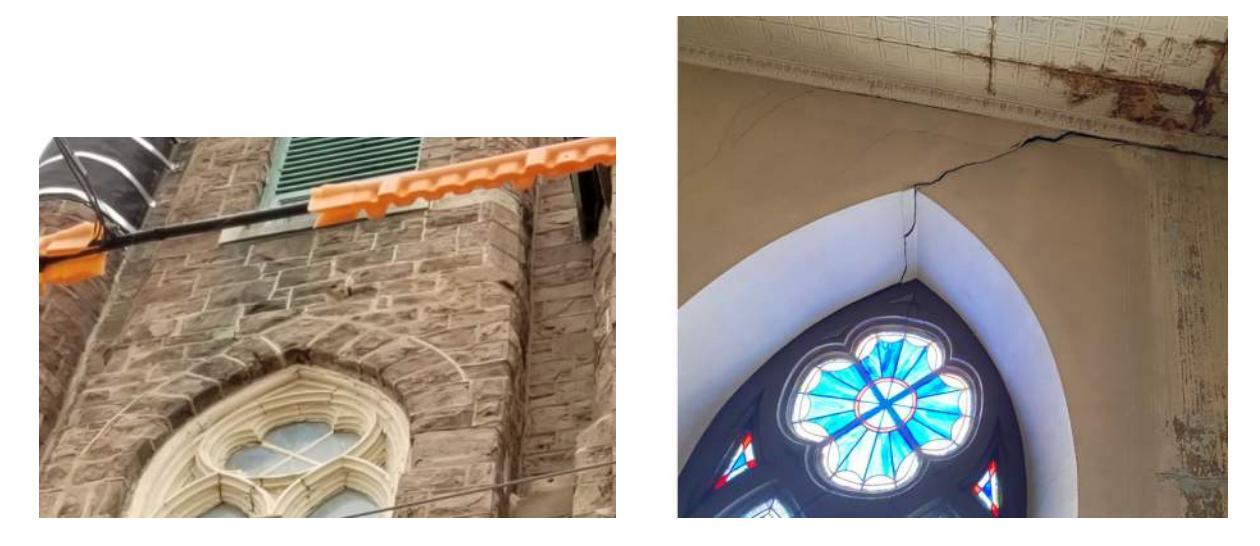
Northern wall eastern tower below mid-level (wood window frame cracked)

Notice that the plaster (and masonry) cracking indicates that the corner is pulling away from the tower.

#3	Failure of arches	Although the interior of the plaster was not removed, it appears apparent that the head of most of the monumental windows have failed	Failure may cause movement of the masonry noted in #2 or vice versa

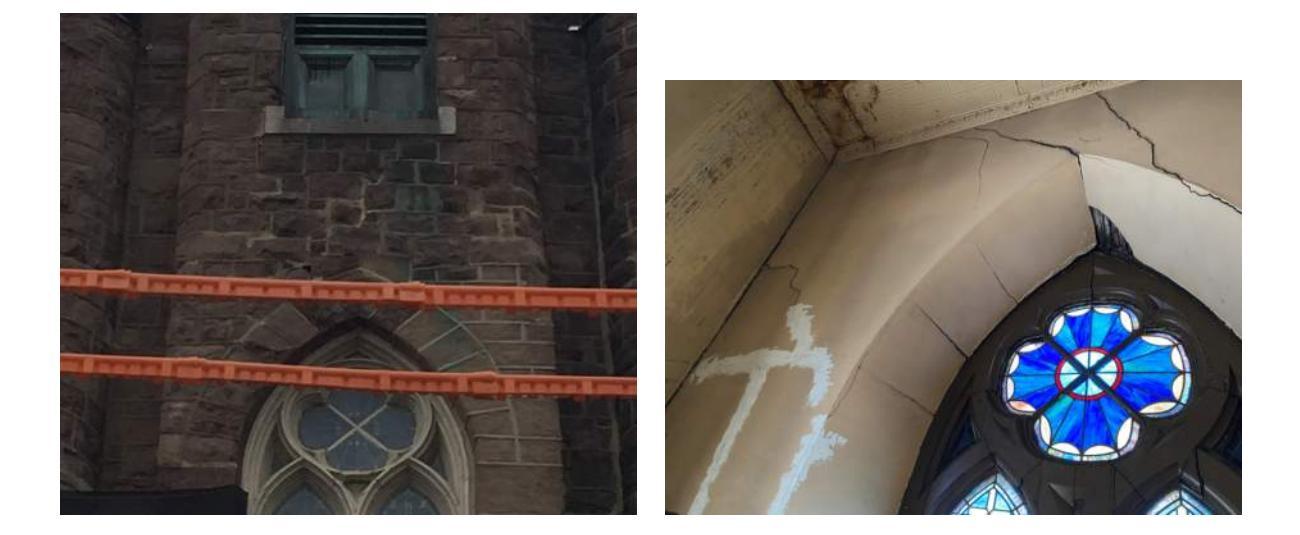
Eastern wall eastern tower below mid-level (wood window frame cracked)

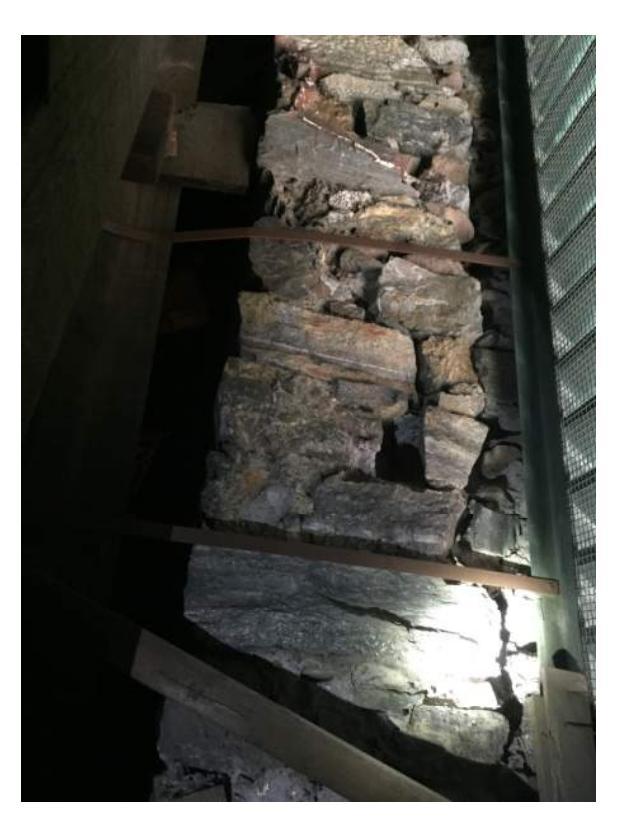
Note smaller stones, lack of mortar

#4	Schist backup quality and degradation of mortar	Original construction of the schist stone backup was smaller stones. The mortar has been impacted through age and freeze thaw.	<b>Significant impact.</b> Smaller stones create extra reliance on mortar. Mortar has significantly degraded between turrets and corner masonry infills. Cracking evident. Lack of maintenance has allowed increased impact from moisture penetration and freeze thaw. Poor quality of backup stone has allowed for geometry (#2) to have a greater impact on the masonry movement and the arch failure. We do not believe pointing is a viable option.

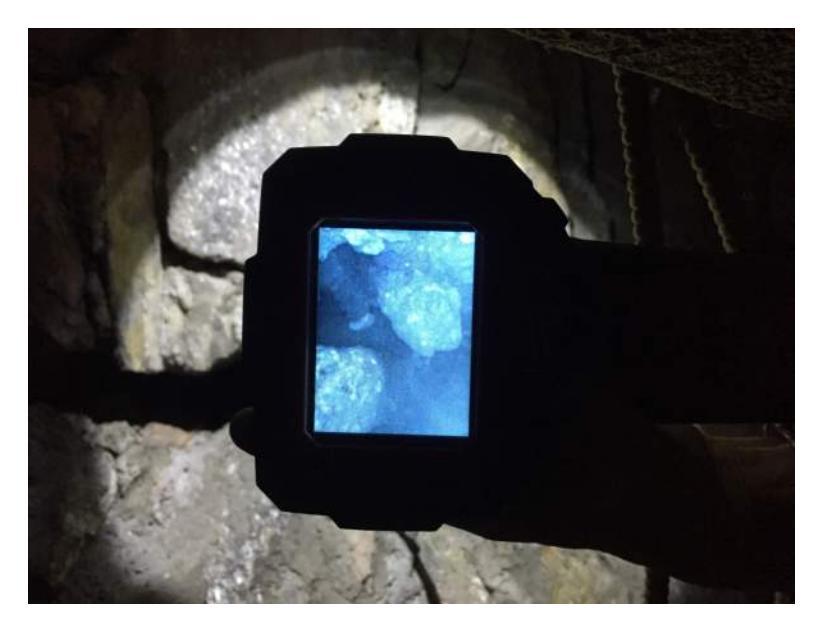
Boroscope readings behind the diagonal infill wall indicates a void originally built. Based on the boroscope readings, the void was filled with dust, remnants of former mortar (damaged through age and freeze/thaw).
