REPORT OF
SUBSURFACE EXPLORATION AND
GEOTECHNICAL ENGINEERING ANALYSIS
FOR STORMWATER MANAGEMENT

PROPOSED STADIUM CASINO
900 PACKER AVENUE
PHILADELPHIA, PA

JUNE 23, 2015

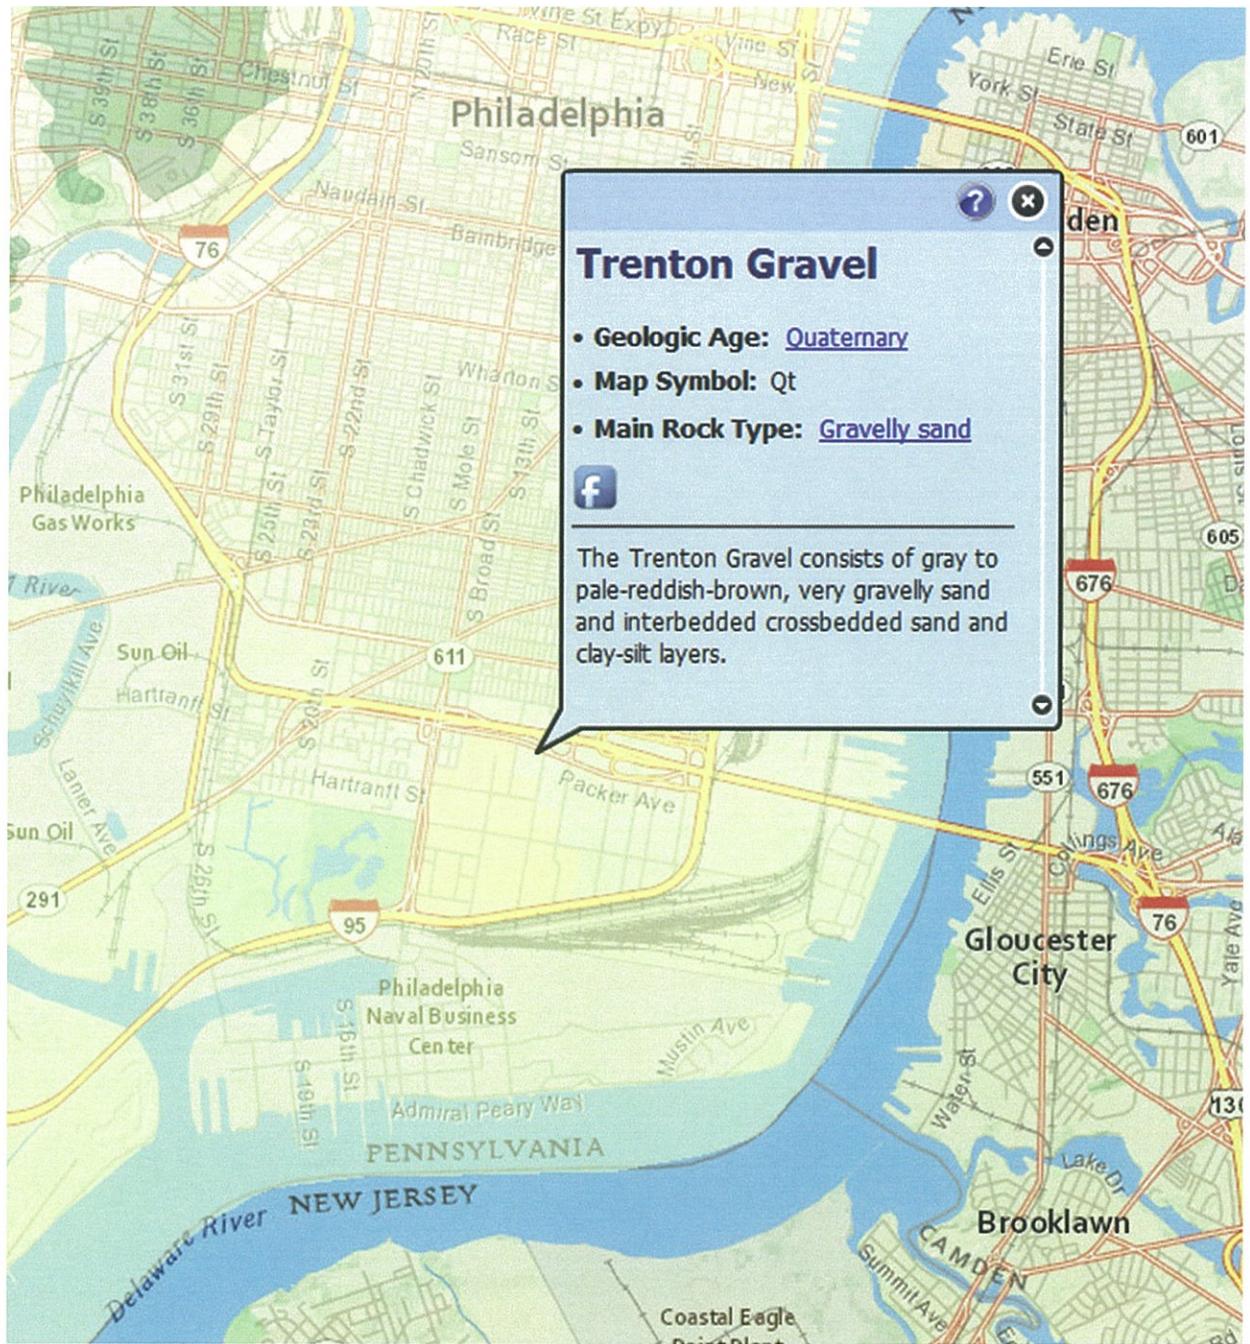
Geology Map
ECS Project 18.3798
April 2015

Trenton Gravel

- Geologic Age: [Quaternary](#)
- Map Symbol: Qt
- Main Rock Type: [Gravelly sand](#)

The Trenton Gravel consists of gray to pale-reddish-brown, very gravelly sand and interbedded crossbedded sand and clay-silt layers.

Based on the *Geologic Map of Pennsylvania* the project site is mapped as being underlain by the Trenton Gravel (Qt). According to *Engineering Characteristics of the Rocks of Pennsylvania*, Second Edition, 1982, by Alan Geyer and Peter Wilshusen, the Trenton Gravel is gray to reddish brown, very gravelly sand; interbedded cross bedded sand and clay layers. The bedrock is well bedded and cross bedded. The weathering is deeply weathered containing weathered gravel of granite, sandstone, gneiss, siltstone, and quartzite. The bedrock is easily excavated with poor cut slope and foundation stability.

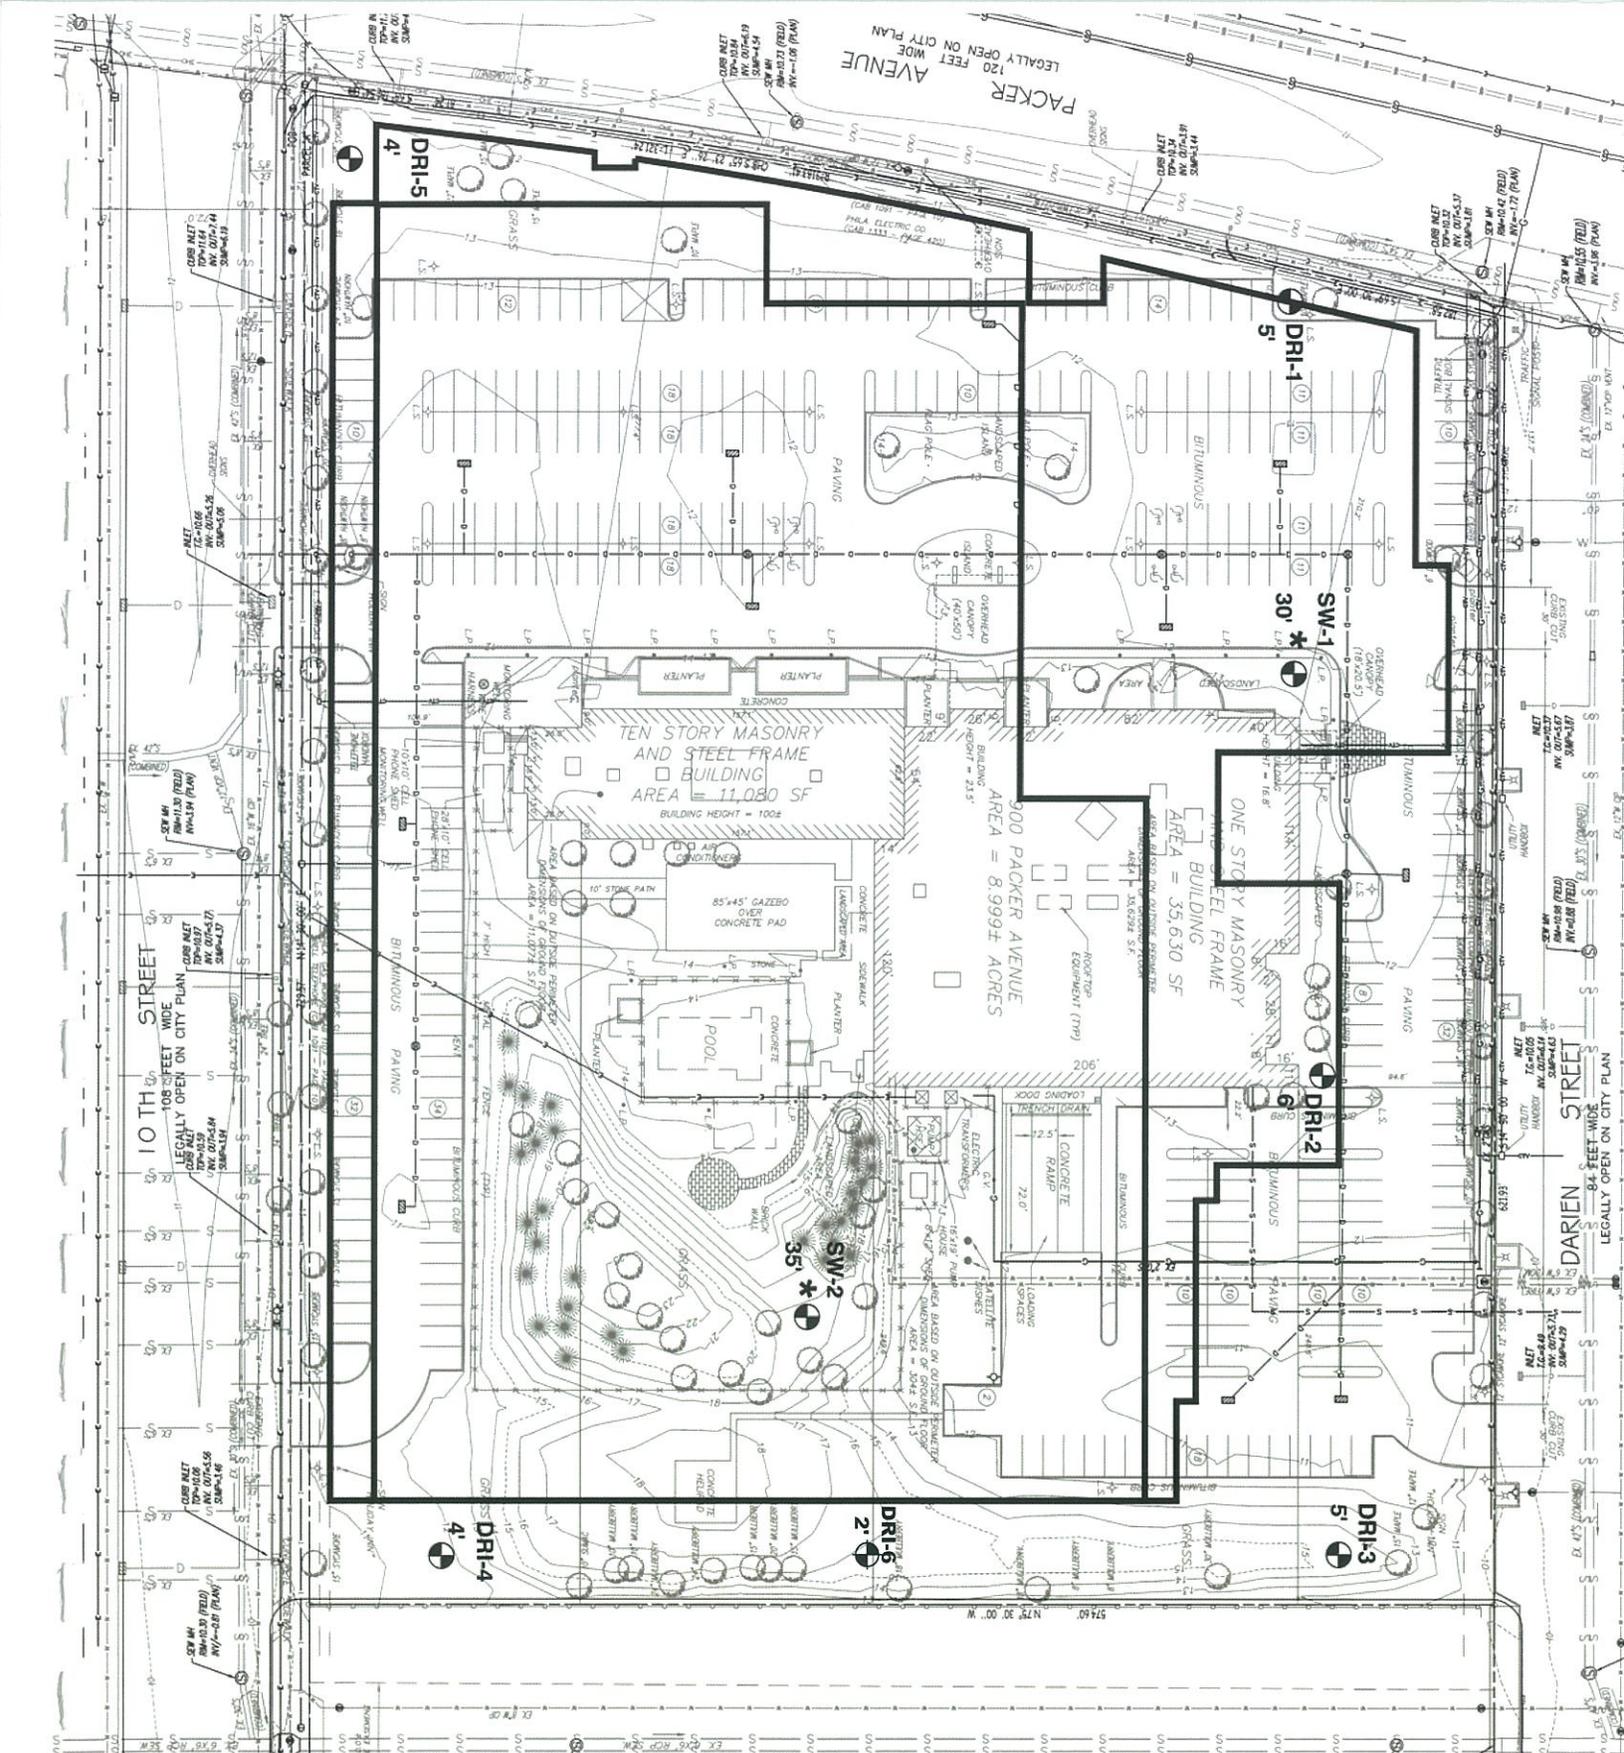
- SW-1 (DEPTH) STORMWATER (DEPTH) NO
- DRI-1 (DEPTH) DOUBLE-RIG INFILTRATION (TEST DEPT)

Refer to the Boring and Test Pit Location Diagram in the Appendix for a depiction of the boring locations. Refer to the Soil Conditions section of this report for a discussion of the subsurface conditions encountered.

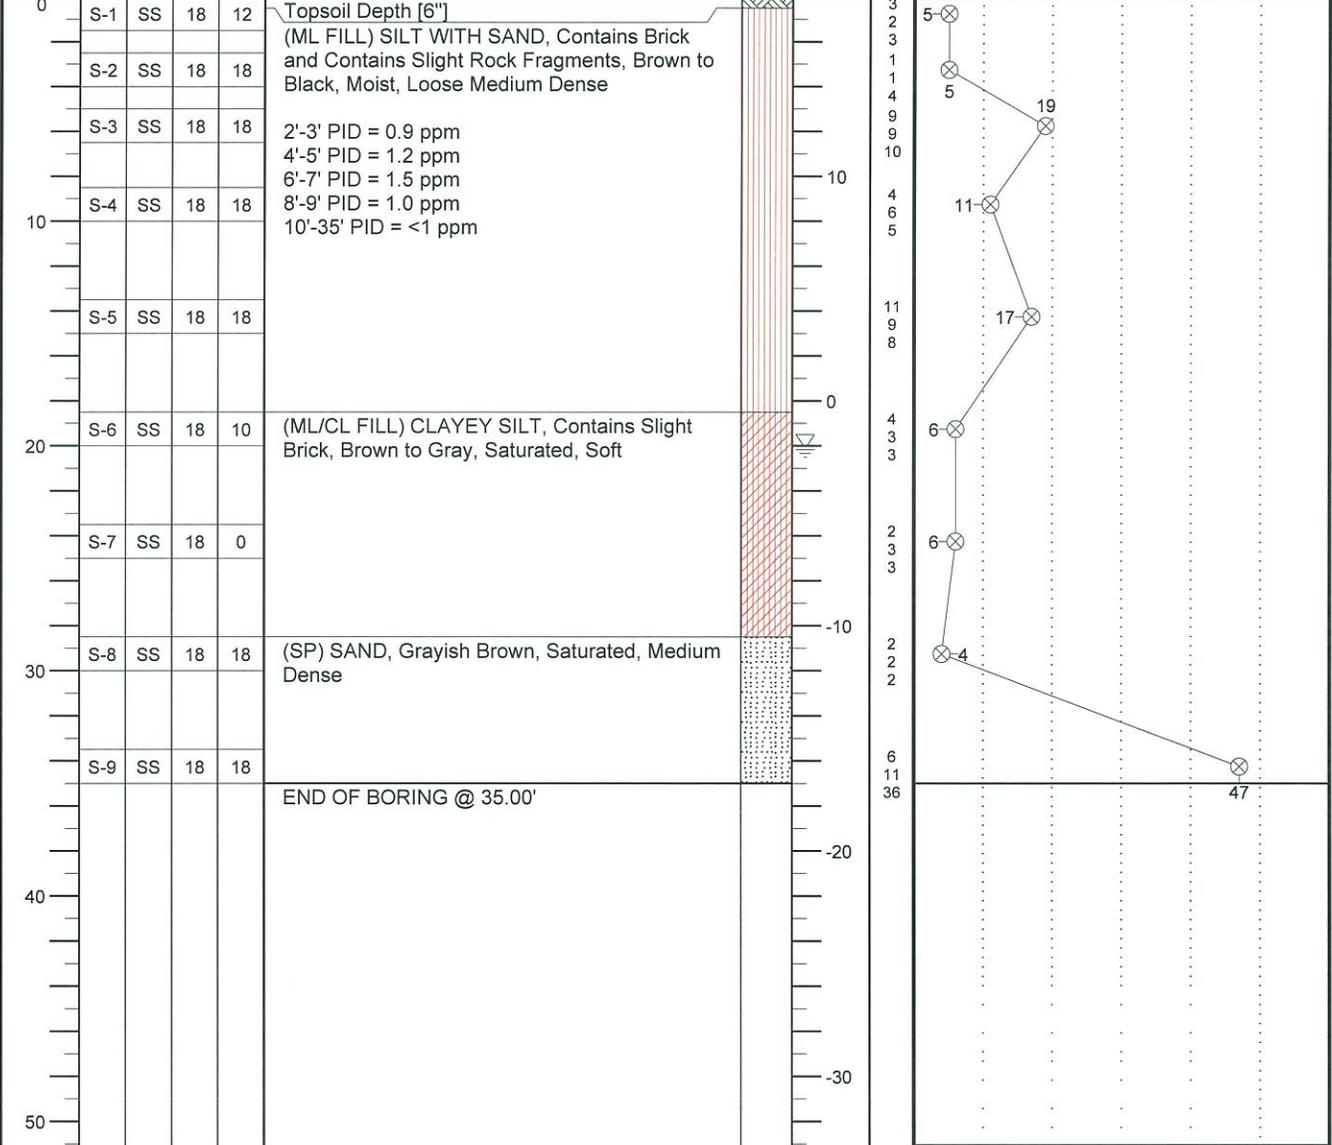
THE STRATIFICATION LINES REPRESENT THE APPROXIMATE BOUNDARY LINES BETWEEN SOIL TYPES. IN-SITU THE TRANSITION MAY BE GRADUAL.

WL 20.0	WS <input type="checkbox"/>	WD <input type="checkbox"/>	BORING STARTED	03/24/15	
WL(BCR)	WL(ACR)		BORING COMPLETED	03/24/15	CAVE IN DEPTH
WL			RIG ATV	FOREMAN	DRILLING METHOD HSA

The test borings encountered similar FILL material, as noted in the test pits, to depths of up to 28 feet with brown SAND being present to the terminated depth. The localized ground water table was encountered at a depth of 13 feet in boring SW-1 and 20 feet in SW-2, which correspond to approximately EL -2. The test borings had variable Standard Penetration Test blow counts, varying between 1 blow/ft and 50 blows per 11 inches. The borings were terminated at a depth of 35 feet. It should be noted that due to the relative proximity of this site to the Delaware River, it is anticipated that the groundwater level will generally correspond to approximately sea level, (EL 0.0), which is generally 10-12 feet below the majority of the existing site grades, with the exception of the elevated area to the south of the existing hotel.
