Exhibit E

Articles on Cinder Concrete

Cinder Concrete Slab Construction

REPAIR OF DRAPED MESH CONCRETE SLABS

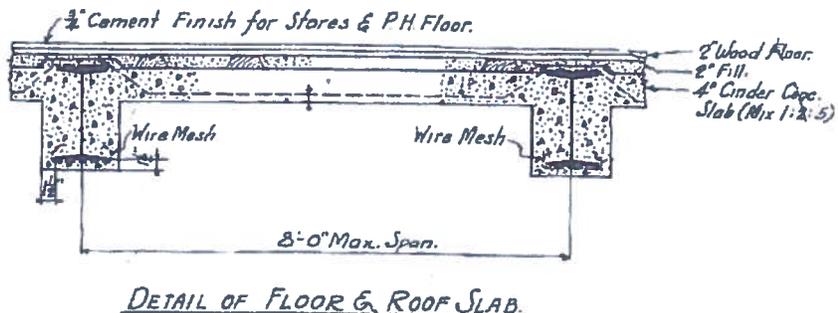
Figure 2.

pitch was required for drainage, the fill could be 6 inches to a 1 foot or more (Figure 2).

A typical slab was 4 inches to 5 inches thick, although 3 1/2 inches thick can be found in many old buildings. Usually the top of the slab is at the beam elevation or just above it. The beams and slabs were then topped with a layer of loose cinder fill, which provided fireproofing to the top flanges. Within this fill layer were beveled wood sleepers, usually 16 inches on center. A hardwood floor could then be nailed to the sleepers. This fill layer was typically 2 inches to 2 1/2 inches thick. At flat roofs, where

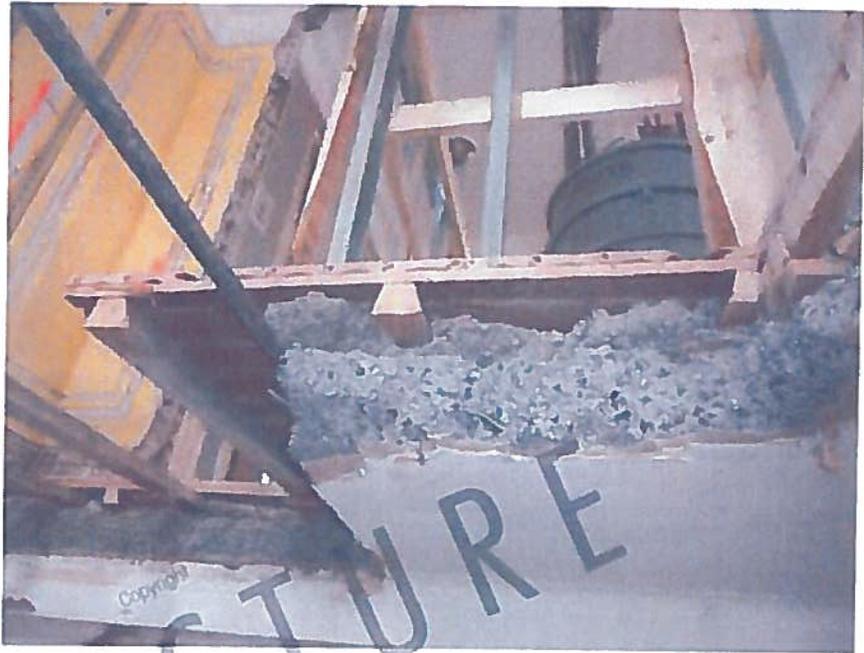
Figure 4.

The usual issues have to do with either planned renovations, where loading changes and opening or closing of stair, mechanical or elevator shafts occur (Figure 4), or repairs due to rusting and corrosion.

Reframing openings can be tricky, since loss of anchorage or continuity of the mesh could theoretically relax the mesh. Many engineers often require contractors to tack weld any exposed mesh to the steel beams, especially adjacent to newly cut slabs.

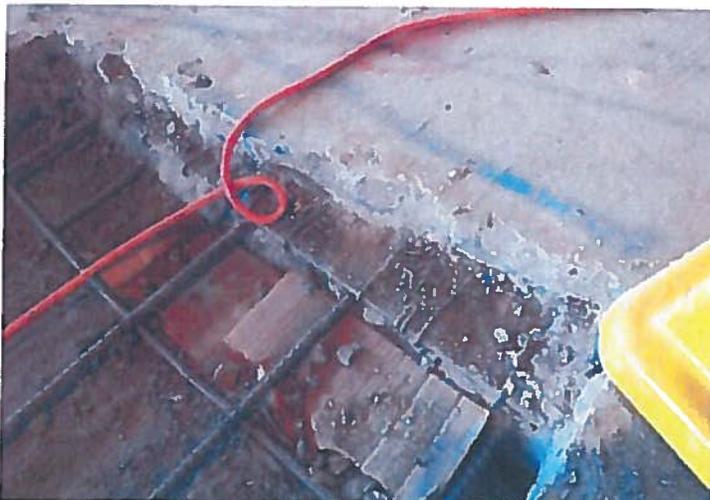
Fig. 1: Typical method of mesh anchorage where welded wire reinforcement is bent and hooked around beam flange

Draped mesh slabs differ from modern reinforced concrete slabs because the steel welded wire reinforcement acts in one-way catenary action rather than in flexural action. At the high point in the slab, the welded wire reinforcement rests atop the steel beams (which are upset into the slab), then

drapes down to a low point near the bottom of the slab at midspan. The welded wire reinforcement is placed continuously across several spans, often across the entire floor plate, and acts only in tension (behaving primarily like the main cables of a suspension bridge). To achieve the necessary structural capacity, the welded wire reinforcement needs to be continuous across all beams and anchored at the end spans (Fig. 1 and 2). As a result, any damage, deterioration, or intentional modifications to the slab must consider a means to maintain the continuity of the welded wire reinforcement, or provide alternative anchorage and/or supplemental supports. The concrete encases and bonds to the welded wire reinforcement and acts as a controlled-strength fill to transmit loads to the reinforcement. Because the concrete does not need to act fully as a structural material, its required strength is typically very low. Therefore, due to the availability of cinders to use as aggregate, cinder-concrete became the most common material used in these floor systems.

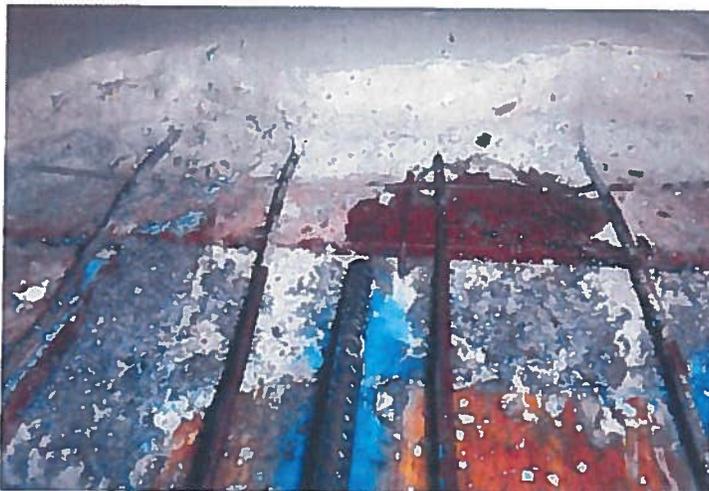
Fig. 2: Perimeter of repair where existing reinforcement extends uninterrupted through repair area

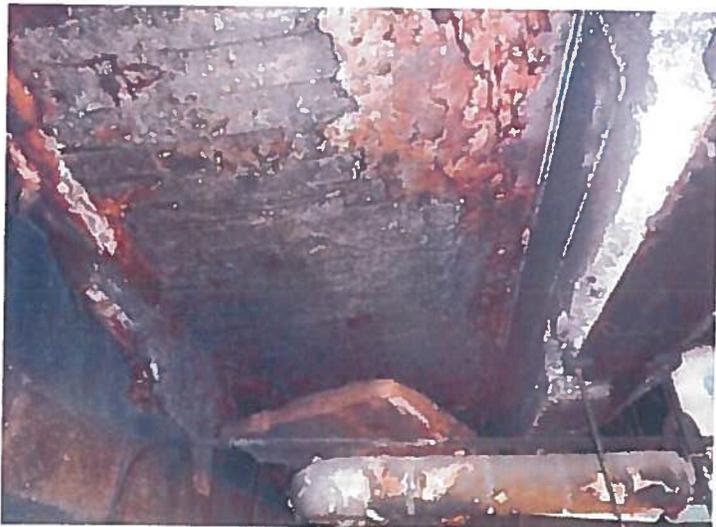
Fig. 3: Deterioration of slab due to corroded reinforcement at slab underside

Draped mesh cinder-concrete slabs have been repaired or strengthened due to deterioration (corrosion of the reinforcement and deterioration of the concrete resulting from exposure to water/moisture over time) (Fig. 3 and 4); due to damage (physical

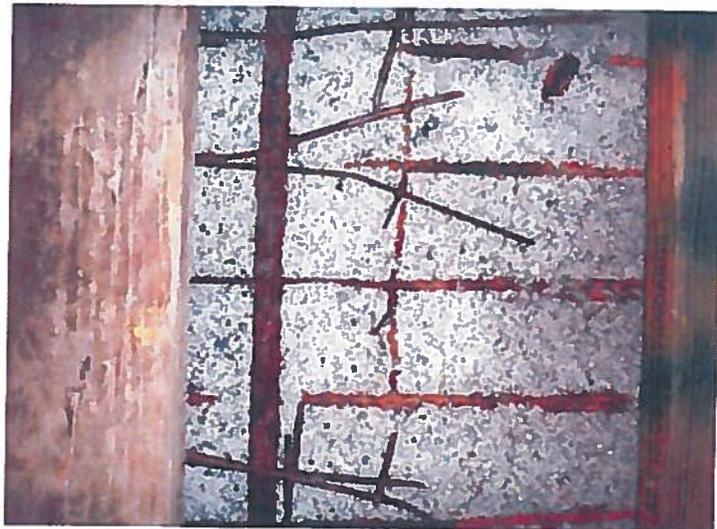
Fig. 4: Close-up view of corroded reinforcement at slab underside

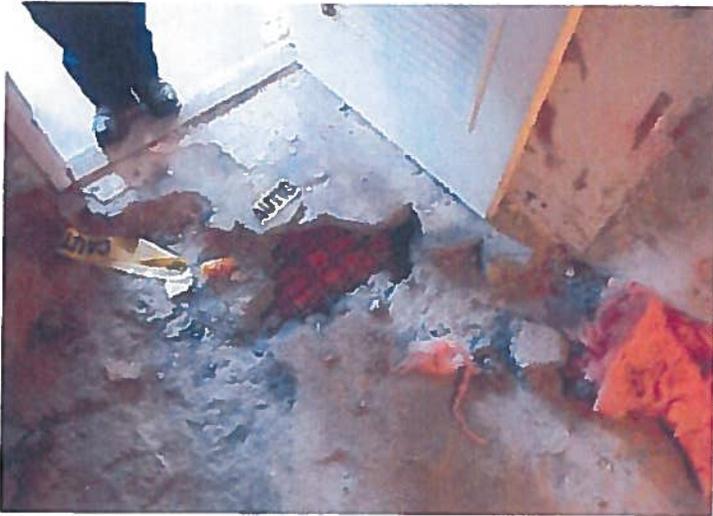
Fig. 5: Partial-depth and full-depth slab damage from finish removal during a tenant fit-out

damage revealed during tenant fit-outs) (Fig. 5 through 7); and for change of use (alterations due to change in occupancy or change in loading). Several typical and often-encountered repair methodologies are discussed in the following sections.

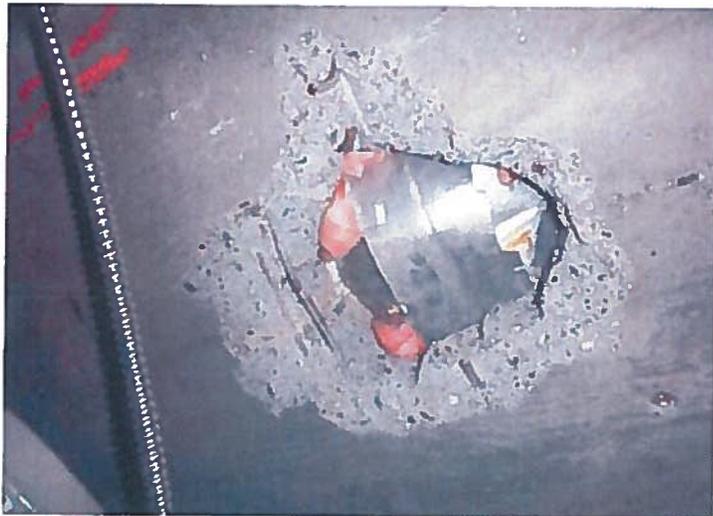
Fig. 6: Existing poorly executed repair made at a full-depth penetration

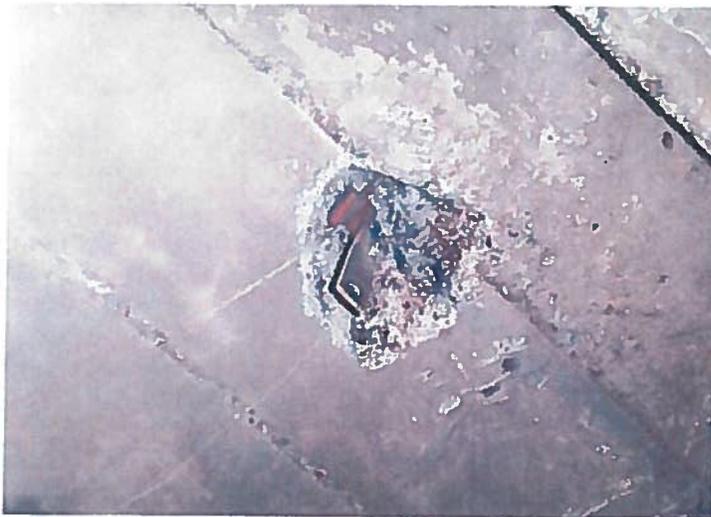
Fig. 7: Partial-depth slab damage where a wire of the reinforcement was exposed and used for supporting a hanger

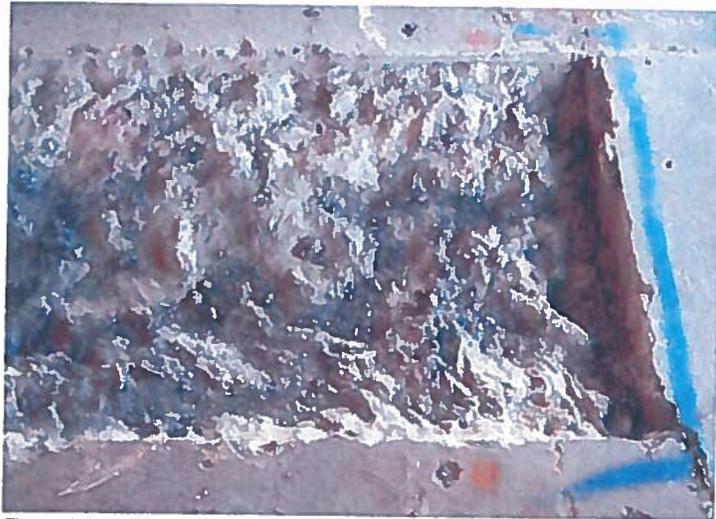
Fig. 8: Selectively demolished partial-depth repair area at top of slab

Partial-depth repairs typically start with carefully removing the compromised cinder concrete, using hand methods, to expose the welded wire reinforcement and prepare the substrate. Power tools are not recommended for this work because of the brittle and unpredictable nature of cinder concrete. Furthermore, care should be taken during selective demolition to avoid loosening the reinforcement from the underside of the cinder concrete, and to avoid disturbing the bearing of cinder concrete onto the reinforcement. In every case, exposed reinforcement should be cleaned, examined for section loss, and coated with a corrosion inhibitor. In smaller areas where an individual wire of the reinforcement is exposed locally, the most common approach is to repair the area with a suitable trowel-applied overhead repair material. At locations where the corrosion of the reinforcement is widespread but the remaining cross section is still sufficient and the bearing of the cinder concrete on the reinforcement is not compromised, a new layer of expanded metal lath can be mechanically anchored to the underside of the slab and a new layer of repair material (troweled, shot, or formed and pumped), for fire and corrosion protection, can be applied. At locations where the cross section of the reinforcement is

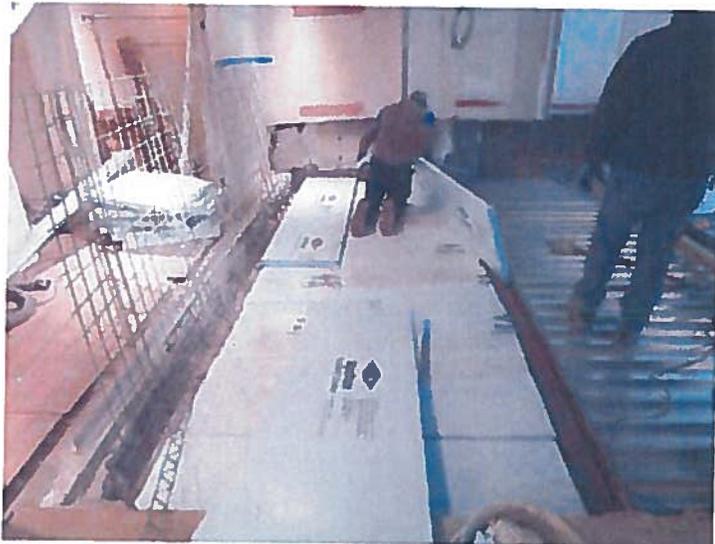
Fig. 9: Unbonded topping slab repair area (with foam filler) adjacent to full-depth repair area on composite metal deck

vided that it can support its self-weight unreinforced. Less-deteriorated slabs can typically remain in place. In most instances, existing finishes, previous toppings, and cinder fill are removed for an unbonded topping slab. If the thickness of cinder fill is greater than the thickness of the topping slab, layers of rigid polystyrene can be installed to act as lightweight filler and to achieve the desirable finished-floor elevation (Fig. 9).

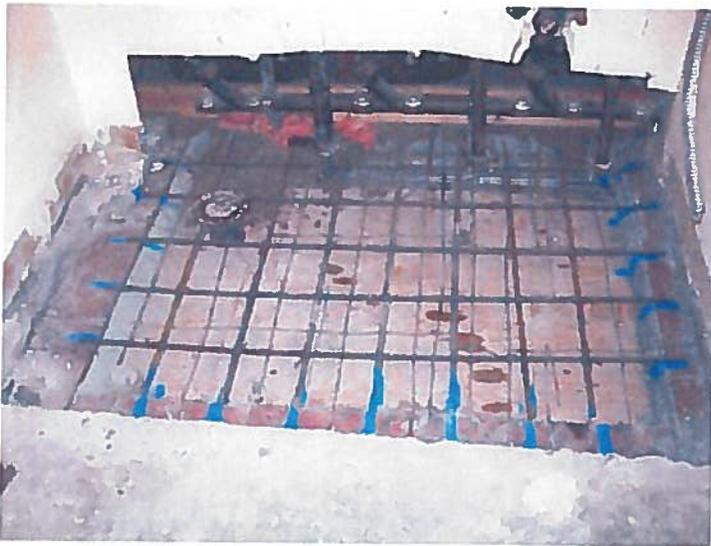
Fig. 10: Full-depth repair area with existing reinforcement and new additional reinforcement placed on wood formwork

Full-depth repairs are required when the existing slab is severely deteriorated and can no longer support the required loading. To maintain the catenary action, the existing draped mesh must either be continuous, without modification throughout the repair span, or be anchored to the steel beams at the adjacent spans (Fig. 10). Usually, the welded wire reinforcement in the repair span is highly corroded, and continuity through the repair span is not possible. Thus, welding of the wire reinforcement to the steel beams at the edge of the repair span may be the only option, and new reinforcing is required for the design of the full-depth repair.

bays, placed as a precaution until the wire reinforcement can be properly anchored. Additional shoring, placed in the bays designated for replacement, is used as a work platform for demolition and to assist with formwork installation. Demolition proceeds with a saw cut at the repair perimeter, typically located over the centerlines of beams and girders. The depth of saw cut should not cut or damage the welded wire reinforcement and/or beam flange. Initially, demolition with small electric rotary or pneumatic hammers can remove the bulk of the cinder concrete at the center of the slab. Finally, selective demolition with hand tools is performed to remove the remaining cinder concrete within about one foot of the saw-cut perimeter. The extent of demolition and condition of the remaining cinder concrete, beams, and reinforcement are reviewed, and further action taken if necessary, prior to proceeding with installation of the new slab reinforcement. Once the new reinforcement is installed, ready mixed concrete or prepackaged repair material (typically extended with aggregate) is placed.

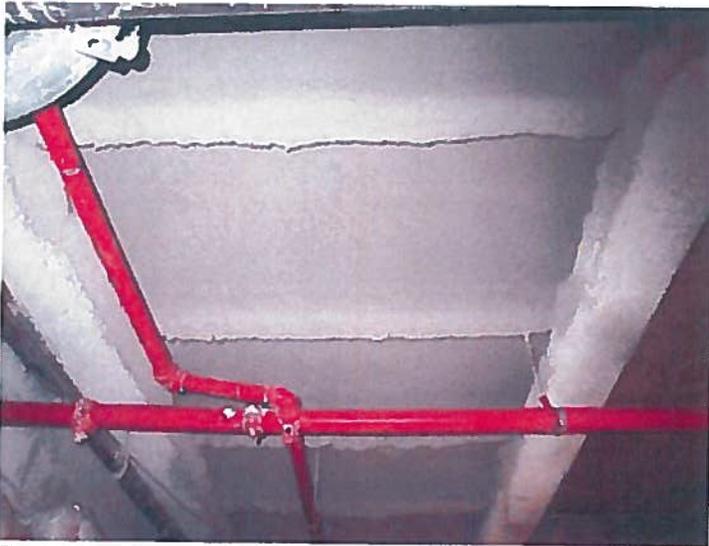
Fig. 11: Closely spaced channels of supplemental support repair (shown after spray-on fireproofing was applied)

At locations where a full-depth repair is performed but the reinforcement in an adjacent span cannot be properly anchored, it may be necessary to support the adjacent spans by providing supplemental supports (Fig. 11). In situations where the reinforcement's ability to carry load in tension through catenary action is interrupted due to lack of anchorage, closely spaced steel channels can be installed at the underside of the slab, parallel to its span, and connected to the existing steel beams. These new channels are sized and spaced to carry the self-weight of the slab and any superimposed loads. The slab can then be analyzed to span as plain concrete perpendicular to the new channels (parallel to the beams) using conservative material strength assumptions. In some cases, steel plates can be installed directly below that slab to act as a deck between the new channels. After the new steel is installed, the space between the underside of the slab and the top of the new steel is pumped or dry-packed with a nonshrink grout.
