Re: 81-95 Fairmount Avenue (the "Property")

Introduction

**George E. Thomas, Ph.D.
CivicVisions LP**

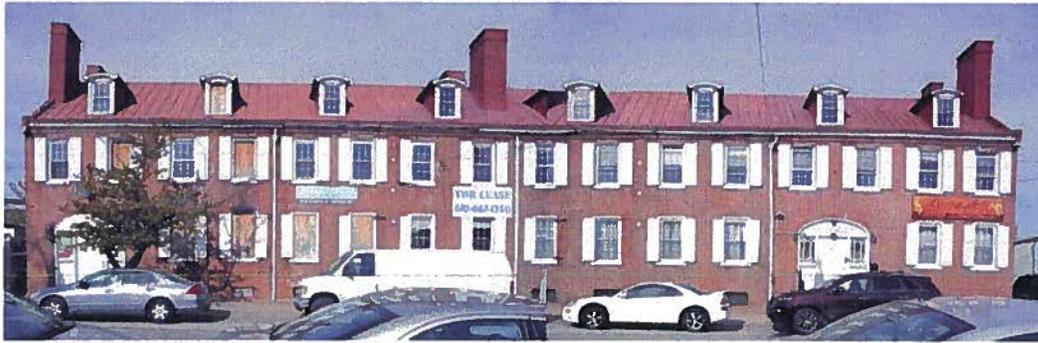
Existing Fairmount Elevation

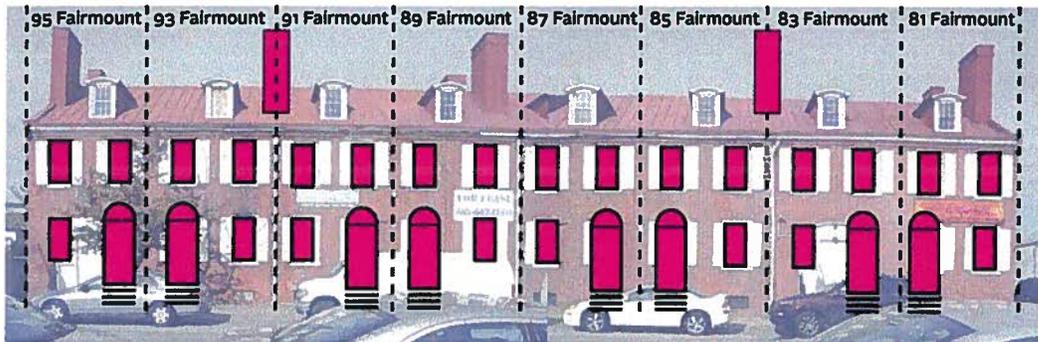
Original Fairmount Elevation: 8 rowhouses each with entrance door; party walls, three shared chimneys and 2 end chimneys

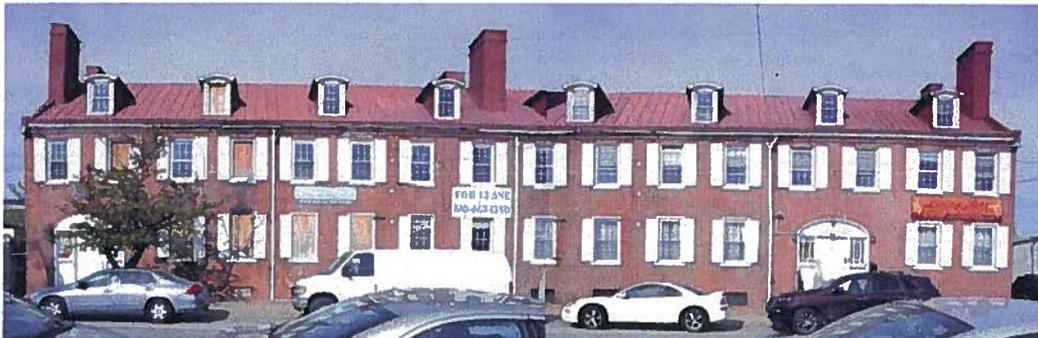
Existing Fairmount Elevation

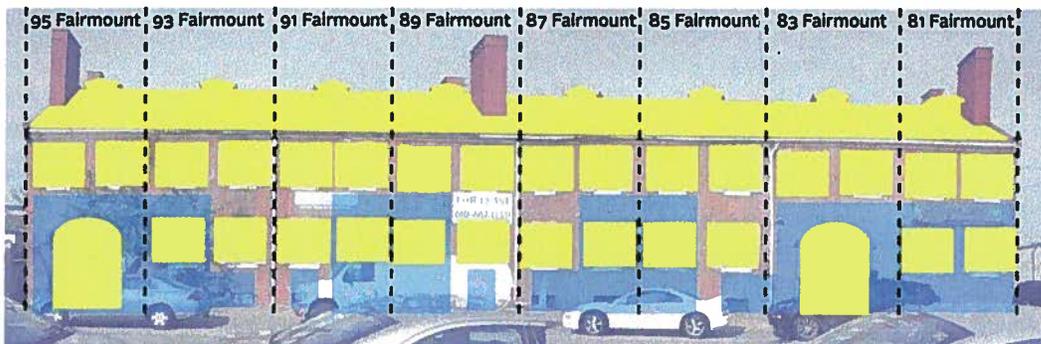
Original Fairmount Elevation non-historic materials: window units, shutters, roof, dormers (shown in yellow); new brick (shown in blue).

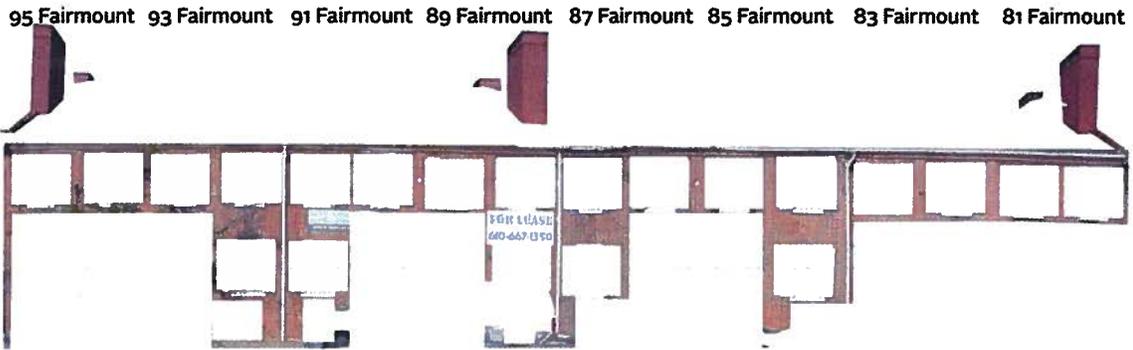
Original Fairmount Elevation remaining historic materials

The present state of the building shows original materials on less than a third of the Fairmount Avenue façade; the end elevations are similarly altered with concrete parging on one façade and windows relocated and replaced.

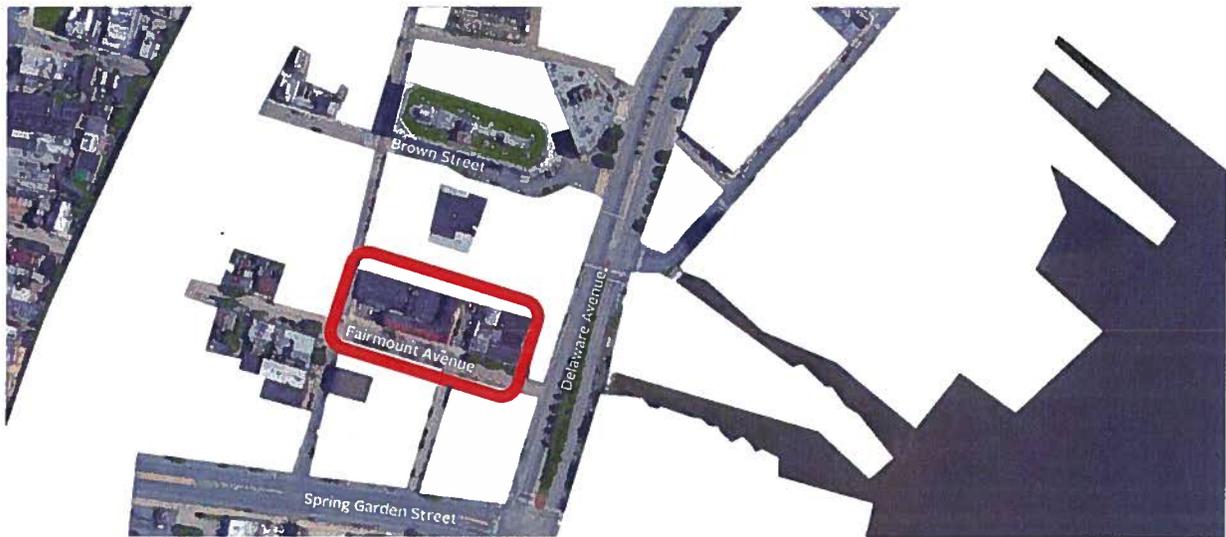
2016: The nearly total demolition of the neighborhood around 81-95 Fairmount Avenue: the site outlined in red.

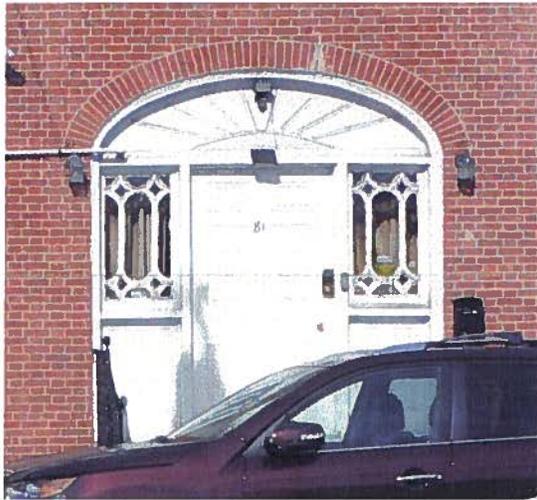
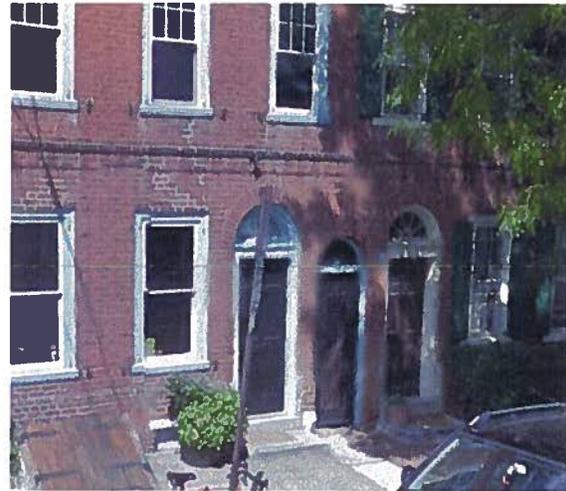
The only elements of the alterations that might be considered "Colonial Revival" are the two new doorways, only one of which survives in its 1920s form. This doorway is an irregular, vernacular hodgepodge of architectural elements, not a serious Colonial Revival restoration or historically appropriate embellishment of the building's original Federal style. The doorway includes an oversized Colonial or Georgian eight-panel door, an oversized Colonial fanlight with basket handle arch, Victorian or Gothic Revival side lights with flat mullions, oversized Colonial mansion style marble steps, and wrought iron handrails (likely salvaged from another site) in a Federal or possibly Georgian style. These elements were common in the late Victorian era when Colonial revival elements were up-sized for 1890s mansions. Their appearance here suggests that the builder / engineer simply selected elements from a local supply yard.

Left: Detail, doorway 83 Fairmount showing similarity to late Victorian Colonialesque doors of Germantown house; right: early 19th century federal doorways at 117-119 Fairmount Avenue of the sort removed in 1922 from the row at 81-95 Fairmount Avenue (Google Earth)

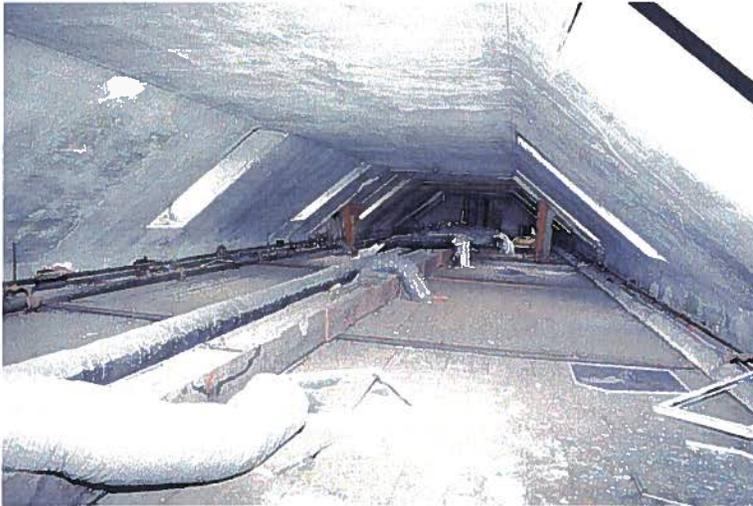
The Attic, looking east – total removal of party walls necessitated rebuilding of entire roof framing and dormers

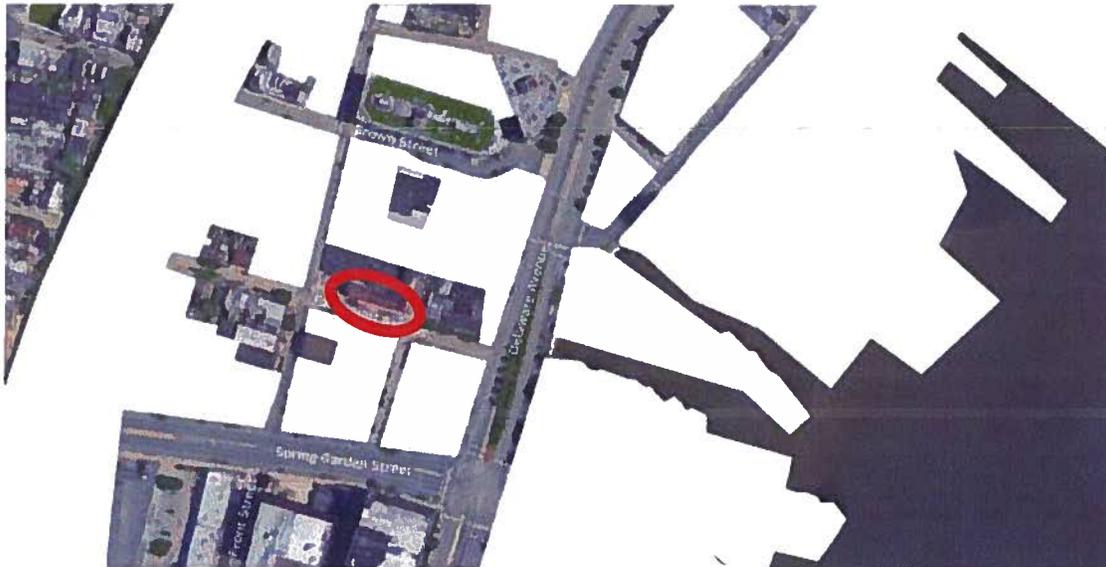
Redevelopment of the fabric around 81-95 Fairmount Avenue since 1959; Delaware Avenue on left. 81-95 Fairmount in red circle. Wharves closed and some adapted for parking and apartment houses.

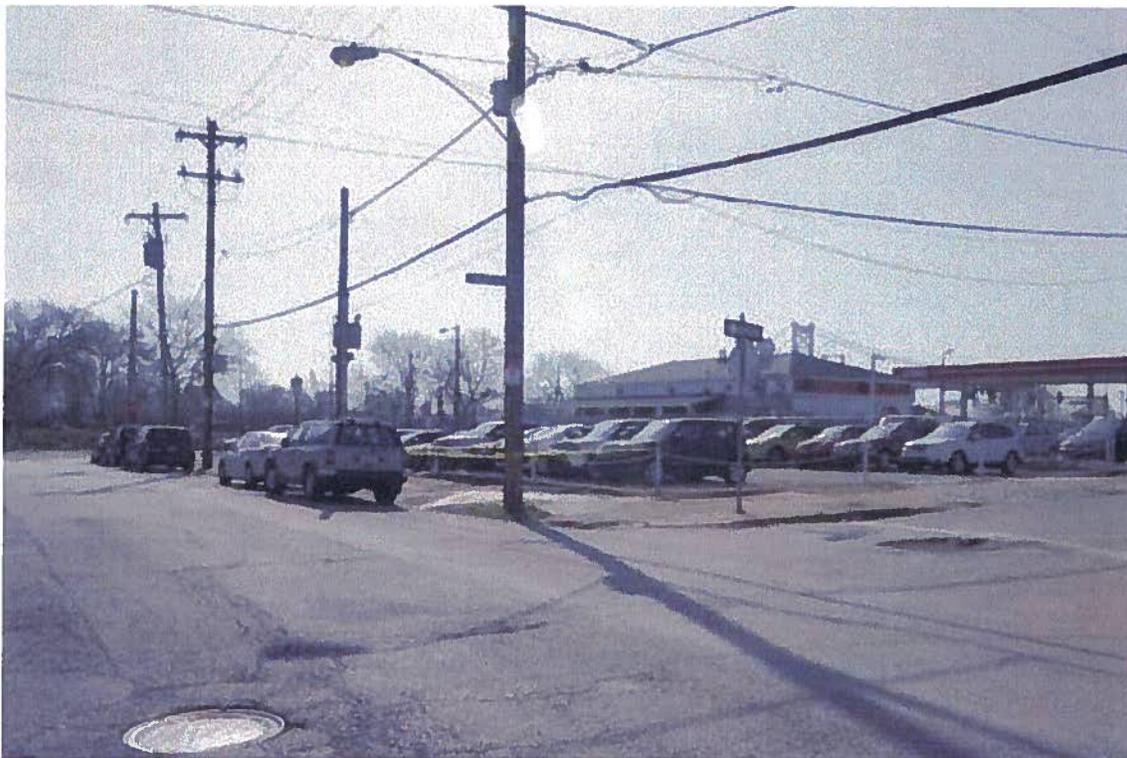
Setting: Looking from site toward river; parking lots and Lukoil.

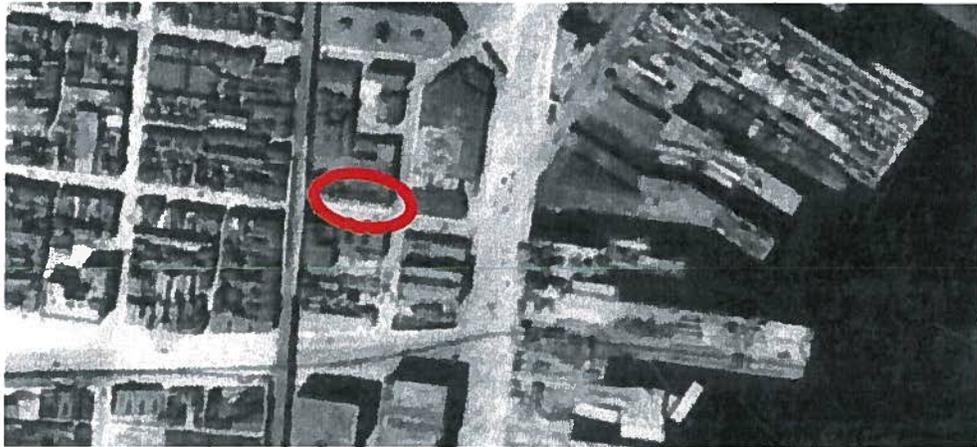
Dallin Aerial Survey, 1930 Elevated transit line to the west of the block; industrial buildings and small residences and workshops in a continuous fabric with easy access to the waterfront; 81-95 circled in red.

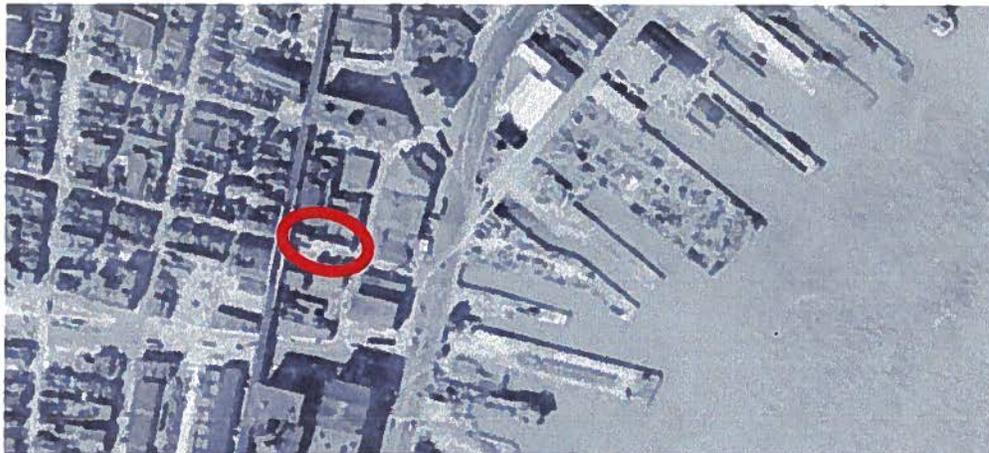
1959 Delaware Valley Regional Planning Commission Aerial Photograph, district largely unchanged from 1930; wharves emptying; some losses along Spring Garden Street; 81-95 circled in red.

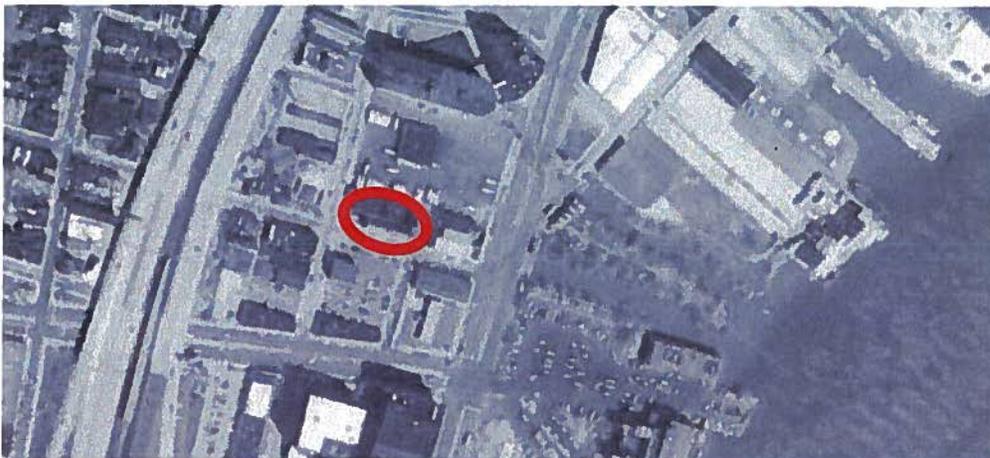
1995 Delaware Valley Regional Planning Commission aerial photo, demolition of most of the area east of I-95; large parking lots and open spaces; 81-95 circled in red.

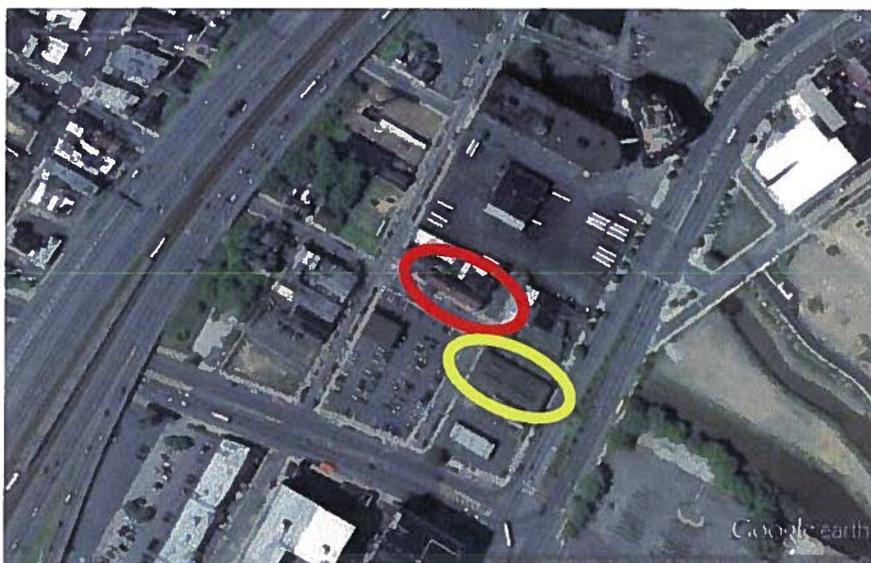
Google Earth View, 2015, Demolition continuing east of I-95. Surviving building for PTC garage since demolished in yellow circle; 81-95 circled in red.

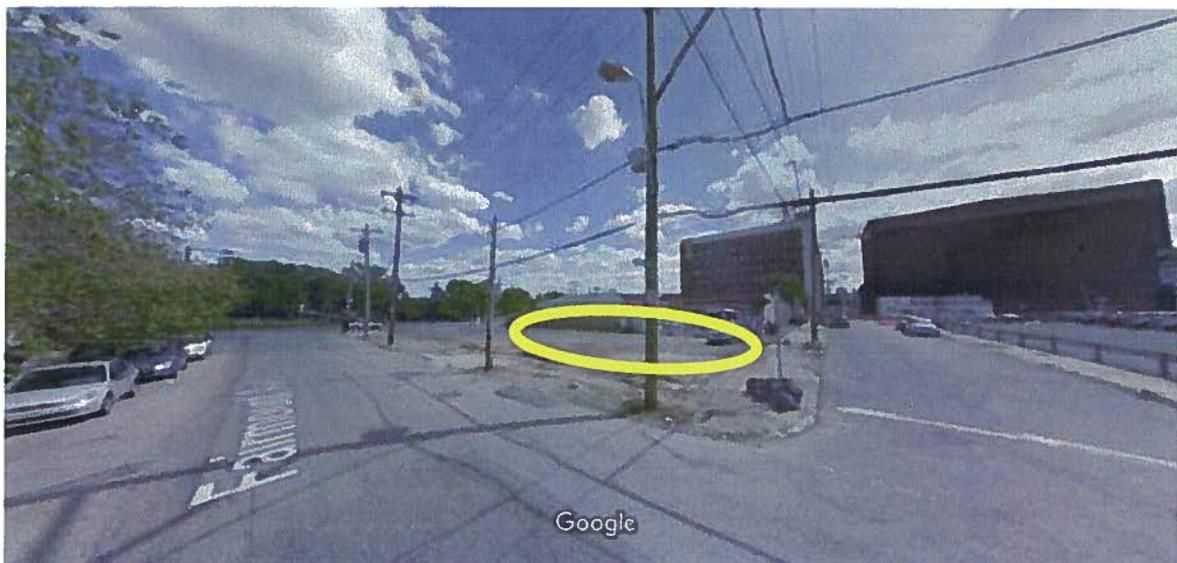
Google Streetview 2016 Demolition of PTC garage clearing entire site across Fairmount Avenue, east of Beach Street. Yellow oval area of recently demolished

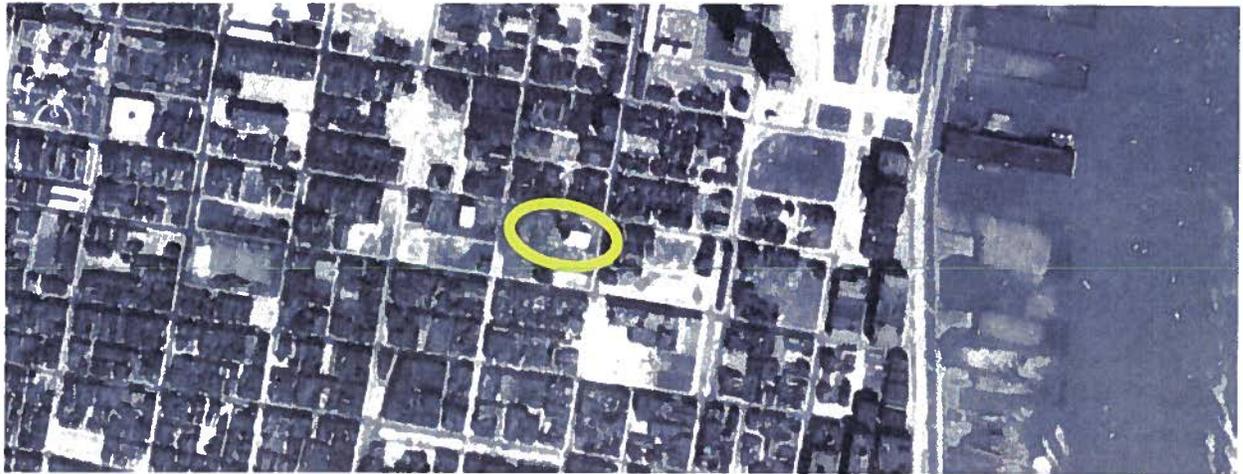
1965 Delaware Valley Regional Planning Commission, aerial view from Delaware River Front to Eighth Street and from Locust Street to Bainbridge Street; some urban demolition accomplished and large areas of intact urban fabric west of Third Street, south of Locust Street and south to Bainbridge Street.

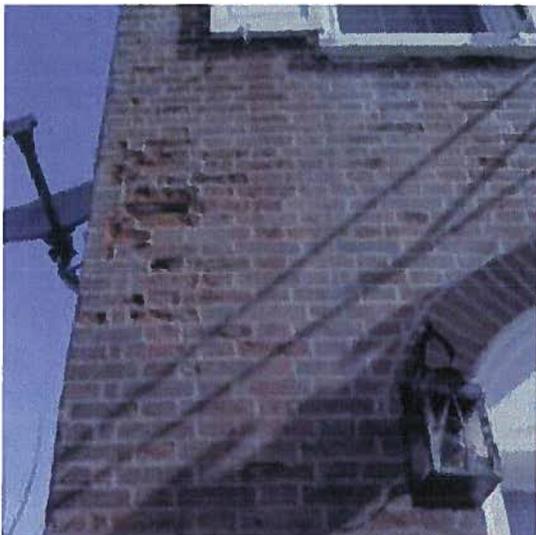
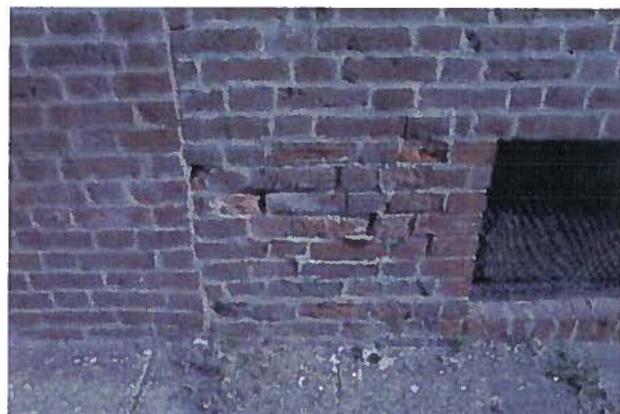
The description continues to be flawed with inaccurate descriptions of materials and no apparent understanding of the extent of deterioration. This is particularly noticeable in the extent of surface damage to the brick from the sandblasting and now extreme weathering that will necessitate additional masonry replacement. Sills of the windows, are not as described in the nomination of stone – but rather wood, now capped with metal that further damages the underlying material.

Sandblast damage to brick; west end, center, typical damage from sandblasting brick

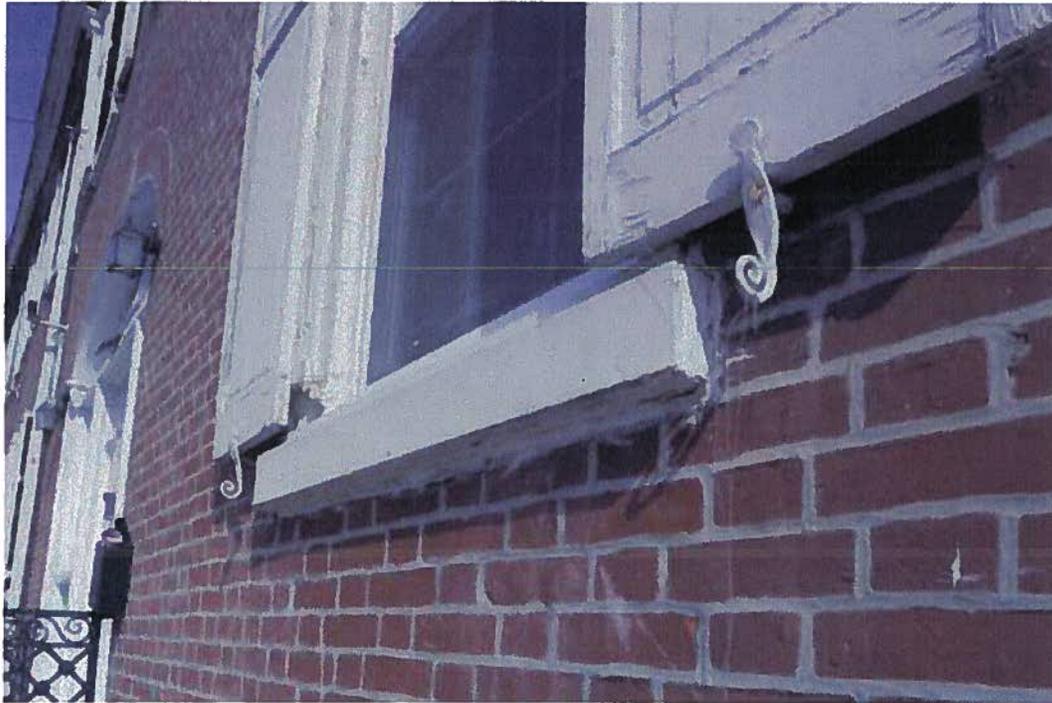
Modern brick, metal clad wood sills, modern shutters, east end of façade

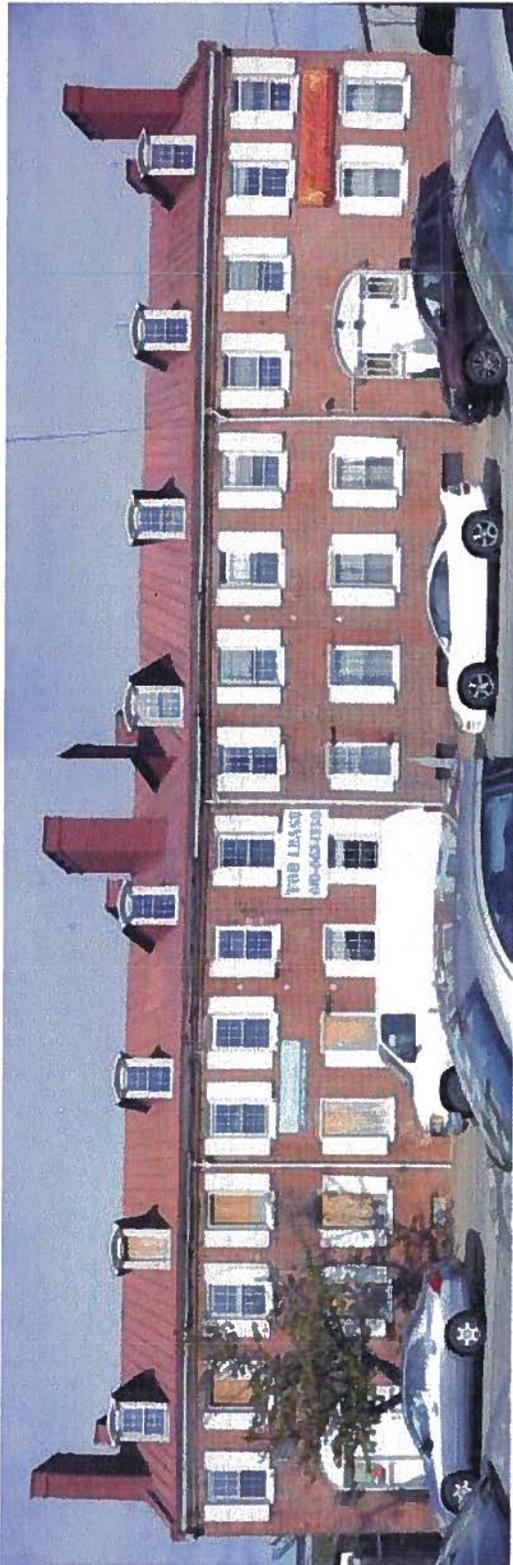
Existing Fairmount Elevation

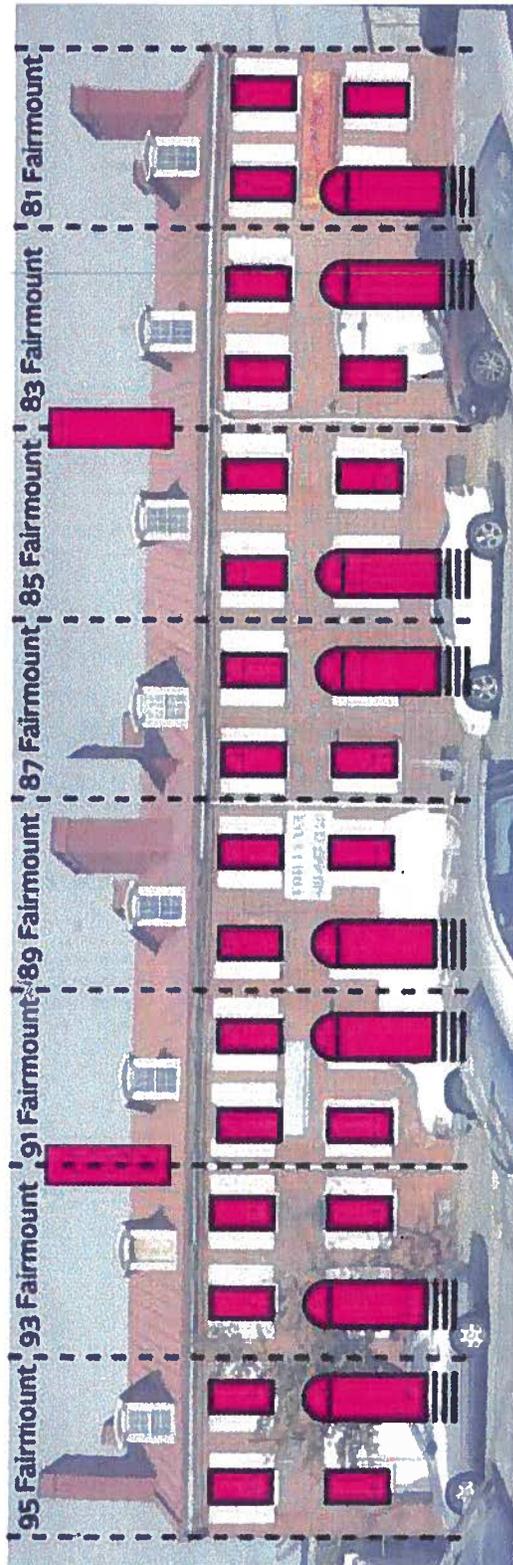
Original Fairmount Elevation: 8 rowhouses each with entrance door; party walls, three shared chimneys and 2 end chimneys

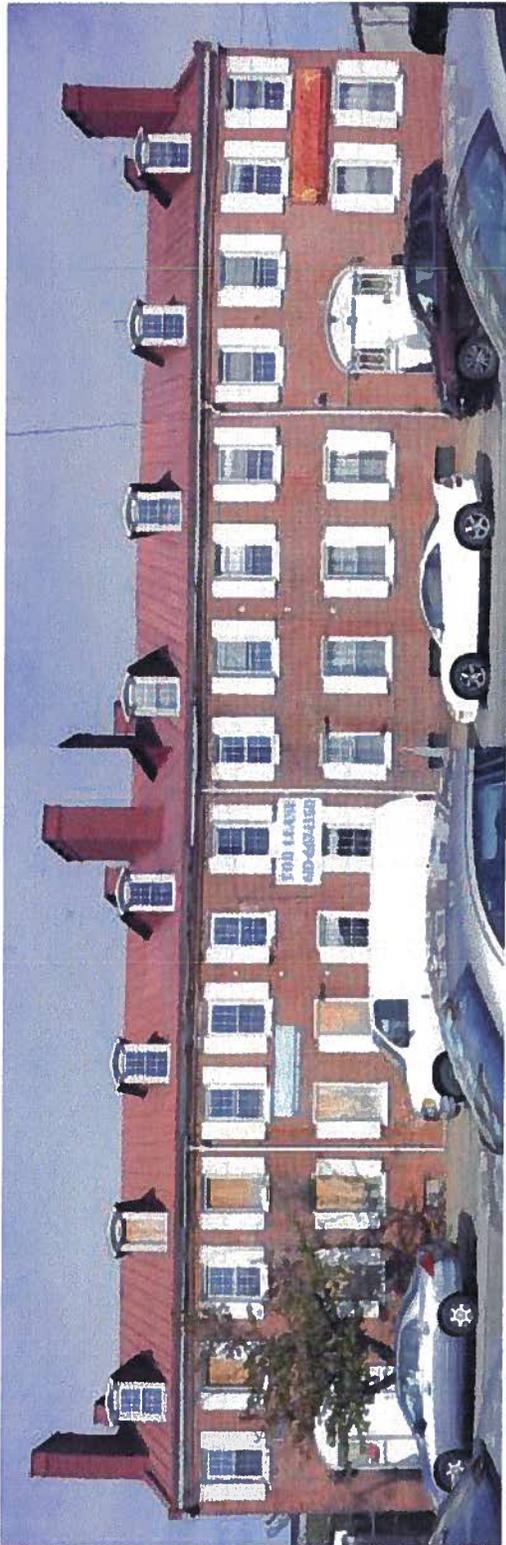
Existing Fairmount Elevation

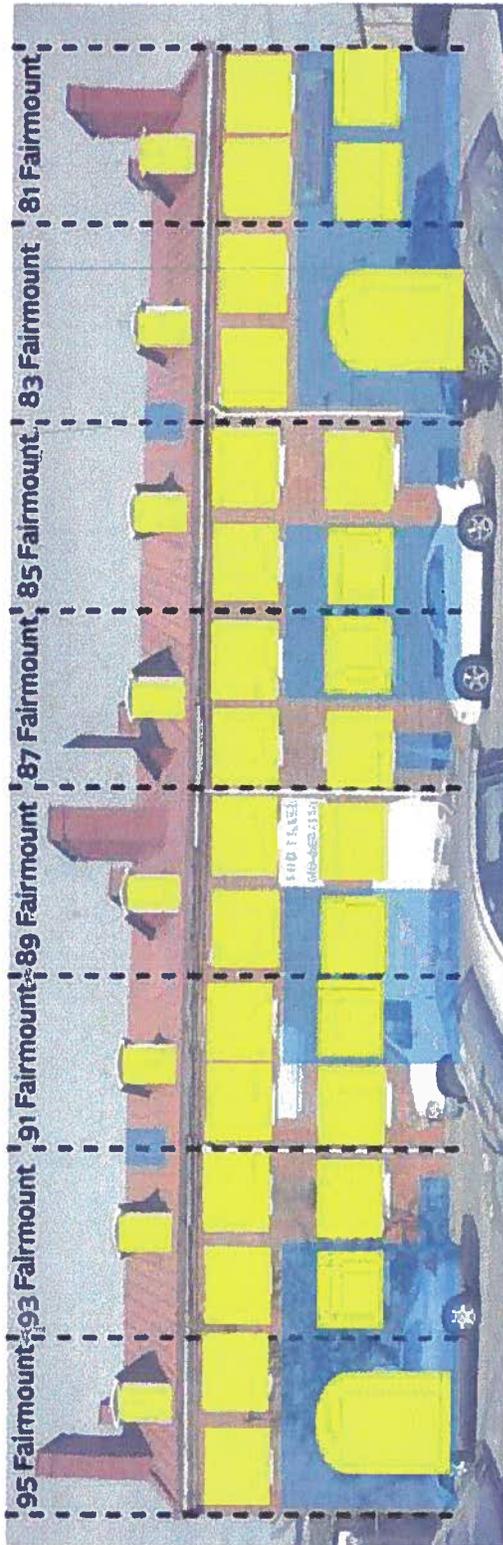
Original Fairmount Elevation non-historic materials: window units, shutters, dormers (shown in yellow); new brick (shown in blue)

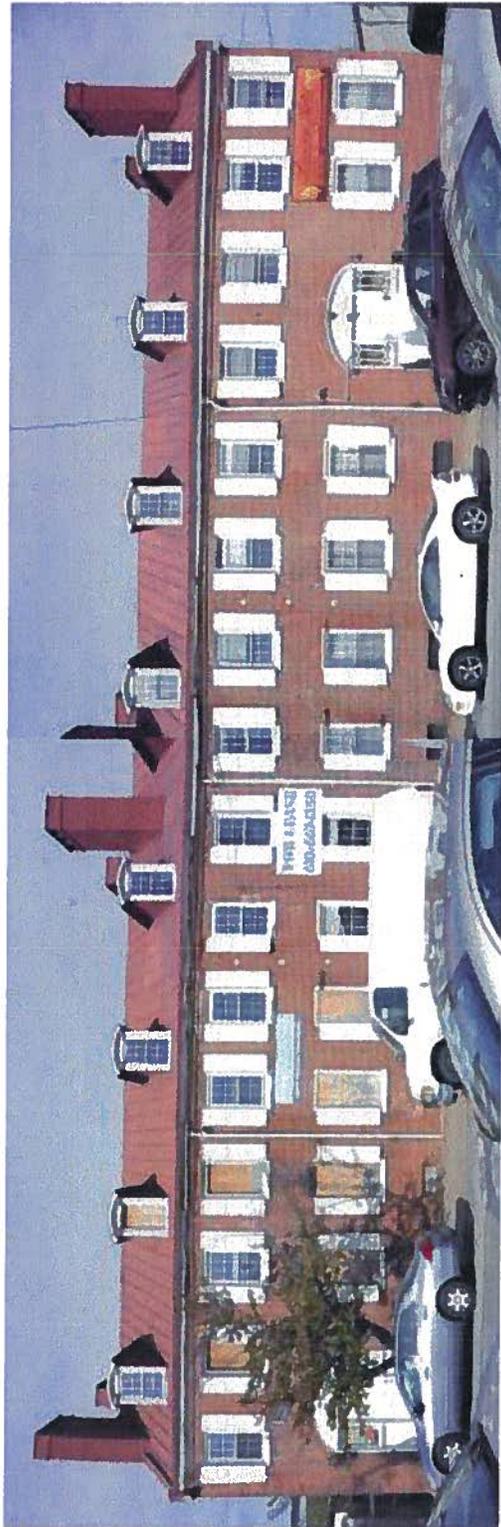
Existing Fairmount Elevation

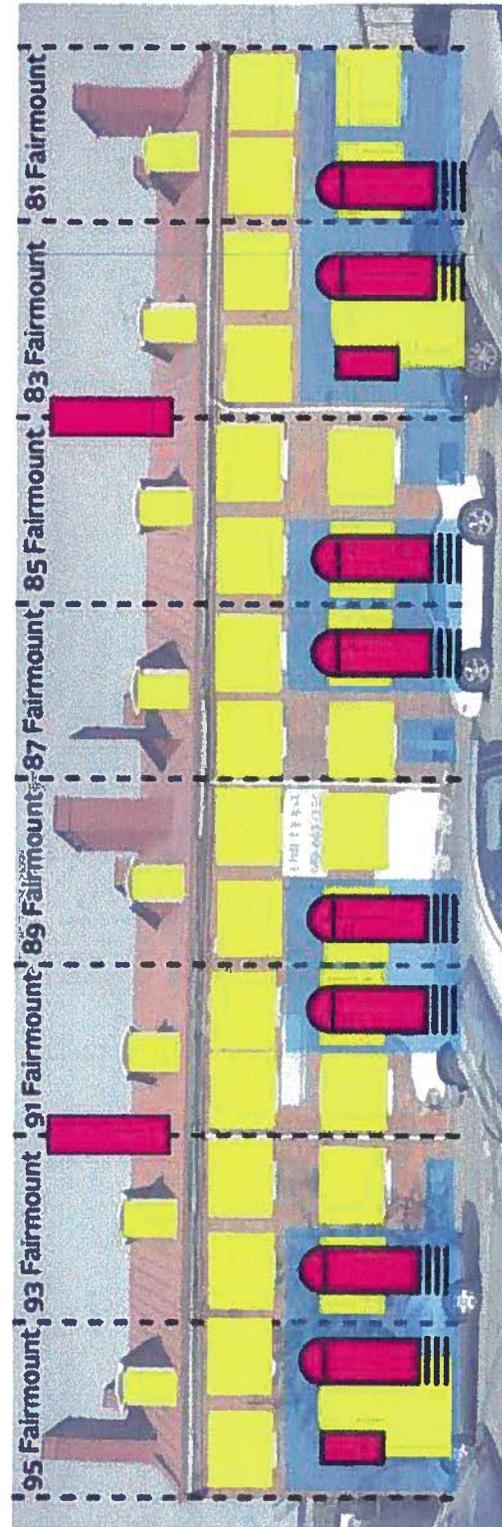
Original Fairmount Elevation non-historic materials: window units, shutters, dormers (shown in yellow); new brick (shown in blue); missing chimneys and changed openings (shown in magenta)

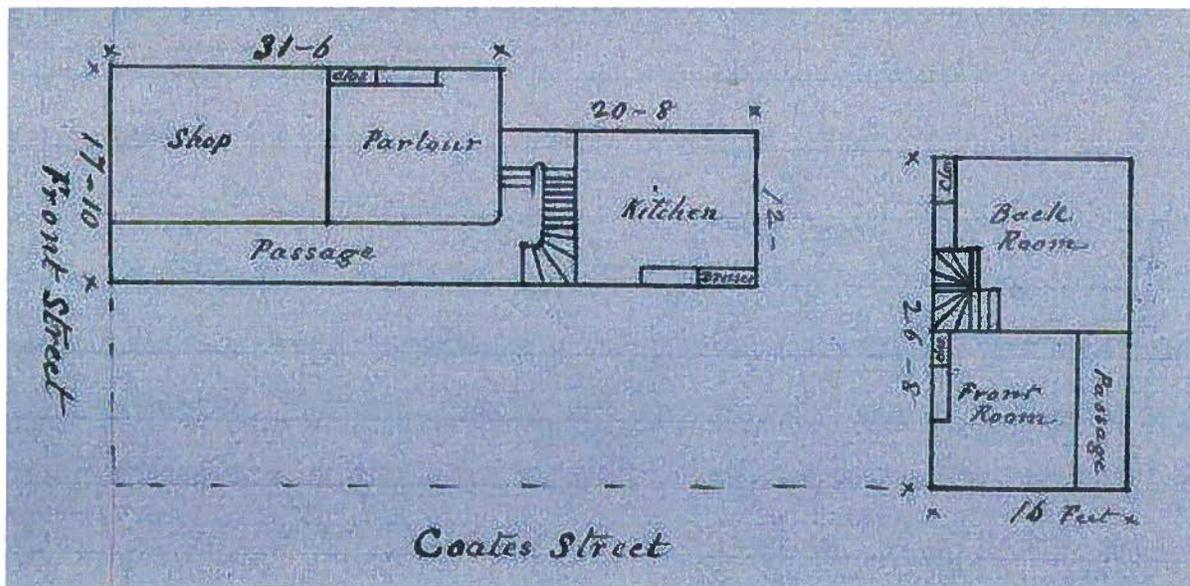
Insurance Survey showing plan of 91 Coates Street on right with passage against the party wall and fireplaces serving the front and rear rooms of the house on the west end.

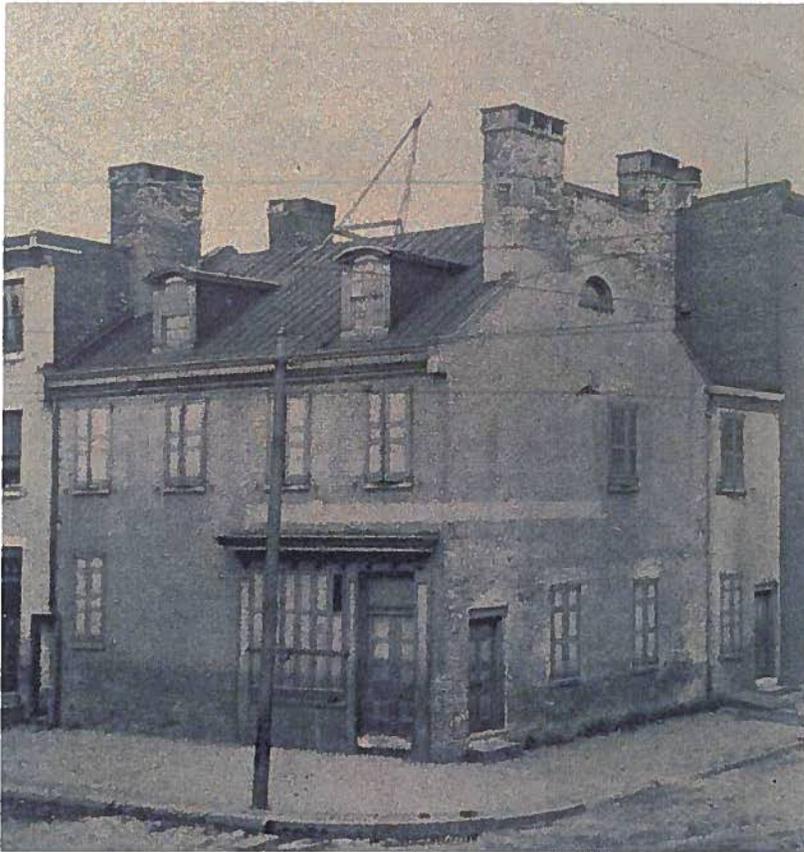
The late 19th century photograph included in the nomination clearly predates the 1920s alteration. This photo shows no large door in the first units at #81 and 83. Therefore it must

have been obvious that the present door was not original to the initial construction because the large present door is not in the 19th century view.

Late 19th century photograph of the corner house showing a commercial shop front on 81 Fairmount; an altered door on the east end wall of the same unit, and faint evidence of the bricking in of the door on the second unit, #83. It also shows banks of oversized chimneys that would have heated the buildings as well as original paneled shutters – all of which have been removed. There is no evidence of the present oversized door in 83 Fairmount Avenue. Also removed is the tiny rear alley door between #83 and #85. This was a common feature of the period and was likely removed from the row as well.

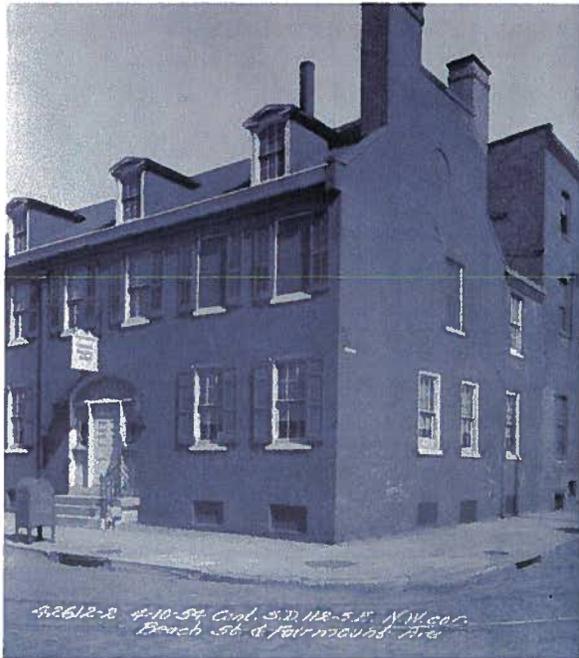
City of Philadelphia Archives, Photograph, April 10, 1954 showing the altered entrance at the east end of the row as well as different operable panel shutters on the upper stories from those on the late 19th century photograph above (p. 10).

- Another example of twentieth century industrial era workmanship replacing earlier craft-era workmanship are the louvered shutters that flanked the windows of the houses in this 1954 view.

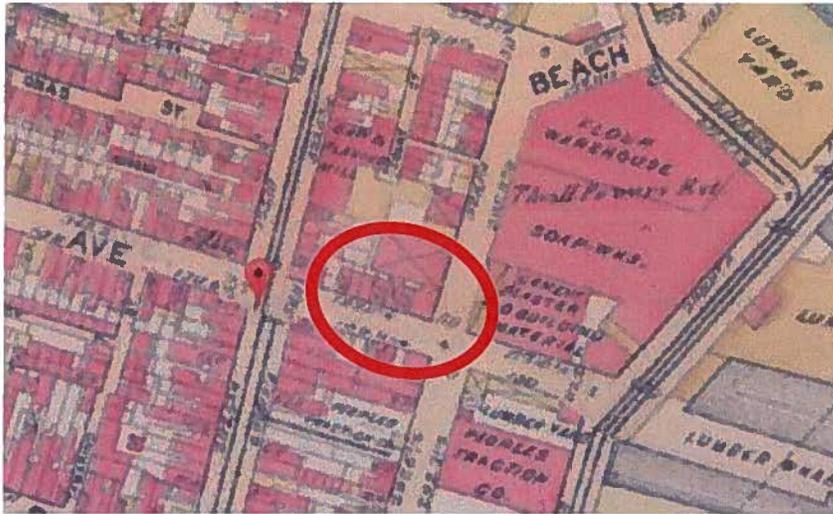
The 1895 Bromley Atlas of Philadelphia shows the transition of the immediate vicinity into workshops, many related to building construction, with wharves and transportation to the east and west.

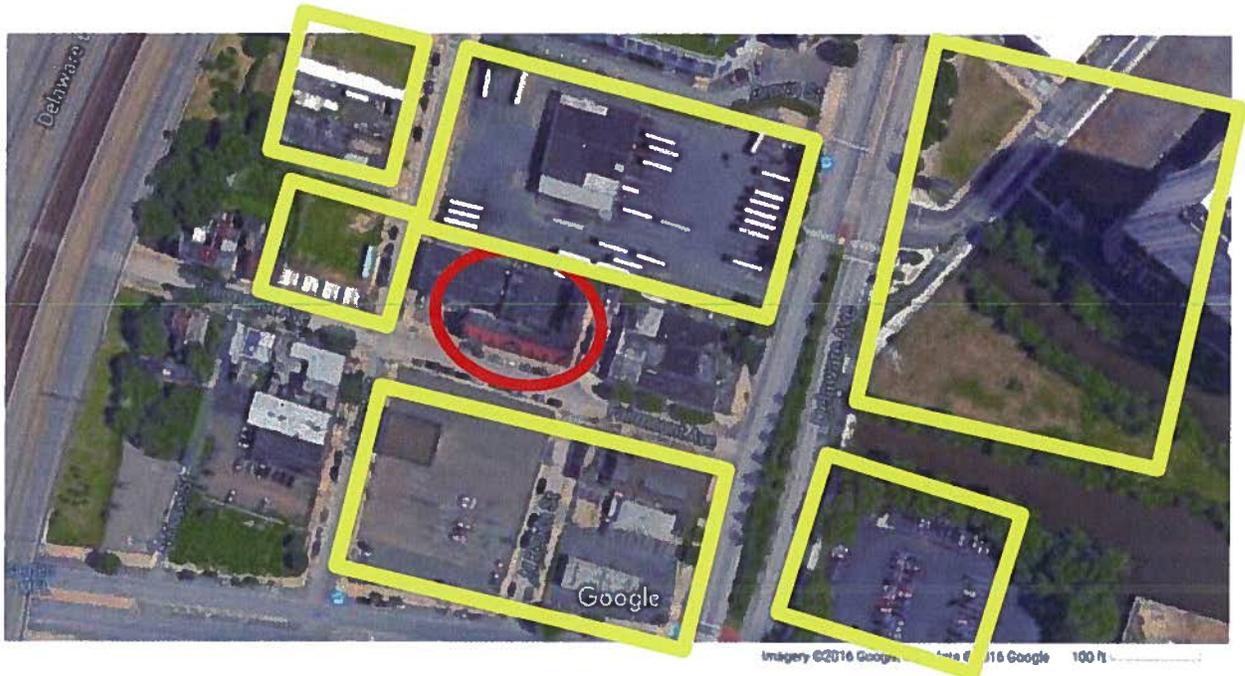
Present day conditions: Google Maps 2016, shows the area cut off from the Northern Liberties by the Delaware Expressway to the upper left; apartment houses along the Delaware replacing the warehouses to the right and most of the area now given over to surface parking with a few new row-houses being built to the west. Yellow outlines parking and other losses of context.

The visual evidence of both the historic planning maps and the current aerial photographs makes it clear that the site is now largely surrounded by parking that has resulted from the demolition of most of the buildings in the vicinity.

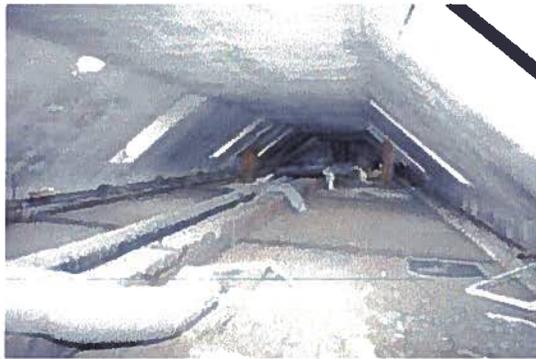
Attic: single interior space, party walls removed

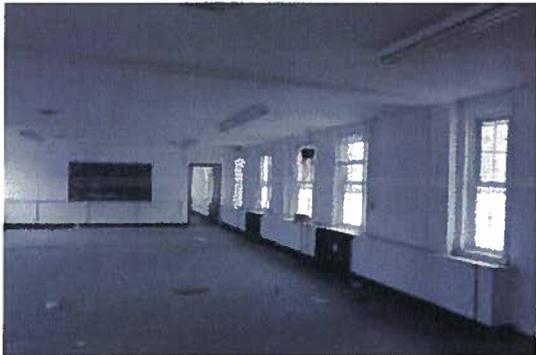
Second floor, single interior space, party walls removed

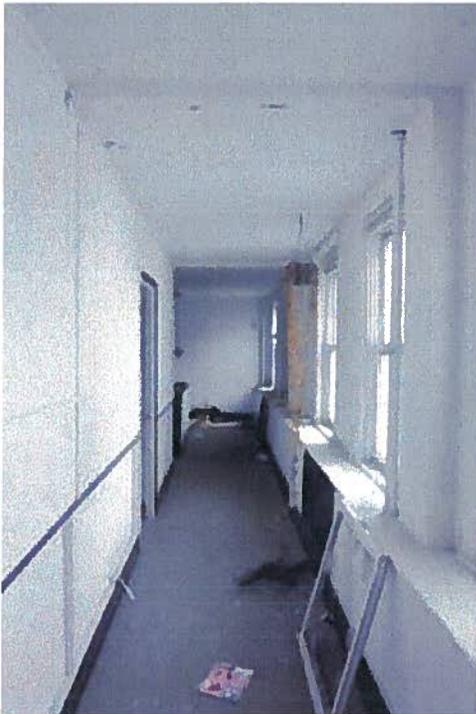
Second floor corridor, party walls removed
