Schuylkill River Wall Collapse

1 March 2012

East Park Canoe House
Marine Wall Assessment Report – November 17, 2011

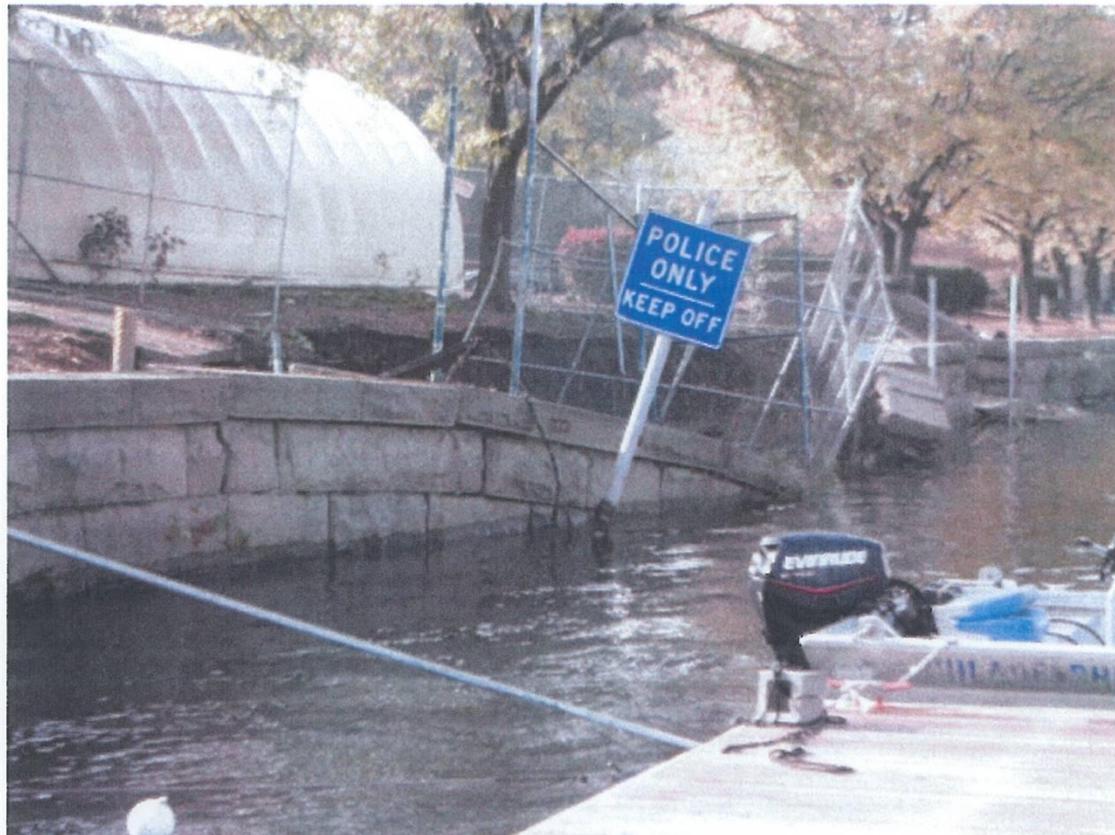
Photo 1: North end of failed section of marine wall looking south

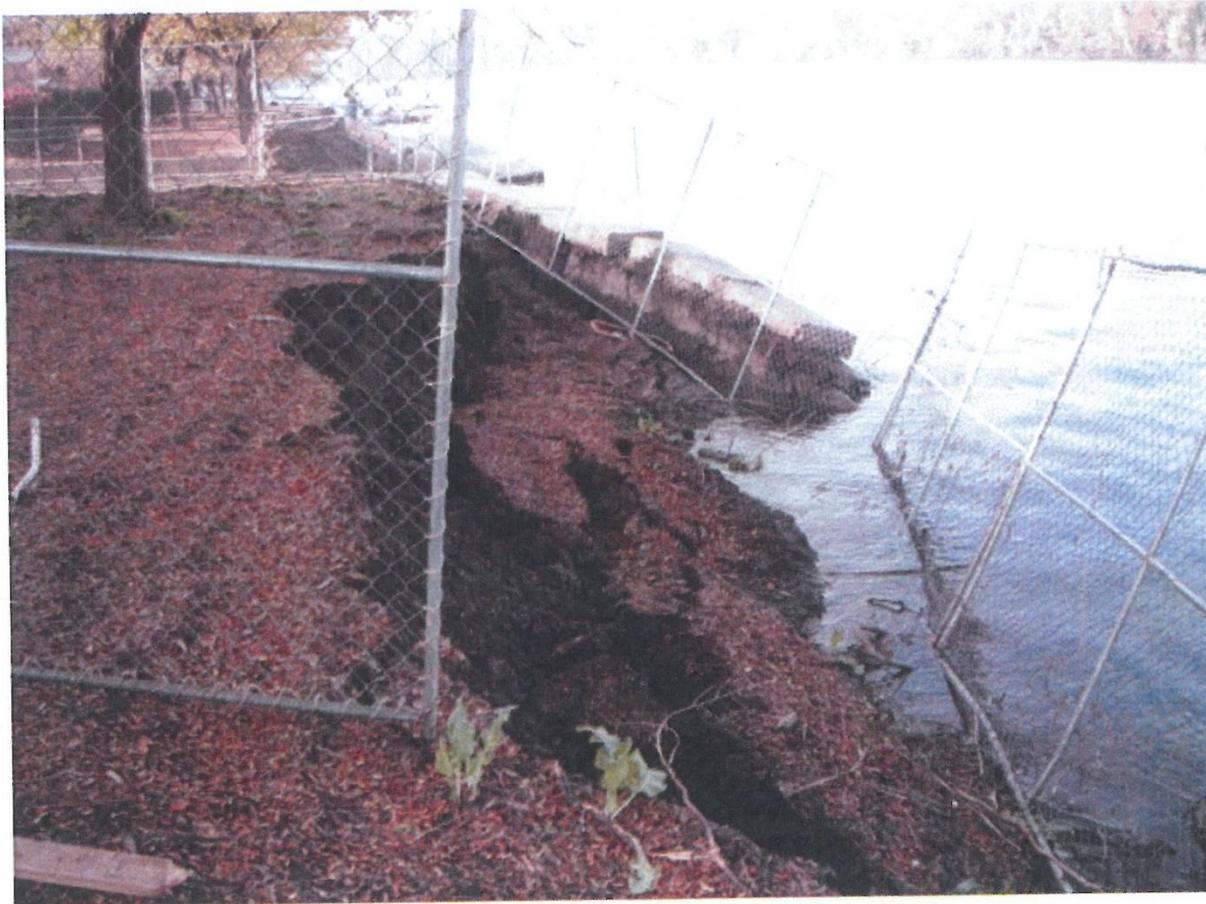
Photo 2: Behind failed section of marine wall looking south

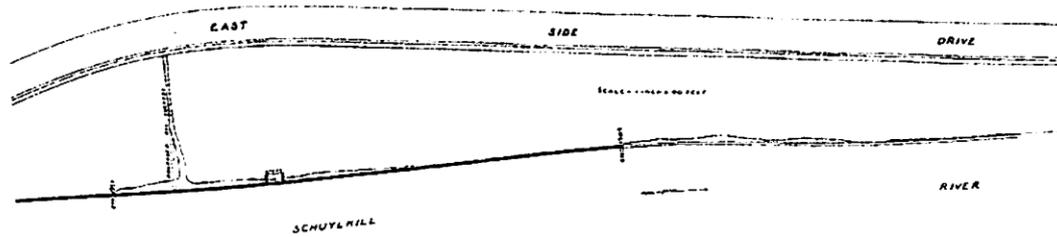
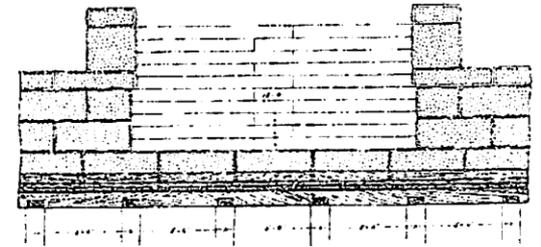
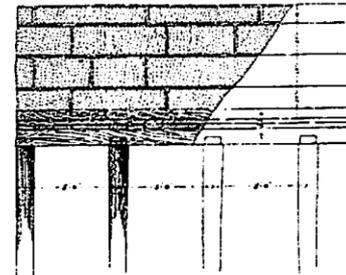
PLAN OF RIVER WALL EAST SIDE SOUTHWARD FROM TROLLEY BRIDGE FAIRMOUNT PARK

SECTION OF STEPS

FRONT ELEVATION OF STEPS

SECTION OF WALL
SHOWING PILING

SECTION OF WALL
SHOWING CONCRETE FOUNDATION

FRONT ELEVATION OF WALL

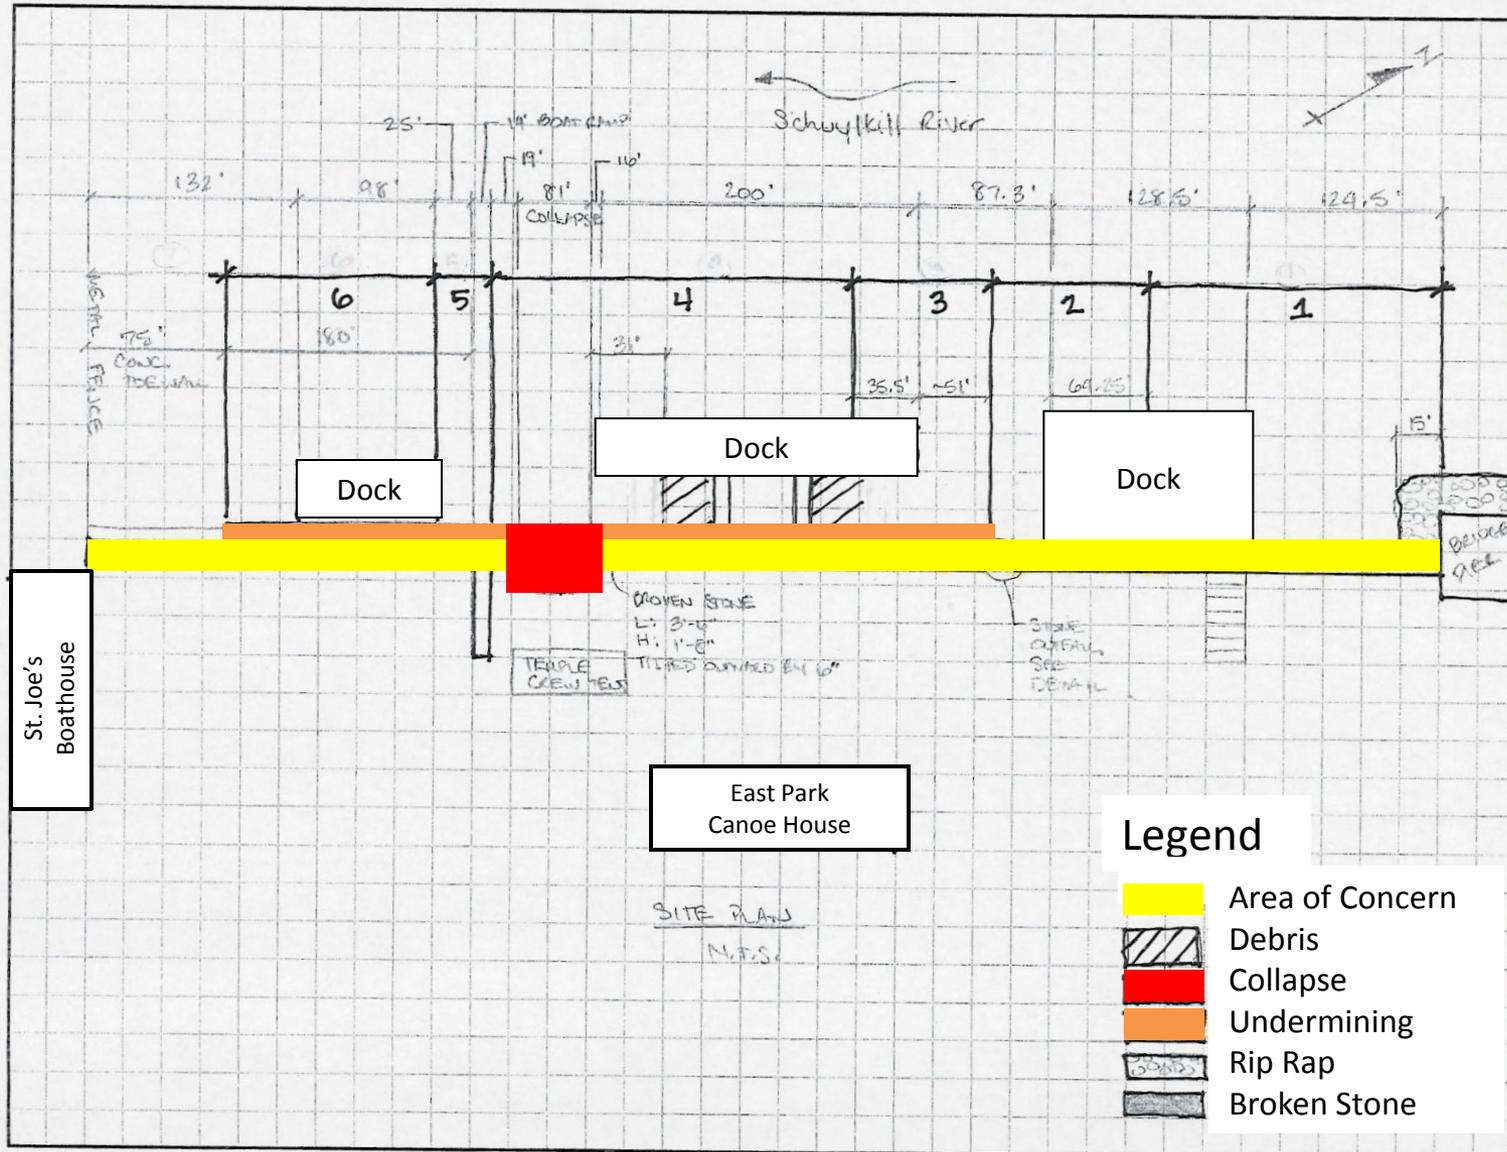
JOB NO. _____
SHEET 1 OF 5
DATE 11/03/11
BY: JLC
CHK'D: JLC
DATE 11/11/11

PROJECT SCHUYLKILL LEVEL WALK
SUBJECT UNDERMINING INSPECTION

SITE PLAN
N.P.S.

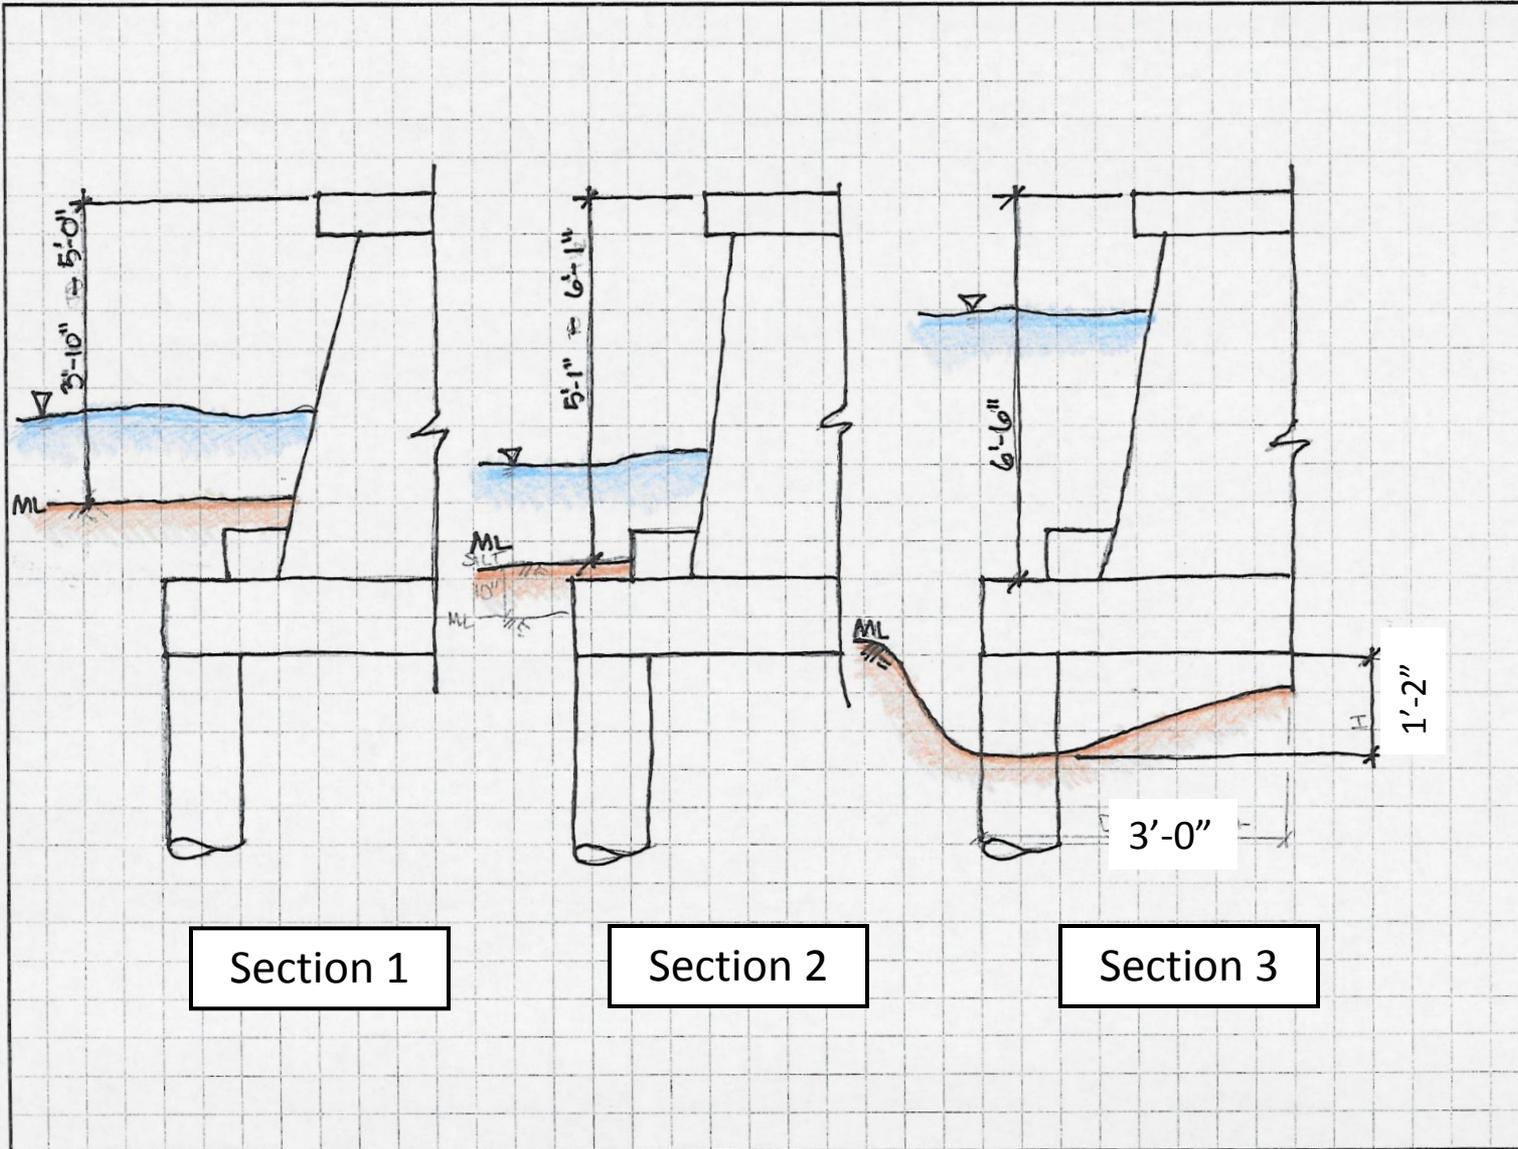
JOB NO.
 SHEET 3 OF 5
 BY: JCL
 CHKD: JCL
 DATE 1/23/11
 1/11/11

PROJECT SCHUYLER BLVD. BRIDGE
 SUBJECT UNDERGROUND INSPECTION

Section 1

Section 2

Section 3

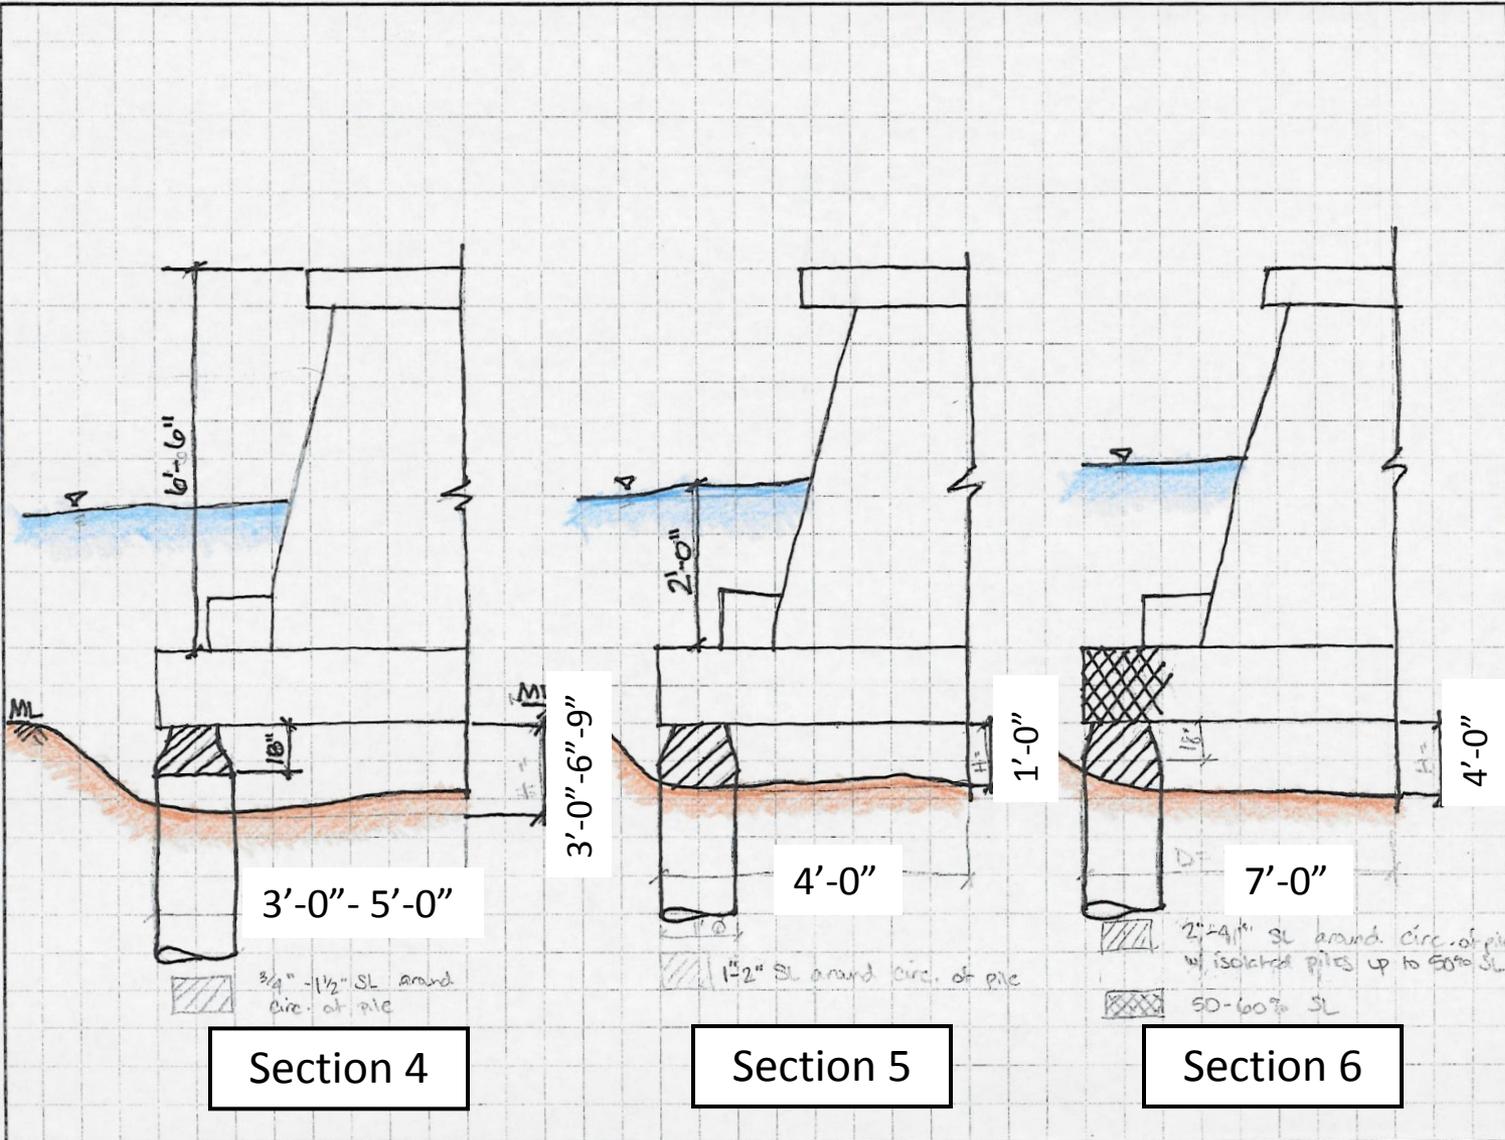
SHEET *4* OF *5*

SUBJECT *UNDESIRABLE VEGETATION*

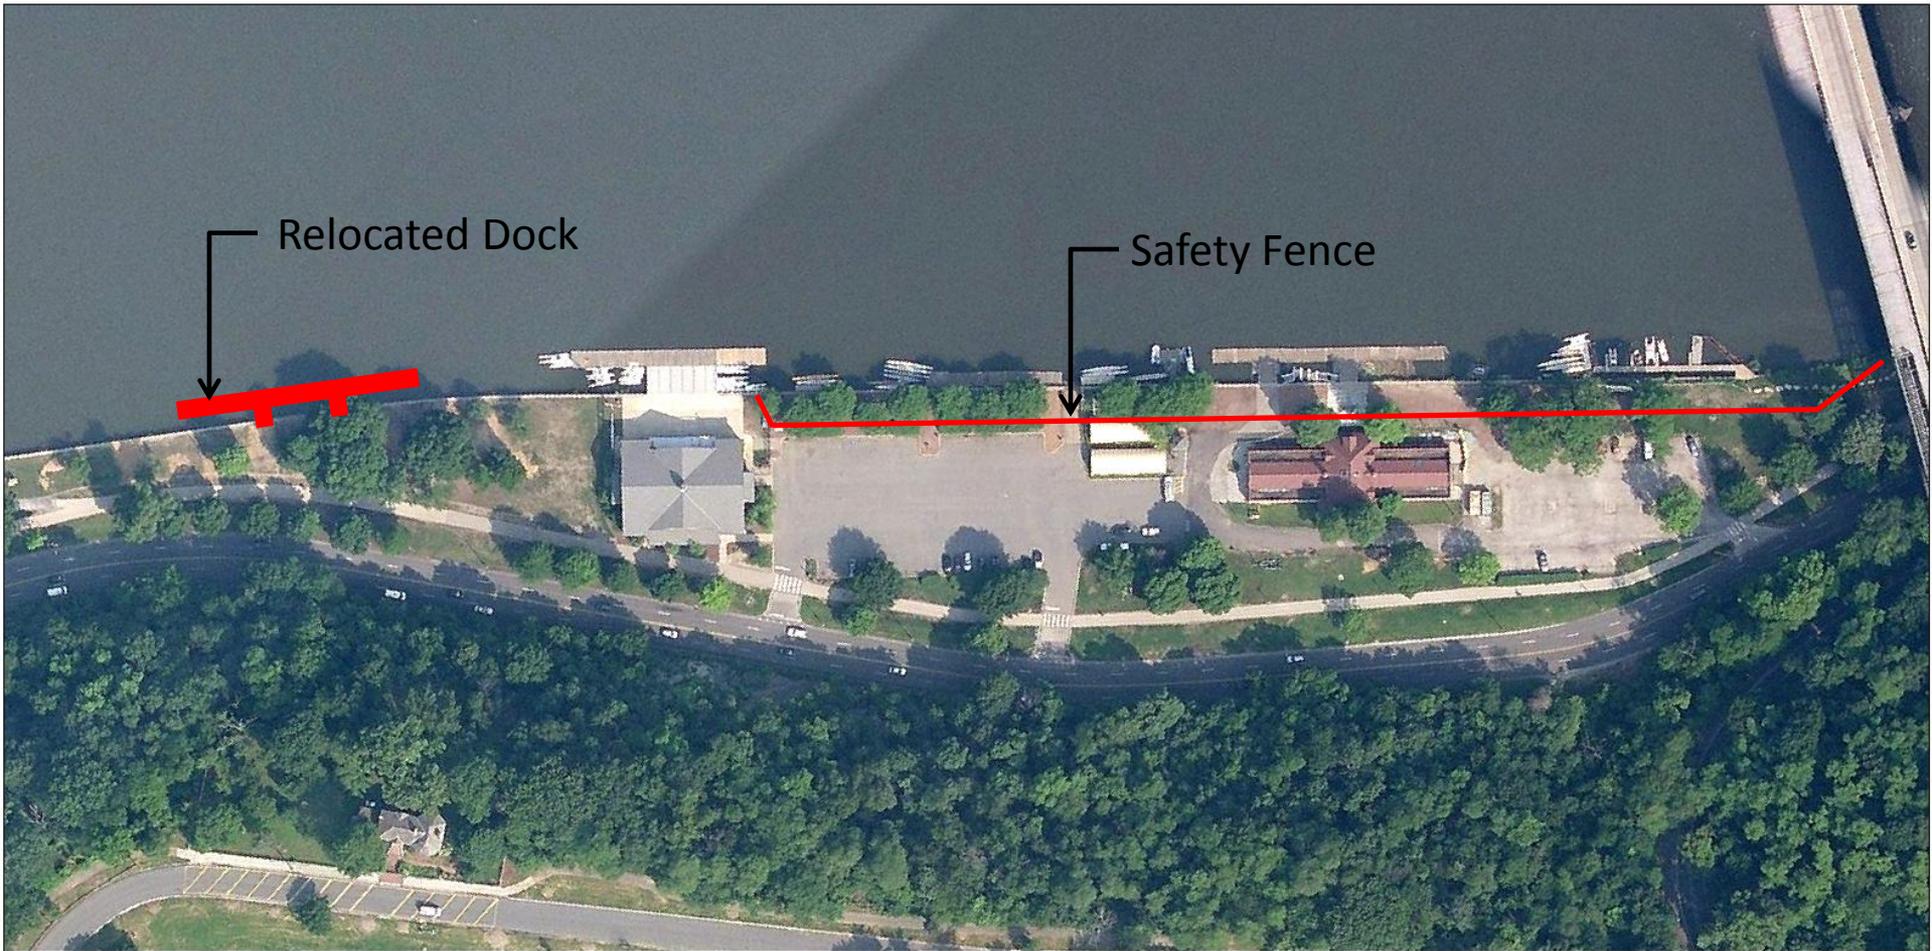
Relocated Dock

Safety Fence

- Get divers in the river to investigate stability of river wall south of St. Joseph's Boathouse.
- If determined to be stable, relocate East Park Canoe House dock.
- Relocate Temple's tents.
- Install fencing to prohibit public access to the river wall from St. Joseph's Boathouse north to Strawberry Mansion bridge.

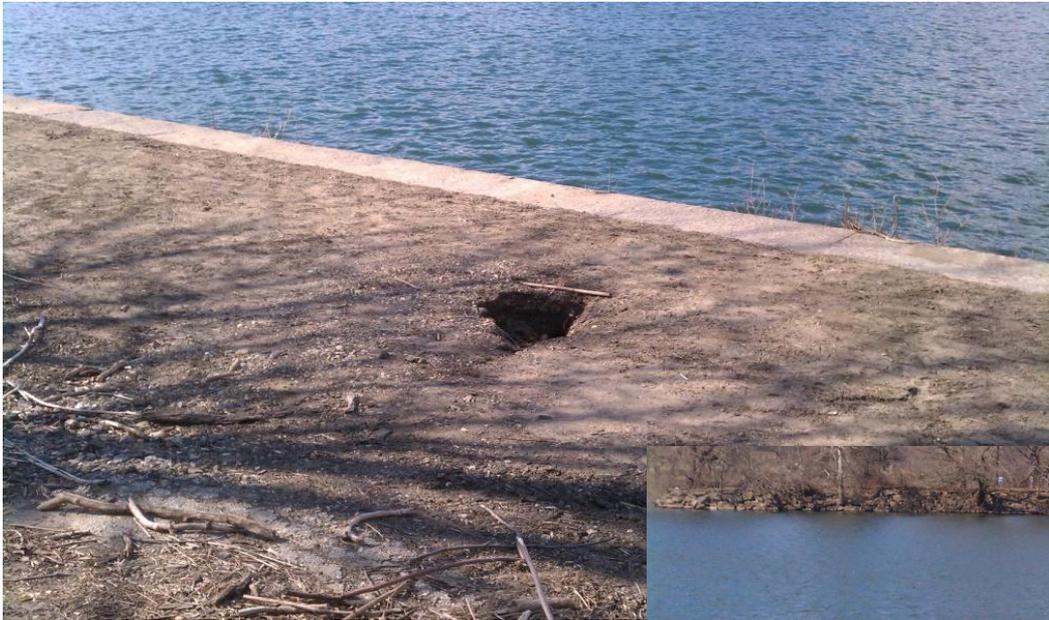
Sinkholes which have developed behind the river wall adjacent to the parking lot north of the grandstand.
