APPENDIX D: CONCEPTUAL RECOMMENDATIONS FOR PEDESTRIAN PRIORITY CORRIDORS AND INDIVIDUAL LOCATIONS

This appendix provides additional information on the 48 pedestrian priority corridors and intersections identified in Chapter 6 of the Plan. A summary map and table of the locations is provided as an overview and specific locations are discussed on the pages that follow. Note that some pedestrian recommendations are discussed in the Bicycle Appendix, Appendix E.

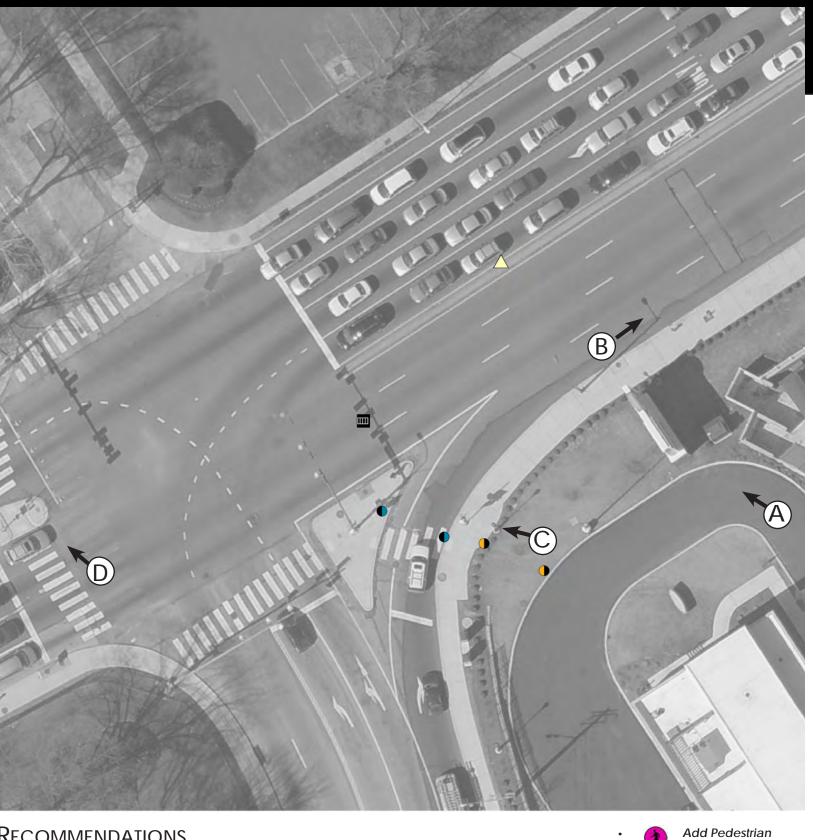
PEDESTRIAN PRIORITY AREA CITY AVENUE & MONUMENT ROAD

CURRENT CONDITIONS Pedestrians who cross City Avenue midblock east of Monument Road, instead of using the pedestrian overpass, endanger themselves and create a traffic The median on the east side is too narrow to serve as a pedestrian refuge. An existing goat path leading to the intersection of City Avenue and Monument Road is not accessible. Pedestrians walking along south sidewalk of City Avenue must cross free right turn from Monument Road, which is so wide that it encourages excessive speed.

RECOMMENDED IMPROVEMENTS	CURRENT CONDITIONS ADDRESSED
Consider adding a fence along the center median island on City Avenue north east of Monument Road to block pedestrian crossings at a precarious location.	1
Evaluate whether any space can be reallocated from existing travel lanes to widen the refuge island on City Avenue at east side of intersection and allow a crosswalk across City Avenue.	2
Consider narrowing the slip lane from Monument Road to City Avenue.	4
Formalize the "goat path" leading to the inter- section of City Avenue and Monument Road by paving the path and adding curb ramps.	3
Add pedestrian related safety signage through the corridor.	1

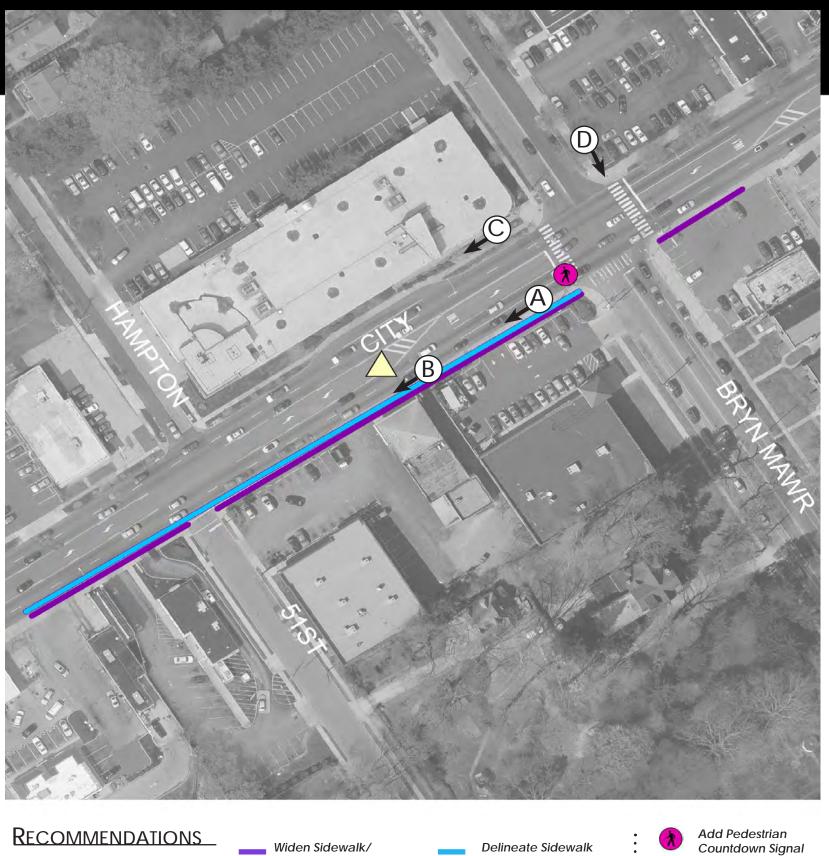
PEDESTRIAN PRIORITY AREA CITY AVENUE FROM BRYN MAWR AVENUE TO 54TH STREET

CURRENT CONDITIONS		
1	Significant traffic volumes on existing narrow lanes limit options to make on-street improvements.		
2	City Avenue crossings are long and difficult for pedestrians.		
3	In some locations, excessively wide, almost continuous driveways, and sidewalks indistinguishable from adjacent parking lots increase possibilities for pedestrian-vehicular conflict.		
4	There is no buffer between the sidewalk and the road.		
5	Obstructions block the pedestrian travel way.

RECOMMENDED IMPROVEMENTS	CURRENT CONDITIONS ADDRESSED
Provide advanced stop lines at all motor vehicle approaches to crosswalks.	NA
Add pedestrian count down signals throughout the corridor.	2
Widen sidewalk on south side of City Avenue as new development occurs, through increased setback requirement (enacted). Incorporate buffer between traffic and pedestrian travel way.	4, 5
Consider a center median island in areas where a center turn lane is not needed, following recommendations of the 2005 Access Management Study.	2
Consider visual or physical measures to demarcate the sidewalk from driveways and parking lots.	3

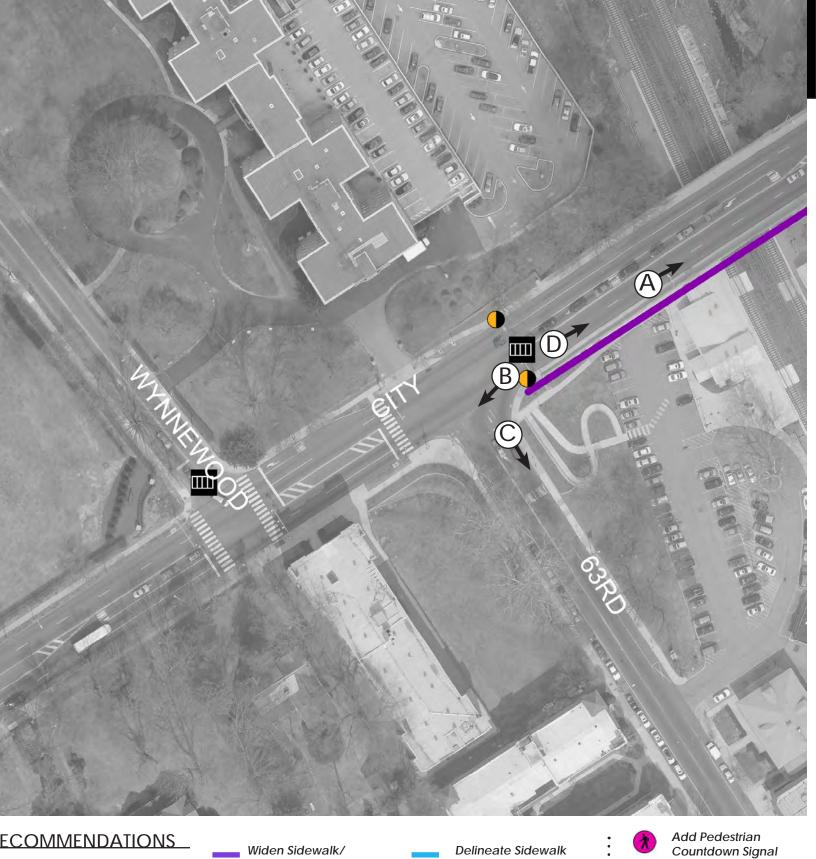
CURRENT CONDITIONS			
1	Significant traffic volumes on existing narrow lanes limit options to make on-street improvements.		
2	The sidewalks on City Avenue where it crosses the railroad tracks are very narrow, particularly considering that pedestrians must share them with bicyclists riding there to avoid the heavy and fast traffic on City Avenue.		
3	Lack of crosswalk on east side of intersection means passengers must make circuitous crossing to travel between Overbrook Station and bus stop on north side of City Avenue.

RECOMMENDED IMPROVEMENTS	CURRENT CONDITIONS ADDRESSED
Restripe existing crosswalks using high visibility pavement markings.	1
Consider additional pavement markings and warning signage to ensure that drivers remain alert for pedestrians and bicyclists.	1
Evaluate whether there is any opportunity to widen the sidewalk on the south side of City Avenue, or alternatively to add a buffer between the road and the sidewalk.	2
Determine whether it would be possible to stripe a crosswalk and add curb ramps on the east side of the intersection of City Avenue and 63rd Street.	3
Provide advanced stop lines at all motor vehicle approaches to crosswalks.	1
Add benches, shelter, or other amenities at bus stops when possible.	NA

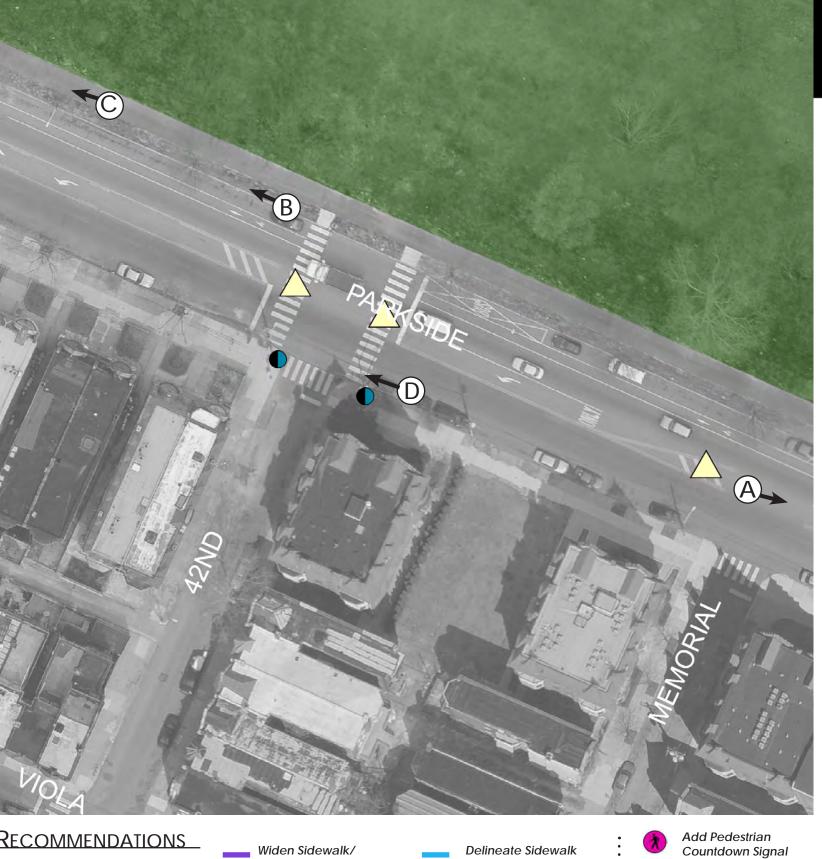
CURRENT CONDITIONS
1	Excessive paved space, for example the continuous center turn lane, is likely not required for traffic operations.
2	Public feedback has indicated that motor vehicle speed is a concern.
3	Pedestrian crossings of Parkside Avenue are long with no median refuge.
4	Controlled crossings are far apart and pedestrians are seen crossing at uncontrolled locations, for example at Parkside and 49th Street.

RECOMMENDED IMPROVEMENTS	CURRENT CONDITIONS ADDRESSED
Consider the addition of a landscaped center median island that would improve pedestrian crossing safety, contribute to traffic calming, and green streets goals.	1, 2, 3
Consider adding controlled crossings at selected lo- cations along the corridor, for example, the intersec- tion of Parkside and 49th Street.	4
Add pedestrian count down signals, for example at the intersection of Belmont Avenue and Parkside Avenue.	3
Construct curb extensions where on-street parking does not appear to be needed.	1, 2, 3

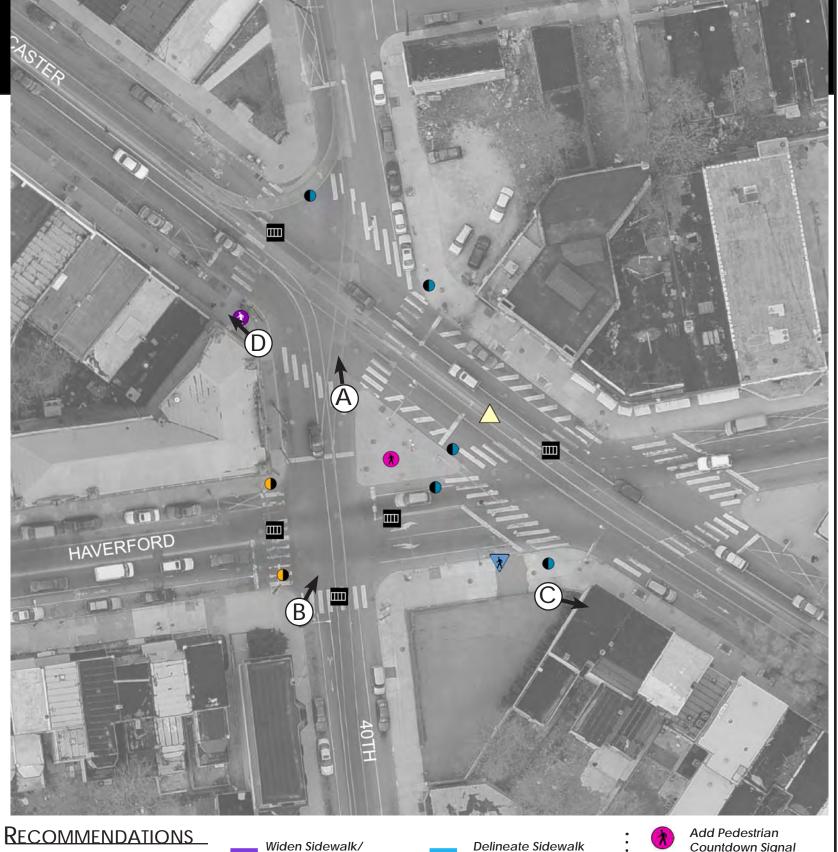
RECOMMENDED IMPROVEMENTS	CURRENT CONDITIONS ADDRESSED
Reduce pedestrian crossing distances through such measures as curb extensions and expansion of the center median island.	1, 3, 4
Add pedestrian count down signals.	1
Add signage to indicate that the existing eastbound bike lane on Haverford Avenue ends.	NA
Improve existing curb ramps throughout the corridor to make them ADA accessible.	5
Build curb extensions, for example at the northwest corner of Lancaster and 40th Street to slow turning vehicles and reduce pedestrian crossing distances.	1, 4
Restripe existing crosswalks and bike lanes using high visibility pavement markings.	2
Consider Leading Pedestrian Intervals where wide turning radii encourage high speed turns.	4

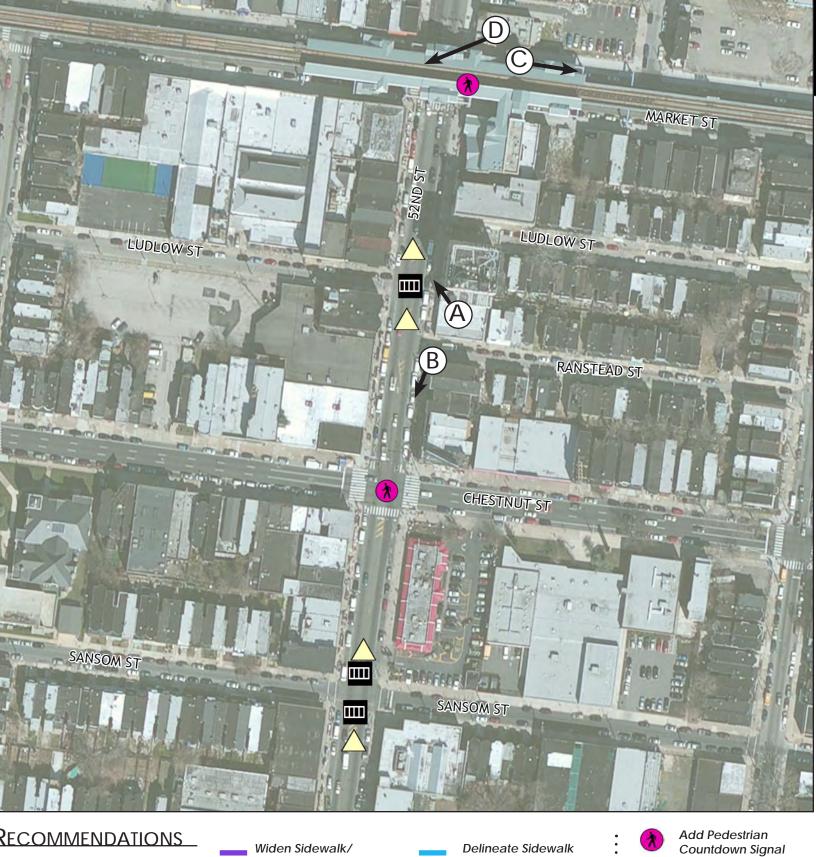
CURRENT CONDITIONS	
1	Poorly maintained crosswalks.
2	Significant pedestrian demand for mid-block crossings and concern about "dart outs".
3	Lack of median islands that serve as pedestrian refuges.
4	Excessive paved space that is not required for traffic operations.
5	Signals are difficult to see under the El.
6	All intersections lack pedestrian crossing signals.

RECOMMENDED IMPROVEMENTS	CURRENT CONDITIONS ADDRESSED
Consider a mid-block crossing at Ludlow Street given existing pedestrian demand and potential impact on bus operations; if so consider crosswalk, pedestrian signal, and on-street parking reduction to improve sight lines.	2
Raise existing painted medians at key locations along the corridor to facilitate safe pedestrian crossings.	3
Add pedestrian countdown signals at all signalized intersections on the corridor.	6
Improve signal placement at the 52nd Street and Market Street intersection.	5
Restripe crosswalks where needed.	1

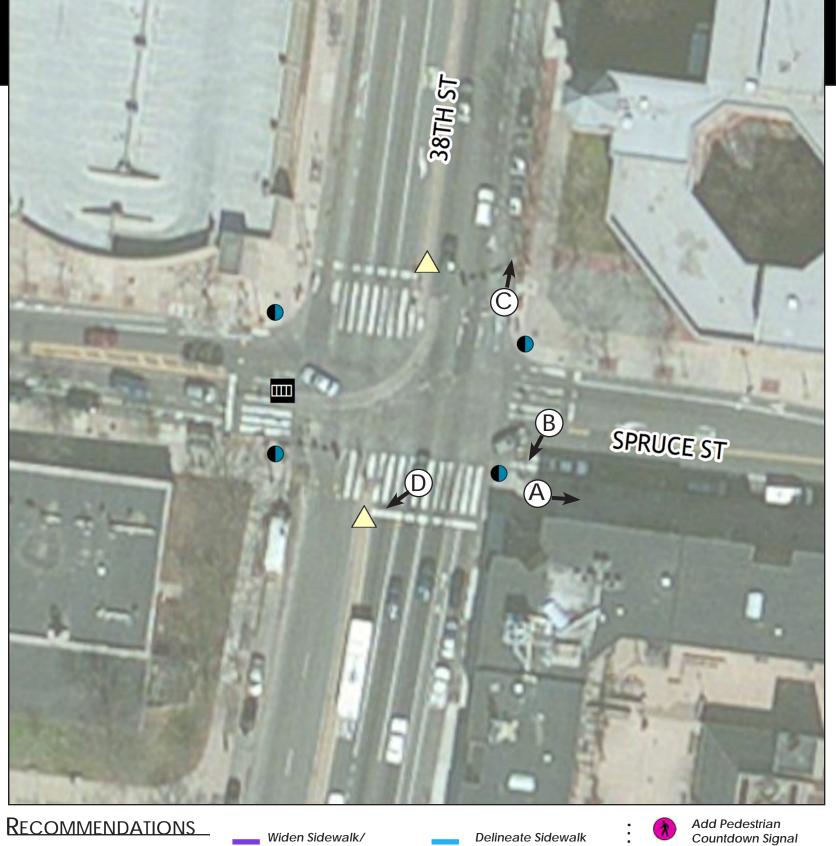
CURRENT CONDITIONS	
1	Poorly maintained crosswalks.
2	All modes are interacting within what is a relatively constrained intersection environment.
3	Existing medians do not meet current standards for pedestrian refuges.
4	Delivery trucks and Wawa customer vehicles block the bike lane, which is a No Stopping Zone. However, a loading zone exists in a lay-by a short distance down Spruce Street.
5	Long pedestrian crossings.

RECOMMENDED IMPROVEMENTS	CURRENT CONDITIONS ADDRESSED
Consider ways to reduce crossing distance or increase width of median on 38th Street/University Avenue.	3, 5
Evaluate whether providing bike boxes on all four legs of the intersection would clarify bike movements across pedestrian travel ways.	2
Restripe existing crosswalks and bike lanes using high visibility pavement markings.	1
Evaluate adequacy of loading space and curb management alternatives near 38th and Spruce.	4
Consider Leading Pedestrian Intervals.	2

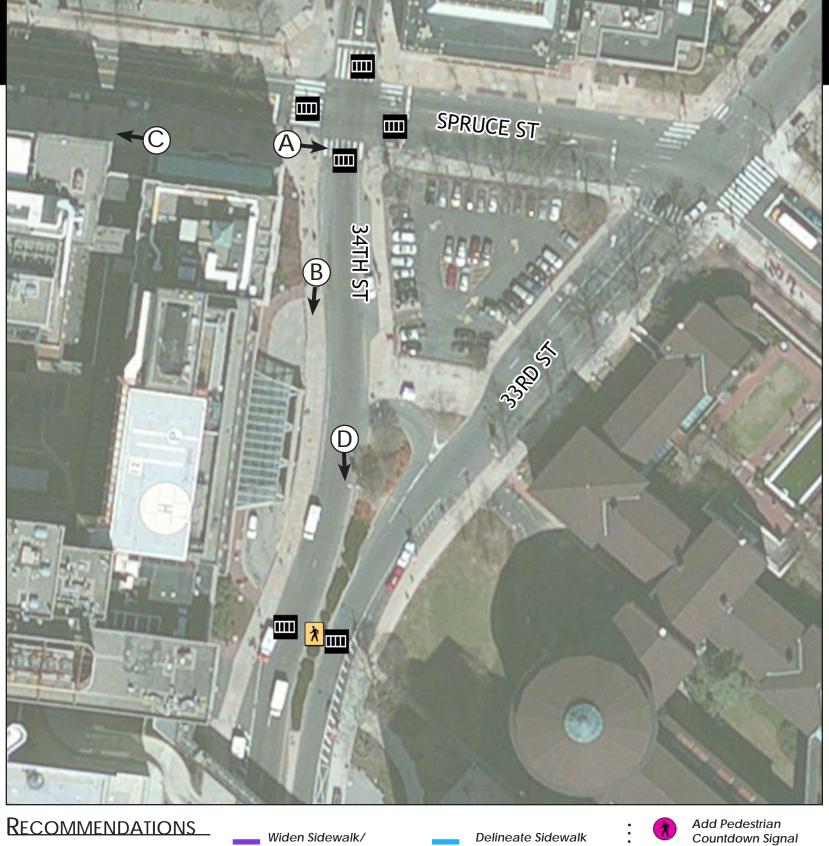
CURRENT CONDITIONS	
1	Poorly maintained crosswalks.
2	Potential conflicts with turning vehicles.
3	East sidewalk of 34th Street and west sidewalk of 33rd Street end mid-block with no path to Convention Avenue or University City rail station

RECOMMENDED IMPROVEMENTS	CURRENT CONDITIONS ADDRESSED
Restripe existing crosswalks and bike lanes using high visibility pavement markings.	1
Consider Leading Pedestrian Intervals.	2
Provide advanced stop lines at all motor vehicle approaches to crosswalks.	2
Evaluate new mid-block crosswalk with traffic control to connect CHOP entrance with existing walkway on east side of 33rd Street.	3

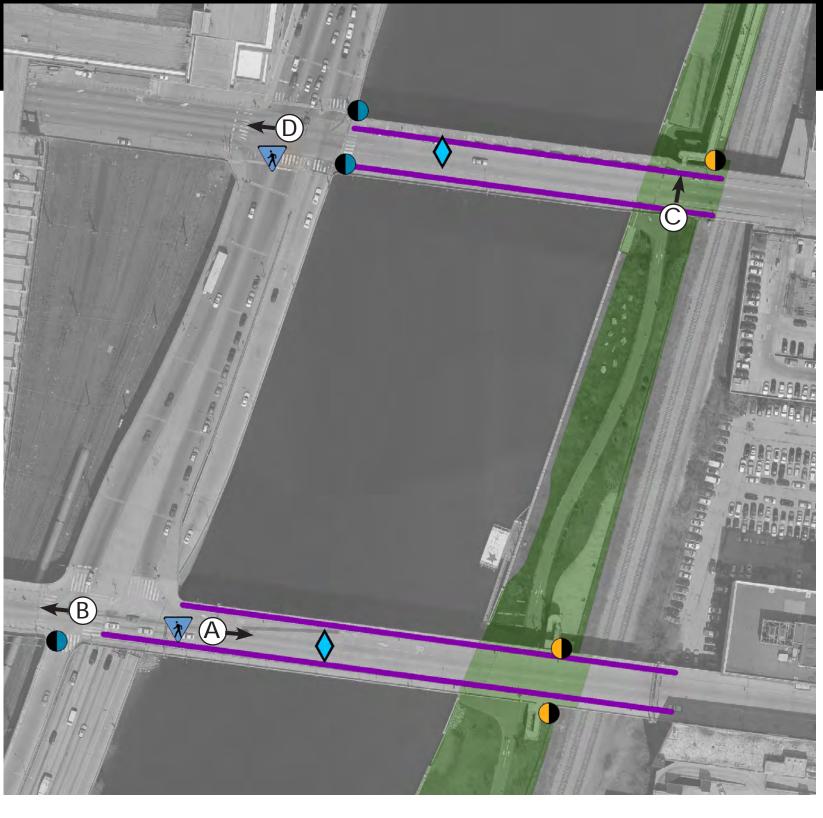
CURRENT CONDITIONS
1	Narrow existing sidewalks with significant pedestrian and bike demand present
2	Significant motor vehicle traffic traveling at high speeds
3	Lack of a buffer between the sidewalk and road
4	Turning radii are wide enabling cars to turn at high rates of speed
5	Sidewalk condition very poor on Chestnut Street bridge.
6	Existing curb ramps are inadequate.
7	Many corners of the Schuylkill Ave. intersection have very pinched sidewalks.

RECOMMENDED IMPROVEMENTS	CURRENT CONDITIONS ADDRESSED
Widen and renew sidewalks, with buffer, e.g. street lights, on both Walnut and Chestnut Street bridges. (planned for Walnut)	1, 3, 7
Relocate bike lanes to left side to reduce conflict with transit loading.	NA
Increase enforcement to reduce travel speeds across both bridges.	2
Tighten up intersections to reduce crossing distance and provide more space to accommodate ADA ramps at corners. (planned at Walnut)	4, 6 ,7
Consider Leading Pedestrian Intervals Intervals at crossings where vehicles fail to yield right-of-way.	NA
Add curb ramps on Walnut and Chestnut Street bridges to improve access to the Schuylkill River Trail.	6

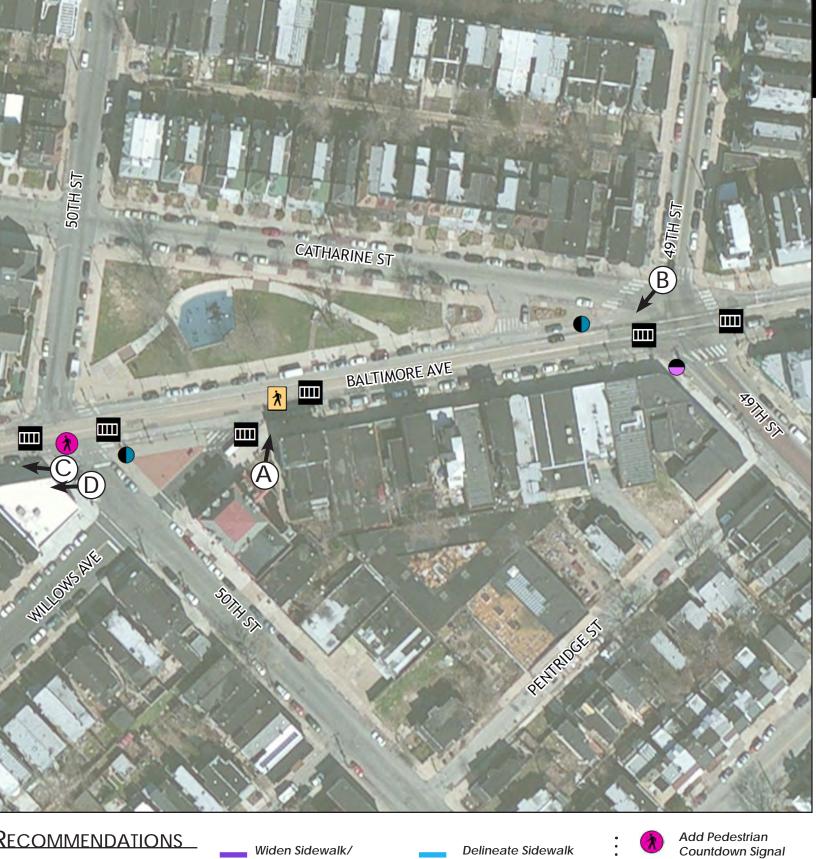
CURRENT CONDITIONS	
1	Poorly maintained crosswalks.
2	Wide turning radii encourages/enables drivers to turn at a high rate of speed.
3	There is an existing pedestrian desire line for a mid-block crossing.
4	Pedestrians do not have much time to cross the street.
5	Existing curb ramps need improvement.
6	Indirect pedestrian crossing, e.g., of Baltimore Avenue on west side of 49th Street.
7	Vehicular intersection of Willows Avenue and Baltimore adds to the conflict created by the desired mid block pedestrian crossing, because drivers are more focused on looking west for approaching traffic on Baltimore Ave.

RECOMMENDED IMPROVEMENTS	CURRENT CONDITIONS ADDRESSED
Explore options to provide a more direct crossing of Baltimore on the west side of 49th.	6
Add pedestrian count down signals, for example for pedestrians crossing Baltimore Avenue at 50th Street.	4
Restripe existing crosswalks and bike lanes using high visibility pavement markings.	1
Consider a mid-block crossing of Baltimore Avenue between 49th and 50th given existing pedestrian demand and potential impact on transit operations. Also consider associated changes such as removing parking spaces to improve visibility and adding a pedestrian signal and high visibility crosswalk.	3
Improve existing curb ramps throughout the corridor to make them ADA accessible.	5
Evaluate the possibility of reversing the short segment of Willows Avenue between 50th Street and Baltimore Avenue."	7

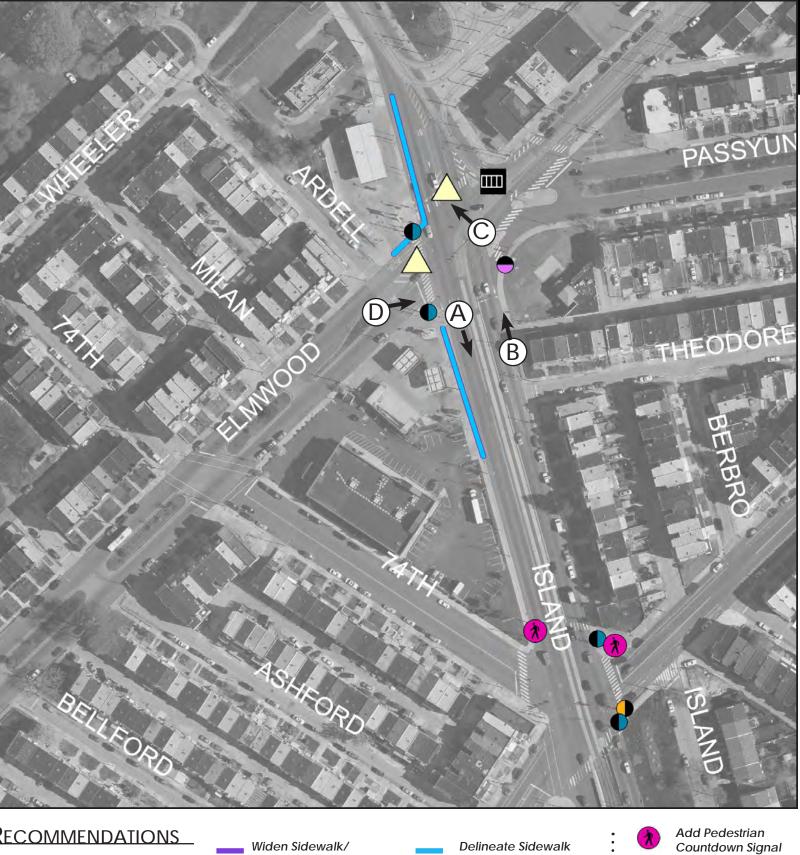
CURRENT CONDITIONS	
1	Excessively wide, almost continuous driveways, and sidewalks indistinguishable from adjacent parking lots increase possibilities for pedestrian-vehicular conflict
2	There is no connection to the Cobbs Creek Greenway.
3	Existing medians are not wide enough to serve as a refuge.
4	Existing pedestrian crossings are not direct and require people to go too far out of their way.
5	Wide turning radii encourages/enables drivers to turn at a high rate of speed.
6	Existing curb ramps are inadequately maintained.
7	Pedestrian signals missing at Island and Buist.
8	Long pedestrian crossings.

RECOMMENDED IMPROVEMENTS	CURRENT CONDITIONS ADDRESSED
Improve existing curb cuts to make ramps ADA accessible.	6
Evaluate the possibility of narrowing existing travel lanes in order to free up space to widen the waiting area for transit passangers.	3
Consider measures to shorten long pedestrian crossings, including curb extensions and median islands.	8
Conduct and access management study to determin whether the selected driveways could be closed.	1
Consider visual or physical measures to demarcate the sidewalk from driveways and parking lots.	1
Evaluate the possibility of adding a more direct crossing between the northeast and the southeast corners of Island/Elmwood/Passyunk.	4
Consider eliminating the slip lane at Island and Passyunk to reduce the turning radius.	5
Develop an improved pedestrian and bicycle connection to the Cobbs Creek Greenway, potentially by creating a sidepath on the west side of Island Avenue.	2

Provide wayfinding signage to the Cobbs Creek Greenway.	2
Add new pedestrian signal at the intersection of Island and Buist.	7

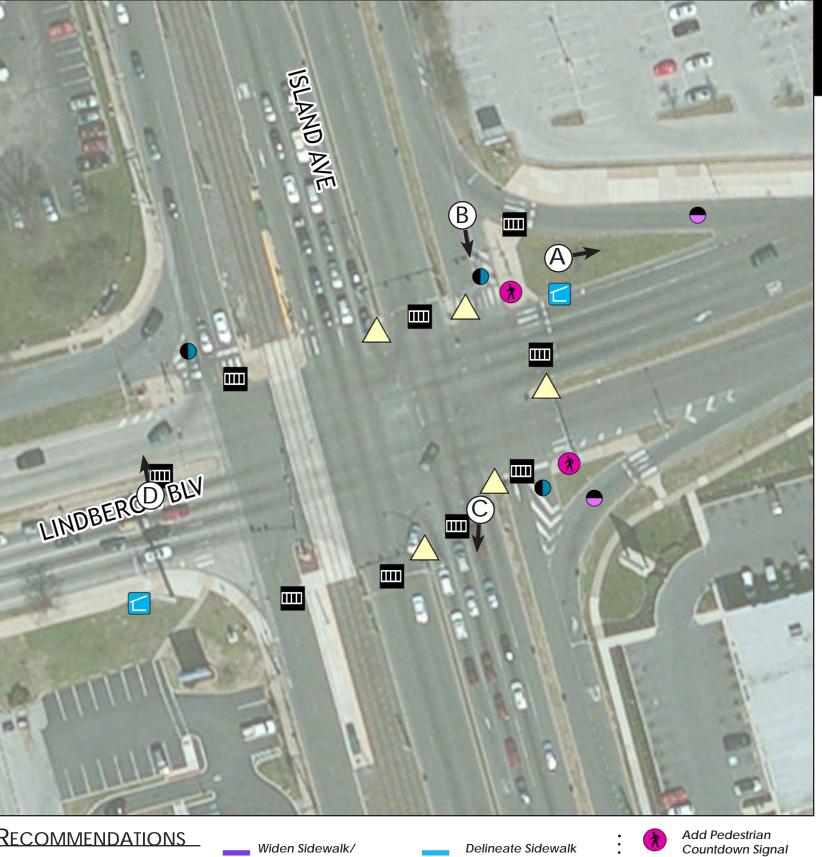
CURRENT CONDITIONS	
1	Wide turning radii encourages/enables drivers to turn at a high rate of speed.
2	Long pedestrian crossing distances.
3	Potential conflicts between pedestrians, cars, bicycles, trolleys, buses, etc.
4	All pedestrian crossings are not accommodated.
5	Missing curb ramps.
6	Poorly maintained crosswalks.
7	Limited queuing space for pedestrians waiting for trolleys.
8	Existing medians are not wide enough to serve as refuges.
9	Excess paved space that does not appear to be needed for traffic operations.
10	Sidewalk is missing or has major gaps on east side of Island Avenue.

RECOMMENDED IMPROVEMENTS	CURRENT CONDITIONS ADDRESSED
Tighten turning radii to slow turning vehicles.	1, 3
Evaluate the possibility of providing a crosswalk between the southeast and southwest sides of the intersection given existing pedestrian desire lines.	4
Reduce pedestrian crossing distance through curb extensions or expanded medians.	2, 3, 8, 9
Evaluate the possibility of narrowing existing travel lanes in order to free up space to widen the queuing area for pedestrians waiting for trolleys.	7
Ensure that the intersection appropriately accommodates the planned bike lanes on Lindbergh Boulevard.	NA
Provide missing curb ramps and restripe existing crosswalks.	5, 6
Provide advanced stop lines at all motor vehicle approaches to crosswalks.	3
Provide more time on pedestrian signals for pedestrians to cross.	2
Provide benches and shelters at all bus stops.	NA

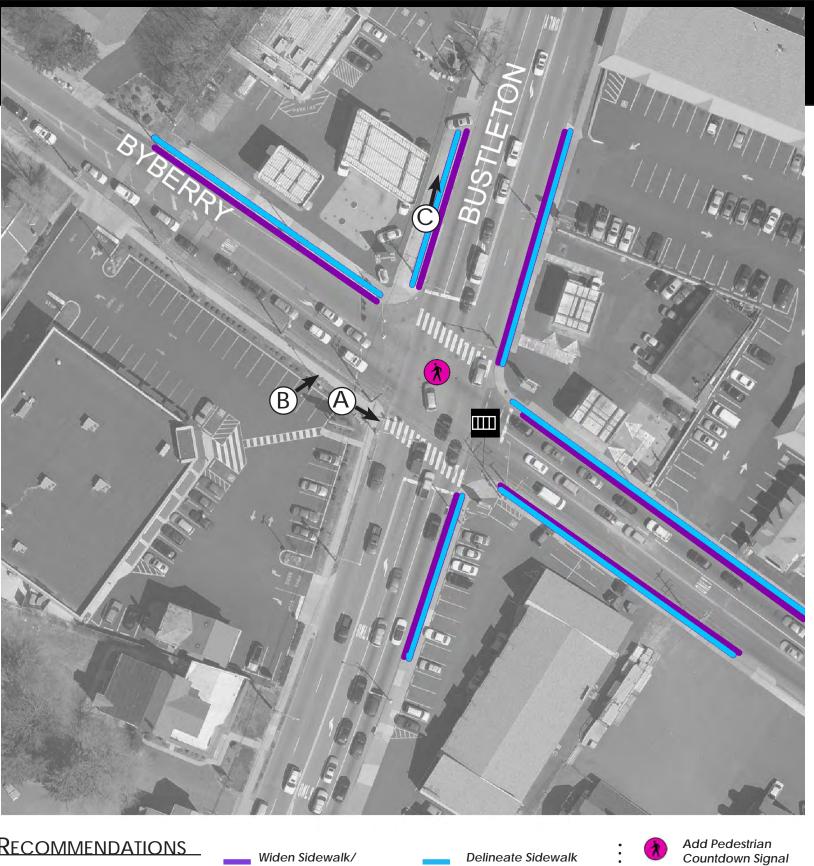
CURRENT CONDITIONS	
1	Lack of median islands that serve as pedestrian refuges.	
2	Long pedestrian crossing distances with short signal timing.	
3	Limited queuing space for pedestrians waiting for buses.	
4	Poorly maintained crosswalks.	
5	No buffer between sidewalks and traffic except for southwest corner of intersection.	
6	Excessively wide, almost continuous driveways, and sidewalks sometimes indistinguishable from adjacent parking lots increase possibilities for pedestrian-vehicular conflict.

RECOMMENDED IMPROVEMENTS	CURRENT CONDITIONS ADDRESSED
Restripe crosswalks with high visibility markings.	4
Provide buffers between sidewalks and traffic.	5
Add pedestrian countdown signals. (planned)	2
Consider visual or physical measures to demarcate the sidewalk from driveways and parking lots.	6

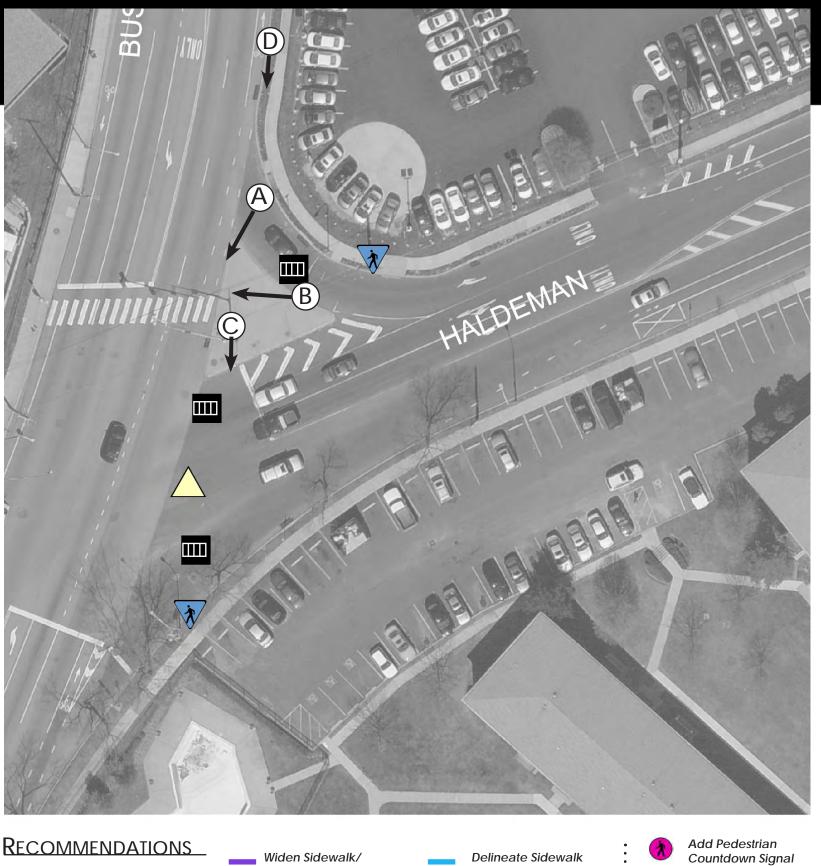
CURRENT CONDITIONS
1	No crosswalk markings for pedestrians walking on the east side of Bustleton, likely because the segment between the median island and the south side of the crossing always has traffic from either Bustleton or Haldeman.
2	Long pedestrian crossing distances with short signal timing.
3	Sidewalks are narrow and, from Haldeman north over the railroad bridge, lack buffers.
4	Wide turning radii encourage/enable drivers to turn at high speeds.

RECOMMENDED IMPROVEMENTS	CURRENT CONDITIONS ADDRESSED	
Add crosswalk markings for pedestrians crossing Haldeman on east side of Bustleton. Add Yield to Pedestrians sign at crosswalk to slip ramp.	1	
Consider buffers between the sidewalk and the roadway.	3	
Provide more time on pedestrian countdown signals for pedestrians to cross.	2	
Provide benches or shelters at bus stops.	NA	
Consider curb extensions to tighten turning radii to slow turning vehicles.	4	
Add a median refuge island on the east side of Bustleton to separate the westbound Haldeman traffic from the eastbound Bustleton right turns. This would allow pedestrians on the east side to cross the intersection in stages, while also slowing the right turning vehicles.	1, 4

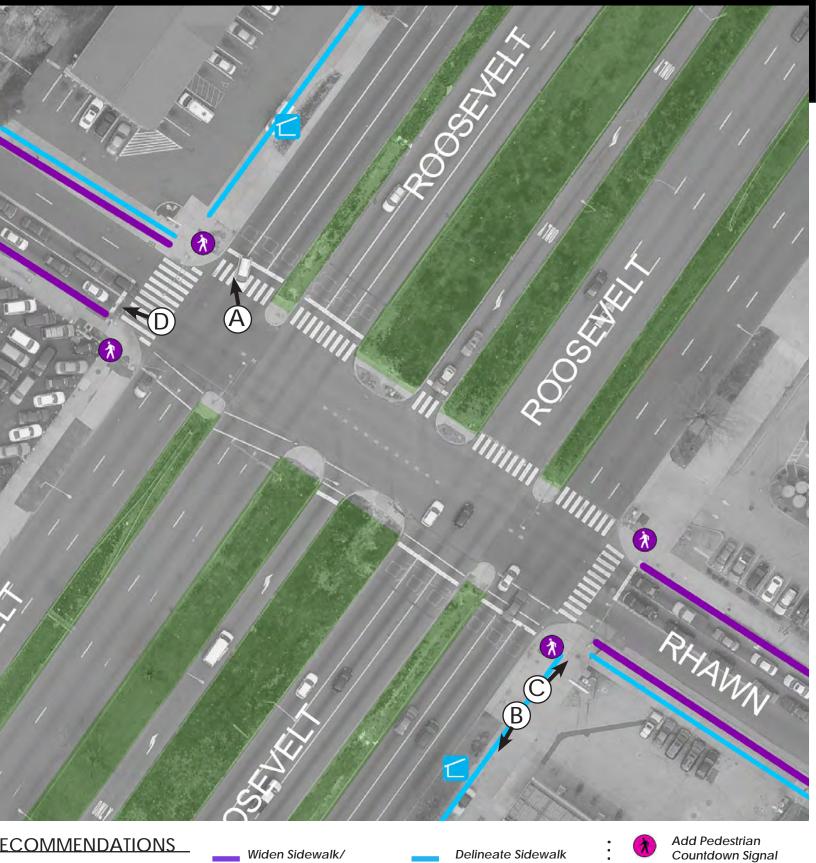
CURRENT CONDITIONS	
1	Limited space and lack of amenities for passengers waiting for buses.
2	Excessively wide, almost continuous driveways, and sidewalks indistinguishable from adjacent parking lots increase possibilities for pedestrian-vehicular conflict.
3	Sidewalk buffers are lacking, particularly on Rhawn Street.
4	Potential conflicts with pedestrians/bicylists and turning traffic.

RECOMMENDED IMPROVEMENTS	CURRENT CONDITIONS ADDRESSED
Provide benches or shelters at bus stops.	1
Improve existing surface quality of the curbs and sidewalks.	NA
Provide buffers between sidewalk and road where possible, particularly trees.	3
Consider LPIs for all crosswalks with turning vehicles.	4
Consider visual or physical measures to demarcate the sidewalk from driveways and parking lots.	2

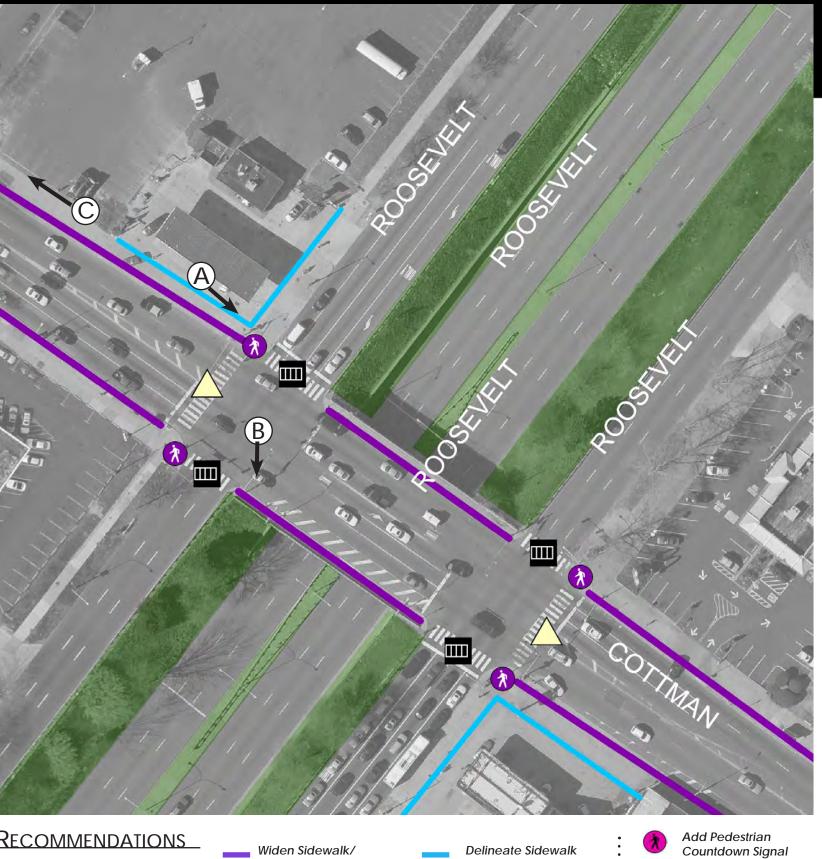
CURRENT CONDITIONS
1	Long pedestrian crossing distances with short signal timing.
2	Waiting areas for bus passengers lack amenities and may be inadequate due to adjacent driveways.
3	No buffer between sidewalk and motor vehicle traffic on Cottman Avenue. Sidewalks on bridge are especially narrow.
4	Potential conflicts with pedestrians/bicyclists and right turning vehicles.
5	Excessively wide, almost continuous driveways, and sidewalks indistinguishable from adjacent parking lots increase possibilities for pedestrian-vehicular conflict.

RECOMMENDED IMPROVEMENTS	CURRENT CONDITIONS ADDRESSED
Consider constructing a median at the intersection of Cottman Avenue and Roosevelt Boulevard.	1
When bridge is rebuilt, widen sidewalks over Roosevelt Blvd. For the rest of Cottman Avenue, add street trees where space allows.	3
Consider LPIs or adjust signal timing to provide more time for pedestrians to cross	2, 5
Provide benches or shelters at bus stops.	2
Consider visual or physical measures to demarcate the sidewalk from driveways and parking lots.	5

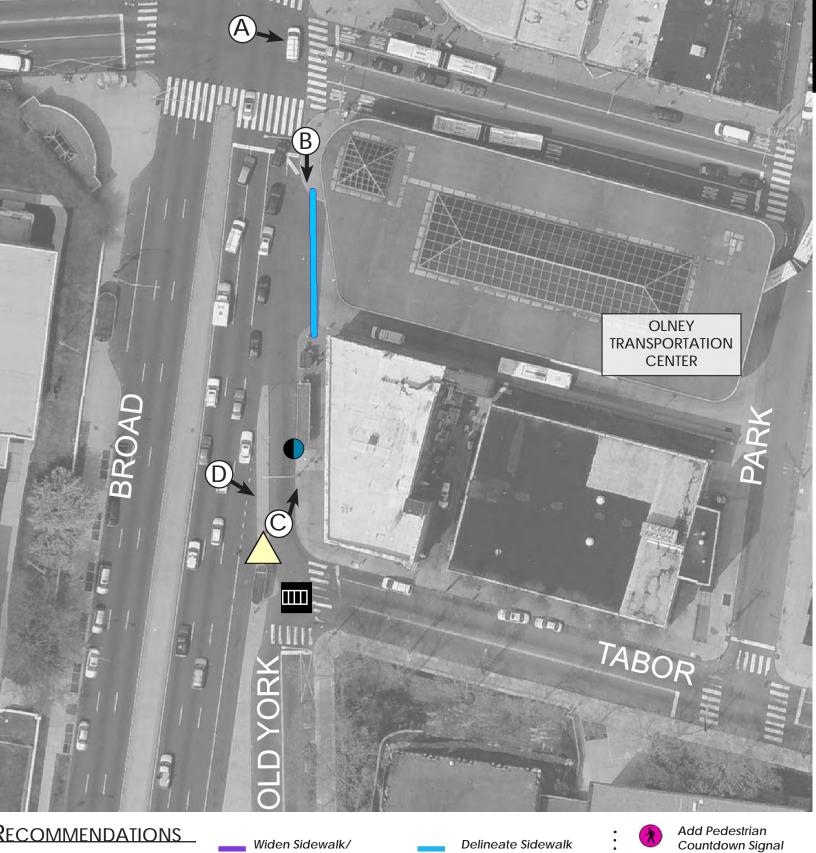
CURRENT CONDITIONS	
1	Limited space for transit passengers on the east side of Broad at the Transportation Center and on the island separating Broad Street from Old York Rd.
2	Significant potential for pedestrian-vehicular conflicts on sidewalk adjacent to Transportation Center driveway.

RECOMMENDED IMPROVEMENTS	CURRENT CONDITIONS ADDRESSED
Evaluate ways to widen the sidewalk around the subway headhouse on the east side of Broad Street from Olney to Tabor in order to provide a better waiting area	1
Evaluate the possibility of widening the median island between Broad St. and Old York Rd. near Tabor Rd. north to provide a better waiting area.	1
Consider design alternatives to better delineate the sidewalk along East side of Broad at Transportation Center driveway.	2

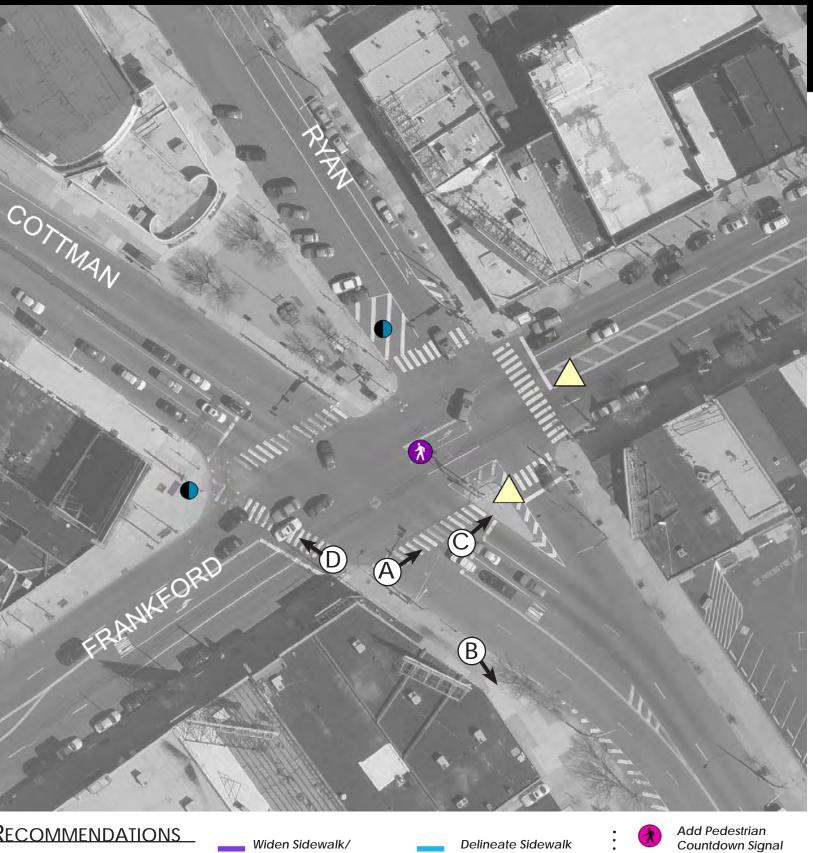
CURRENT CONDITIONS	
1	Lack of amenities for passengers waiting for buses.
2	Potential conflicts with pedestrians/bicyclists and right turning vehicles.
3	Wide angles can allow turns at high speeds.
4	Excessively long pedestrian crossings, especially along Frankford Avenue.
5	East bound Cottman phase is safe for pedestrians crossing Ryan but signal does not allow the movement.
6	Conflicts caused by multiple left turn opportunities in close proximity.

RECOMMENDED IMPROVEMENTS	CURRENT CONDITIONS ADDRESSED
Provide benches or shelters at bus stops.	1
Consider pedestrian plaza treatment, curb extensions, or expanded medians to reduce crossing distances, tighten turning radii, and reduce paved area.	3, 4
Consider Leading Pedestrian Intervals where wide turning radii allow high speed turns.	2, 3
Identify opportunities to add landscape buffers, green elements within medians, and other features to increase pervious surface and contribute to green streets goals.	NA
Separate signalization of Ryan and Cottman crosswalks, using expanded median refuge islands.	5
Consider prohibiting left turn from northbound Frankford to Ryan.	6

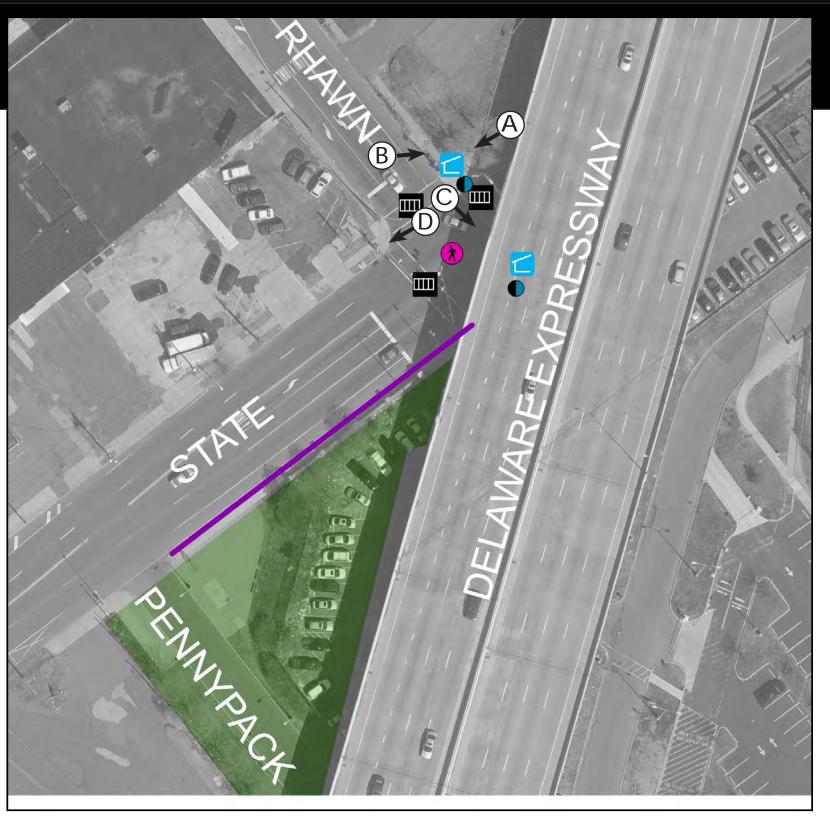
CURRENT CONDITIONS	
1	There are no pedestrian signals.
2	Long pedestrian crossing distance across State Road.
3	Limited queuing space and lack of amenities for pedestrians waiting for buses.
4	Poor connection to Pennypack Path east of State Road and south of intersection.
5	Poor visibility due to I-95 overpass.
6	Existing sidewalks are in very poor condition.
7	Existing curb ramps need improvement.
8	Lack of a buffer between the sidewalk and road.
9	Existing obstructions in the pedestrian travelway.

RECOMMENDED IMPROVEMENTS	CURRENT CONDITIONS ADDRESSED
Install pedestrian countdown signal.	1, 2
Provide benches or shelters at all bus stops.	3
Consider curb extensions to shorten crossings, improve pedestrian visibility, and create queuing area for bus passengers.	2, 5
Install high visibility crosswalks.	5
Consider converting shoulder of State Rd. between Rhawn St. and Pennypack Path to expand sidewalk for shared use by bicyclists and pedestrians and to add a buffer.	4
Add wayfinding signs at intersection to direct path users to the proper route.	4

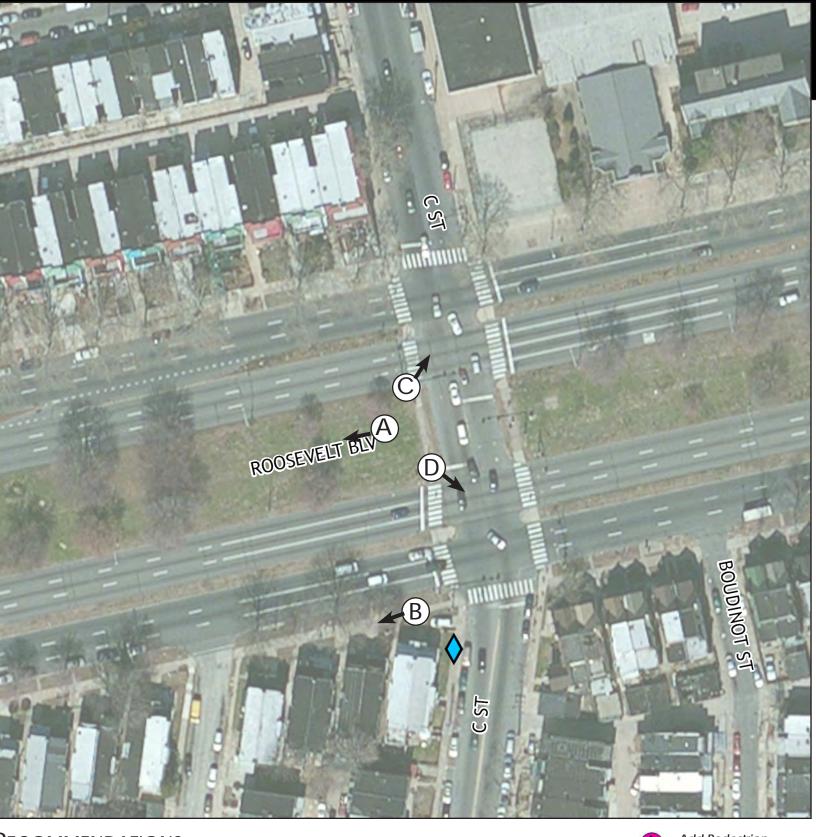
CURRENT CONDITIONS	
1	Existing curb ramps need improvement.
2	Existing medians provide varying degrees of refuge pro- tection for pedestrians.
3	Heavy traffic volumes on Roosevelt Avenue make cross- ing uncomfortable.

RECOMMENDED IMPROVEMENTS	CURRENT Conditions Addressed
Improve existing curb ramps throughout the corridor to make them ADA accessible.	1
Consider options to reduce crossing distance on C Street, such as curb extensions or center medians.	2

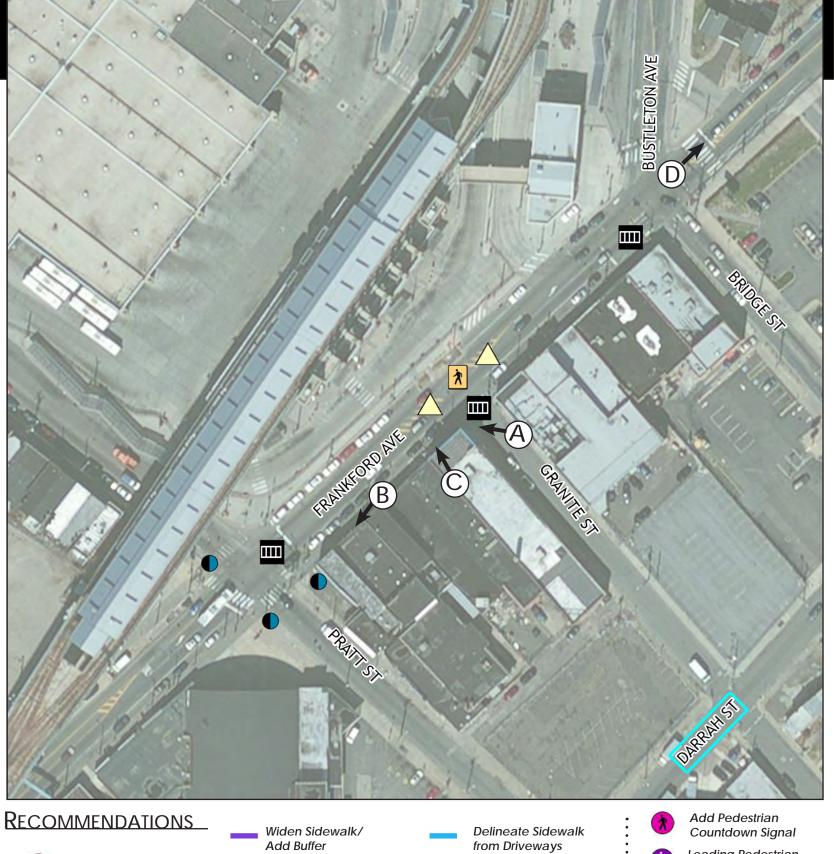
CURRENT CONDITIONS	
1	Significant level of pedestrian crossings at uncontrolled intersections and mid-block locations.
2	Poorly maintained crosswalks.
3	Existing curb ramps need improvement.
4	Turning radii are wide, enabling cars to turn at high rates of speed.
5	The existing painted median on Frankford Avenue doesn't function as a pedestrian refuge.

RECOMMENDED IMPROVEMENTS	CONDITIONS Addressed
Consider raising existing painted median on Frankford Avenue to better serve as a pedestrian refuge.	1, 5
Evaluate a mid-block crossing treatment of Frankford Avenue around Granite Street, and other associated changes, for example removing parking spaces to improve visibility and adding a pedestrian crossing signal and high visibility crosswalk. Consider realigning crosswalk across interior drive at Frankford Transportation Center to meet mid-block crossing.	1
Reduce pedestrian crossing distance and improve visibility by adding curb extensions.	4
Improve existing curb ramps throughout the corridor to make them ADA accessible.	3
Restripe existing crosswalks using high visibility pavement markings.	2

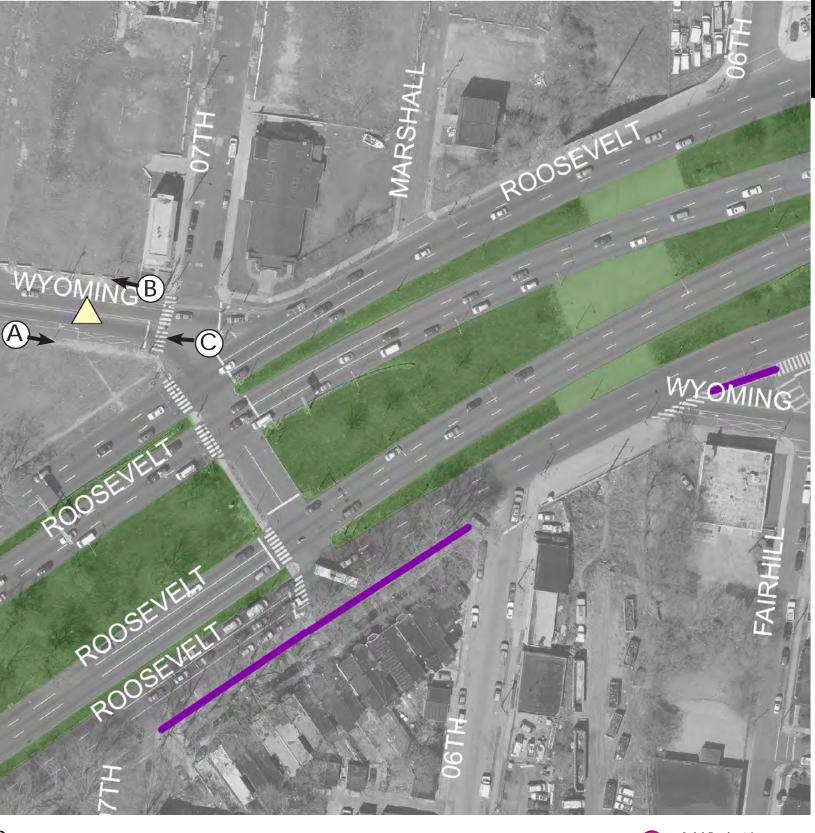
CURRENT CONDITIONS	
1	Sidewalks that are missing or in poor condition along Wyoming Avenue and Roosevelt Boulevard limit pedestrian access and connectivity.
2	Existing curb ramps need improvement.
3	Existing sidewalks are in disrepair.

RECOMMENDED IMPROVEMENTS	CURRENT CONDITIONS ADDRESSED
Consider measures to narrow crossing distance across Wyoming Avenue	NA
Improve sidewalk on southeast side of Roosevelt Boulevard between Wyoming Avenue and 6th Street to serve as a shared use sidepath.	1
Construct sidewalks along Wyoming Avenue and Roosevelt Boulevard.	1
Improve existing curb ramps to make them ADA accessible.	2
