APPENDIX D: CONCEPTUAL RECOMMENDATIONS FOR PEDESTRIAN PRIORITY CORRIDORS AND INDIVIDUAL LOCATIONS

This appendix provides additional information on the 48 pedestrian priority corridors and intersections identified in Chapter 6 of the Plan. A summary map and table of the locations is provided as an overview and specific locations are discussed on the pages that follow. Note that some pedestrian recommendations are discussed in the Bicycle Appendix, Appendix E.

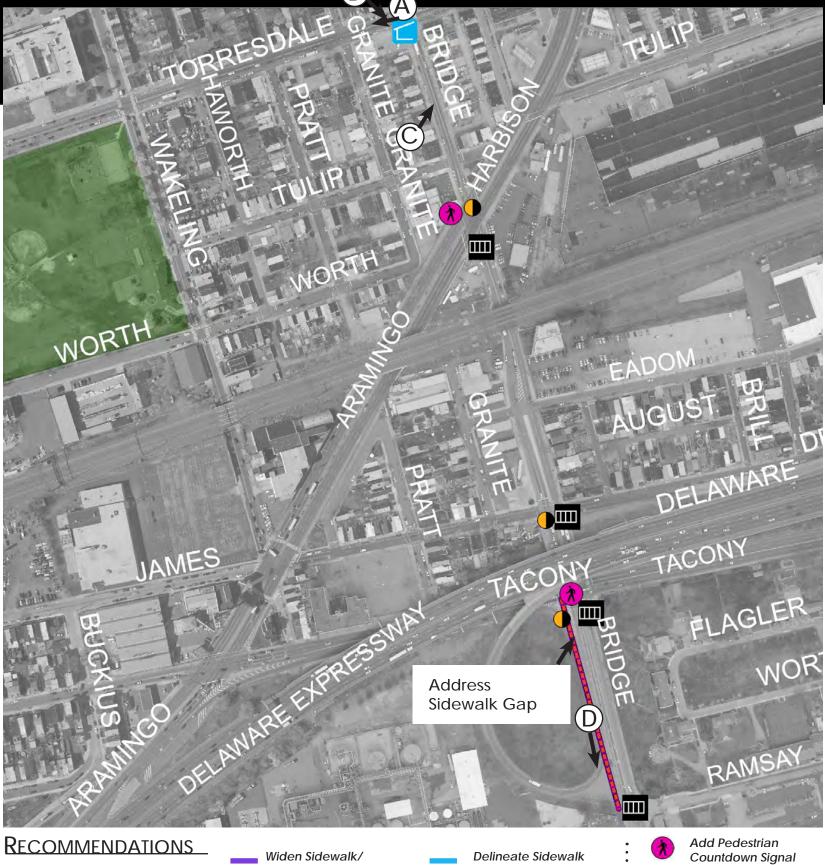
CURRENT CONDITIONS	
1	Poorly maintained crosswalks.	
2	Existing curb ramps need improvement.	
3	Bus passengers at the stop at Bridge Street and Torresdale Avenue have to wait for the bus in a parking lot with no shelter or seating.	
4	Excessively wide, almost continuous driveways, and sidewalks indistinguishable from adjacent parking lots increase possibilities for pedestrian-vehicular conflict e.g., near Torresdale, Aramingo, and Eadom.	
5	Expressway ramps and missing sidewalk makes it difficult to travel along Bridge Street, especially between Tacony and Ramsay.	
6	Bus stop on west side of Bridge at Ramsay is inaccessible due to missing sidewalk north to Tacony and lack of crosswalk at Ramsay.	
7	Excessively long crossings with no median at intersection with Bridge Street and Aramingo/Harbison.	
8	Intersection of Bridge and Tacony Streets suffers from poor visibility caused by elevated expressway and ramp structures, limited sidewalk infrastructure. Left turn lanes are planned on all approaches as part of I-95 project, so both raised median and painted median will be removed

RECOMMENDED IMPROVEMENTS	CURRENT CONDITIONS ADDRESSED
Reconfigure the southwest corner of the intersection of Bridge and Torresdale, possibly using a curb extension, to create an improved passenger waiting area, separated from vehicular traffic, with a shelter or bench and other amenities.	3
Consider visual or physical measures to demarcate the sidewalk from driveways and parking lots.	4
Restripe existing crosswalks using high visibility pavement markings, for example at the intersection of Bridge Street and Harbison Avenue.	1
Evaluate alternatives to provide pedestrian access to bus stop at Bridge and Ramsay, including extension of west sidewalk from Tacony to Ramsay, or new crossing at Ramsay. Alternatively, consider moving the bus stop further south where crossing may be safer.	5, 6
Add pedestrian signals with countdowns at Bridge Street intersections with Aramingo/Harbison and with Tacony Street.	7, 8

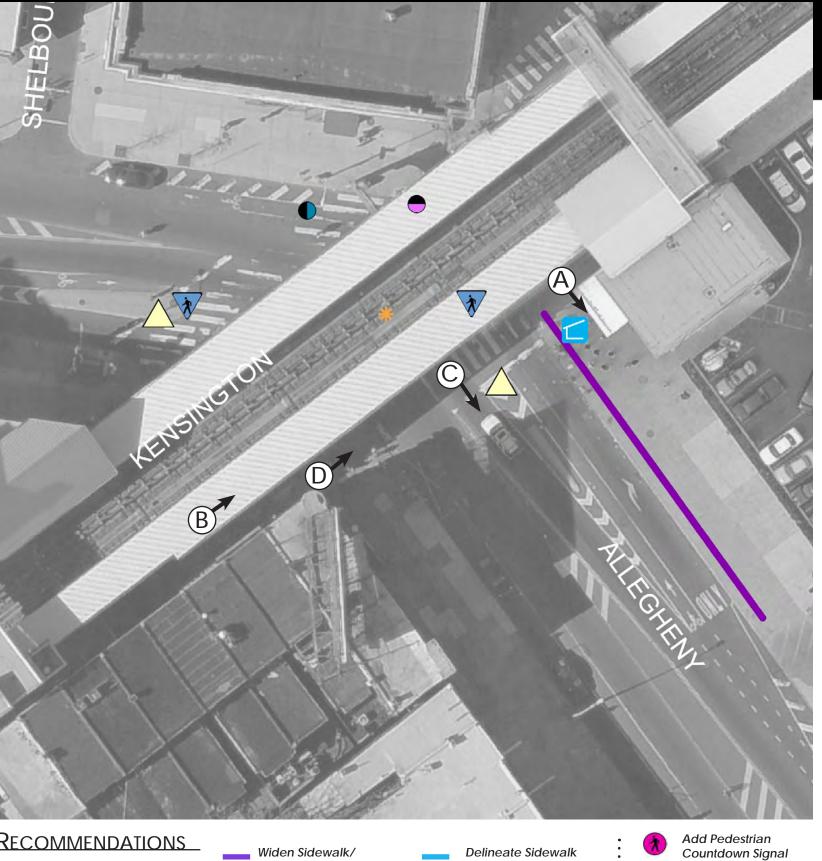
CURRENT CONDITIONS		
1	Existing medians on Allegheny may be confusing to pedestrians because they don't separate opposing traffic.		
2	Lighting under the tracks appears to be limited.		
3	Wide turning radii encourages/enables drivers to turn at a high rate of speed.		
4	Existing curb ramps need improvement.		
5	Busy transit station with many passengers transferring to intersecting bus routes.		
6	Long pedestrian crossing distances.

RECOMMENDED IMPROVEMENTS	CURRENT CONDITIONS ADDRESSED
Consider Leading Pedestrian Intervals.	3
Reduce pedestrian crossing distances.	6
Consider signs to warn pedestrians to look both ways as they cross the medians on Allegheny Ave.	1
Improve lighting under the transit tracks.	2
Provide a tree or landscape buffer on Allegheny Ave south of Kensington Ave to improve the pe- destrian environment while contributing to "green street" goals	NA
Add bus shelter or benches on Allegheny Ave.	5

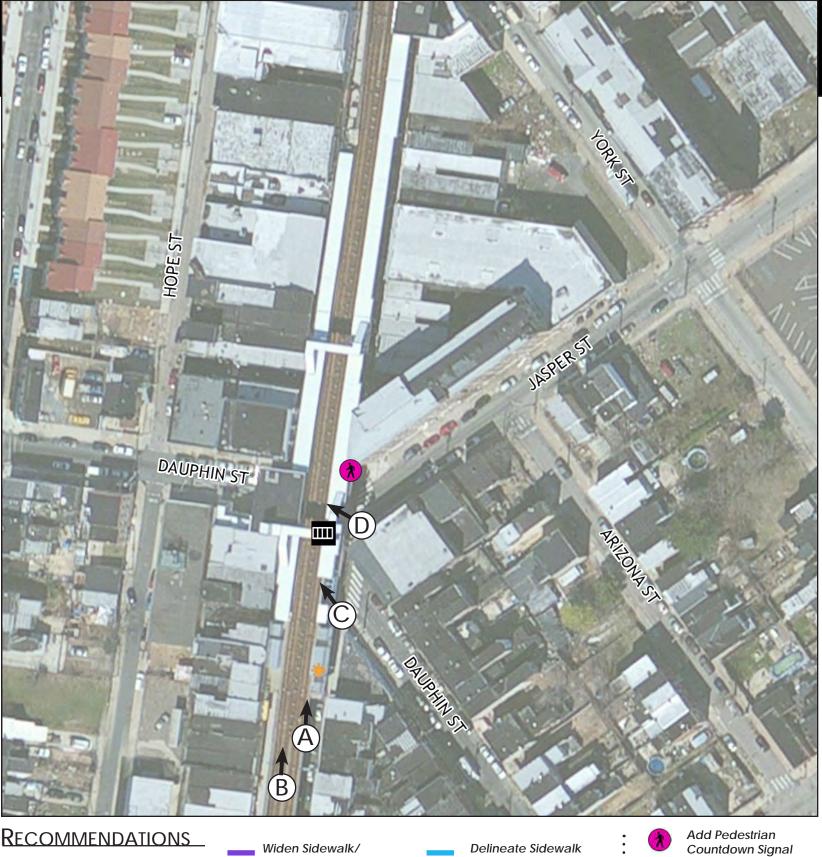
CURRENT CONDITIONS

Significant pedestrian demand forcrossings at locations lacking traffic control and concern about "dart outs".

RECOMMENDED IMPROVEMENTS	CURRENT CONDITIONS ADDRESSED
	Consider formalizing uncontrolled crossing locations given existing pedestrian demand; if so, consider crosswalk, pedestrian signal, and on-street parking reduction to improve sight lines. Evaluate whether an exclusive pedestrian phase would be possible given existing pedestrian desire lines and diagonal streets.	1
	Improve existing curb ramps throughout the corridor to make them ADA accessible.	NA
• •	Evaluate lighting conditions along Front Street under the elevated tracks and improve where needed.	NA

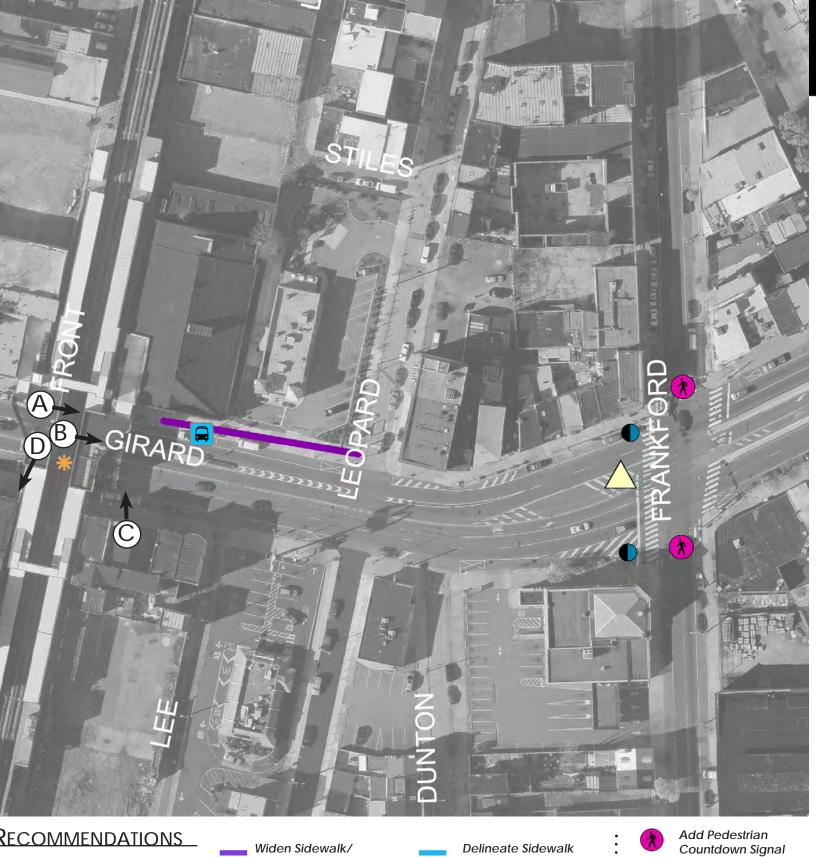
CURRENT CONDITIONS		
1	The waiting area for transit passengers along Girard Avenue is narrow.	
2	Wide turning radii encourages/enables drivers to turn at a high rate of speed.	
3	Lighting under the tracks appears to be limited.	
4	Minor street crosswalk markings are barely visible.	
5	There is no buffer between the sidewalk and the road.	
6	Long pedestrian crossings at Girard and Frankford.

RECOMMENDED IMPROVEMENTS	CURRENT CONDITIONS ADDRESSED
Add buffers to sidewalk where missing, especially where no parking is adjacent.	5
Consider relocation of bus stop on northeast corner of Girard and Front to far side to encourage passengers to walk away from the bus before crossing the street.	NA
Restripe crosswalks on minor streets.	4
Consider adding pedestrian countdown signal for crossing of Frankford at Girard Avenue.	6
Consider measures to reduce crossing distance and reduce turning radii on the west side of Frankford and Girard, such as curb extensions and/or a pedestrian refuge island.	2, 6
Create nodes of light to define station areas.	3
Consider Leading Pedestrian Intervals where wide turning radii encourage high speed turns.	2
Following I-95 Revive projects, evaluate need for two travel lanes in each direction on Girard east of Front Street. Reconfiguration might allow addition of bike lanes and improved pedestrian crossings.
