ADDRESS: 1830 RITTENHOUSE SQ, UNIT 6A

Proposal: Replace Windows

Review Requested: Final Approval

**ROSEN RESIDENCE
1830 RITTENHOUSE SQUARE
UNIT 6A
PHILADELPHIA, PA 19103**

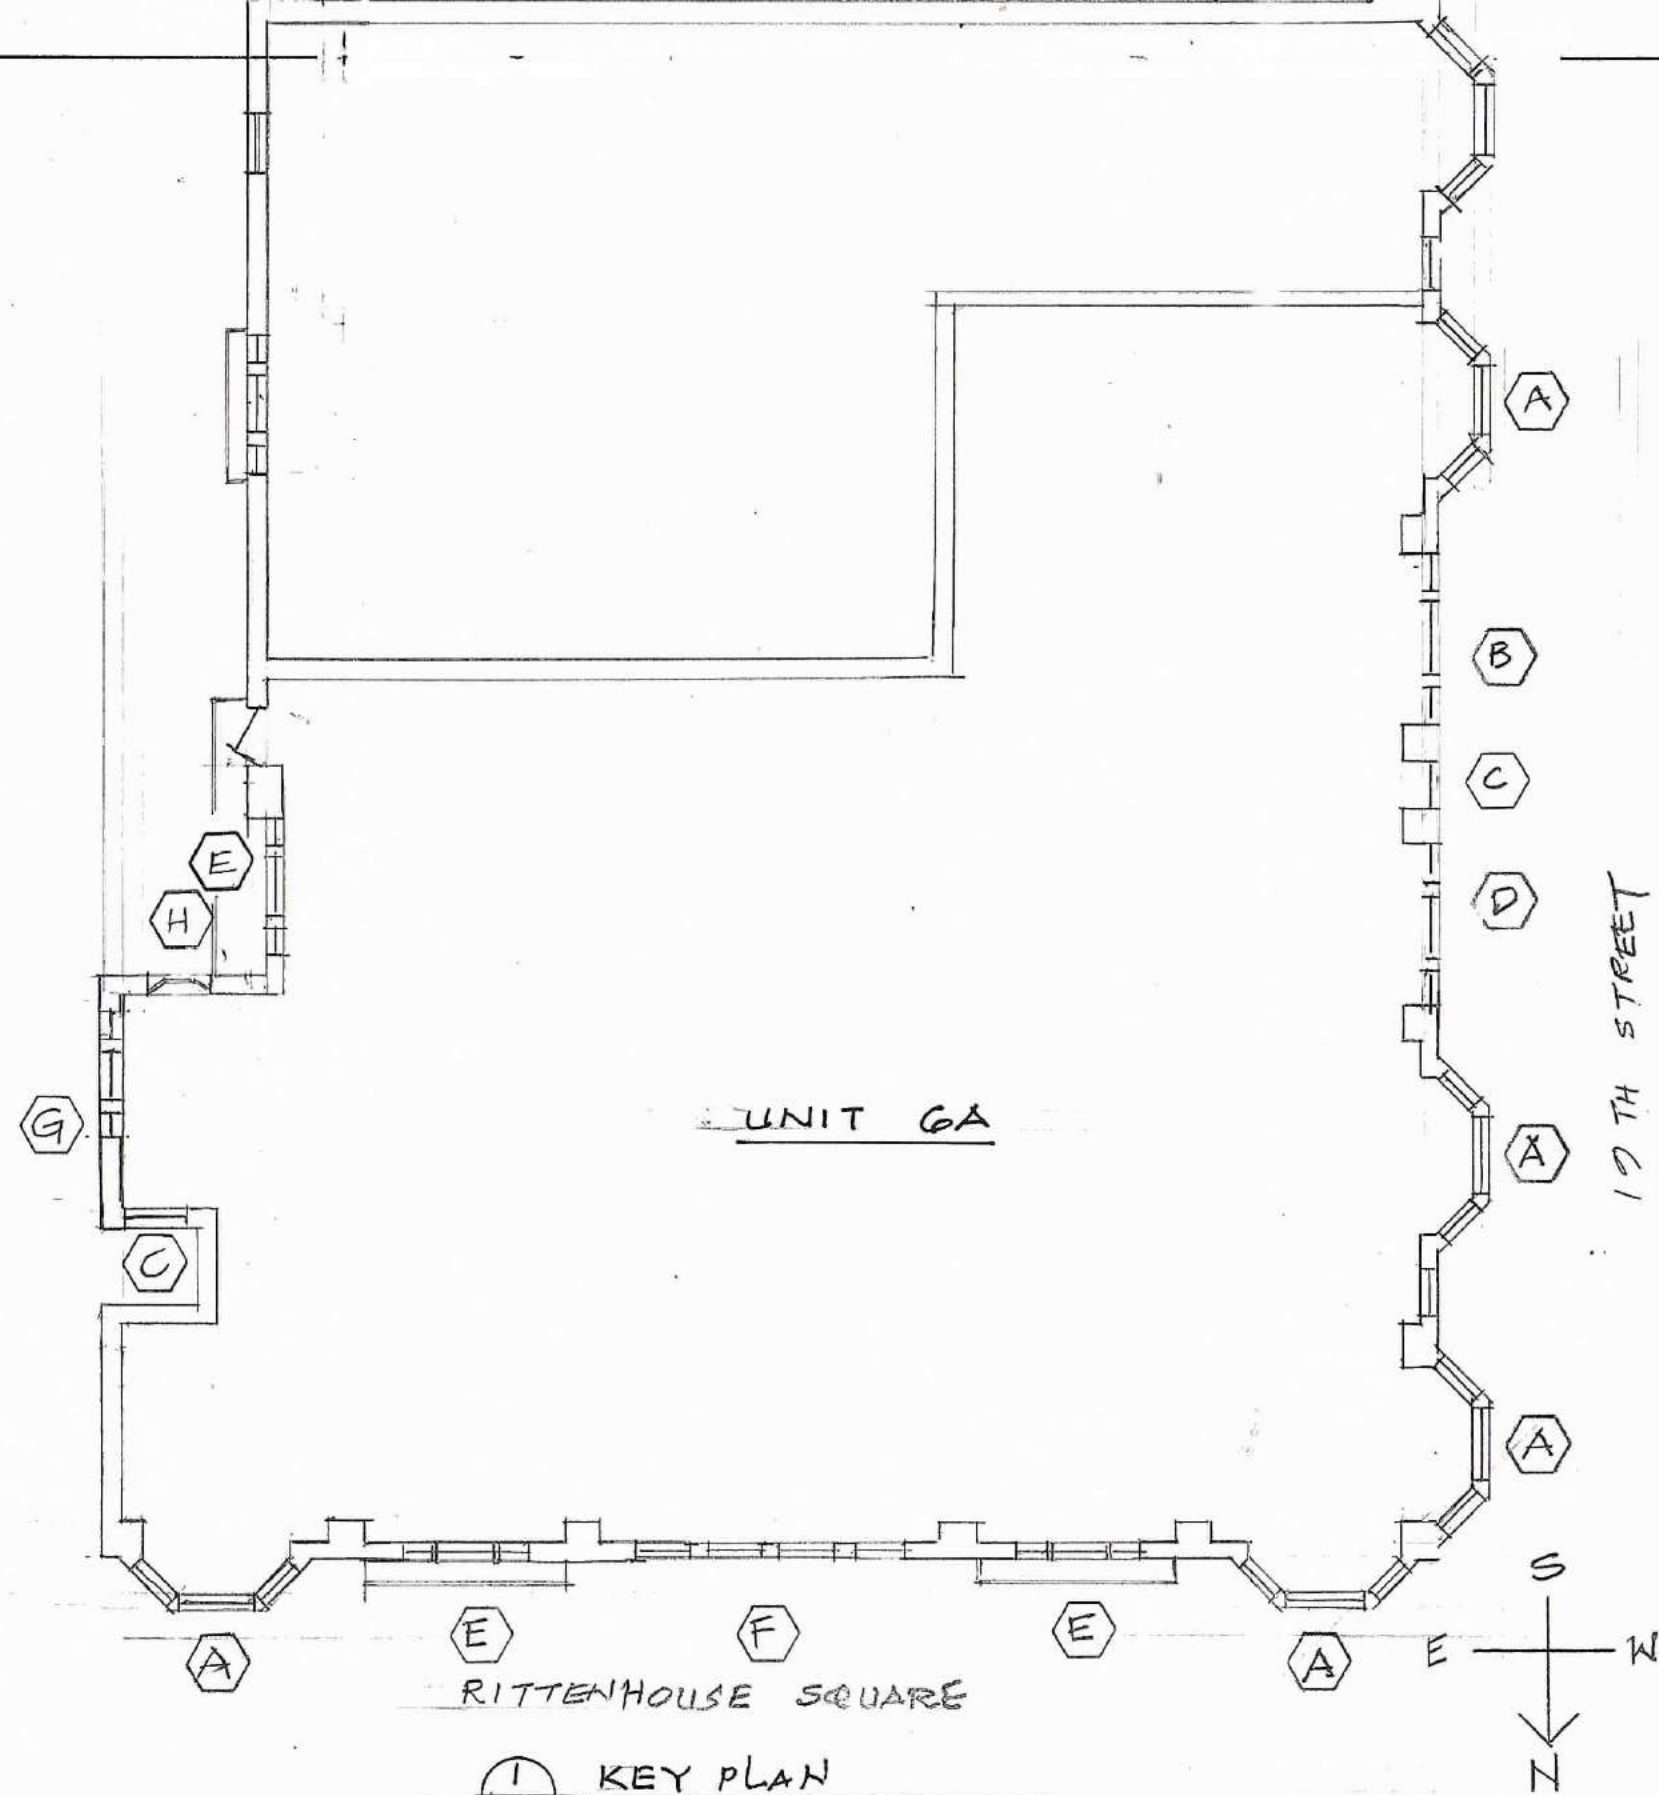
1 KEY PLAN
SK-1 NO SCALE

**(10) Metal Flanking 1/1 Double Hung Windows at Bays Type "A" on Plan SK-1. Elevation 1- SK-2
(6) on 19th Street West Elevation and (4) on North Elevation Rittenhouse Street. Pictures 4,5,6,7 and 8
With Wood Historically Correct 1/1 Sash Kits.**

**They are also replacing a Bay Window on the South Elevation "H" on Plan SK-1. Picture #9 and #10
with A Historically Correct Bay Window. Pictures # 11 and #12 Detail 4 on SK-3**

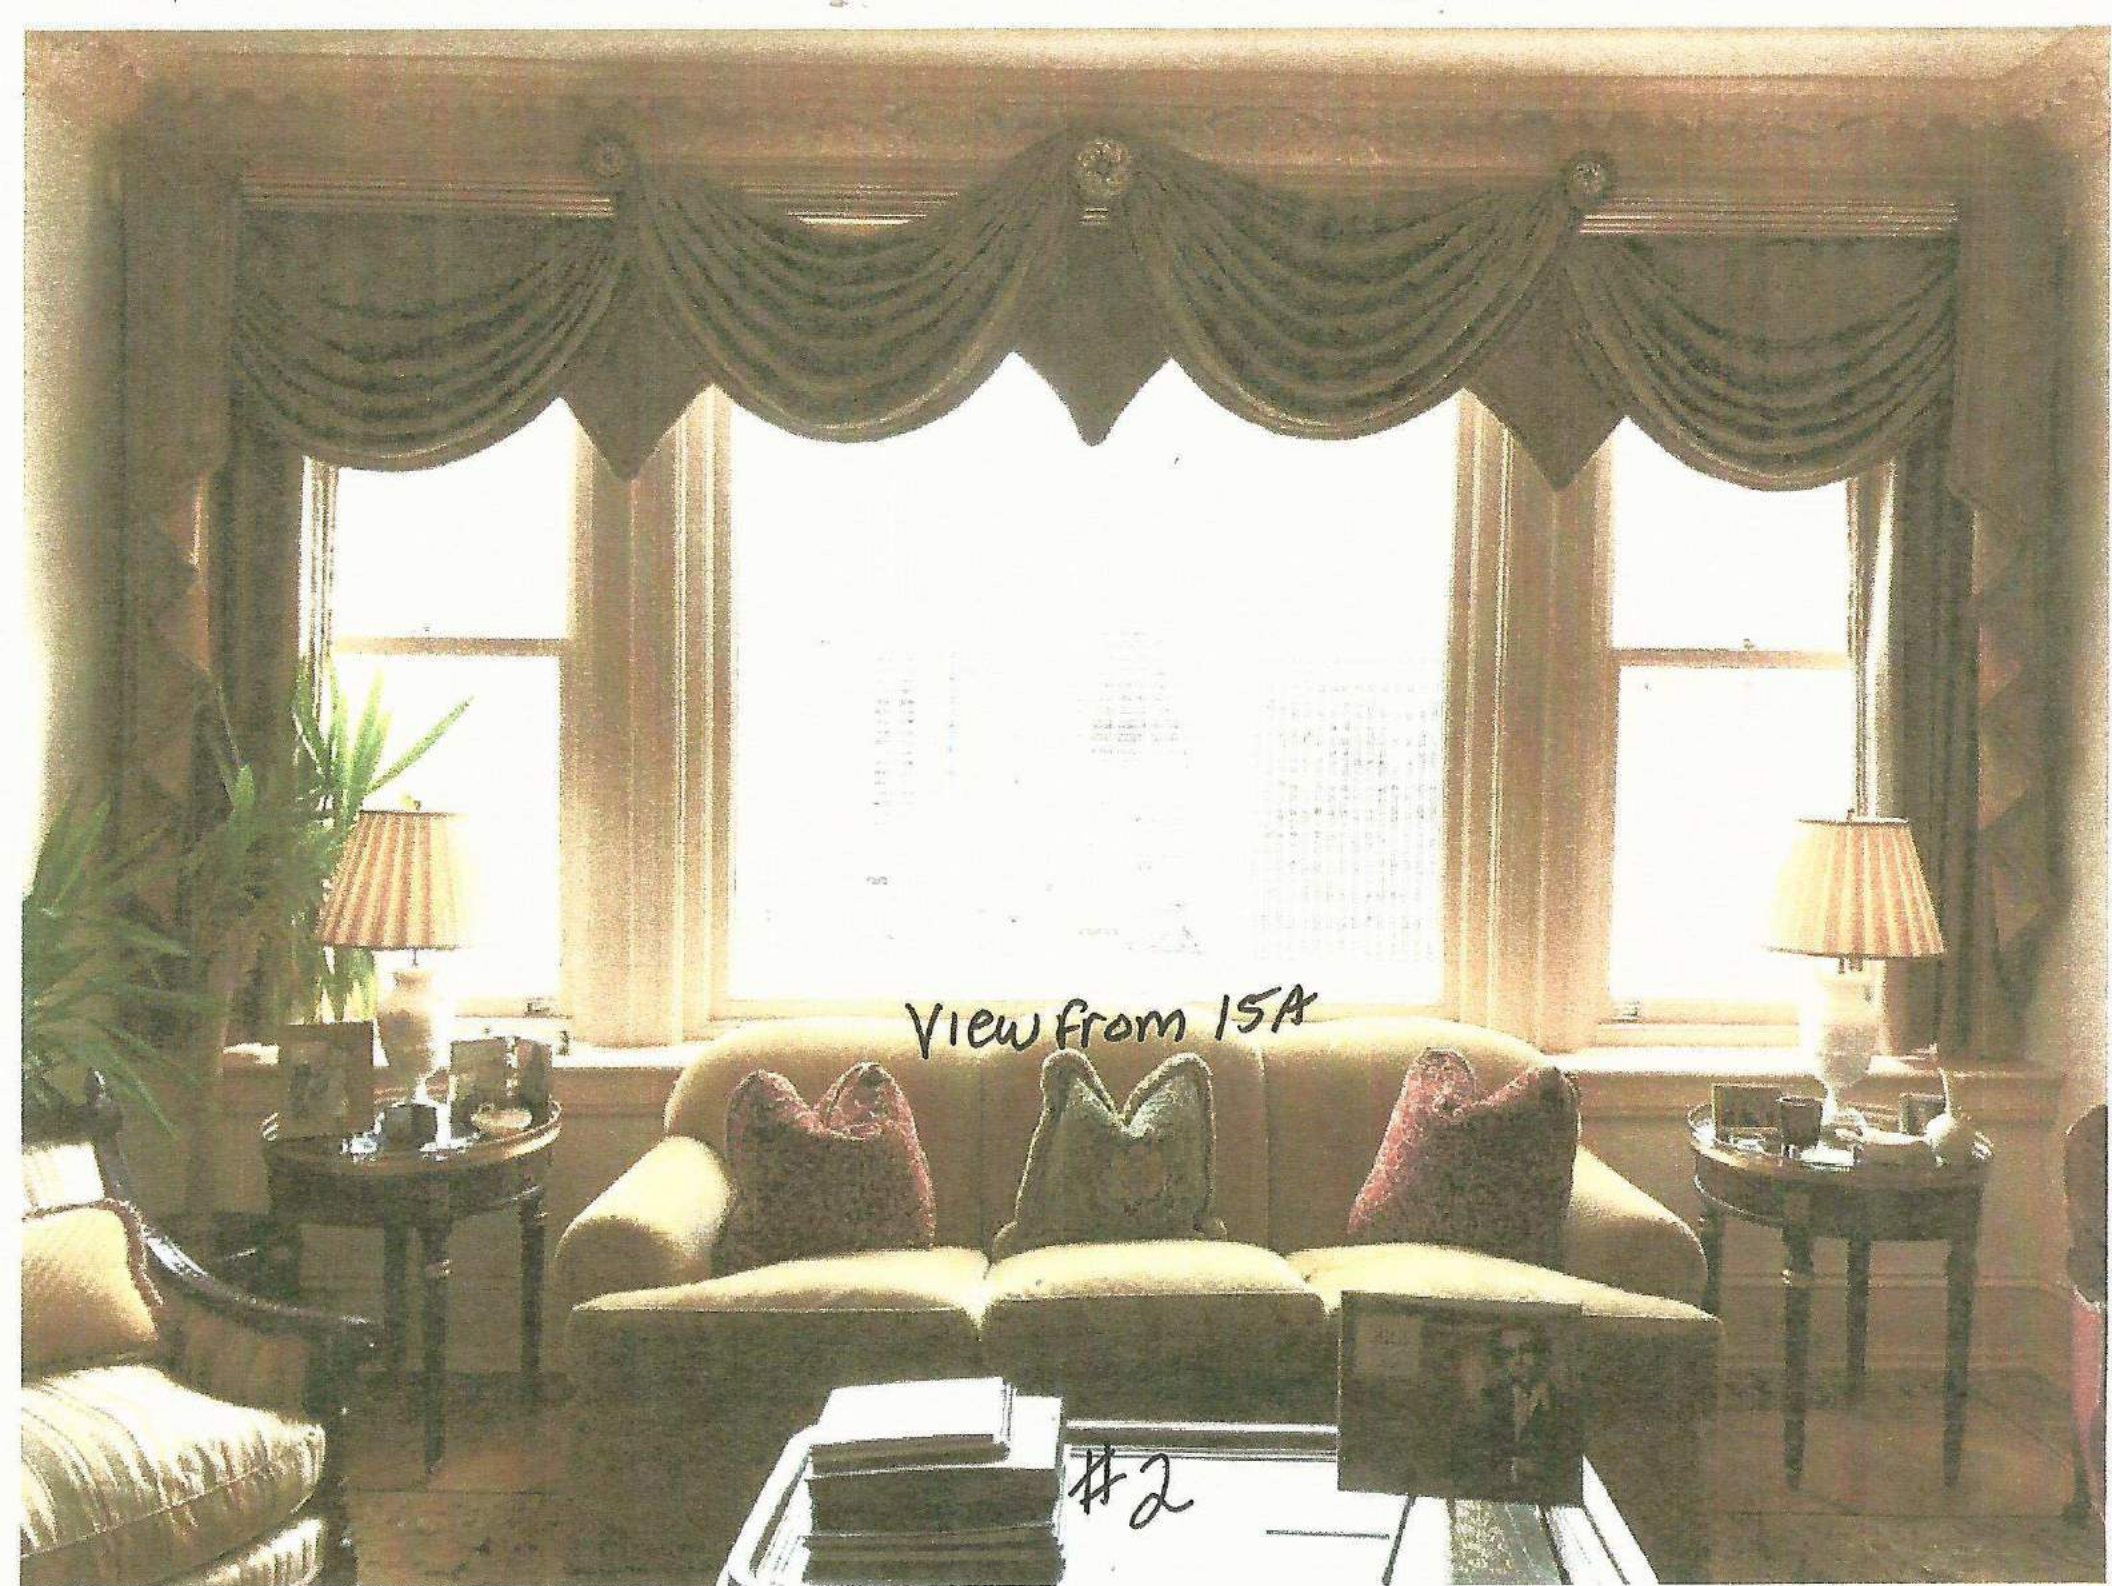
#2

Similar Windows

Replace the existing
(4) casement
windows in 6-A with
a new (2) double
hung and (1) fixed
center window unit

**Paul and Wendy Rosen would like to remove the (4) Casement Windows on the North Elevation
And Install A Center Picture Window and (2) Flanking 1/1 Double Hung Windows.
(See Pictures #1 and #2)**

**Please note on Picture #3 there are (5) Picture Windows in that North Elevation.
4th , 9th, 10th, 11th and 15th Floor.**

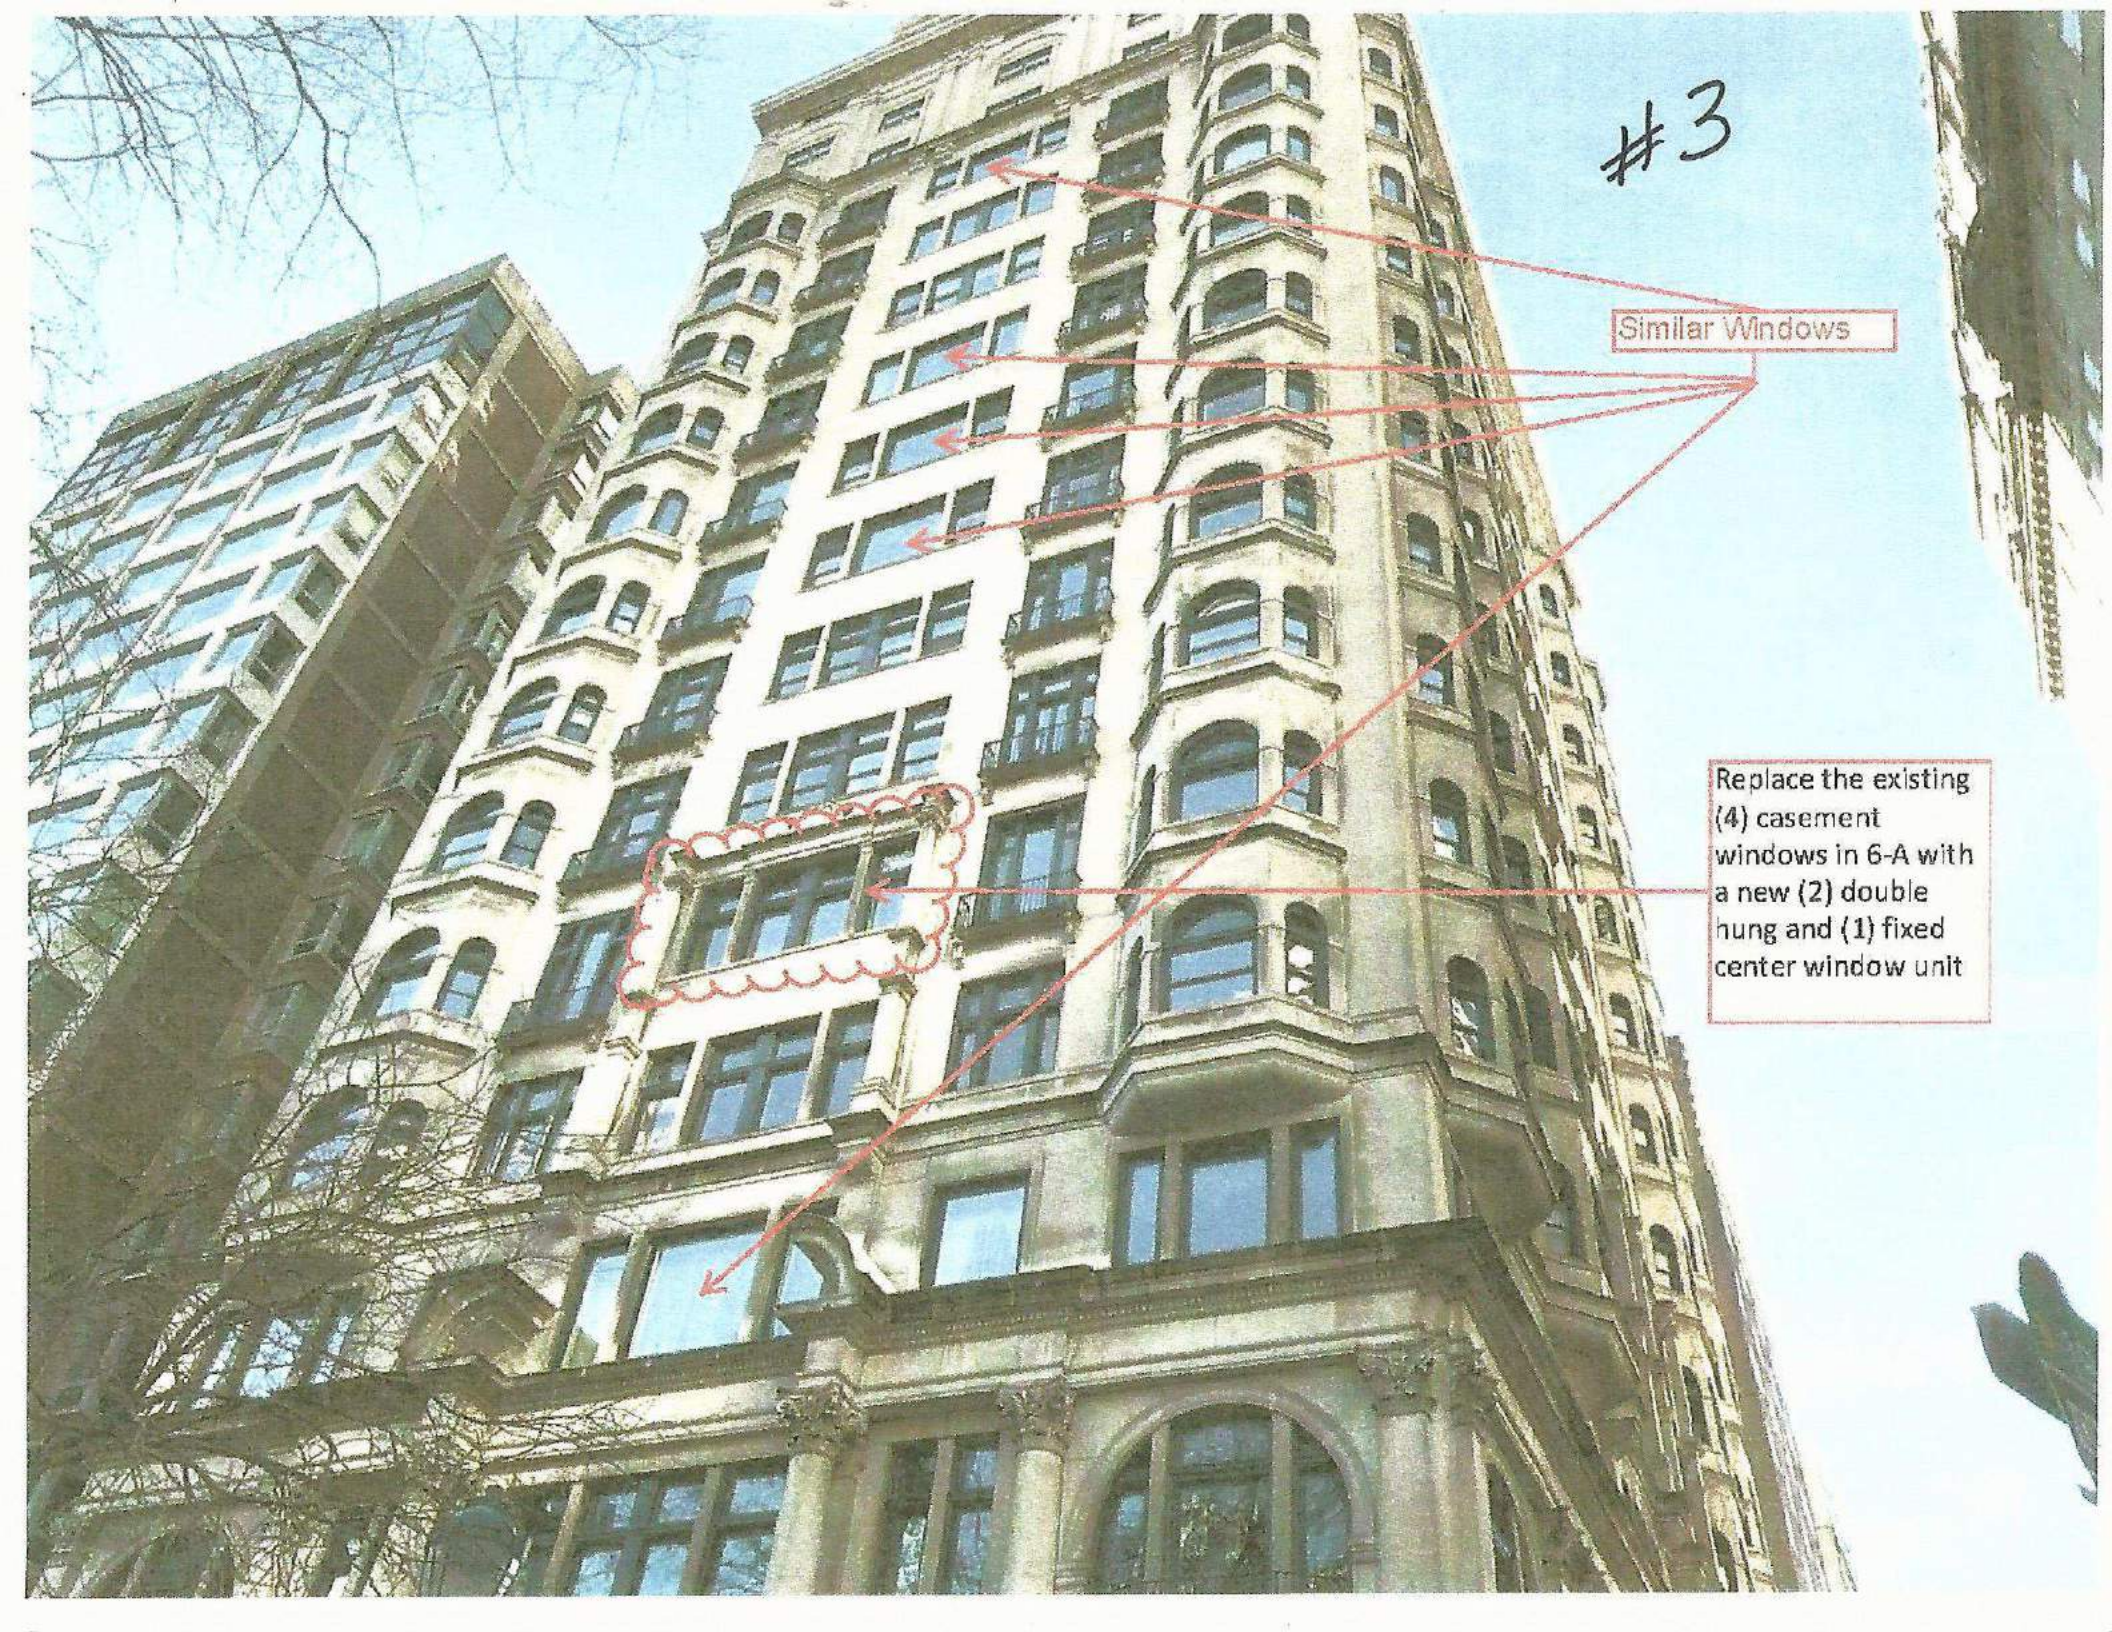
#4

metal

Bay ONE
West Elevation

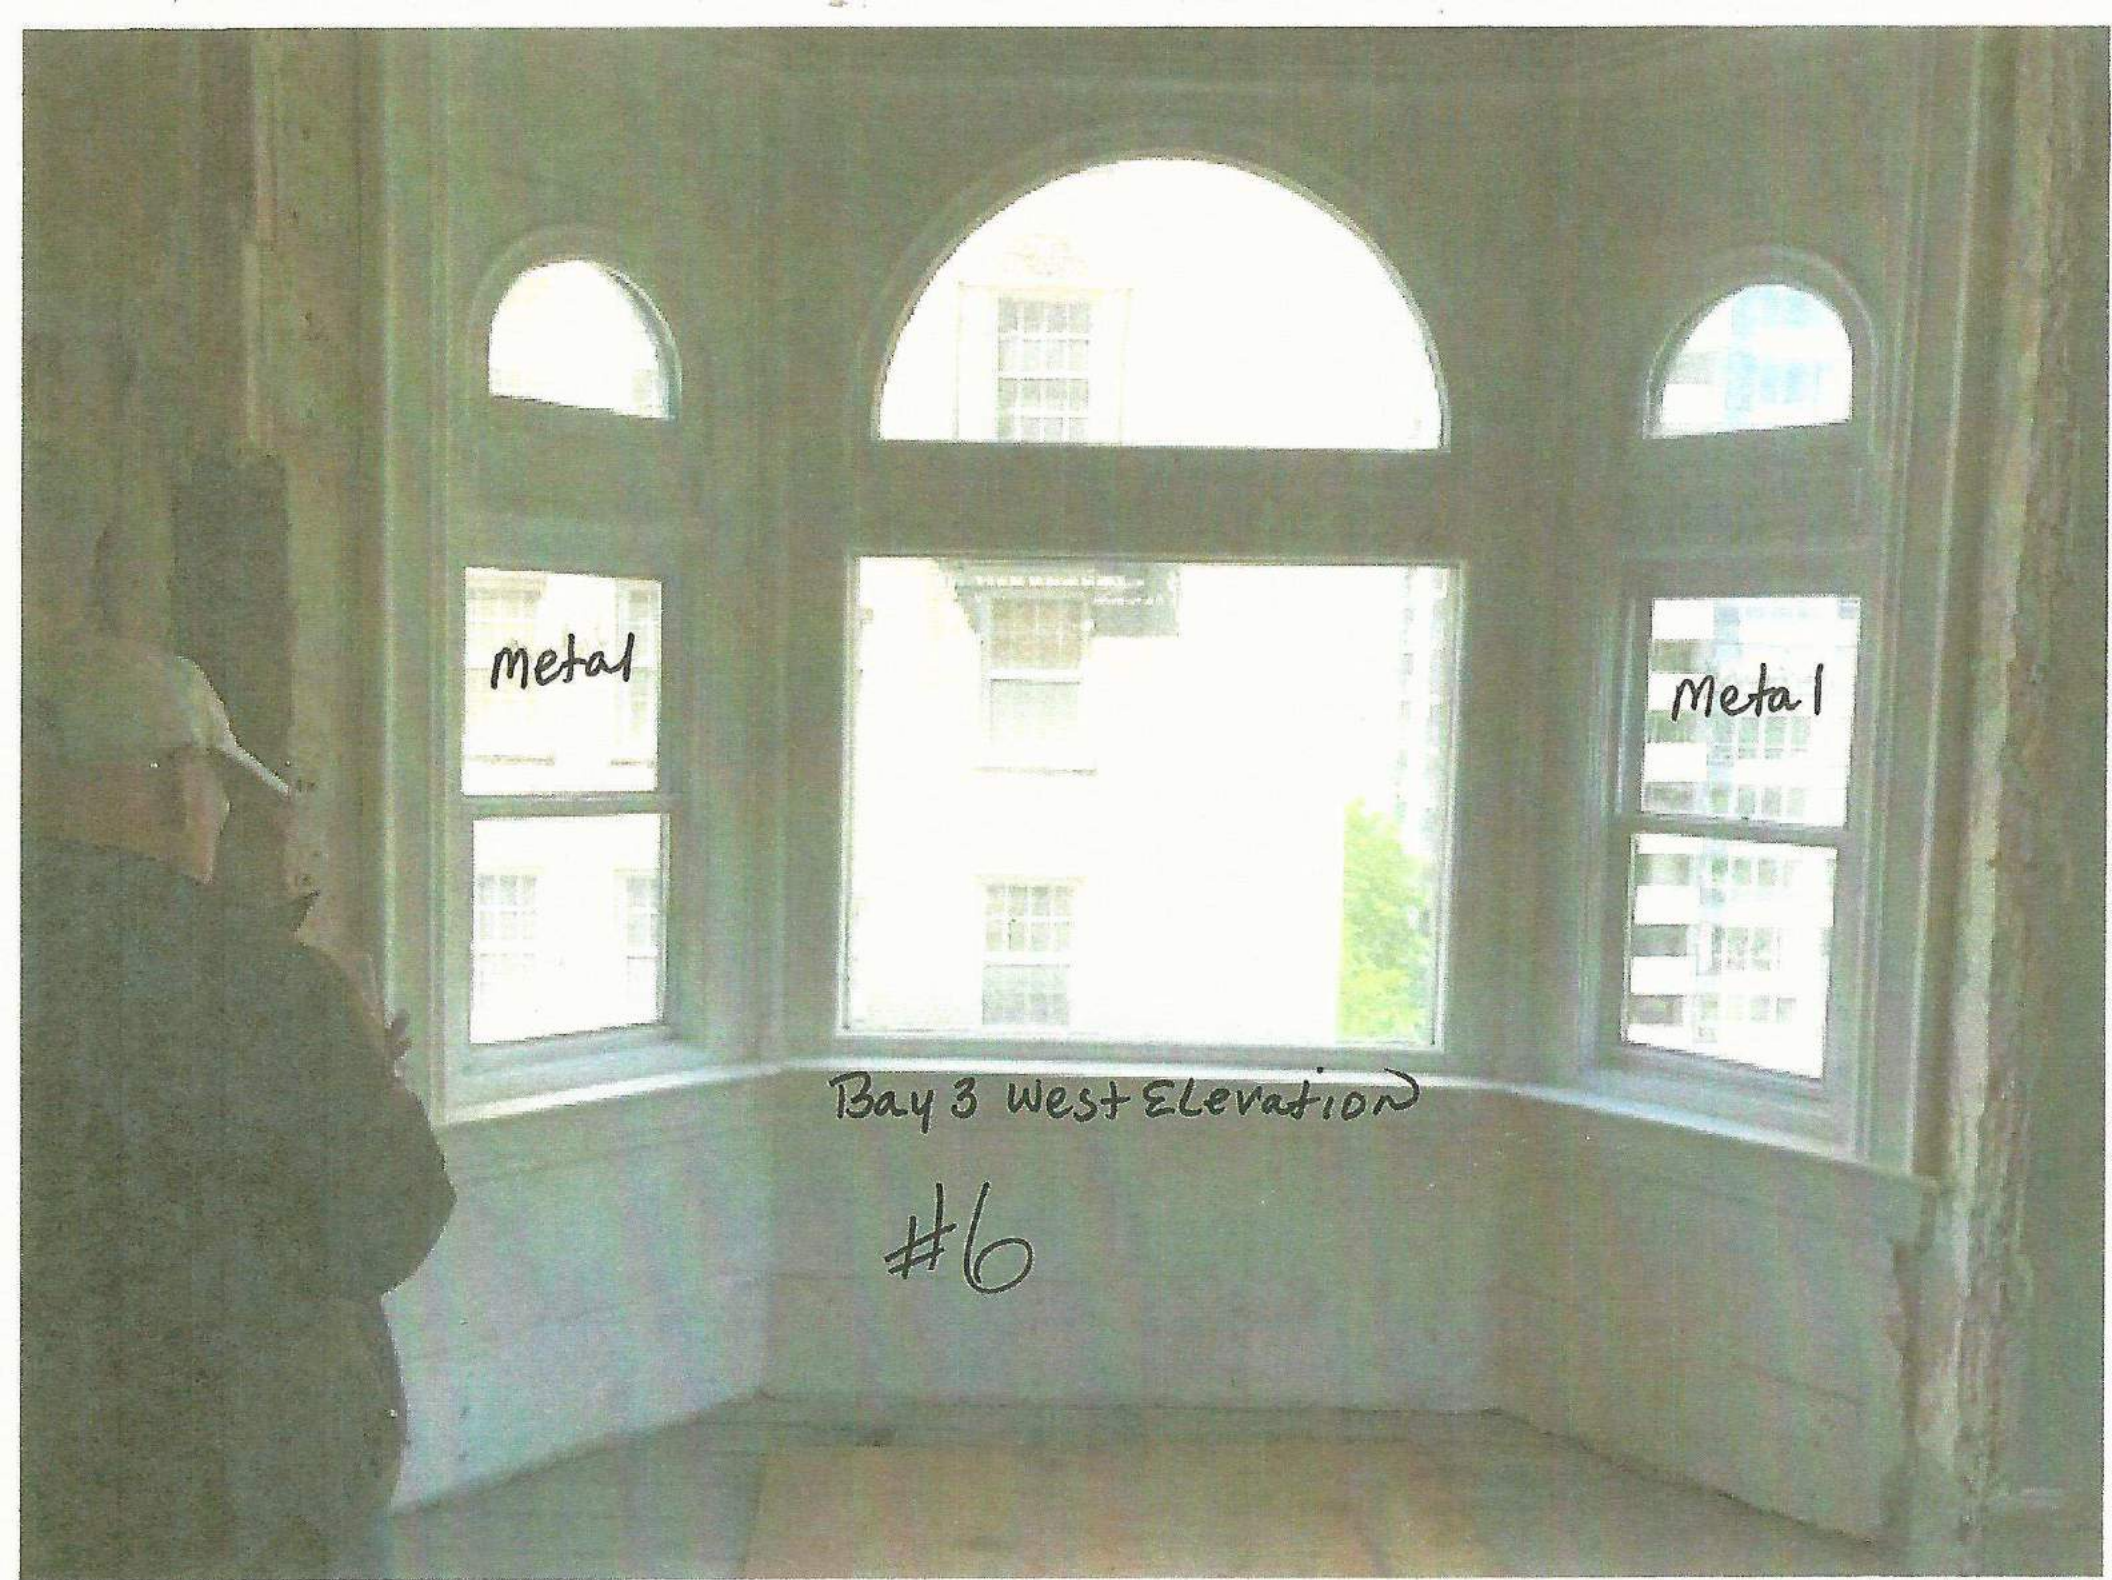
#6

metal

Bay 3 West Elevation

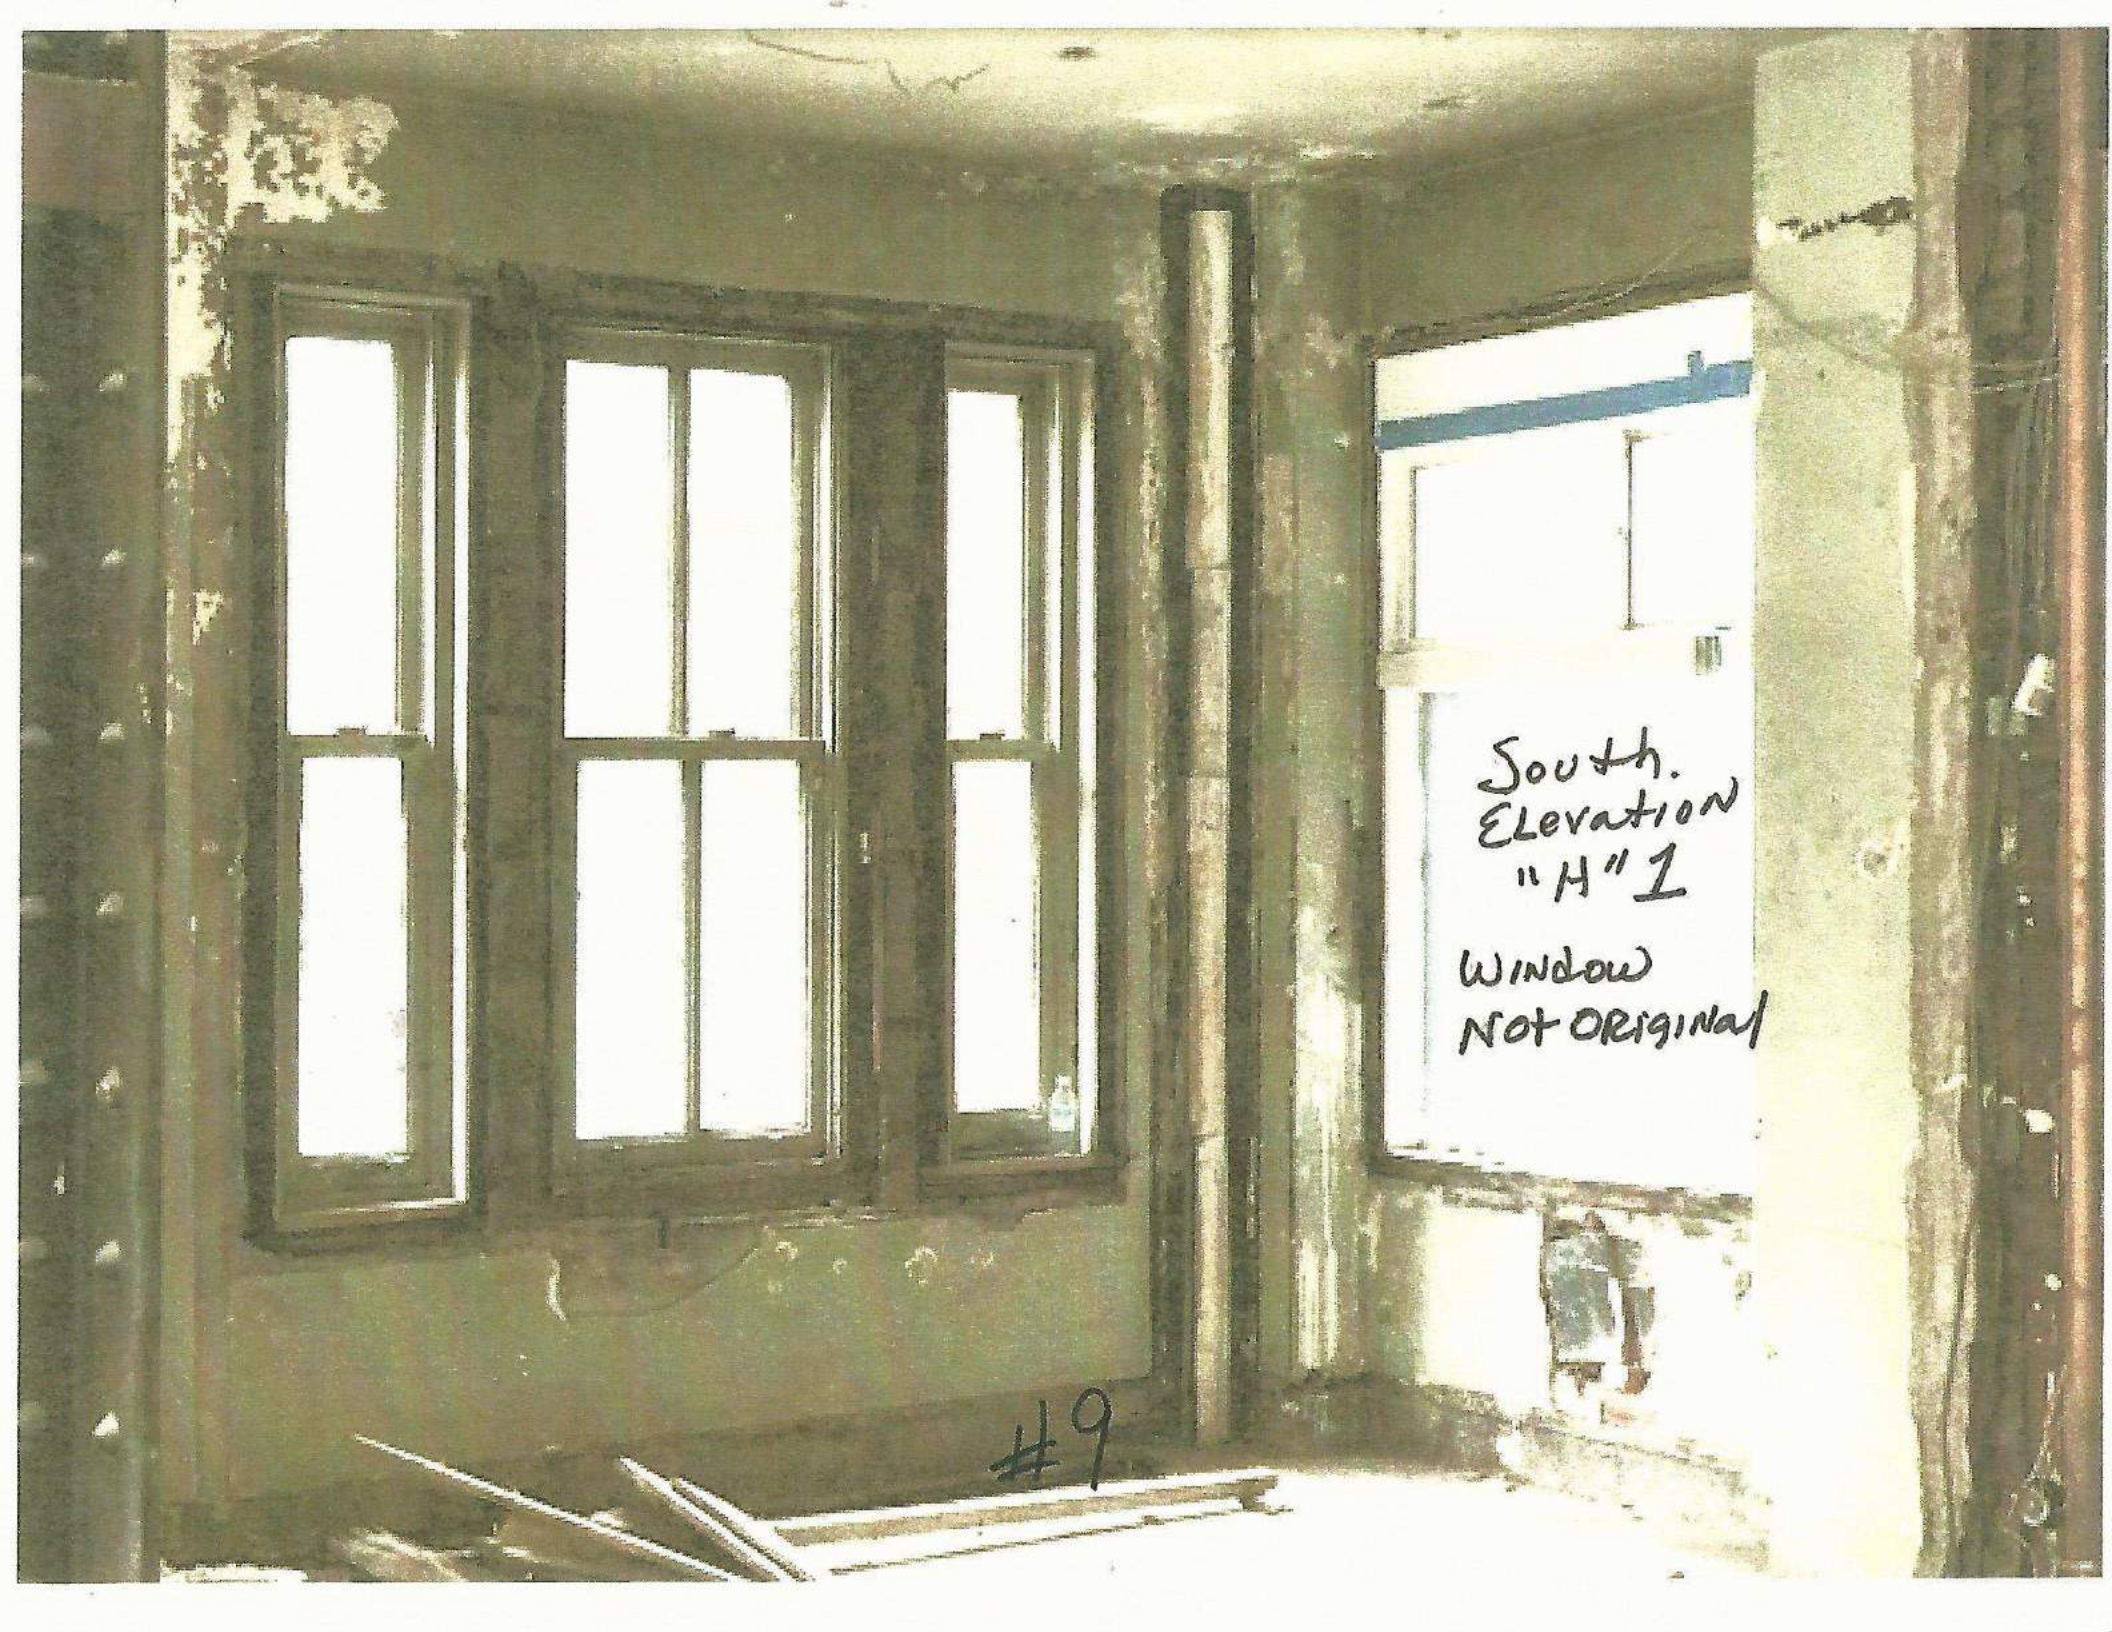
#9

South.
Elevation
"H" 1

Window
NOT ORIGINAL

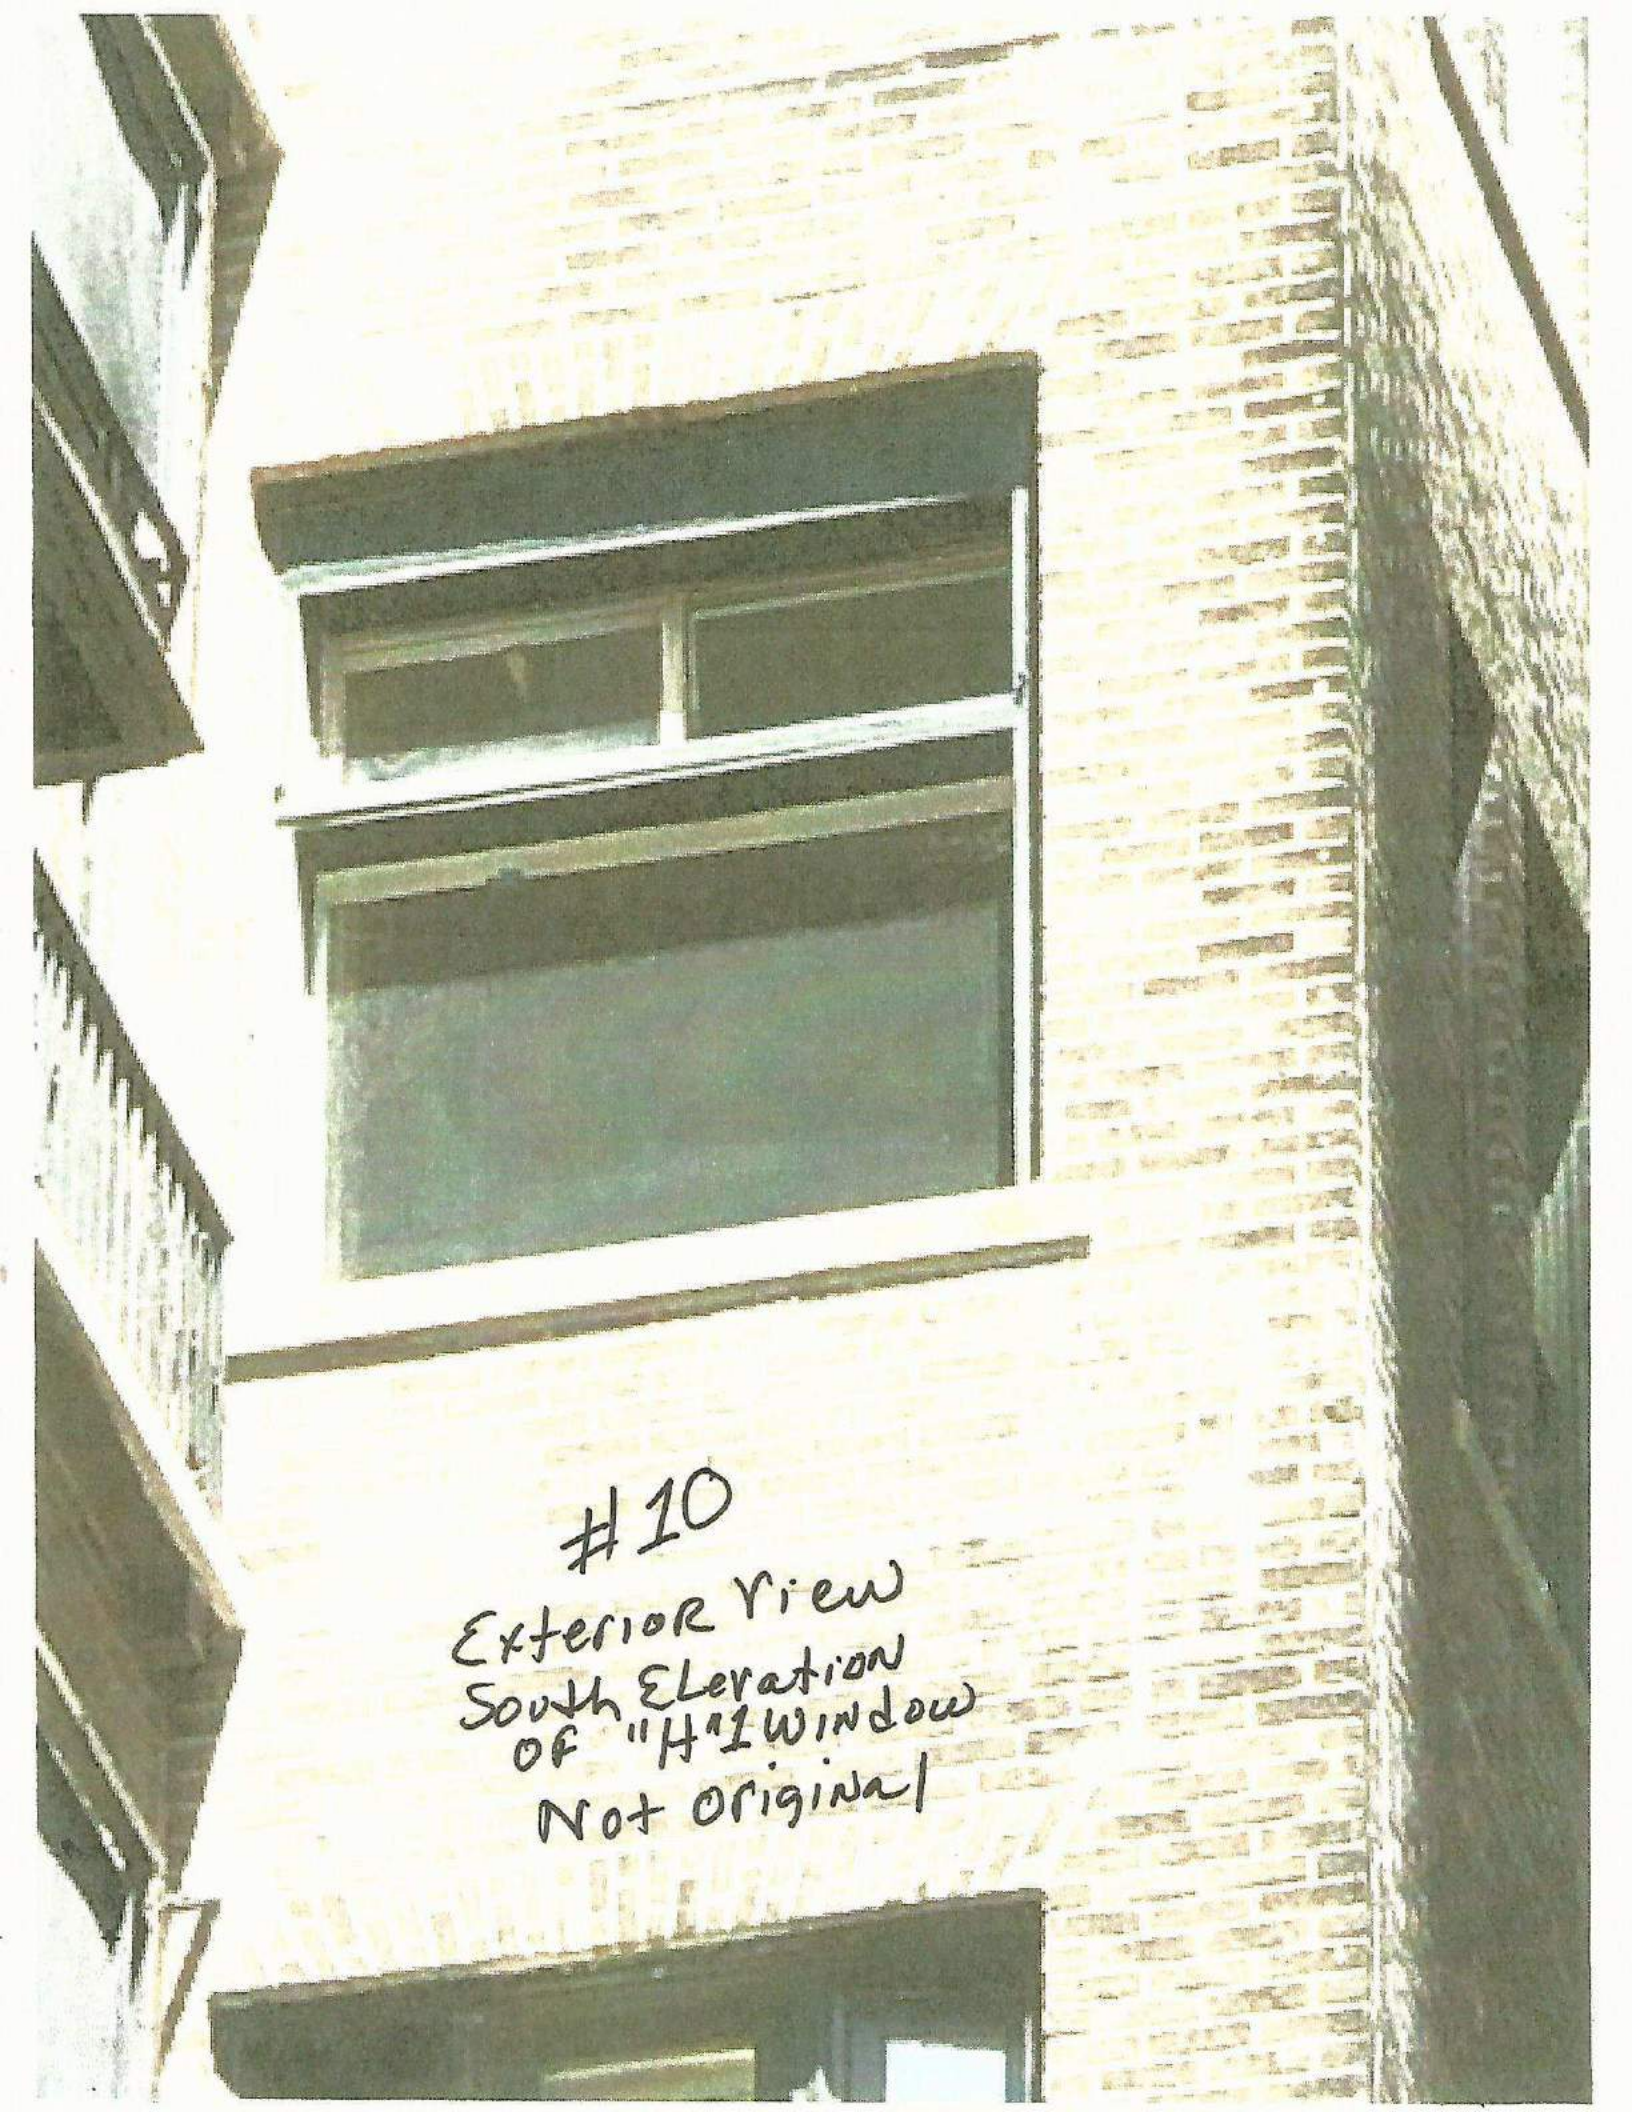
#10
Exterior View
South Elevation
of "H1 Window"
Not Original

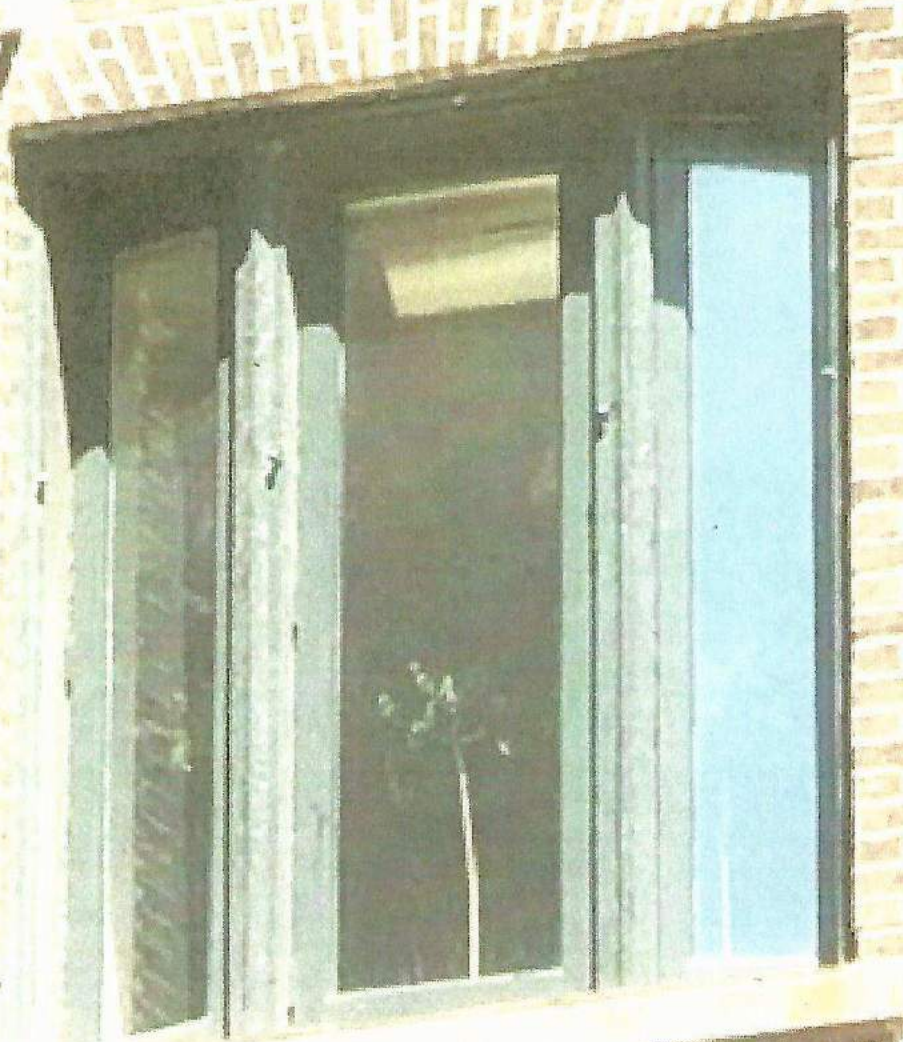
#11

Exterior View
South Elevation
of "H" 2
Original Window
