ADDRESS: 1830 RITTENHOUSE SQ, UNIT 6A

Proposal: Replace Windows

Review Requested: Final Approval

**ROSEN RESIDENCE
1830 RITTENHOUSE SQUARE
UNIT 6A
PHILADELPHIA, PA 19103**

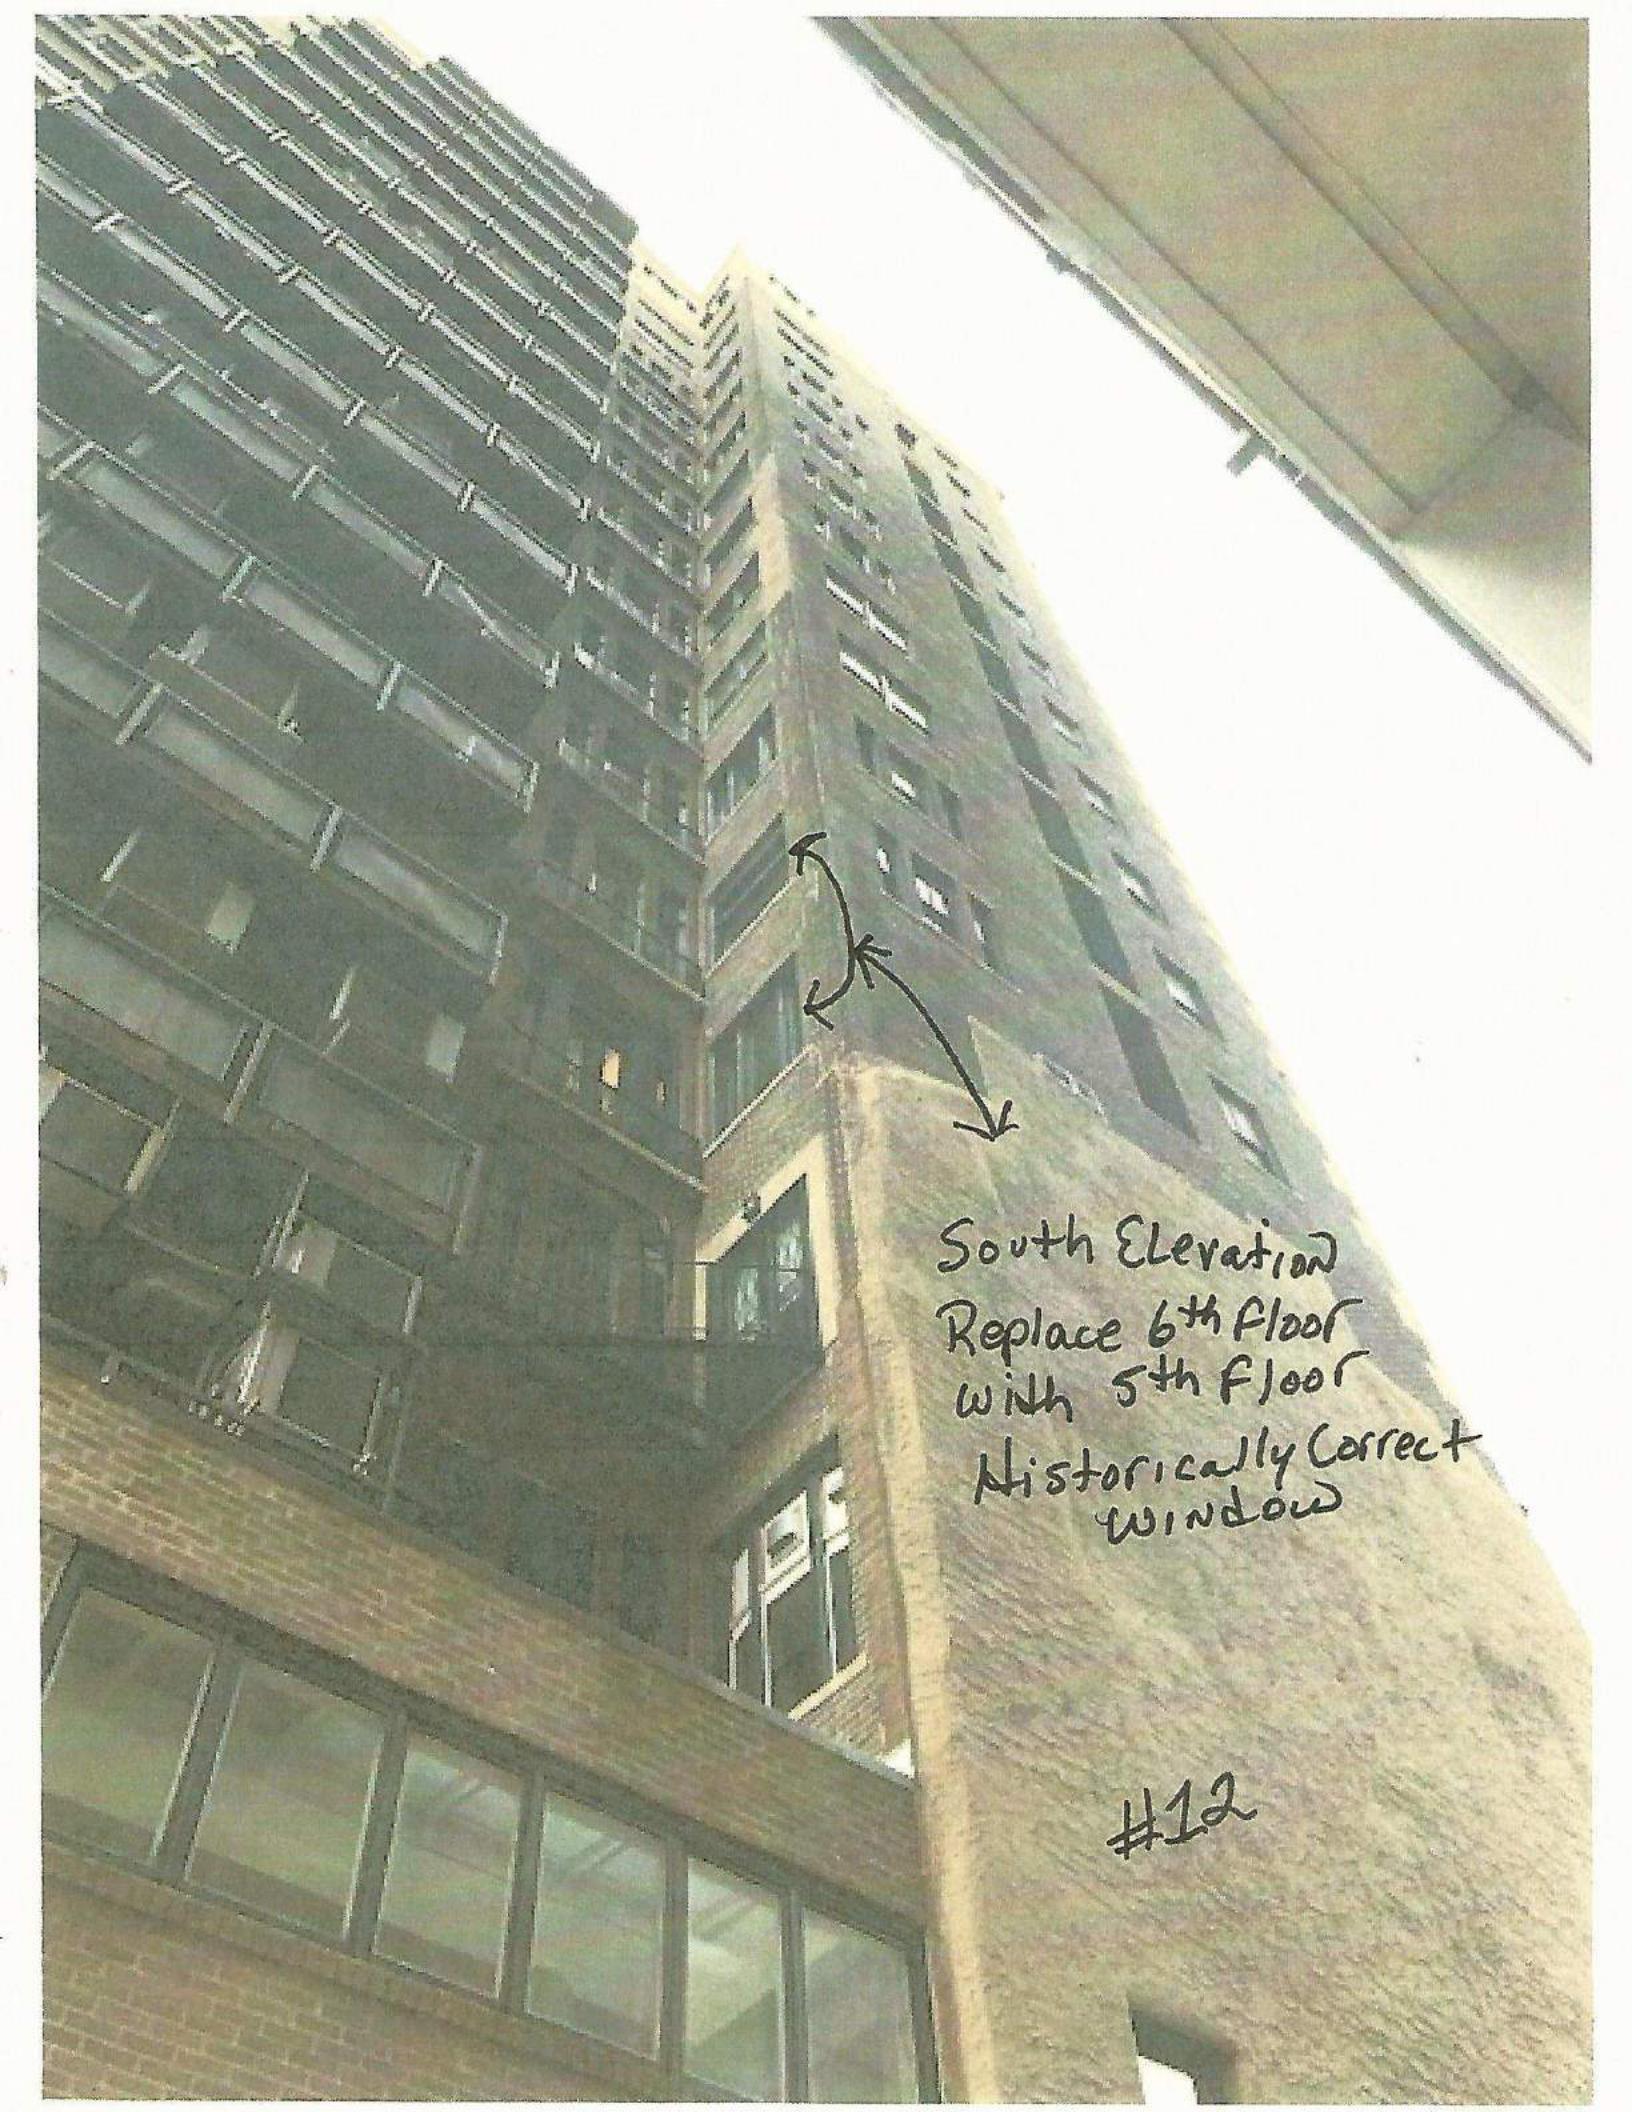
South Elevation
Replace 6th Floor
with 5th Floor
Historically Correct
Window

**They are also replacing a Bay Window on the South Elevation "H" on Plan SK-1. Picture #9 and #10
with A Historically Correct Bay Window. Pictures # 11 and #12 Detail 4 on SK-3**
