COMMENT ON NATIONAL REGISTER NOMINATION

ADDRESS: 4601 MARKET STREET, PROVIDENT MUTUAL INSURANCE BUILDING

Historic name: Provident Mutual Insurance Company

Street & number: 4601 Market Street

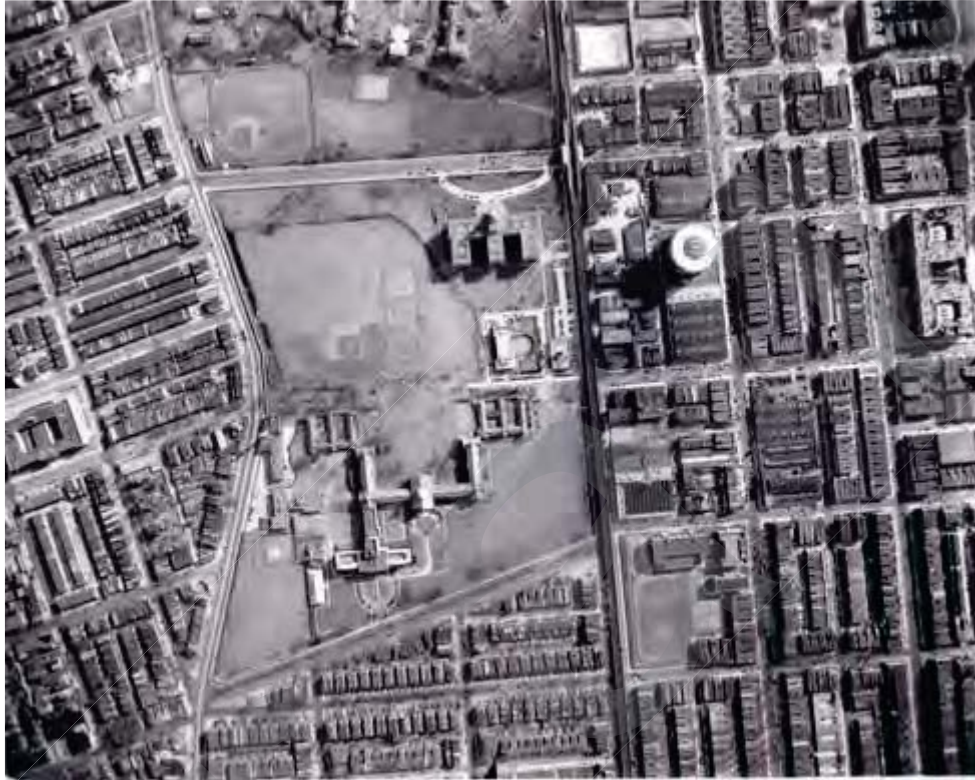
Figure 4: Dallin Aerial Survey, 1938, Hagely Museum Collection

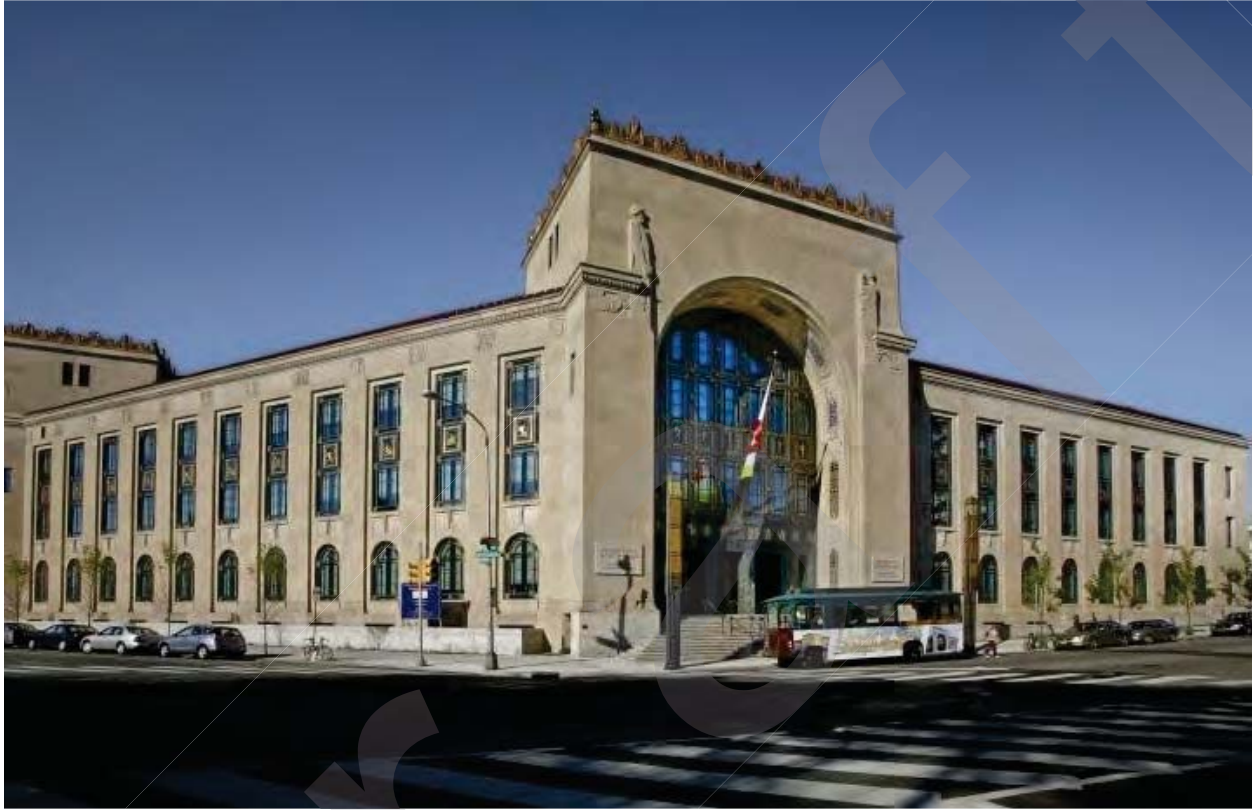
Figure 5: Photo of the Fidelity Mutual Life Insurance Company Building (Image taken from the Philadelphia Athenaeum)

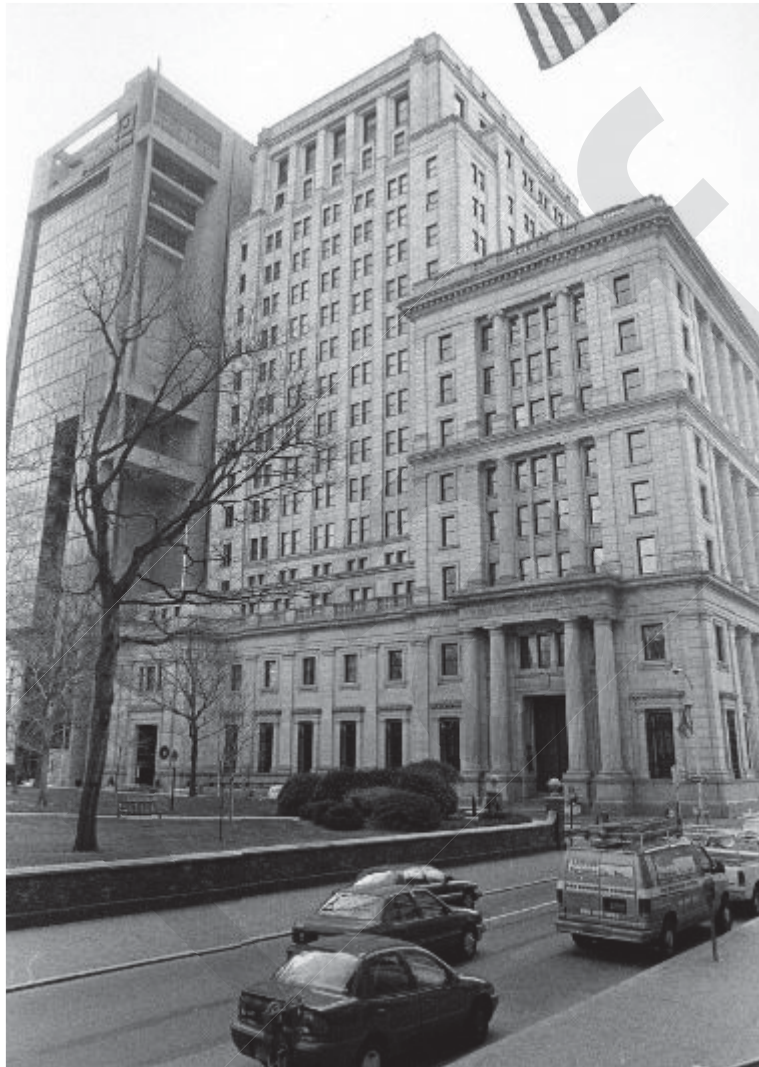
Figure 6: Photo of the Penn Mutual Life Insurance Company Building (Image taken from the Philadelphia Athenaeum)
