## ADDRESS: 3001 BYBERRY RD

Proposal: Construct one-story addition and ADA ramp Review Requested: Review In Concept Owner: Trustees of the Byberry Friends Meeting Applicant: Kate Cowing, Kate Cowing Architect, LLC History: 1808; Byberry Friends Meeting House Individual Designation: 9/12/1974 District Designation: None Staff Contact: Randal Baron, randal.baron@phila.gov, 215-686-7660

Site:	Byberry Meeting House		
Address:	3001 Byberry Road, Philadelphia PA 19154		
Owner:	Trustees of the Byberry Friends Meeting		
Representative: Kate Cowing, Kate Cowing Architect, LLC			
Scope:	One-story addition to the northwest side of the building.		
Review type:	In-concept

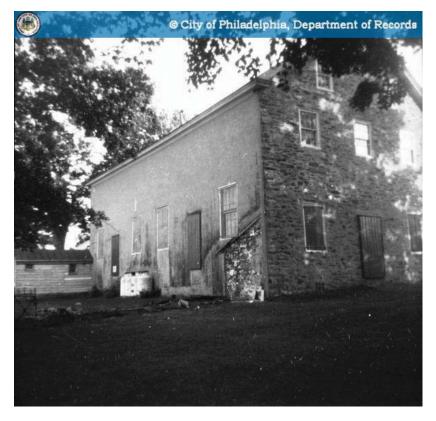
Historic Image 6 -The north elevation, 1964. Note the scar from the recently removed building at the corner. *Credit:* DOR Archives, Historical Commission 12167-6, Asset No. 73480. https://www.phillyhistory.org/ PhotoArchive , retrieved Sept. 20, 2019.

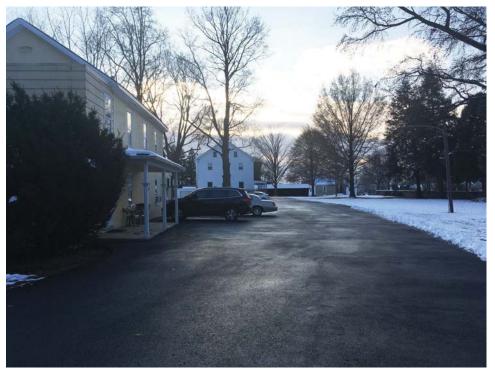
Photo 1 - Facing east at the west entrance. December 2017.

The proposed location is on the west side of the building at an existing side door. A hallway extends from the door to the bulk of the addition set back from the northwest corner of the meeting house. The existing exterior wall will remain exposed within the hall. On the two exterior walls, the hall is enclosed with glass between 6" x 6" posts to suggest an enclosed porch. This is shown in the attached drawings as large glass panels. However, the final design may include casement or hopper windows to provide natural ventilation. An exterior door provides access to an ADA-compliant ramp from the parking lot.

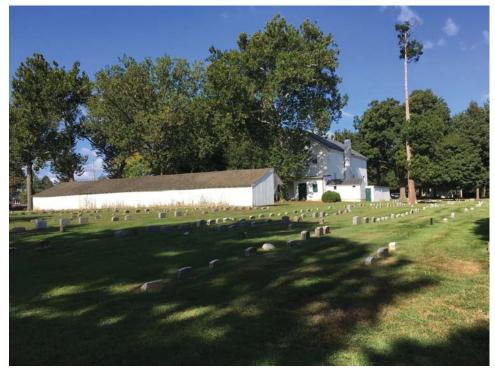
*Photo 11*– The west elevation. September 2019.

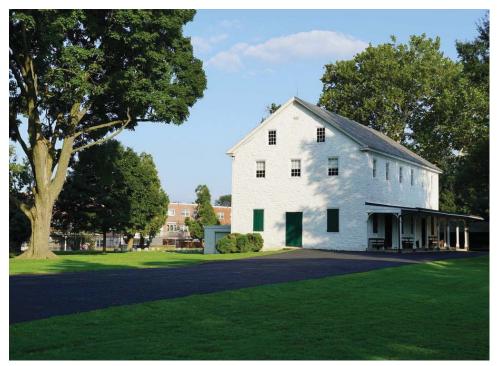
## *Photo 12* - The west elevation. September 2019.

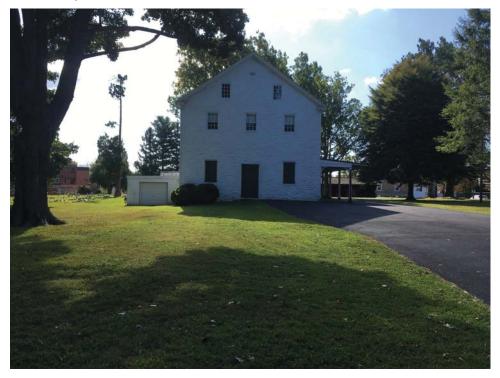
*Photo 13*– The northwest elevation. September 2019.
