RE: Heitzman Recreation Center

I am writing to place an item on the December agenda for the improvements to the Heitzman Recreation Center as part of a Rebuild project. Due to the limited improvements for both the Building and Site aspects we are requesting administrative approval for this project. Below you will find a description of the existing conditions, the purpose and proposed improvements, and the contact information required for this project. Please verify if administrative approval can be sought based on the provided information.

HEITZMAN RECREATION CENTER

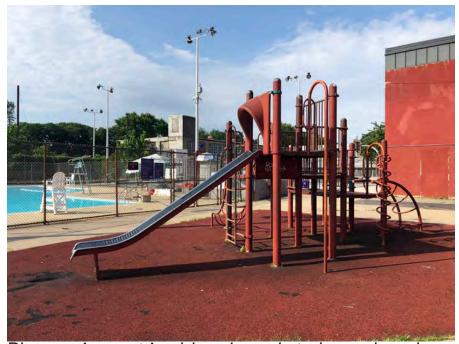
Play equipment is old and needs to be replaced

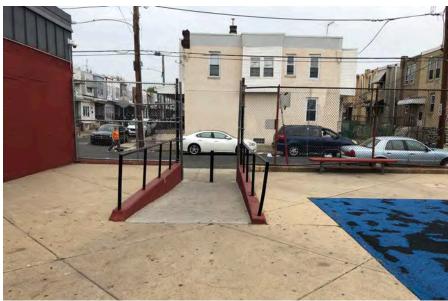
Entry ramp does not meet code

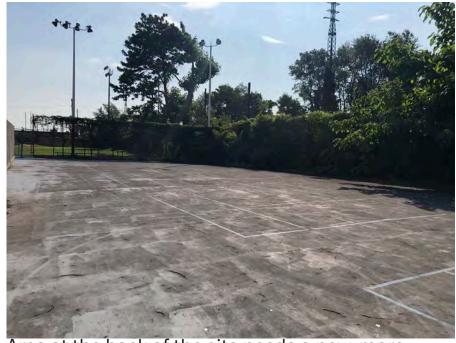
Area at the back of the site needs a new, more active use

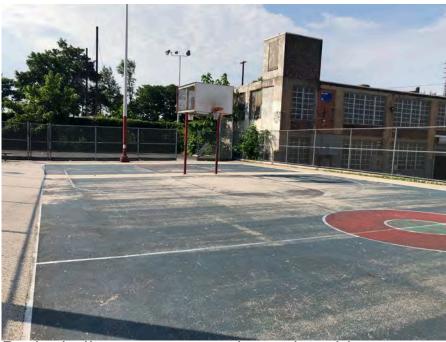
Basketball courts are popular and could use new surface paint

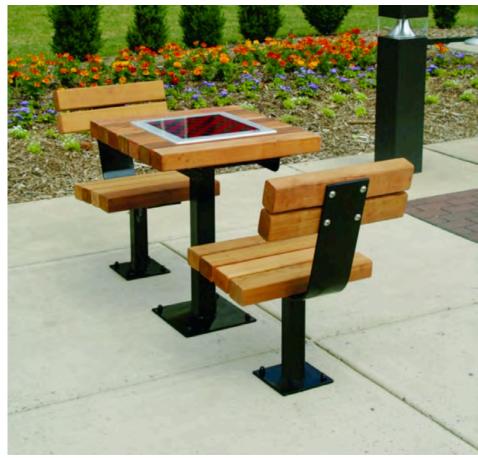
PPR standard game table - 3-seat and 4-seat options proposed

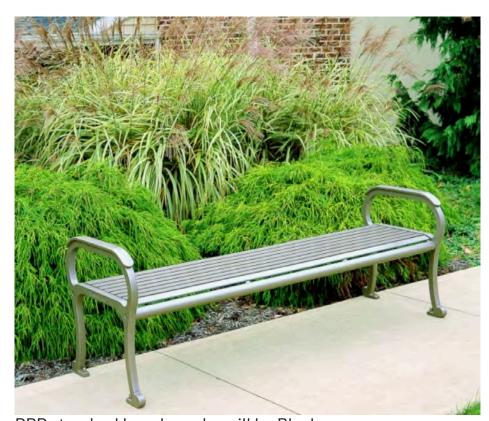
PPR standard bench - color will be Black

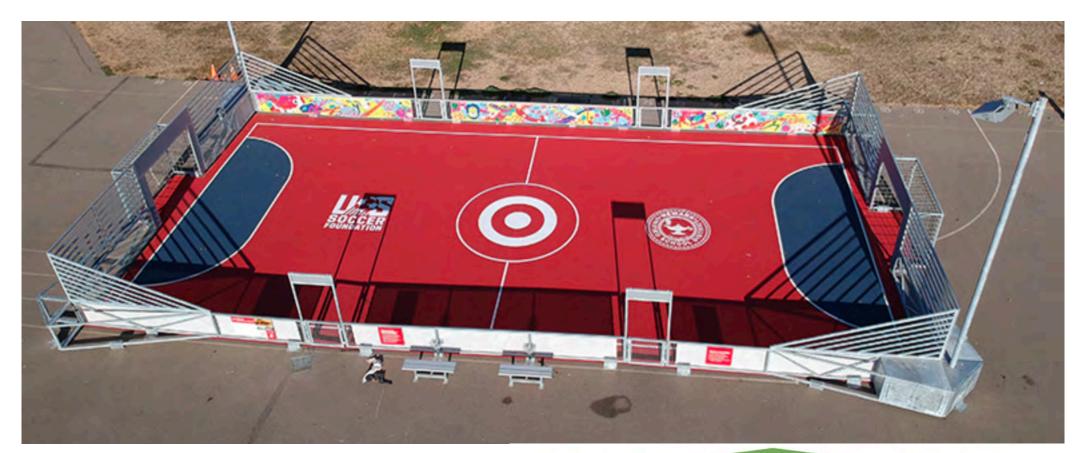
Former hockey court at back of site will be turned in to a soccer mini-pitch. The mini-pitch system will have surrounding low metal walls, entry gates, and goals as shown.

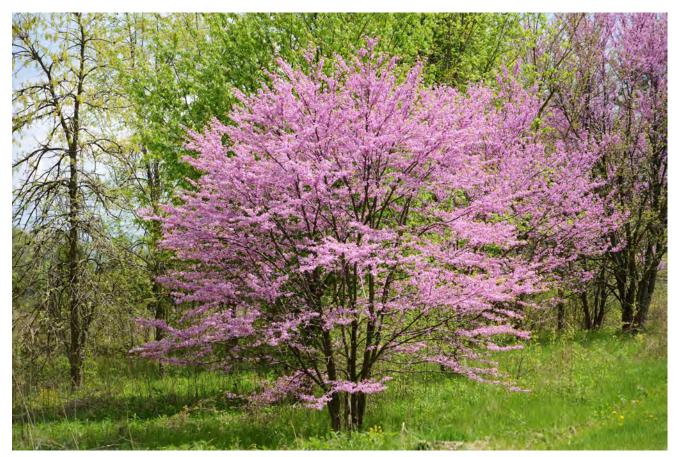
Eastern Redbud at entrance to site

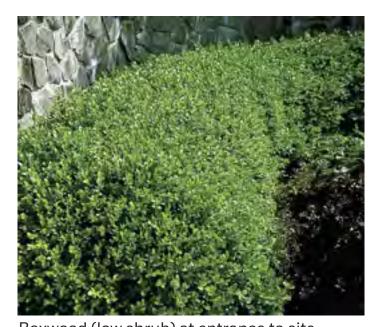
Boxwood (low shrub) at entrance to site

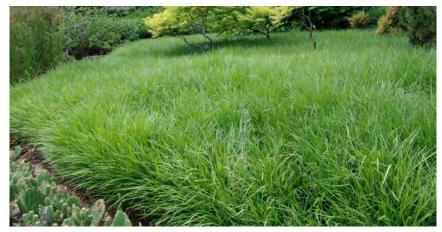
Liriope (low maintenance groundcover) at entrance to site

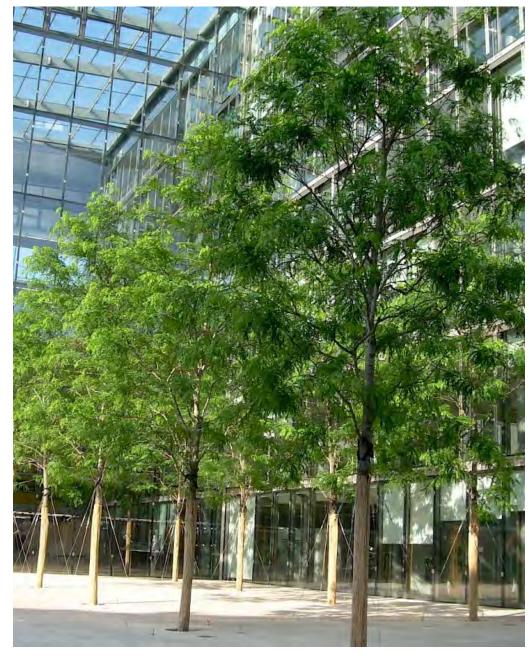
Skyline Honeylocust at sitting area between building and pool
