# 2300 CHESTNUT EXTERIOR IMPROVEMENTS

PRICING SUBMISSION - JUNE 28, 2019

EXTERIOR  
IMPROVEMENTS  
2300 CHESTNUT STREET  
STOLTZ REAL ESTATE  
PARTNERS

PRICING SUBMISSION

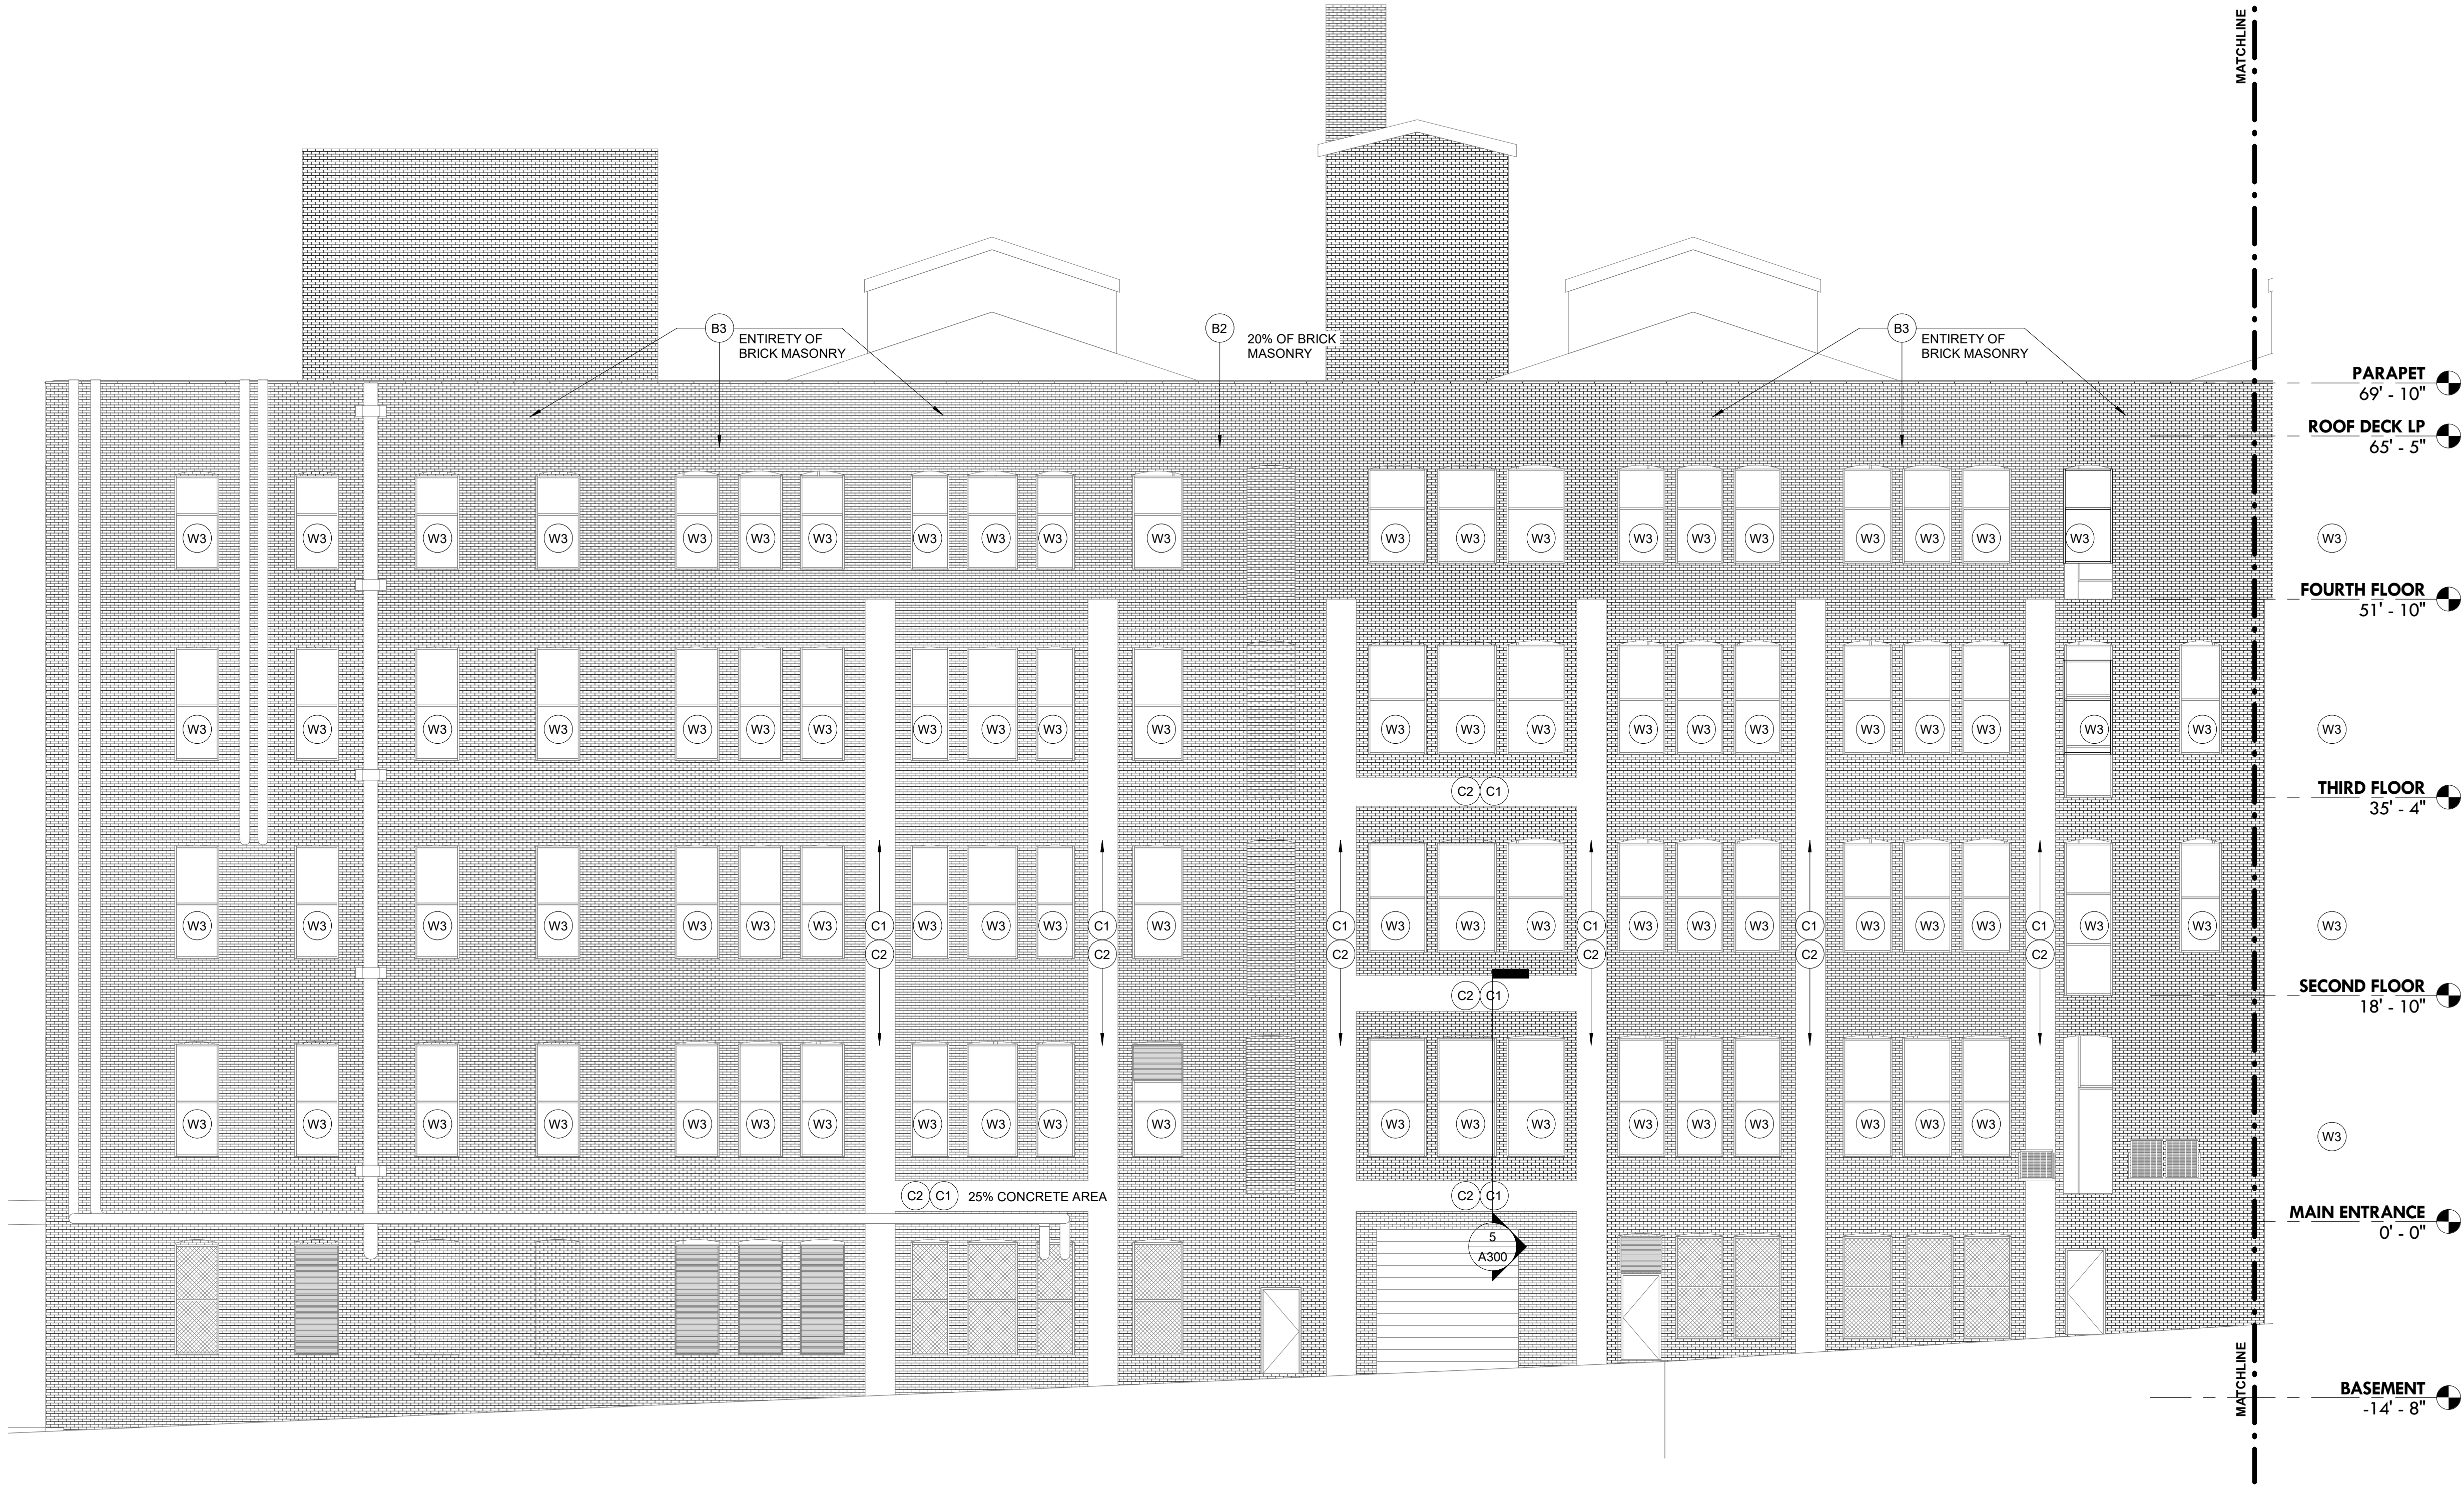
1 SOUTH (IONIC STREET) ELEVATION A  
SCALE: 1/8" = 1'-0"

KEYNOTES

- C1 CONCRETE CRACKING - ROUT CRACK AND FILL WITH PATCHING COMPOUND
- C2 CONCRETE SPALLING - REMOVE LOOSE MATERIAL AND RESTORE WITH PATCHING COMPOUND
- C3 CONCRETE COATING FAILURE - PREPARE SURFACE AND APPLY SPECIFIED COATING PT-1

- B1 BRICK DISPLACEMENT - STABILIZE BRICK MASONRY WITH HELICAL MASONRY ANCHORS 16" OC MIN
- B2 BRICK MORTAR JOINT DETERIORATION - RE-POINT
- B3 CLEAN BRICK MASONRY AS SPECIFIED
- B4 MASONRY COATING FAILURE - PREPARE SURFACE AND APPLY SPECIFIED COATING PT-1

- T1 TERRA COTTA UNIT DISPLACEMENT - STABILIZE TERRACOTTA UNIT WITH HELICAL MASONRY ANCHORS 16" OC MIN
- T2 TERRA COTTA JOINT DETERIORATION - RE-POINT
- T3 TERRA COTTA UNIT CRACKING - ROUT CRACK AND FILL WITH PATCHING COMPOUND
- T4 TERRA COTTA SPALLING - REMOVE BROKEN MATERIAL AND RESTORE WITH PATCHING COMPOUND
- T5 TERRA COTTA COATING FAILURE - PREPARE SURFACE AS REQUIRED AND APPLY NEW COATING

- M1 COATING FAILURE AT SPANDREL - PREPARE SURFACE, APPLY SEALANT AT PERIMETER JOINTS AND APPLY SPECIFIED COATING PT-2
- M2 METAL CORNICE DISPLACEMENT - REMOVE AND REPAIR DAMAGED MATERIALS
- M3 COATING FAILURE AT CORNICE - PREPARE SURFACE AND APPLY SPECIFIED COATING
- M4 COATING FAILURE AT METAL BRACKETS - PREPARE SURFACE AND APPLY SPECIFIED COATING PT-2 (TYP. FOR 10)
- M5 CONFIRM AND REMOVE ABANDONED EXHAUST VENT - REPAIR SPANDREL TO MATCH TYPICAL EXISTING
- M6 REMOVE APPLIED ORNAMENTS FROM SPANDREL - REPAIR TO MATCH TYPICAL EXISTING

- W1 NOT USED
- W2 DAMAGED GLAZING - REPLACE PANEL WITH COMPOSITE METAL SPANDREL - PREPARE SURFACE INCLUDING MULLIONS AND APPLY SPECIFIED PAINT. SEE DETAILS.
- W3 SEALANT FAILURE - TOOL OUT EXISTING SEALANT, ENTIRE PERIMETER OF UNIT. INSTALL BACKER ROD AND SPECIFIED SEALANT
- W4 REPAIR, PAINT AND SEAL WOODEN MULLIONS AND SILL. REPLACE SEALANT PER NOTE W3

- X1 REMOVE FABRIC AWNING INCLUDING ALL FRAMING AND ANCHORAGES
- X2 DISPLACED GRANITE - REMOVE AND REPAIR EXISTING TERRA COTTA
- X3 REMOVE GRANITE FASCIA, SOFFIT AND ASSOCIATED FRAMING. SEE DETAILS
