#### Re: <u>Pending Nomination of 1106-14 Spring Garden Street (the "Property")</u>

Inappropriateness of Designation of 1106-1114 Spring Garden Street

## 1106-14 Spring Garden Street does not merit designation on the basis of Criteria C and D

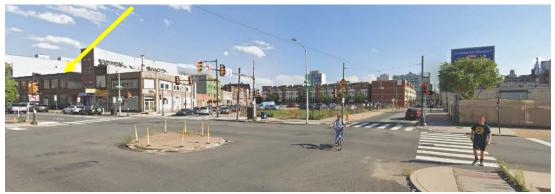
View of site (yellow arrow) from NW with rows of new houses, contemporary apartment buildings, vacant lots, and badly altered buildings: Google Street View 2019

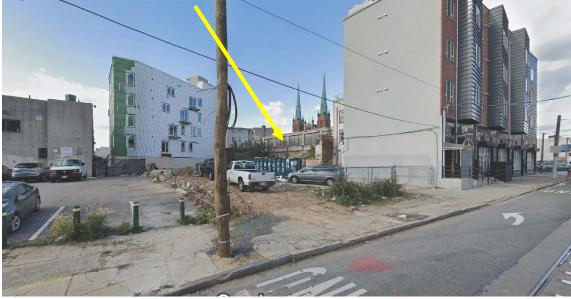
Context from SE, immediate block with demolished rear (yellow arrow), new building at 11<sup>th</sup> and Spring Garden (right) and building under construction, Ridge Avenue, (center left) with parking lots for remainder of block.

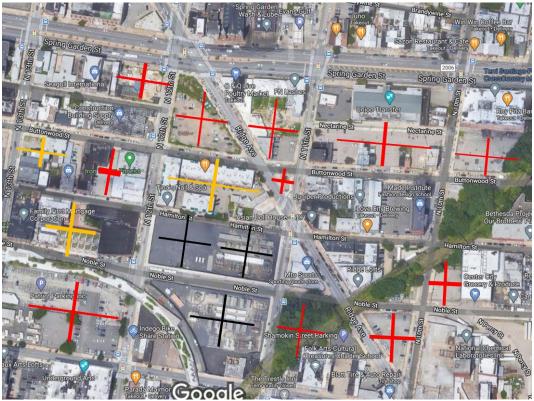
2021 Google Earth view of site: red, vacant and parking; black, power grid; yellow, recent construction; a few one and two story much-altered buildings (not marked)

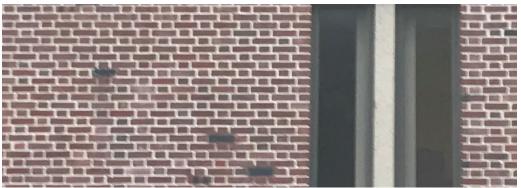
Flemish bond brick panels University of Pennsylvania Chemistry Building, Ballinger Co. and H2L2, 1969-73

• For example, Flemish bond brickwork is used on a modern lab building at Penn but the building is a modern industrial laboratory.

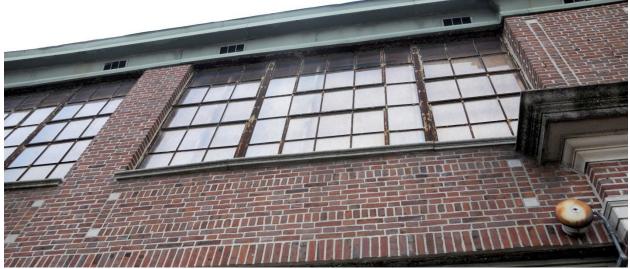
Copper cornice, banks of industrial sash, moderne paneling, soldier course brick spanning window openings – none of these features are Colonial Revival

• the broad banks of industrial windows; - *these are not the triple windows claimed*

• the rolled sheet metal cornice at the top of the façade; *this is not a dentilled cornice*

• the Prairie Style panels flanking the door and spandrel panels set off with header courses and accented at the corners with the small blocks of cast stone, etc, are in keeping with modern styles rather than the Colonial Revival; *these are not pendants*

- the use of soldier courses concealing steel lintels spanning window openings instead of jack arches is not Colonial Revival
- The presence of loading docks on either side of the front door is not a Colonial Revival characteristic.

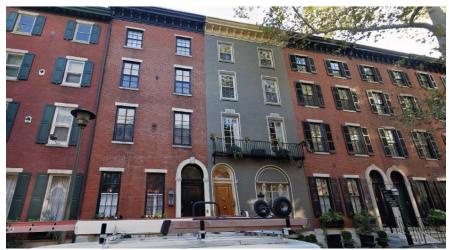
1800 block, Delancey Street, round headed doors with light stone trim; rehabbed art deco (gray) – none colonial revival

Just because a building is built of brick with a rounded arched-headed door and light-hued masonry accents does not mean that it is Colonial Revival in style. These same features and materials might equally represent a mid-nineteenth century Italianate townhouse row on Delancey Street.

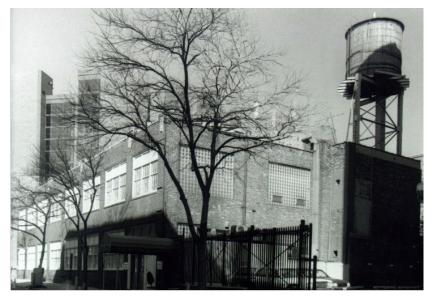
1987 photo, Bernie Cleff, (Athenaeum of Philadelphia), 8<sup>th</sup> and Locust Street, east and south facades, showing industrial glass block and doors on east façade with banks of sash added on south facade- with dropped ceilings.

• The 8<sup>th</sup> and Locust commercial building is a 1950s or '60s redo of a 1921 industrial building probably influenced in its rehab by the Society Hill project. At that time oversized colonial doorways were added that covered earlier architectural elements and are not in keeping with the original façade (Elgin Development 8<sup>th</sup> and Locust, 1920, Leroy Rothschild, Newpapers.Com).

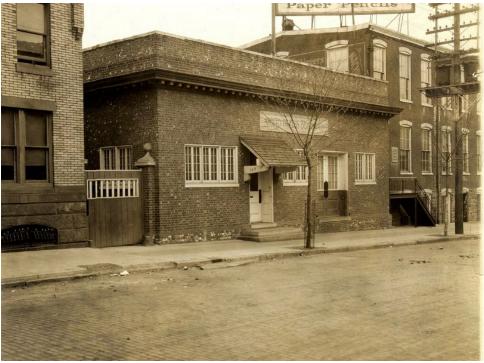
Mellor & Meigs, Arguto Building, 1912 – Arts & Crafts canopy over door, casement windows, strong asymmetry (Athenaeum, Mellor & Meigs Collection)

• Others examples cited are generally in entirely different styles such as the offices for the Arguto Oiless Bearing Co. which is actually an Arts & Crafts rather than

Colonial Revival style (Mellor & Meigs, 1912, see bracket-supported canopy over door, casement windows and asymmetry).

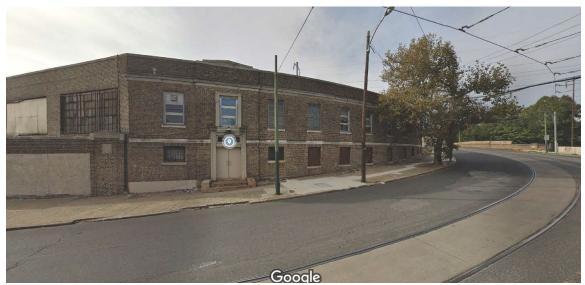
Crescent Iron Works, 4905 Grays Avenue with yellow Traymore sand-textured brick, moderne ornament

• The Crescent Iron Works (Philip Johnson, 1928, Clio Index 0022424) also is not Colonial Revival, referencing instead other moderne styles, here the 1914 Traymore Hotel in Atlantic City with the yellow Traymore brick and modern tapered capitals.

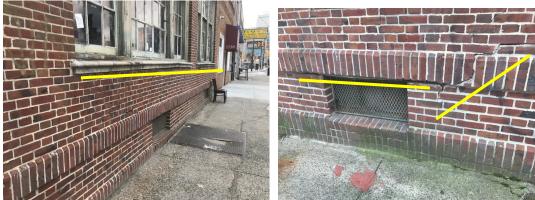
Façade looking west showing sills raised out of position and major cracking of spandrels caused by rust jacking of the basement windows

• The façade photographs make clear the extent of damage to the Spring Garden Street façade that should have raised questions about the suitability of the building for designation. In those photographs, window sills are significantly out of alignment; basement window heads are clearly damaged with extensive rust jacking of basement window lintels, and with a bit of care, it can be seen that the spandrels are bowing out as well.

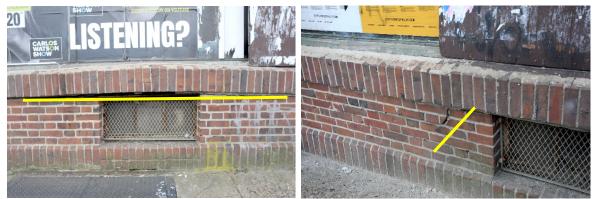
Left: steel lintel above window jacked out of position; right: soldier course pushed out of plane to left of window

• A comparison with the historic 1940s photograph below shows that all of these elements were straight – so the changes represent physical deterioration of the façade caused by rusting of the steel lintels that have jacked the entire façade out of plane.

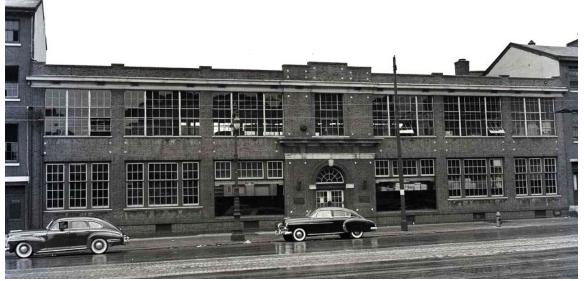
1106-14 Spring Garden in 1949; window sills flat, no distortion or evidence of obvious problems (Free Library of Philadelphia)

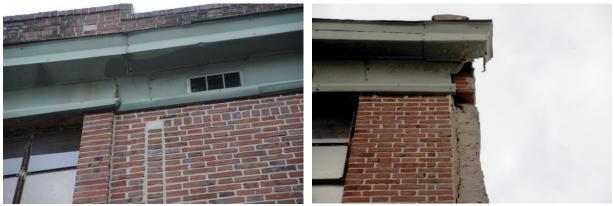
Left: sheet copper cornice (not stone) riveted together; end of copper cornice showing torn end where drain line removed – obviously metal. Not stone.

- The inability of the nominator to distinguish building materials should have been red flags for the Designation Committee and the full historical Commission.
- For example the question raised in the nomination about the type of masonry that made up the cornice is revealing. The shaped material is uniform green which should have suggested that it is made of sheet copper.
- A closer examination finds screws or rivets holding the sheets of copper together and a casual look at the end of the façade finds jagged, torn edges where drain lines were pulled out. It should have been obvious that the cornice is made of sheet copper – and has nothing to do with Colonial Revival. This is more a moderne element than a Colonial Revival feature.

- The material of the cornice described as ".... a lightly-colored, smooth-faced stone or concrete" is copper sheet metal.
- The reference to the second story windows "... appears to be metal, multi-light industrial sash windows" makes one wonder if the nominator ever visited the site.

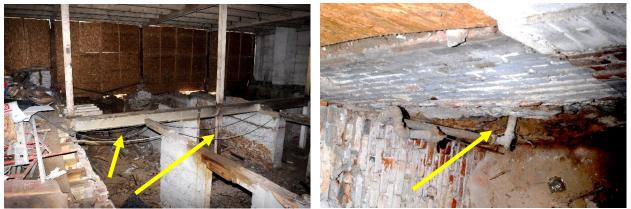
Rubble masonry party walls of original rowhouses; rubble masonry foundations of party walls and front wall (yellow arrows) from original rowhouses.

- The nominator did not understand the importance of the five-year-old interior photographs that were included in the nomination that show dividing masonry walls in the basement of the front block of the building. This is a very unusual configuration for a modern building and makes it obvious that the walls are remnants of the pre-1929 row buildings that once occupied the site a fact that could have been confirmed by examining the pre-fire conditions from historic atlases.

- The visual evidence also shows that the basement walls are standard mid-19<sup>th</sup> century row house construction with walls of rubble stone infilled with clay lime mortar. That mortar fails when exposed to exterior moisture. Topped with brick to carry the steel structure, these walls raise the question of whether this was a quickie building on the cheap in which the site was not fully cleared after the 1929 fire that destroyed the factory; previous elements were simply incorporated into the new building.
