ADDRESS: 935 S 3RD ST

Proposed Action: Rescind Individual Designation Property Owner: Queen Village Home Rescue

RE: Request for Recission Of The Historic Designation of 935 South 3rd St., Phila., PA. 19147

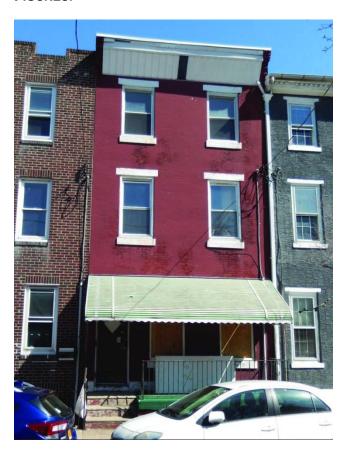
Figure 1. (Left) Photo of current conditions of 935 S. 3rd Street, courtesy of applicant. Figure 2. (Right) File photo of 935 S. 3rd Street ca. 1966, courtesy of PHC.

As depicted in the images below, the subject property has been altered since the time of designation. It is unclear whether these changes were approved by the Historical Commission. However, the current review is not intended to determine the legality of the building's current conditions. The cornice has been covered with metal. However, original corbeling flanking the flashing is still visible. The brick has been painted a red color. A front porch with a metal awning has been installed at the ground floor of the house. Although the windows and front door appear to be replacements, the original masonry openings, lintels and sills appear to be intact. The height of the structure has not changed. In general, the primary features of the building, its front façade, window and door openings, and roofline, survive and the building could be restored to its appearance in the 1966 designation photograph below.

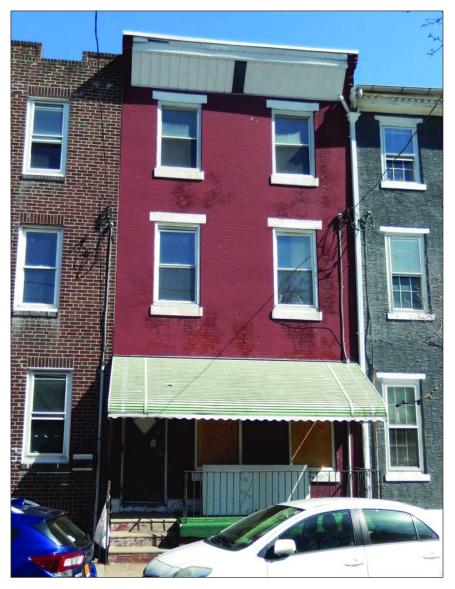
1. 935 S. Third Street - Front Elevation

- 2. <u>Building</u> Structure is a three story red brick façade row house, the middle unit in a forlorn remaining 3 building section at mid-block. Rear has had several wood framed additions none of which are visible from S. Bodine Street. There is a partial Basement in the original front section. (Views 1.1 and 1.2; 2.1, 2.2. and 2.3; 5.2)

- 3. Front Façade Elements The front façade consists of a 3 opening (entry door & two adjacent windows) bay at the First Floor and two window bay configuration at 2nd and 3rd Floors. The top parapet exhibits 2 corbelled brick projecting end brackets bookending an assumed wood or metal cornice, concealed behind aluminum fascia panels. First Floor has an aluminum shed roof, raised concrete porch and concrete steps with painted wrought iron railing at front edge. Windows have original carved stone headers and sills. The architectural style can only be classified as "Vernacular". (Views 1.1; 4.2 & 4.3)

- 1. <u>Front Façade Alterations</u> The following items we believe to be both significant, and inappropriate, alterations to the original building façade (Views 1.1, 1.2 and 2.2):

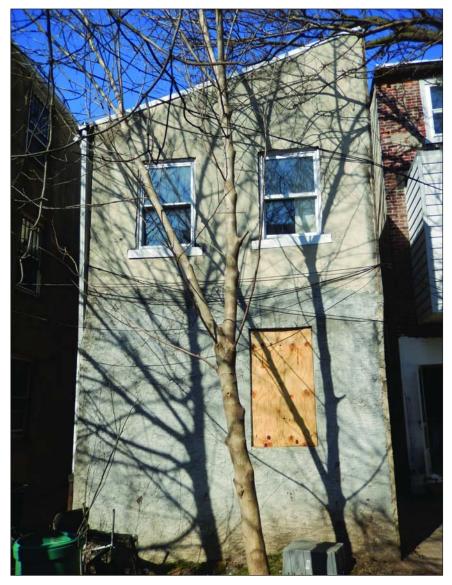
1. Rear Elevation

- 6. <u>Rear Additions</u> Several 2 story wood framed, rear additions are in poor condition and exhibiting significant uneven settlement. No additions are street visible from South Bodine to the east. (Views 2.1, 2.2 & 2.3)

- 8. <u>Structure</u> Front(street) masonry wall is in good condition from what is visible (not including the concealed projecting cornice). However, the entire building (original front and the rear additions) exhibits significant uneven settlement on all floors in the north-south direction with a pronounced and discomforting slope and w/undulating surfaces.

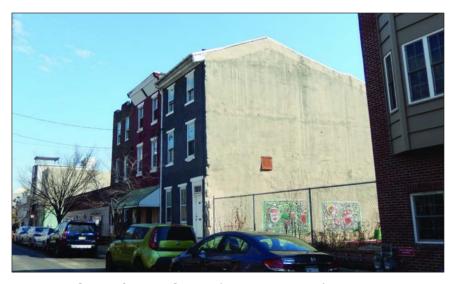
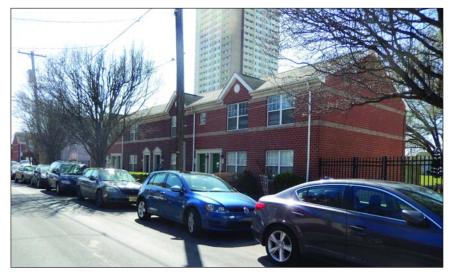
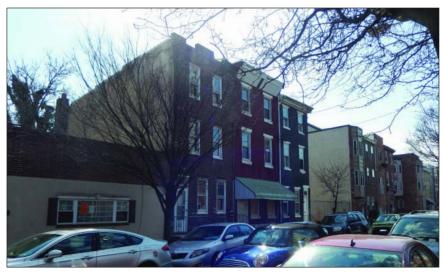
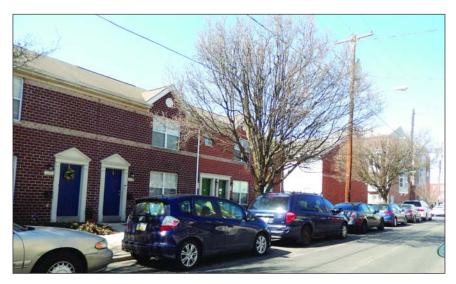
- 1. 900 Block of South 3rd (cont'd.)
 - larger residential building; and several vacant lots. Of the six remaining rows on the east side (of which 935 is one) only three have their original brick facades intact due to masonry failure of some sort in past decades resulting in re-facings. (Views 3.1 thru 3.4)

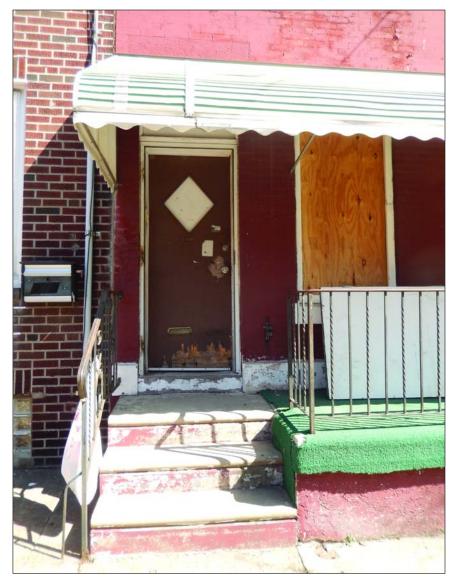
1. 935 S. Third Street Front Door and Stoop

- a. <u>Front Porch Addition</u> Existing raised concrete slab porch and stair are a later addition circa <u>1950's</u> and do not represent the historic street level architectural elements still evident in the 937 South 3rd building immediately next door. The porch railing is inappropriate in style and construction. While the colorful aluminum shed roof is common in the community, its outsized physical and visual dominance serves to detract from the building's remaining historic character. (View 4.1)

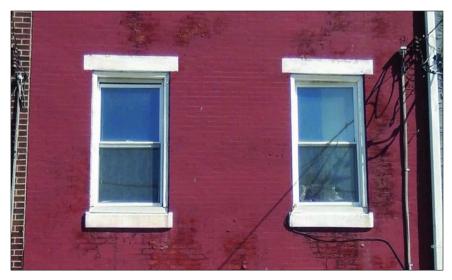
2. 935 S. Third Street Front Windows and Brick Coating

- b. <u>Windows</u> Windows of the period will most certainly be single pane, true divided lite, 6/6 or 4/4 configuration. Present windows are inappropriate 1/1 lite aluminum replacements from unknown time frame. (View 4.2)

- c. <u>Masonry Condition</u> Entire brick façade has been painted over in a thick, gloppy red coating concealing all the brick texture, color and jointing. Removal of such coatings can often irrevocably damage brick faces and discolor the joint mortar. (View 4.2)
- d. <u>Damaged Decorative Projecting Cornice</u> Given its long term aluminum concealment, it is probable that whatever decorative cornice treatment was original to the façade is substantially damaged or no longer fully intact (View 4.3). Excellent intact examples abound locally. (See View 6.3 at 918-20 Moyamensing Avenue)

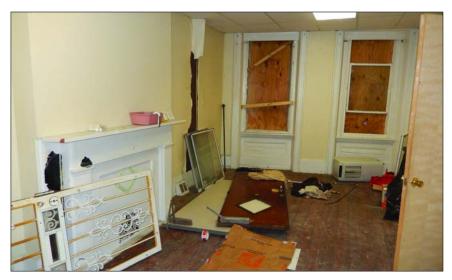
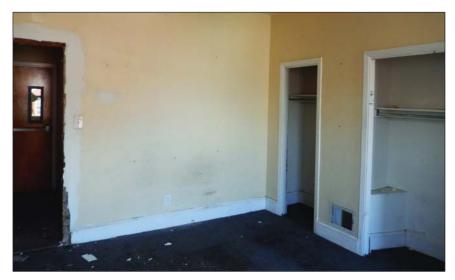
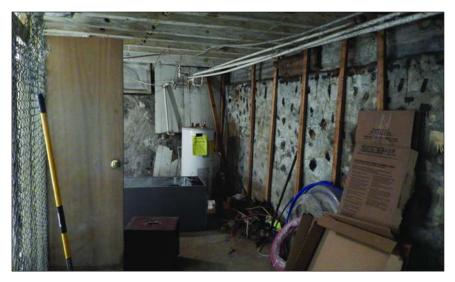
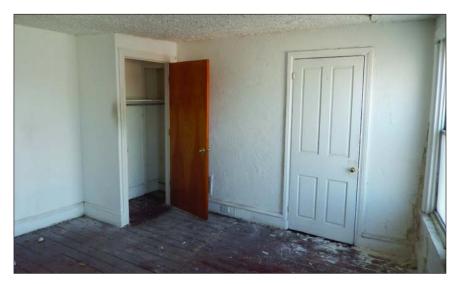
- 7. <u>Interiors</u> The building has been partitioned off into "boarding/rooming house" type bedrooms, common toilets, common kitchen/eating area, etc. There is an original central stair now with fire-rated barrier doors at each floor level. These room configurations do not reflect the likely original interior layout of a single family abode.

- The interior finishes are plain and ordinary for the period with no decorative treatments remaining such as cove moldings, fluted door trims, raised panel doors and wall bases. Any original details have probably been removed. (Views 5.1, 5.2, 5.3 and 5.4)

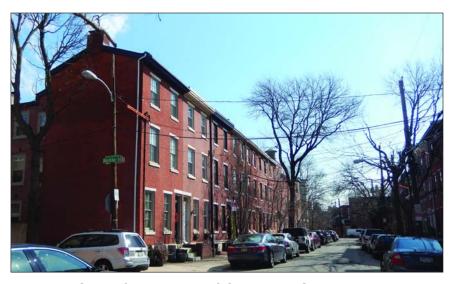
1. North Side of 200 Block of Carpenter Street

- 2. <u>200 Block of Carpenter Street</u> Photos show the street facades of numerous examples of thoughtfully restored and maintained 2 and 3 story rows of the same period and architectural style as that at of 935 S. 3rd including projecting cornices. The majority have original brick in good condition and uncoated in any way on both the north and south street facing parcels. (View 6.1)

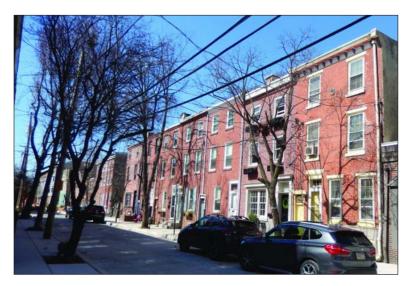
2. North Side of 200 Block of Montrose Street

- 3. <u>200 Block of Montrose Street</u> Photos show the street facades of numerous examples of thoughtfully restored and maintained 2 and 3 story rows of the same period and architectural style as that at of 935 S. 3rd including excellent projecting cornices. Many have original brick in good condition on both the north and south street facing parcels. (View 6.2)
