REPORT ON 514 S 4TH STREET
PREPARED BY MEREDITH KELLER, 19 APRIL 2021

Timeline of Construction and Alteration

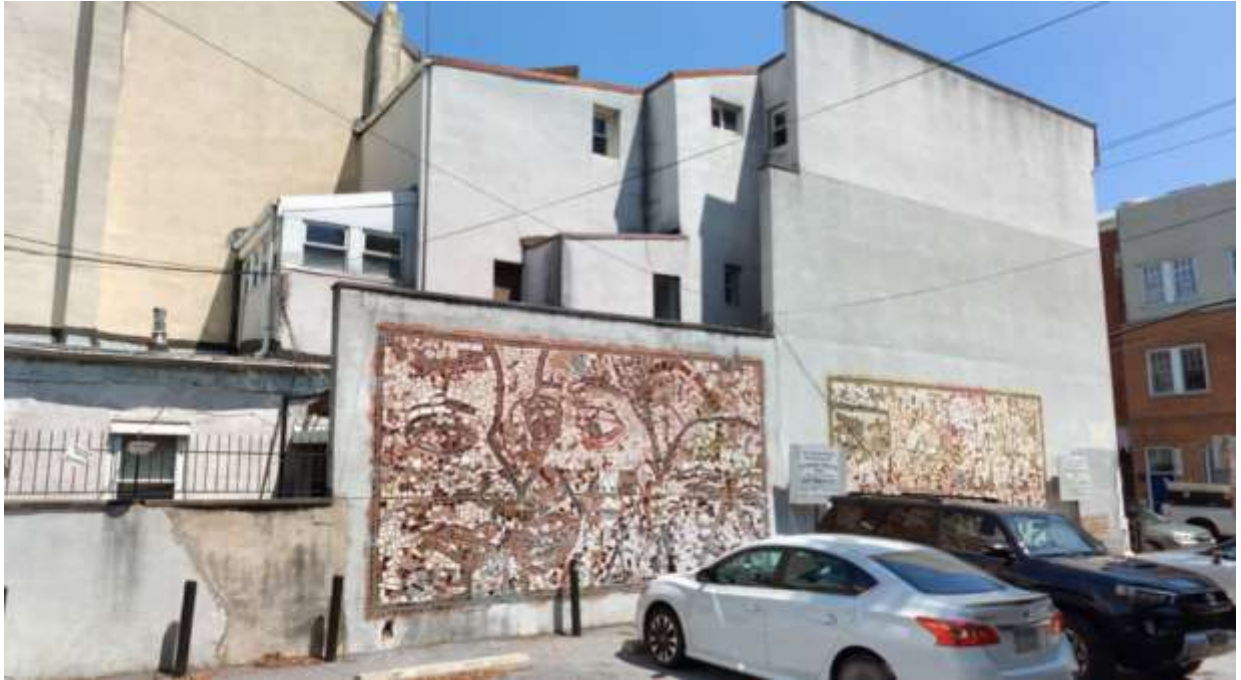
Figure 2: Rear of the three-story building fronting S. 4th Street, showing the main block, piazza, and three-story kitchen.
Source: Cyclomedia.

structures remain. The insurance survey and 1917 Sanborn map identify the building fronting S. 4th Street as consisting of a main block with a piazza, three-story kitchen, and two-story addition (Fig. 1). The main block, piazza, three-story rear kitchen, and two-story frame addition remain visible despite subsequent additions and alterations (Figure 2). Though no longer visible from the exterior, both the survey and map show that a 3-foot alleyway at the south provided access to the building at the rear of the property, identified as 514 ½ S. 4th Street on the Sanborn map.

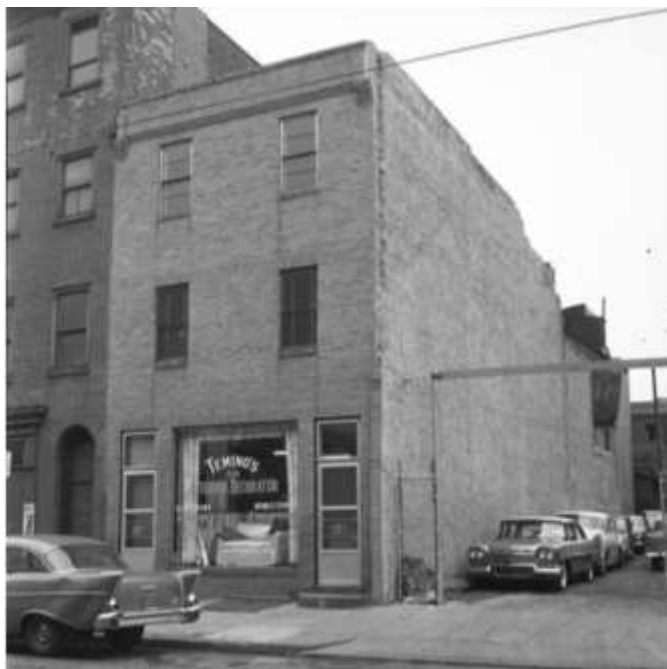
Figure 3: 514 S. 4th Street in 1959, 9 years after the façade was reconstructed. Source: Department of Records.

The district inventory inaccurately dates the changes to the main structure's façade to c. 1920. However, zoning records indicate that the front façade was reconstructed in 1951. At that time, the building was listed as vacant and the work was described on the permit application as: "Repairs to roof, install new front and general interior repairs. No additions." A 1959 photograph shows the reconstructed façade (Figure 3).

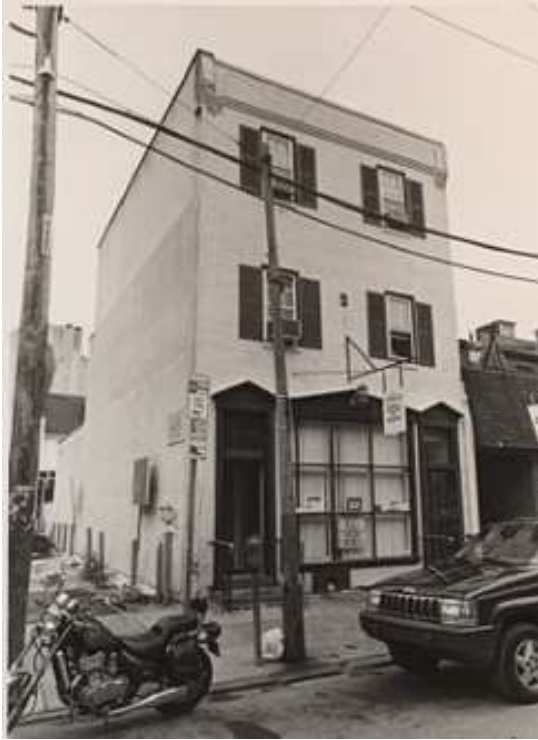
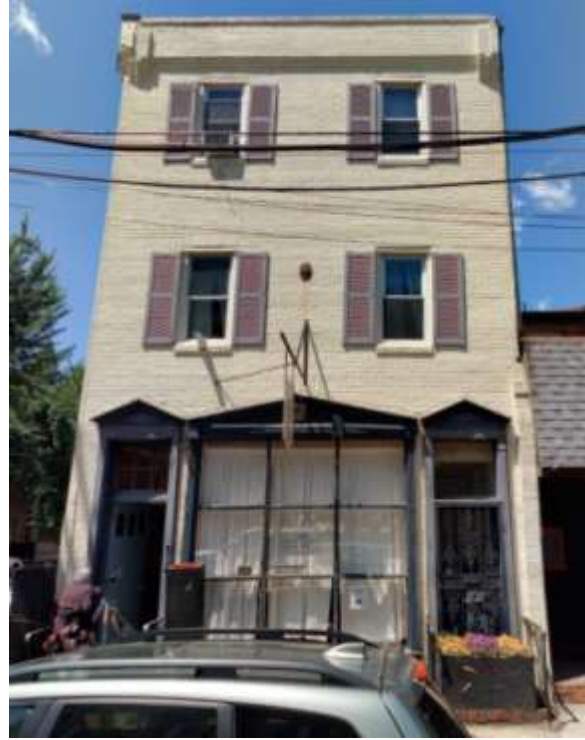
Figure 5: 1999.

The property at 514 S. 4th Street was designated as a significant resource in the Society Hill Historic District on 10 March 1999. While the Historical Commission has the authority to reclassify properties, there has been no loss or destruction of the qualities that caused the property's original entry on the Philadelphia Register of Historic Places. The images below show that changes to the property have been minimal over the last 22 years since designation.
