COMMENT ON NATIONAL REGISTER NOMINATION

ADDRESS: 118-60 E INDIANA AVE, Hoyle Harrison and Kaye Textile Mill

National Register of Historic Places Registration Form

Historic name: Hoyle Harrison & Kaye Textile Mill

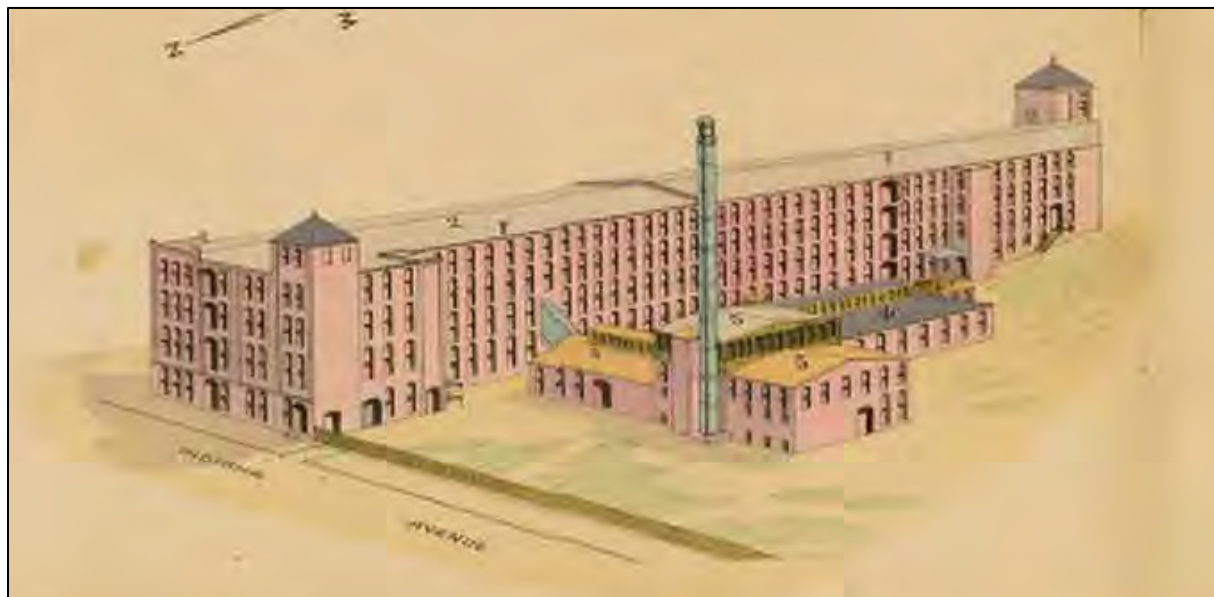
FIGURE 1 — Hoyle, Harrison & Kaye's New Mill, Philadelphia, Pa. Source: Hexamer General Surveys, Volume 27, Plate 2654-2655. <https://www.philageohistory.org/rdic-images/view-image.cfm/HGSv27.2654-2655>. This image shows the Mill before the 1899 additions.

The initial construction of the Textile Mill complex included six buildings that were identified as Buildings 1 through 6 as part of the Hexamer General Surveys (see Figures 1 and 16¹). Initially, Buildings 1 and 2 were only four storeys in height. In 1899, a fifth floor was added to Buildings 1 and 2 and an Annex addition was constructed along the west elevation of Building 2 (see Figure 18). Between 1895 and 1910, four, non-mill related additions were added onto the west elevation of Building 6 with the Building 6-Addition #2 being two-storeys in height (see Figures 16, 17, 18, and 19). A one-storey, brick masonry Warehouse was constructed along East Indiana Avenue between 1919 and 1940. Then, between 1940 and 1951, additions were added onto Building 6 (Building 6-Addition #5) and the Warehouse (Warehouse Addition) (Figure 21). The last additions were added onto the north elevation of Building 6-Addition #4 (Building 6-Addition #6) and to Building 1 (Building 1-Addition); however, it is unknown exactly when these various additions were constructed and by whom. Between 1981 and 1992, Buildings 4 and 6 were demolished along with Building 6-Additions #1 and #2 (Figures 13 and 14). Currently the entire parcel is surrounded by a chain link fence. See Chronology on page 37.

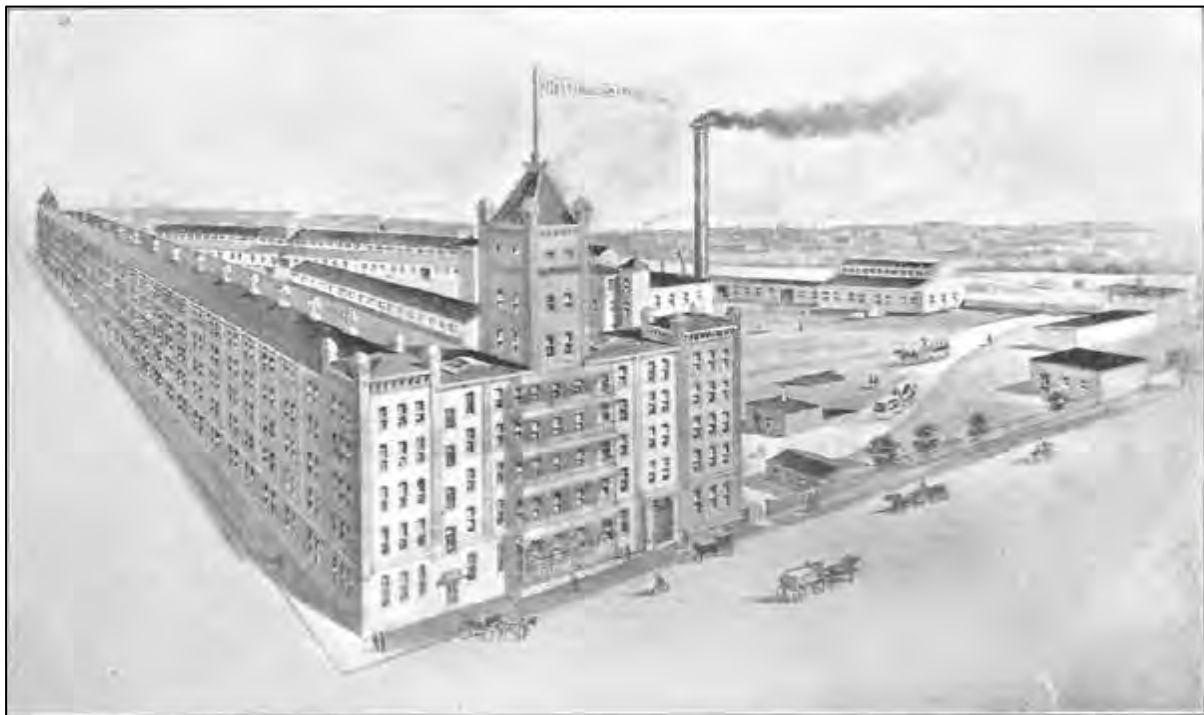
Figure 2 – Hoyle, Harrison & Kaye, Tapestries & Upholstery Fabrics. Source: King, Moses, *Philadelphia Notable Philadelphians*, 1901, p.44. This image shows the Mill after the 1899 additions.

Extensive improvements were undertaken to the mill in 1899, which included “the construction of a fifth storey, 429 feet long and 62.4 feet wide, on the present mill, with a division wall in the center, and the erection of a five-storey office building addition, 60.2 X 62.4 feet. The addition will be properly fitted up and there will be fire sprinklers, etc., and *precautions and conveniences* [emphasis added].”⁷ This addition, which became known as the Annex, was designed by Hales & Ballinger, who was the successor firm to Geissinger & Hales and was constructed by John Mitchell.⁸

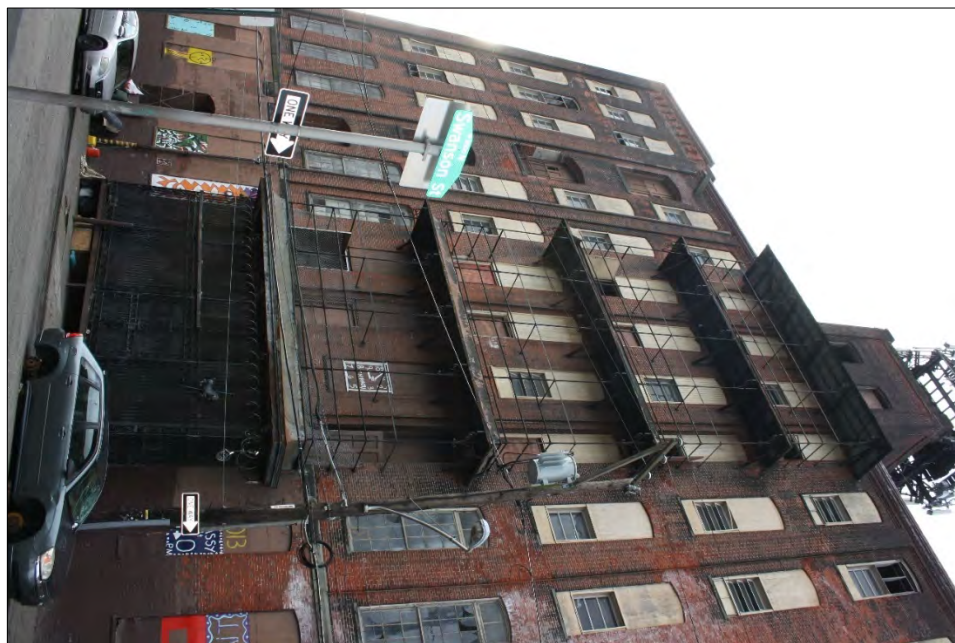
PHOTOGRAPH 2 – Building 2 and the Annex, north (front) elevation, Bays 1 to 12 with the balconies located in Bays 7 to 10.

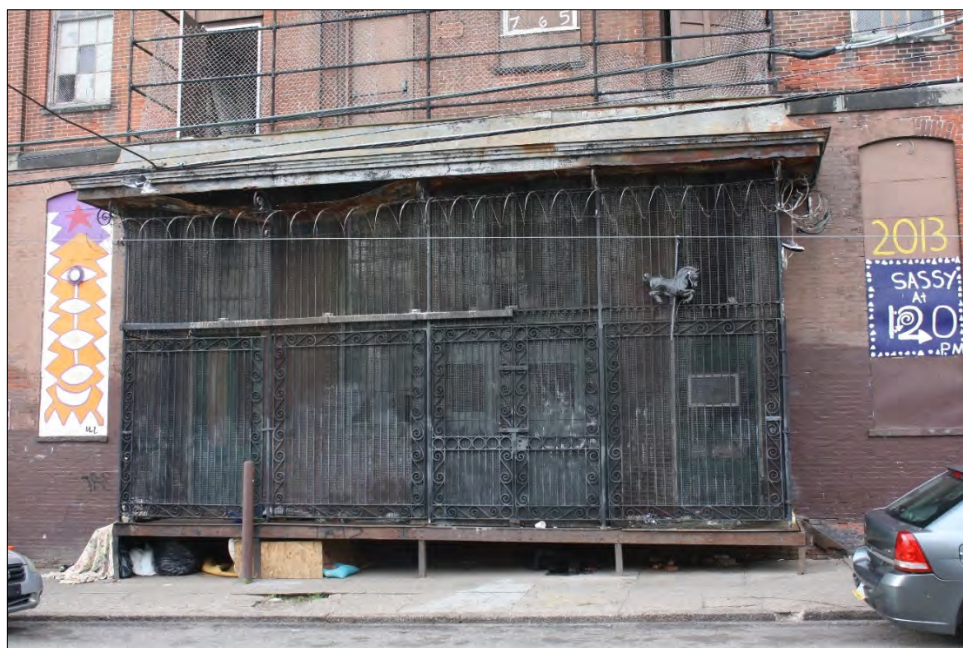
PHOTOGRAPH 3 – Building 2, north (front) elevation, first floor balcony that occupies Bays 7 to 10.

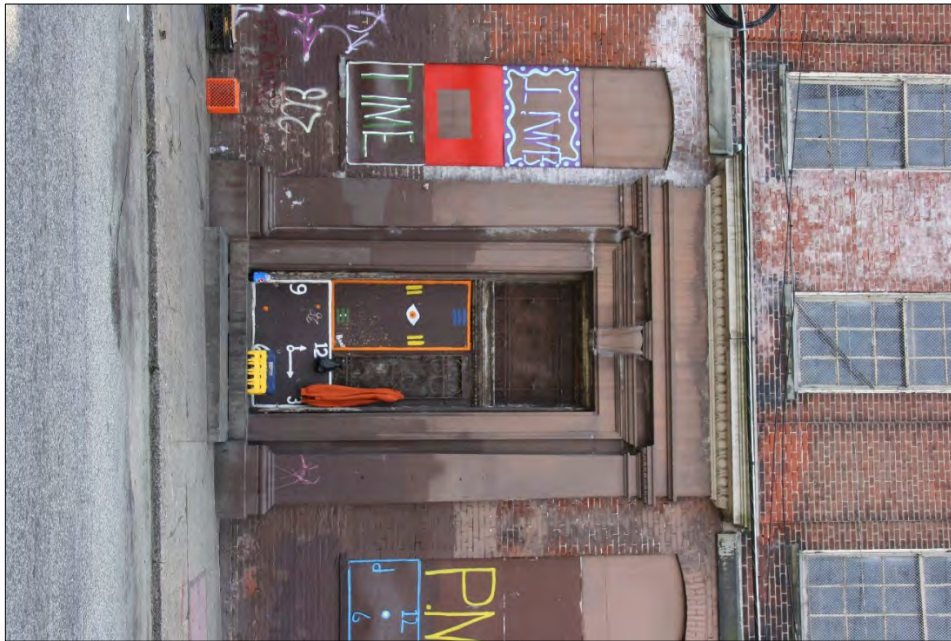
PHOTOGRAPH 4 – Annex, north (front) elevation, main entry door in Bay 13.

The main entrance into the building (actually in the Annex) is in Bay 13 and is accessed from two steps that follow the slope of the street (Photograph 4). The entrance is comprised of flanking, symmetrical Roman Doric pilasters that support an entablature with egg and dart molding beneath molded cornice cap. Centered within the pilasters is a flat molded frame with a scroll-shaped bracketed keystone. Recessed within this frame is a pair of doors with wrought iron framework over the doors that is partially exposed. Above the door and set within a wood frame is a large single-light transom that is also covered with wrought iron framework.

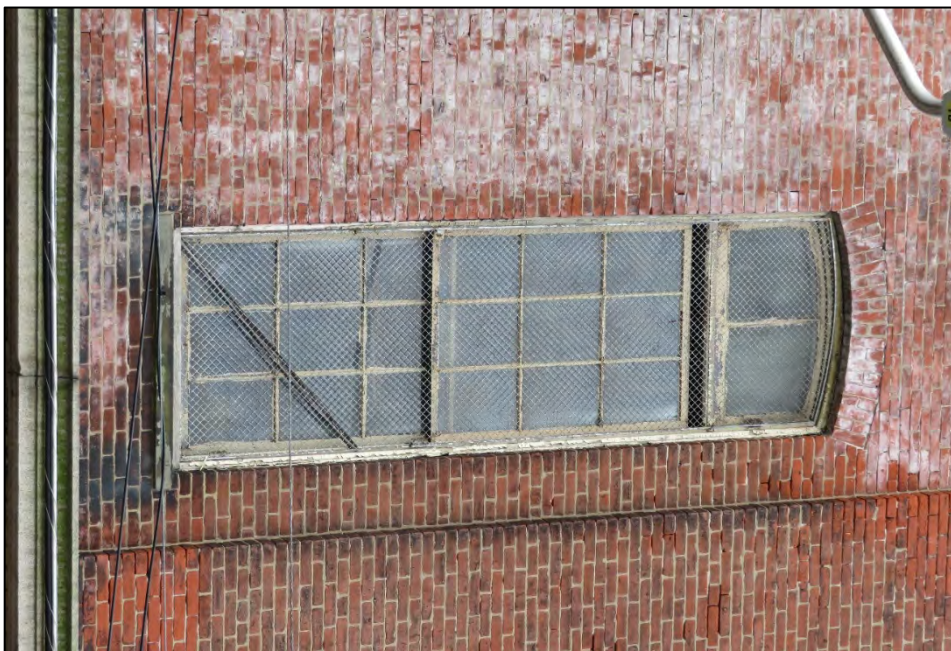
PHOTOGRAPH 5 – Annex, north (front) elevation, second floor, Bay 13, with typical nine-over-nine, double hung wood sash with a two-light, segmental arched transom.

Each bay has regularly spaced, segmental arched, brick masonry openings with nine-over-nine, double-hung, wood sash with a two-light transom all set within a wood frame (Photograph 5). For the most part, the window openings have all been covered on the exterior with plywood to save the remaining wood windows that are in poor condition except for some windows on the north elevation second floor that remain exposed. Within the north elevation of the Annex, several of the third, fourth, and fifth floor windows have been replaced with three-light aluminum sash. The window sills throughout the building are blue stone that are in poor condition except for the Annex, which have been panned with painted, galvanized metal.

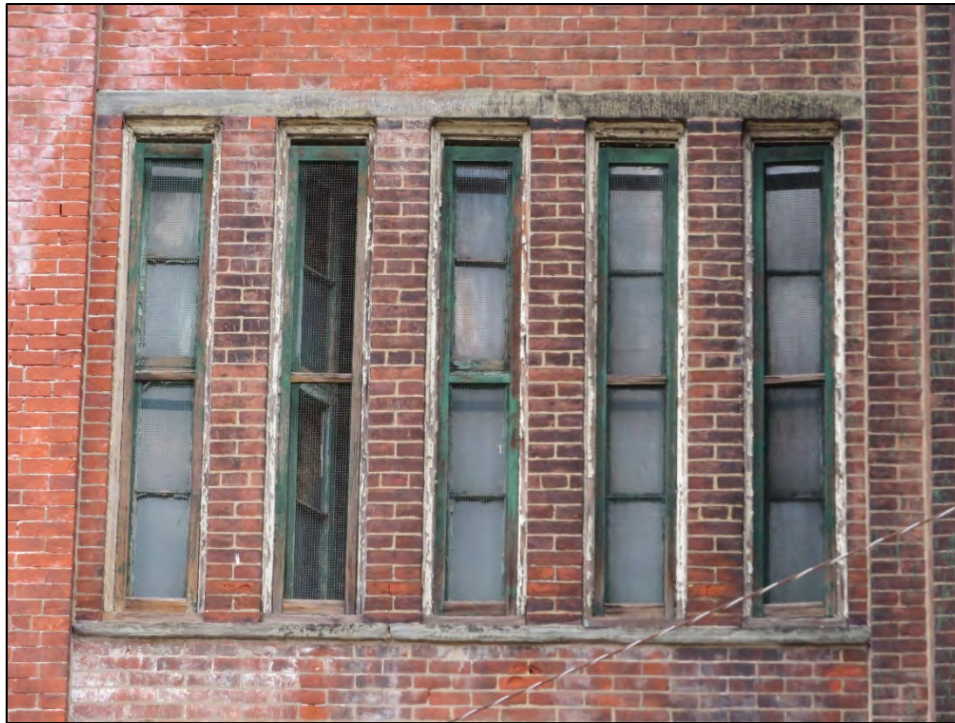
PHOTOGRAPH 10 – Building 1, south (rear) elevation, second floor wood casement windows that are set between stone lintels and sills.

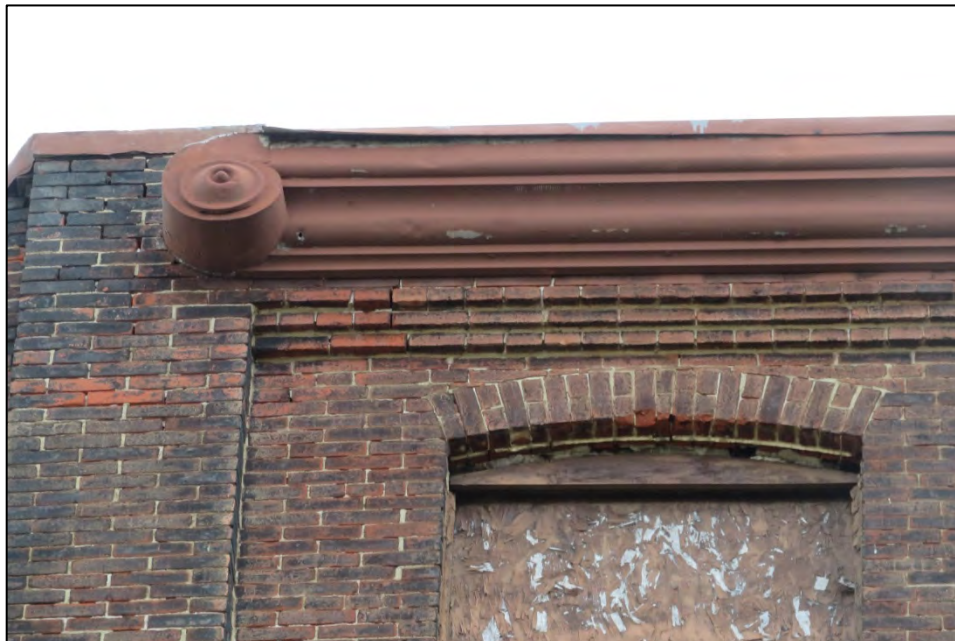
PHOTOGRAPH 11 – Building 1, south (rear) elevation, parapet with a painted, galvanized metal cornice at the head of the corbelled blind panel

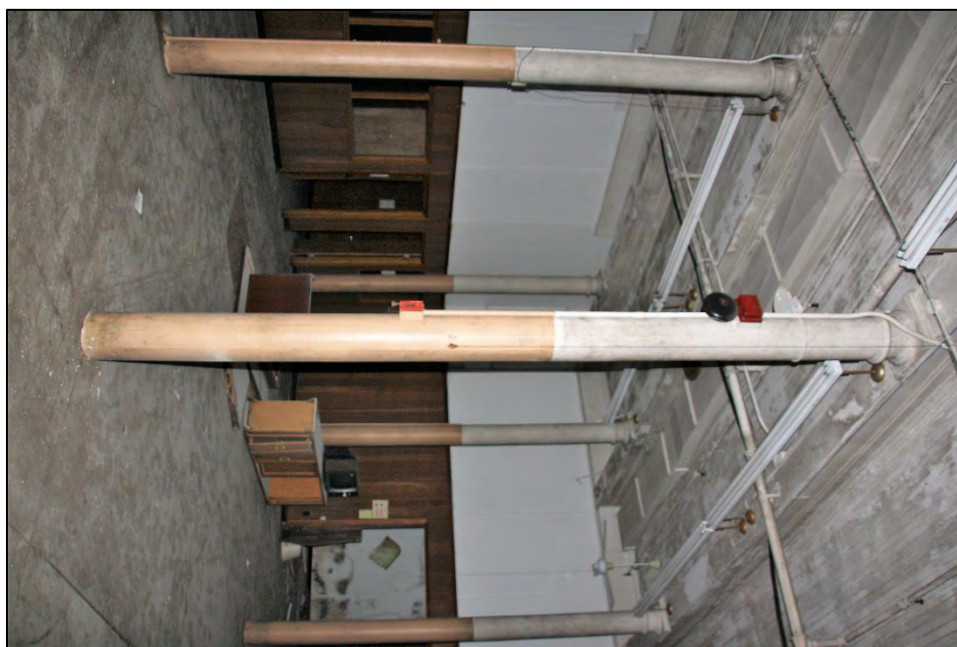
PHOTOGRAPH 22 – Annex – first floor interior looking southeast between the two rows of round, metal columns. These are the only round, metal columns within the complex.

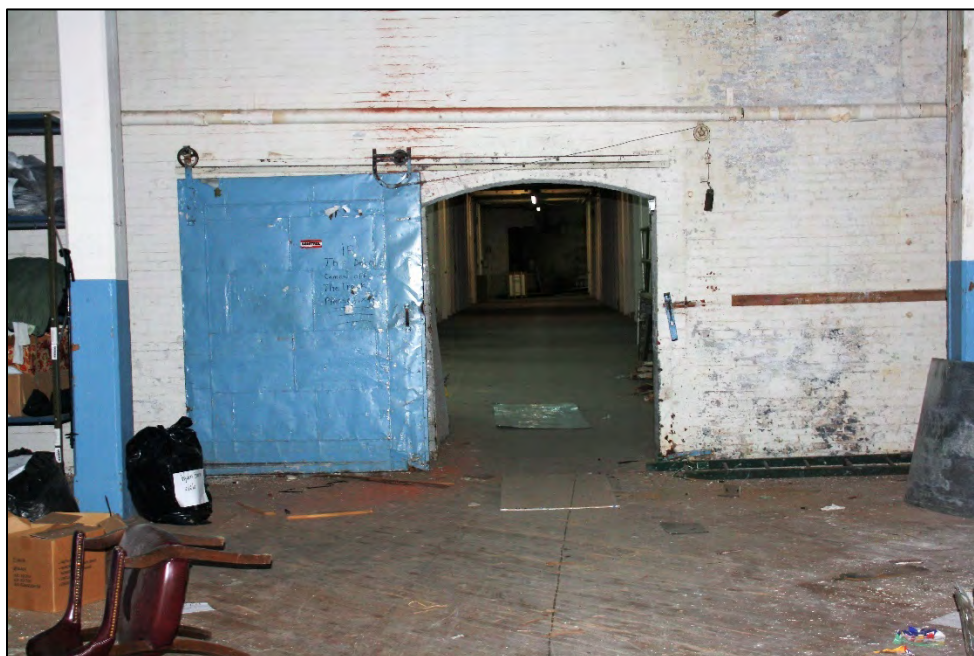
PHOTOGRAPH 23 – Building 2 – first floor interior looking at the fire door within the masonry wall between Buildings 2 and 1.

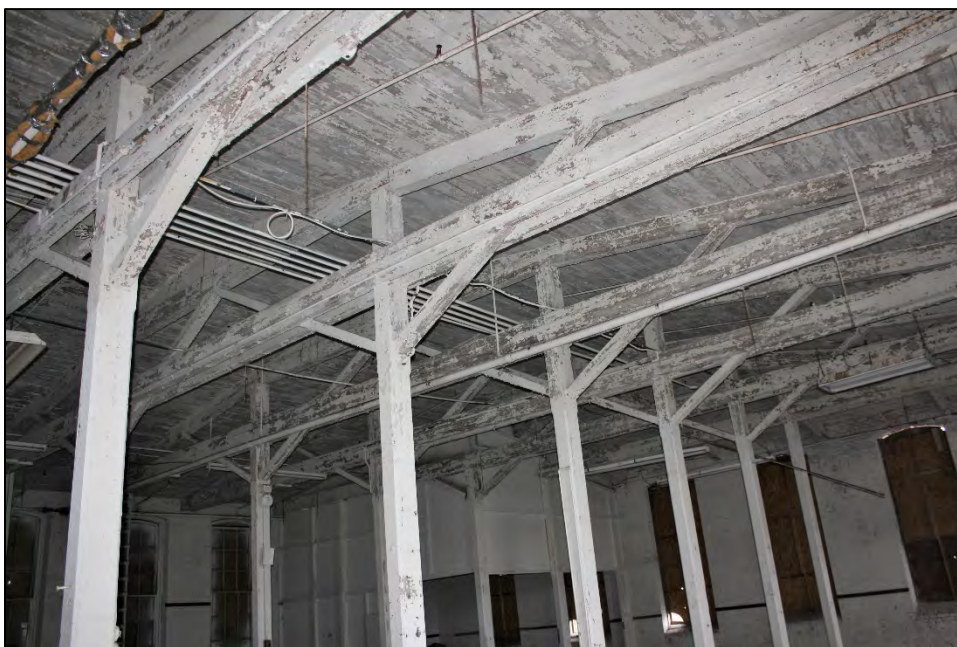
PHOTOGRAPH 30 – Annex – fifth floor interior looking up at the roof deck trusses.

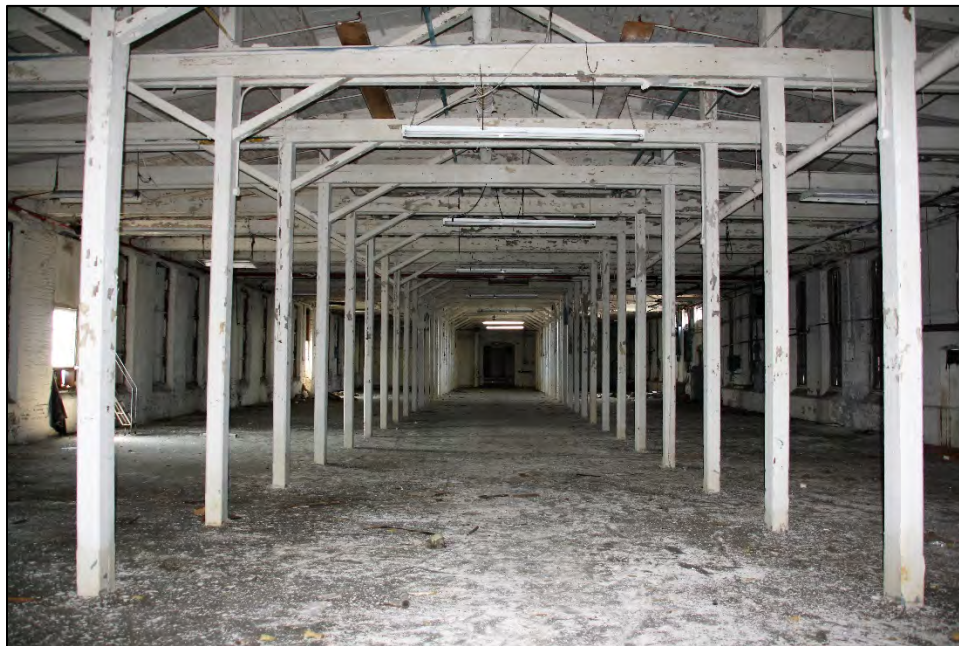
PHOTOGRAPH 31 – Building 2 – fifth floor interior looking south with the roof deck trusses that extend below the beams.

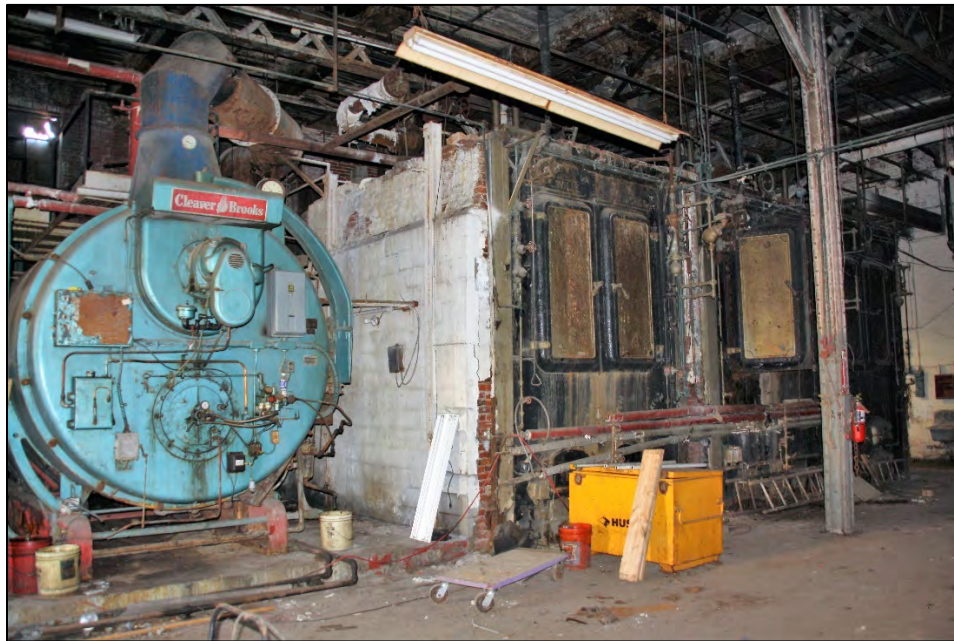
PHOTOGRAPH 33 – Building 5, interior of Boiler House.

Building 5 was also constructed in 1892-1893 and was used as a boiler house on the first floor and Dry Yarns on the upper floors. Building 5 was originally comprised of two buildings: a two-storey eastern half and a three-storey western half over the boilers with the third storey being wood frame with a slag roof. Dry yarns were stored on the second and third floors within this section of the building. The wood frame structure was removed at an unknown time and replaced with brick. Building 5 is constructed immediately to the east of Building 3 separated by a brick masonry wall. Building 5 is a five bay (66 feet) by four bay (54 feet), three-storey, brick masonry building with a shallow pitched gable roof (Photograph 14). Like Buildings 1, 2, and 3, the window openings have been infilled at an unknown time. The interior is filled with boiler house equipment (Photograph 33). Buildings 3 is contributing.

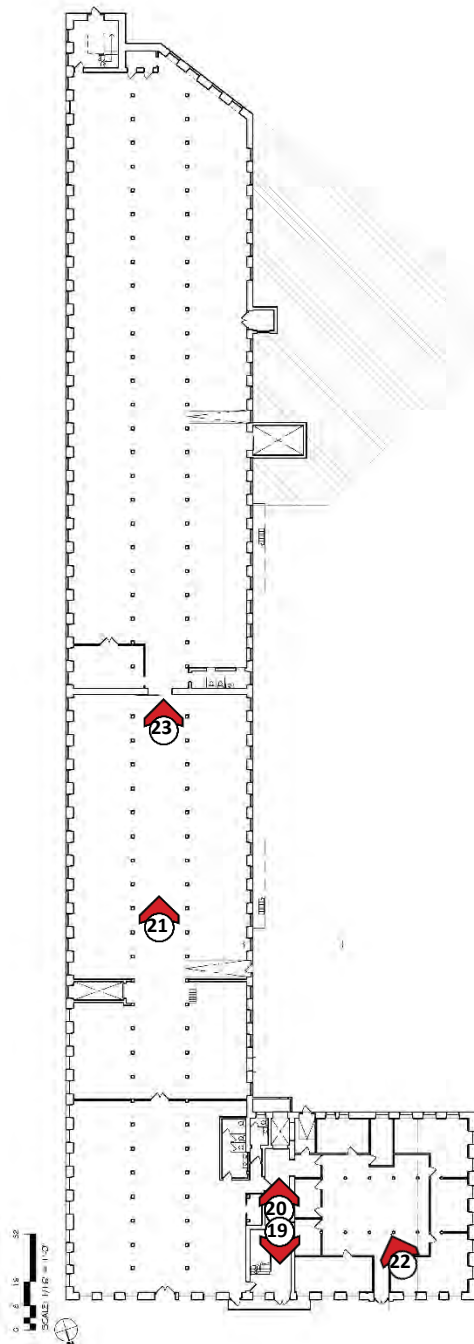
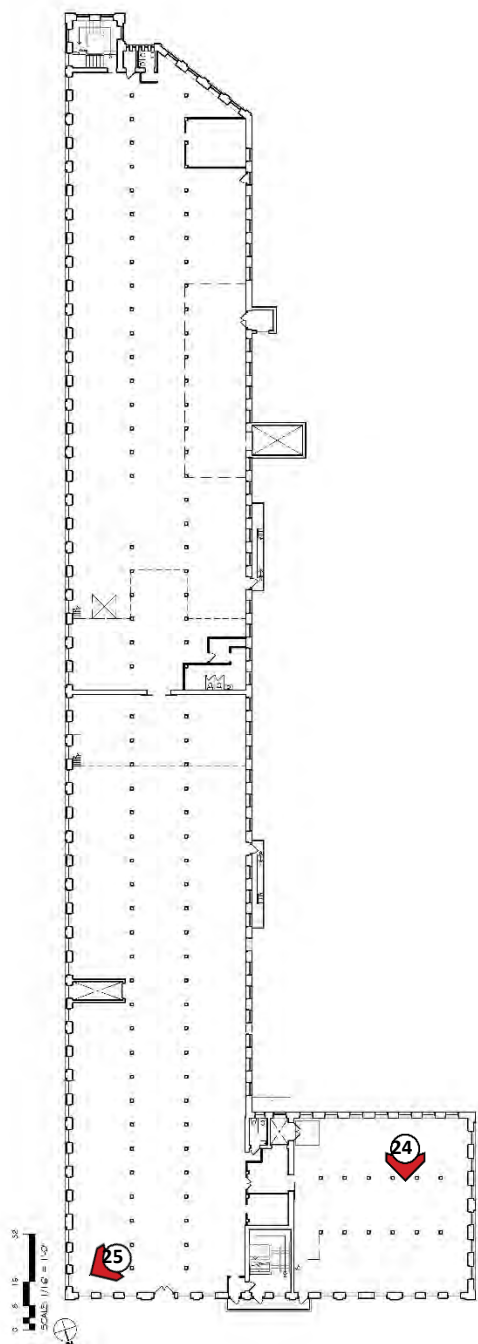
2 2ND FLOOR PLAN - EXISTING CONDITIONS

1 1ST FLOOR PLAN - EXISTING CONDITIONS

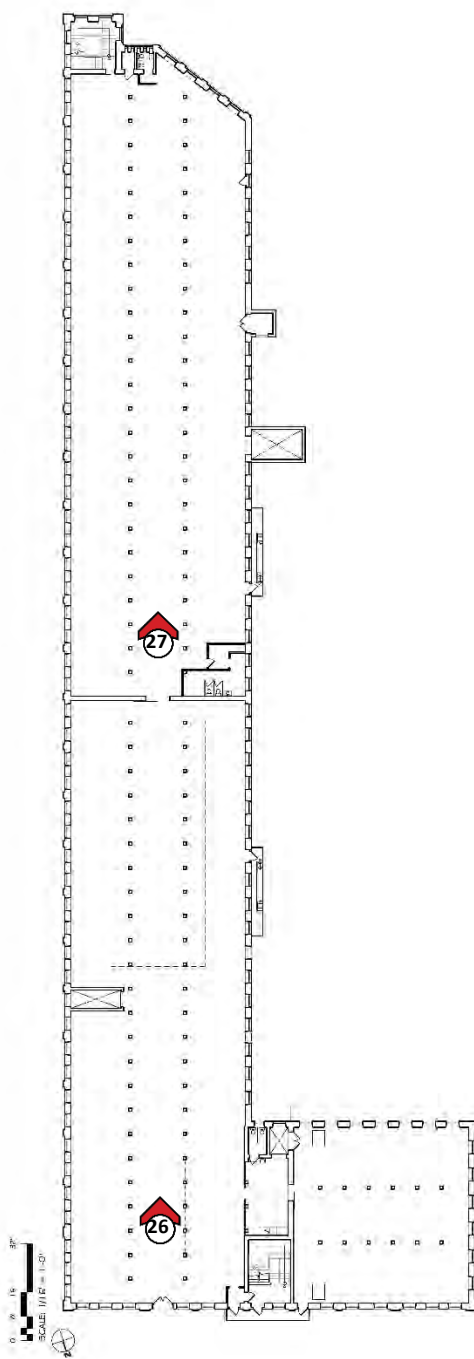
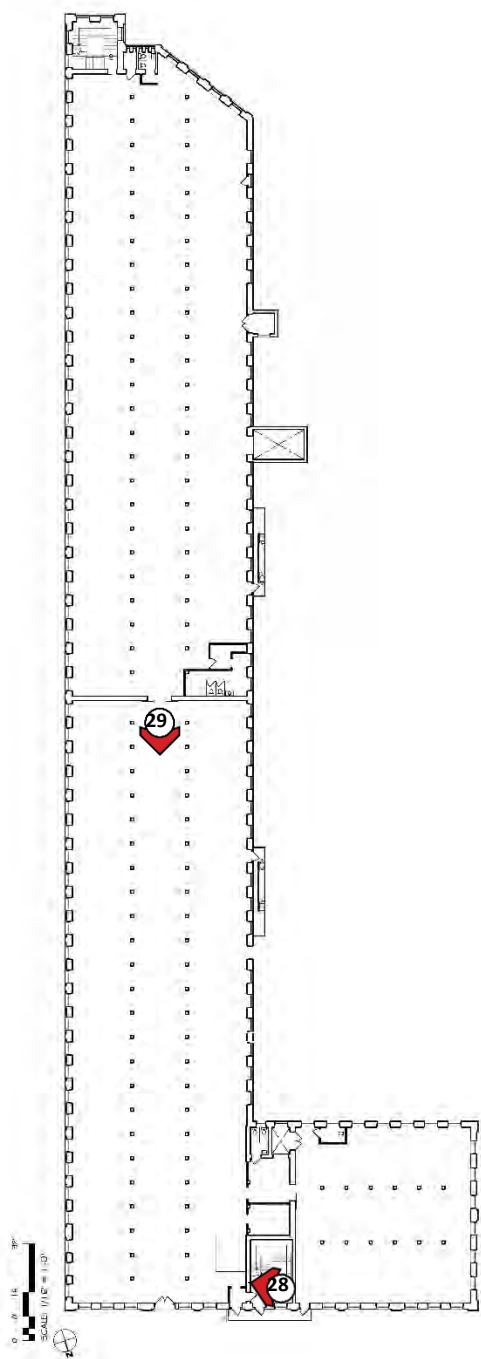
2 4TH FLOOR PLAN - EXISTING CONDITIONS

1 3RD FLOOR PLAN - EXISTING CONDITIONS

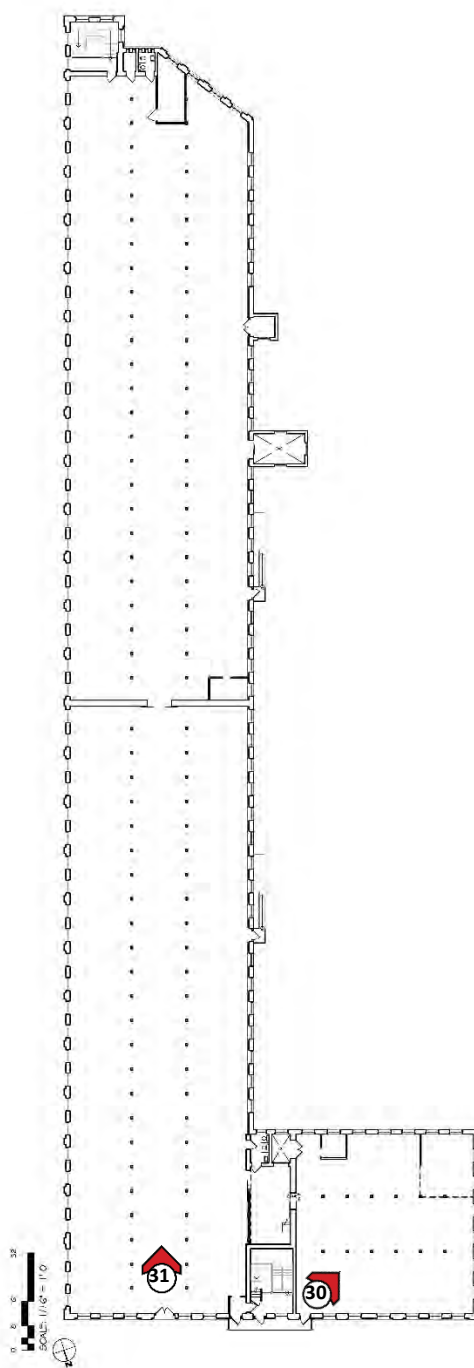
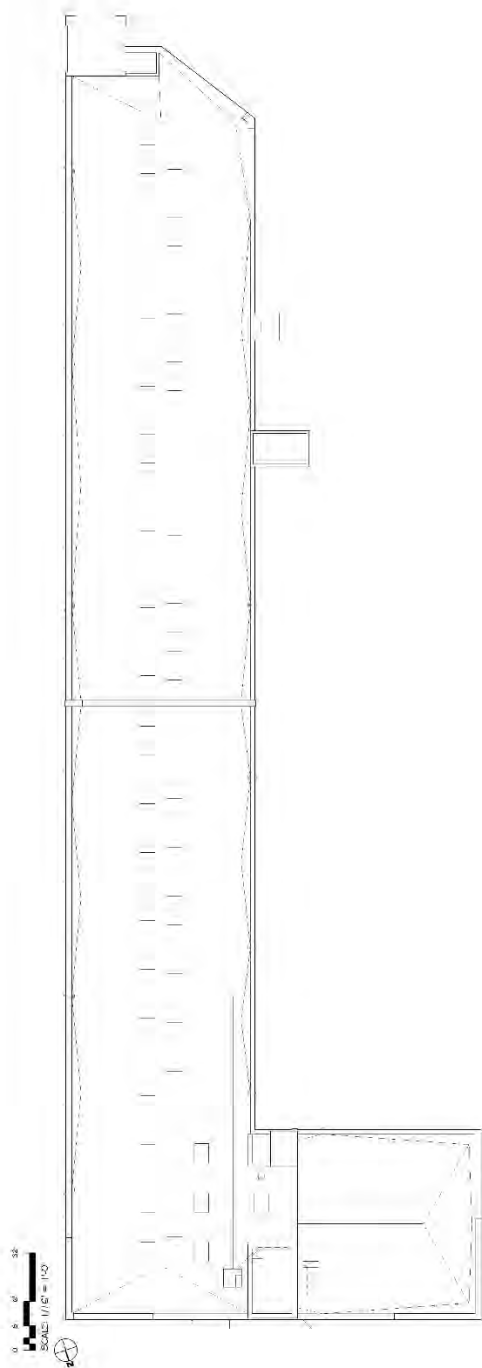
2 ROOF PLAN - EXISTING CONDITIONS

1 5TH FLOOR PLAN - EXISTING CONDITIONS
