COMMENT ON NATIONAL REGISTER NOMINATION

ADDRESS: 5115-39 BELFIELD AVE, Bellevue Worsted Mills

United States Department of the Interior
National Park Service**National Register of Historic Places Registration Form**

1. Name of PropertyHistoric name: Bellevue Worsted MillsOther names/site number: NAName of related multiple property listing: NA**2. Location**Street & number: 5115-5139 Belfield AvenueCity or town: Philadelphia State: PA County: PhiladelphiaNot for Publication: NA Vicinity: NA**3. State/Federal Agency Certification**

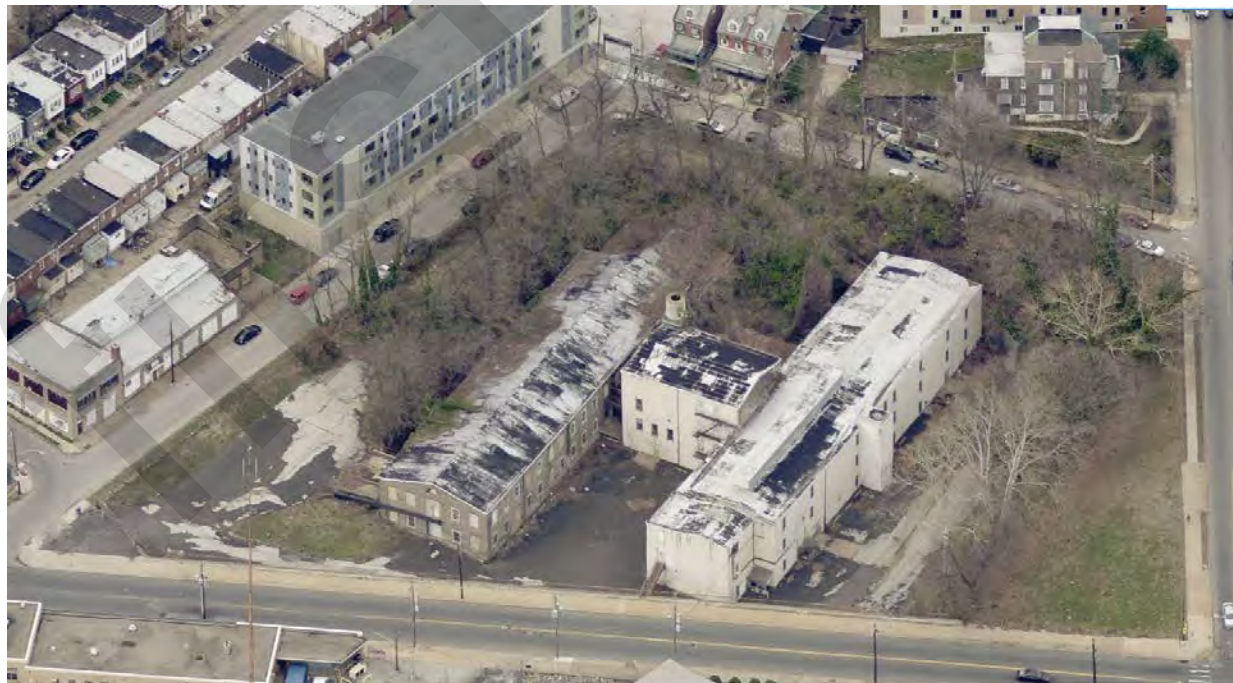
Figure A: Current Aerial View, looking north (Pictometry). In this view, Belfield Avenue is at the bottom, and Wister Street is at far right.

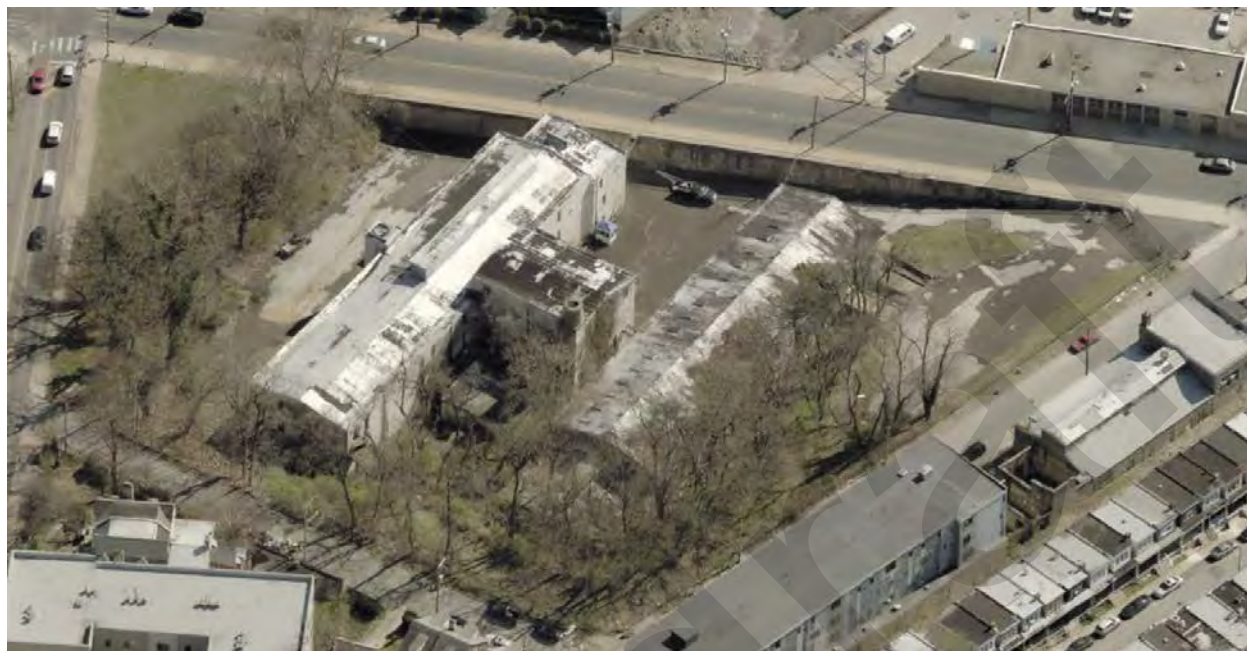
Figure B: Current Aerial View, looking south (Pictometry). In this view, Belfield Avenue is at the top, and Wister Street is at far left

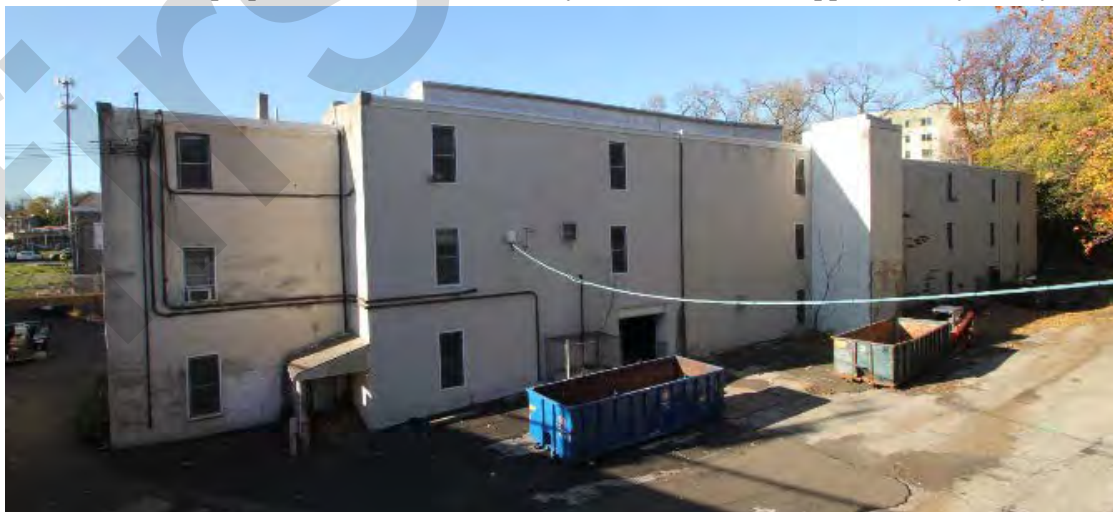
Photo 1: East elevation of Mill #1, looking northwest from Belfield Avenue. The rooftop monitor on the southern half of Mill #1 is visible in this view. The square tower on the east elevation contains an elevator shaft.

On the east elevation, there is a three-story square tower that projects out from the main volume (**Photo 1**). This tower, which contains an elevator shaft, was built with the northernmost addition in 1900. Other notable features include a narrow rooftop monitor located on the ridge of the original three-story section from 1875 (**Photo 1**). On the north elevation, the center opening on the third floor contains original paneled wood loft door (**Photo 3**). Adjacent to the north elevation of the four-story section is a one-story boiler house that was built in 1875-76 and expanded in 1893 and 1900 (the boiler house, which is connected to the first floor of Mill #1, was not accessible at the time of survey due to locked doors). As it was built with and is internally connected to Mill #1, the boiler house is not counted as a separate resource. At the northwest corner of the four-story section, there is square chimney with a cylindrical top (**Photo 4**). The chimney is a part of the original 1875 construction however the cylindrical section appears to have been reduced in height compared to the version that exists in several nineteenth-century fire insurance surveys.

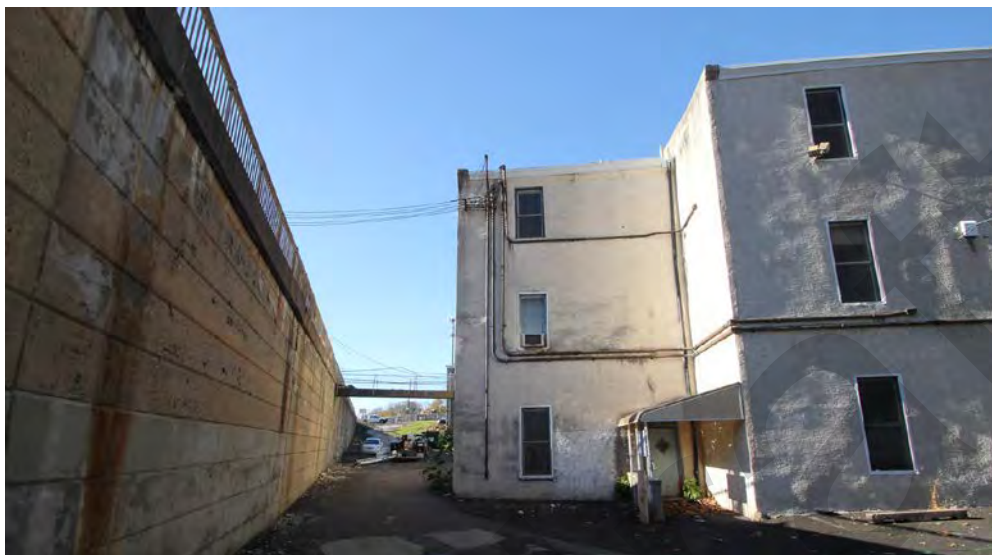
Photo 2: East elevation of Mill #1 (south end), looking west. The retaining wall seen at far left was built in 1912-1913 when Belfield Avenue was extended through the property.

Both sections have stucco-clad schist walls and low-pitched gabled roofs. It is unclear when the stucco finish was installed, however in some locations it appears that the current, slightly textured stucco was applied over an earlier, much thicker and smoother stucco that likely dates to the early twentieth century (an aerial photo from 1929 shows the building clad in stucco). On all elevations, many of the original window openings are blocked in and covered with stucco, alterations that were completed by a later tenant in 1969-1970. The windows that do remain are one-over-one, double-hung aluminum units that appear to have been installed sometime in the last 10 years, replacing earlier replacement windows that were installed in 1969-1970. These windows sit within the original openings.

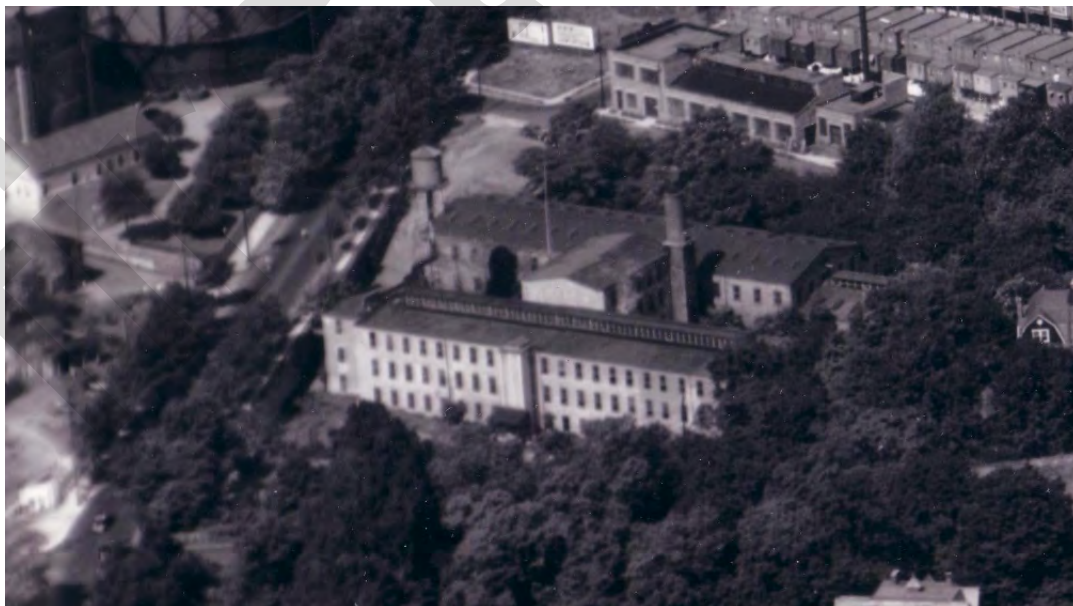
Figure D: Aerial view by Dallin Aerial Survey, 1929, looking west toward the east elevation of Mill #1. This image shows Mill #1 with a stucco exterior, but prior to the infill of some of the window openings in 1969-1970.

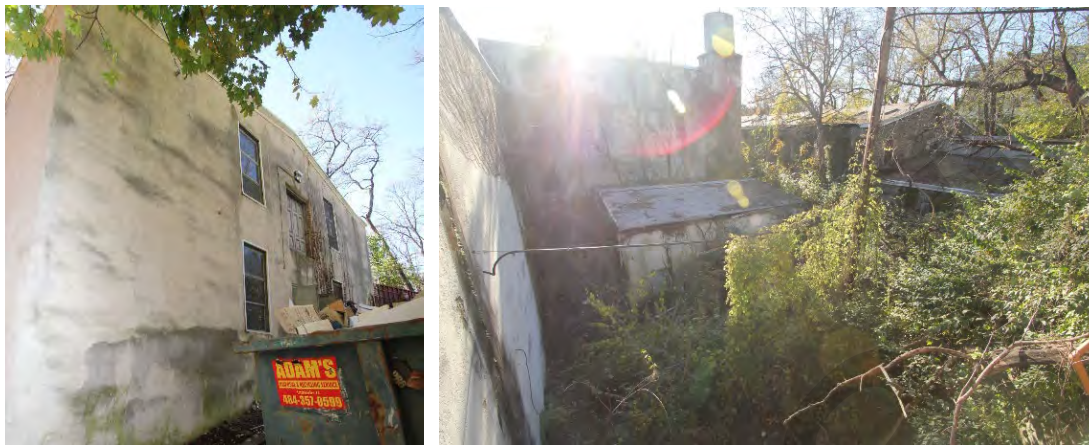
Photo 3 (left): North elevation of Mill #1 (three-story section), looking southwest.

Photo 4 (right): North elevation of Mill #1 (four-story section), looking south.

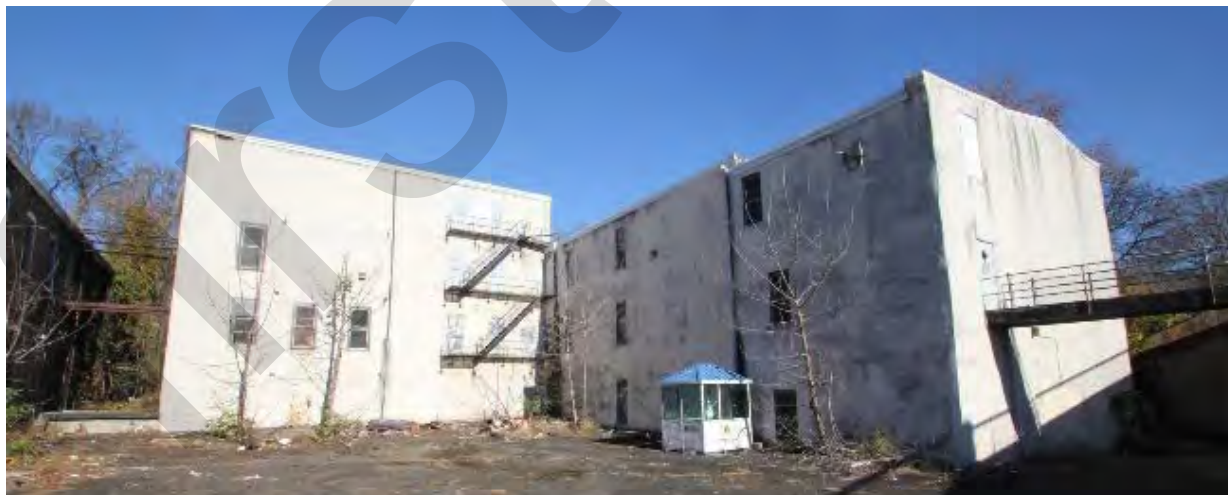
Photo 5: South and west elevations of Mill #1, looking northeast. At far left, an elevated, horizontal steel framing member between the four-story section of Mill #1 and Mill #2 is likely a remnant of a covered passage that is indicated on a 1924 Sanborn map (**Figure 10**).

On the south elevation of the four-story section, a metal fire escape, which was installed around 1900, spans the three easternmost bays on the second through fourth floors (**Photo 5**). On the south elevation of

the three-story section, a metal bridge connects a door opening in the westernmost bay on the second floor to the sidewalk along Belfield Avenue (**Photo 5**). The precise date of the bridge is not known. The bridge does not appear on a 1924 Sanborn map, therefore it postdates the period of significance (**Figure 10**).

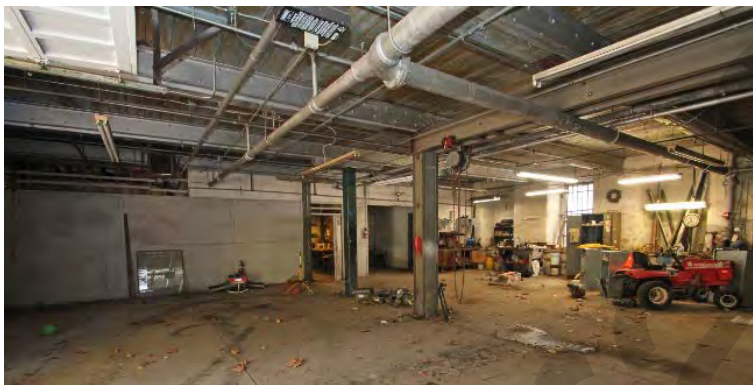
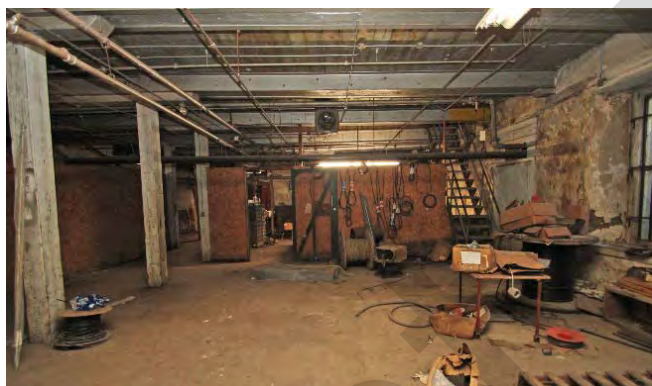
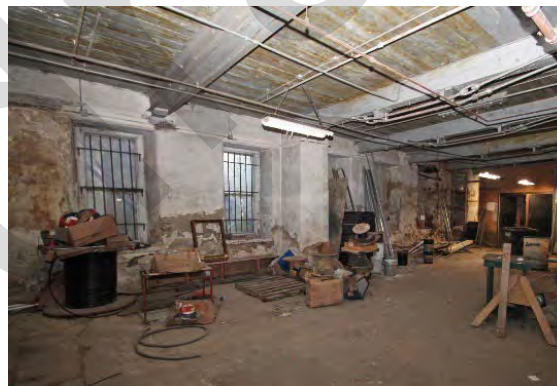
Photo 6: First floor of Mill #1 (three-story section), looking southwest.

Photo 7 (left): First floor of Mill #1 (three-story section), looking south.

Photo 8 (right): First floor of Mill #1 (three-story section), looking northwest.

The interior of Mill #1 retains nearly all original nineteenth-century finishes and structural features. Most of the historic interior volumes and spatial arrangements also remain intact. Except as explained below, the interior has changed little over the last 121 to 146 years.

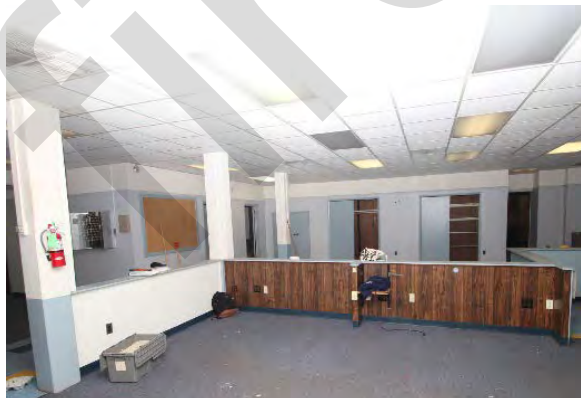
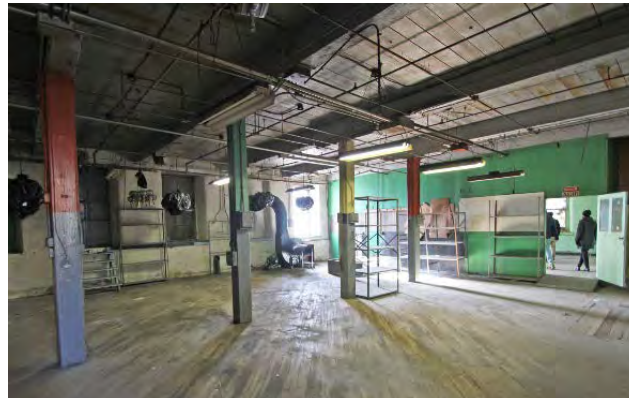
Photo 9 (left): Second floor of Mill #1 (three-story section), looking south.

Photo 10 (right): Second floor of Mill #1 (four-story section), looking southwest.

On the second floor, the north half of the three-story section contains a modern, open office space with carpeted floors, drywall partitions and dropped acoustical tile ceilings (**Photo 9**). The remainder of the second floor contains wood floors (both diagonal and straight, depending on the section), parged perimeter walls, and heavy timber columns and beams at the ceiling (**Photos 10-12**).

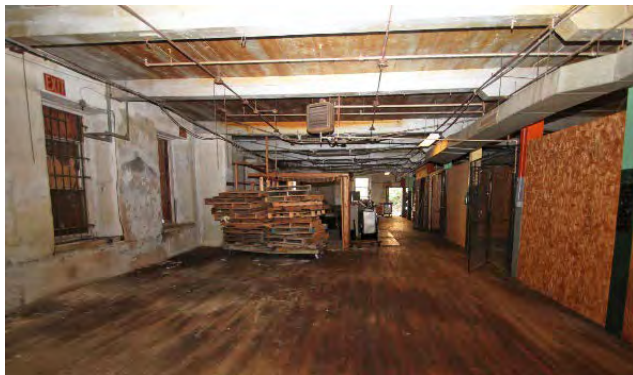
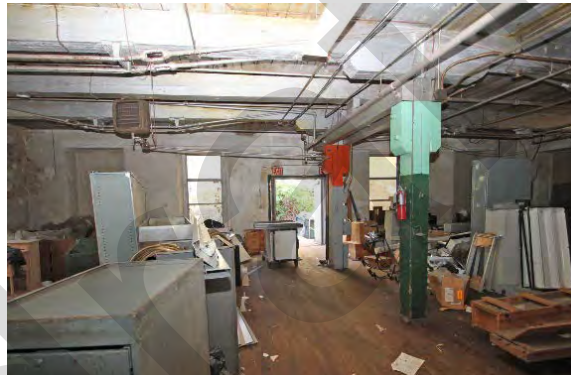
Photo 11 (left): Second floor of Mill #1 (three-story section), looking north.

Photo 12 (right): Second floor of Mill #1 (three-story section), looking north

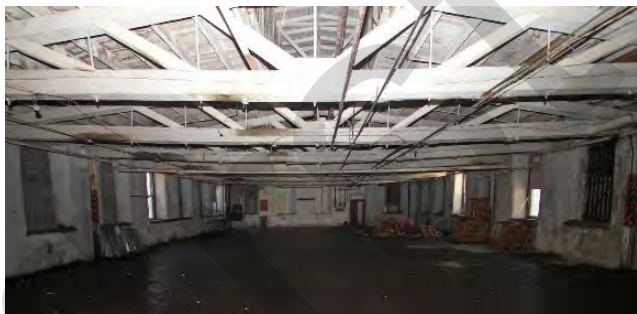
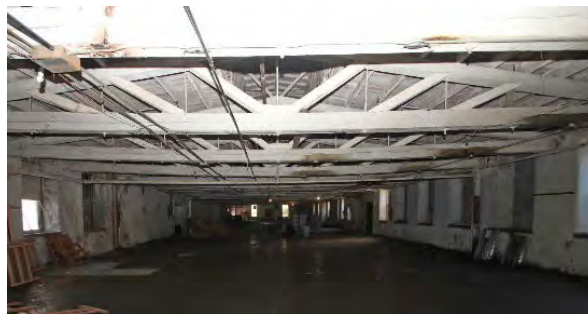
Photo 13 (left): Third floor of Mill #1 (three-story section), looking south.

Photo 14 (right): Third floor of Mill #1 (three-story section), looking north.

The third floor of the three-story section (the top floor of that section) consists of a single large space with diagonally laid wood floors, parged perimeter walls, and exposed heavy timber roof trusses, which are painted (**Photos 13, 14**). Within the third floor space, the original rooftop monitor, featuring continuous six-over-six, double-hung wood windows, is visible (**Photo 15**). The third floor of the four-story section contains finishes similar to the three-story section but also contains a small room at the northwest corner with drywall partitions (**Photo 16**).

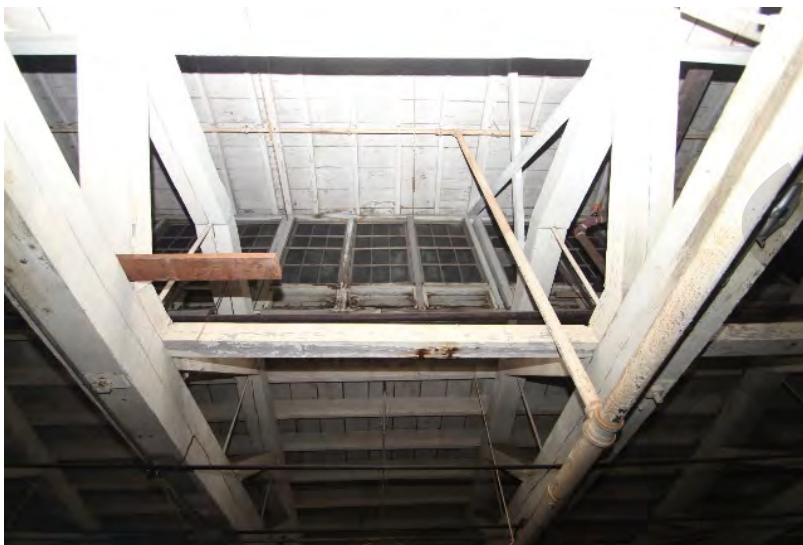
Photo 15: Third floor of Mill #1 (three-story section), rooftop monitor.

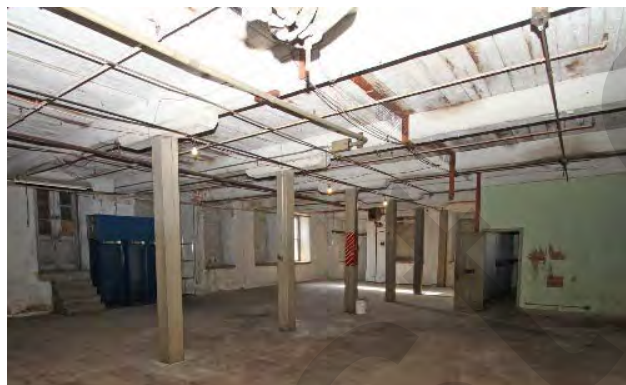
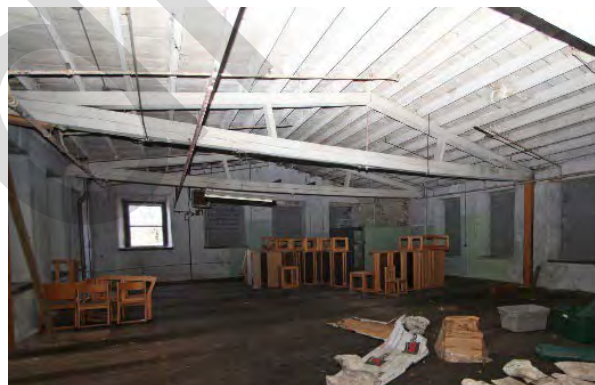
Photo 16 (left): Third floor of Mill #1 (four-story section), looking southwest. The partition at the northwest corner of this space (in green) consists of 2x4 framing with drywall, therefore it almost certainly did not exist during the tenure of Benjamin W. Greer.

Photo 17 (right): Fourth floor of Mill #1 (four-story section), looking northwest.

The fourth floor of the four-story section has wood floors, parged perimeter walls, and exposed heavy timber roof trusses, which are painted (**Photo 17**).

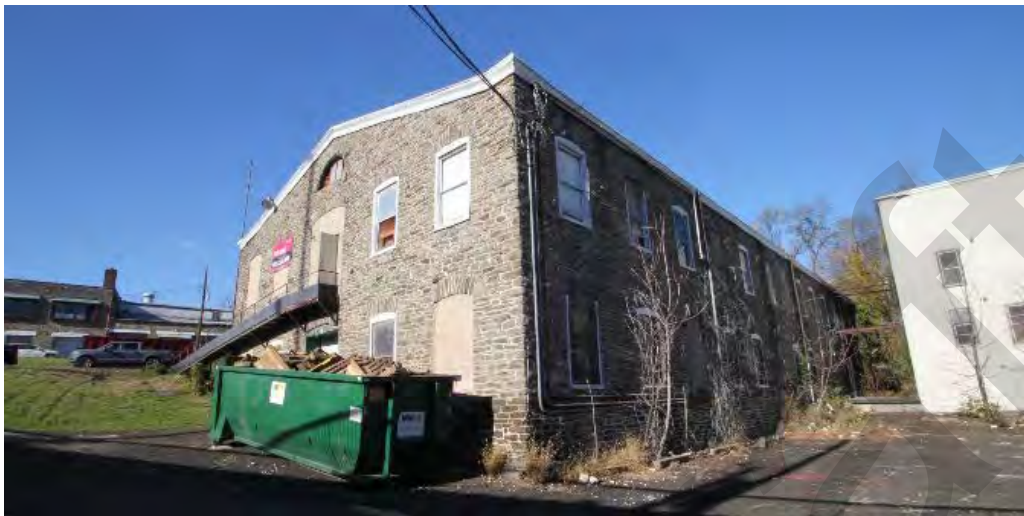
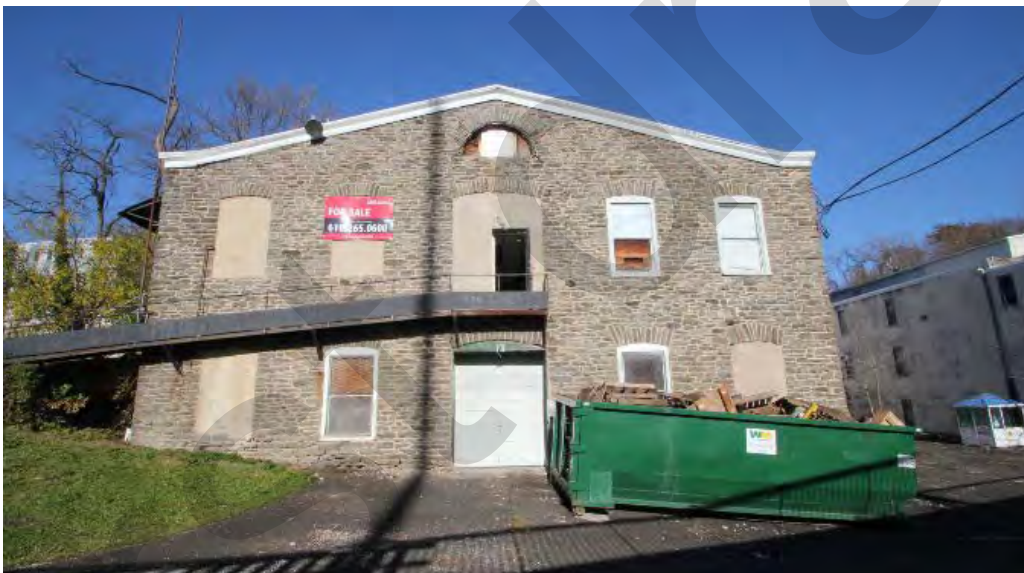
Photo 18 (top): South and east elevations of Mill #2, looking northwest.

Photo 19 (bottom): South elevation of Mill #2, looking north. The wider center openings on the first and second floors are original, but now contain later replacement doors and infill.

Mill #2 is a two-story, approximately 60' by 250' rectangular mill building with schist exterior walls that was built in 1900, replacing an earlier building in the same general location. The north end of the building, a section that measures approximately 45' long, is one-story tall. Both the one- and two-story sections have low pitched gabled roofs like Mill #1 and contain painted metal cornices. Although some of the original window openings have been infilled with stucco on each of the four elevations, the openings, including their segmental arched heads, are still apparent (**Photo 18**). The windows that do remain are one-over-one, double-hung aluminum replacement units that were installed sometime in the last 30-40 years. On the south elevation, there are larger, garage-sized openings in the center bays, which retain their original size, but with later door replacements and/or infill: the opening on the first floor contains a modern, roll-down metal door and the opening on the second floor contains largely stucco infill with a

single, hollow-metal swinging door (**Photo 19**). Above the center opening on the second floor, there is a half-circle window opening that currently contains an aluminum louver with plywood panels on the sides.

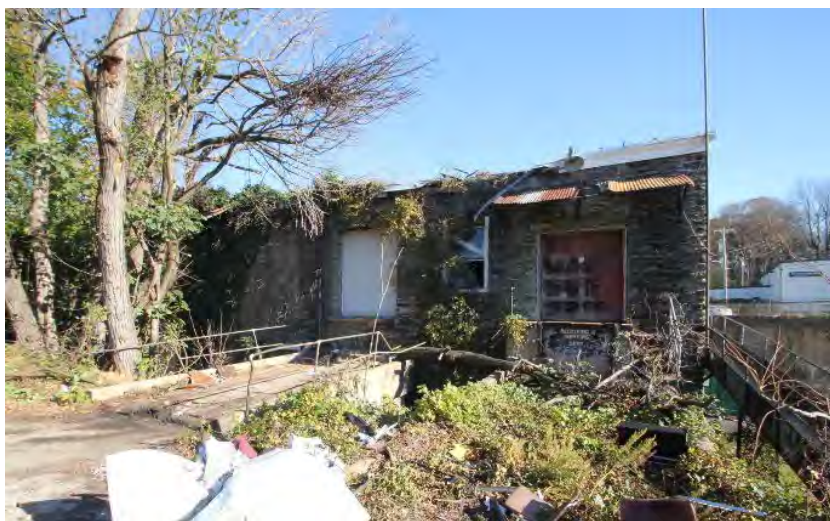
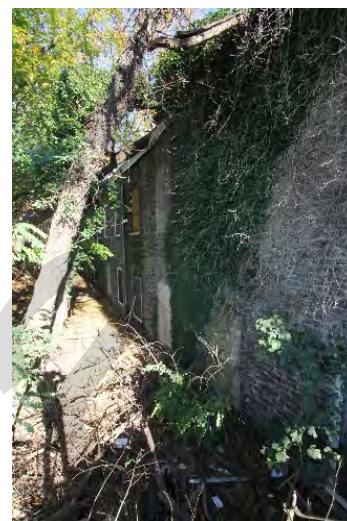
Photo 20 (left): West elevation of Mill #2 (south end), looking east.

Photo 21 (right): West elevation of Mill #2, looking northeast from the loading dock seen in Photo 20.

A metal ramp parallel to the south elevation slopes down from the entrance in the center bay on the second floor to the parking area west of the building. On the west elevation, the first and third bays from the south contain roll-down metal garage doors (**Photo 20**). These loading bays are accessed by short concrete ramps. The first bay contains a partial corrugated metal awning. Most of the remainder of the west elevation, as well as the north elevation, is largely obscured by trees and overgrown bushes (**Photo 21**).

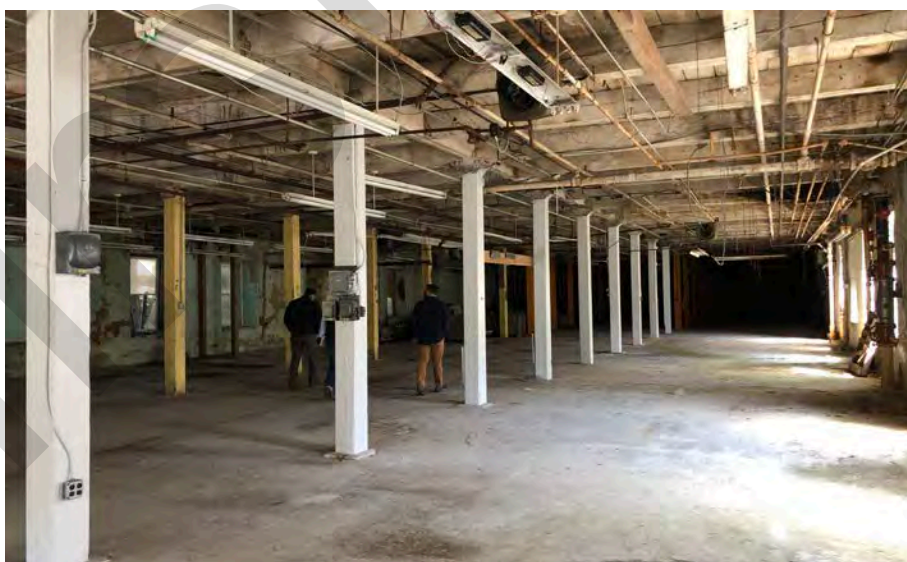
Photo 22: First floor of Mill #2, looking north.

Except as explained below, the interior has changed little over the last 121. The first floor is largely open in plan, containing concrete floors, parged perimeter walls, as well as two rows of heavy timber columns supporting the heavy timber floor joists at the ceiling (**Photo 22**). On the second floor, there are a few small offices at the southeast corner that occupy less than 10% of the total floor area. These spaces contain carpeted floors, partitions with drywall or painted wood panels, dropped acoustical tile ceilings and appear to date to the 1960s or later (**Photos 23-24**). The remainder of the second floor contains diagonally laid wood floors, parged perimeter walls, and exposed heavy timber roof trusses, which are painted (**Photos 25-26**).

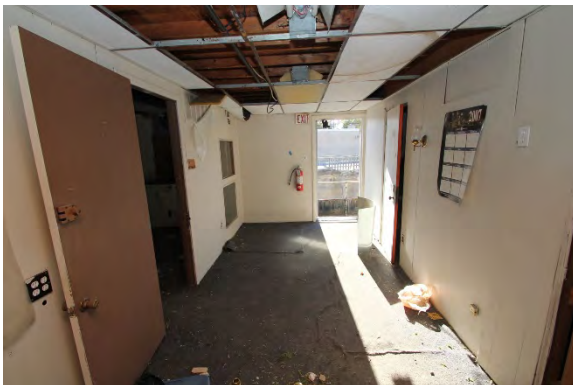
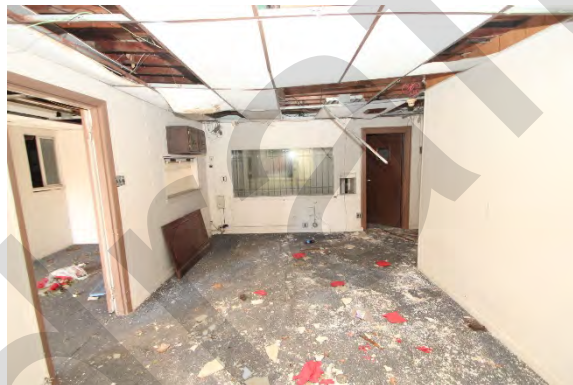
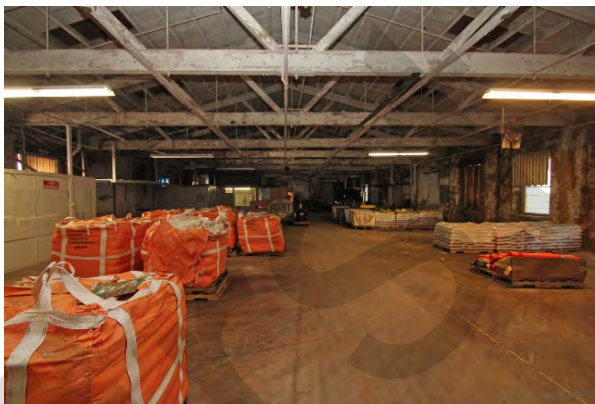
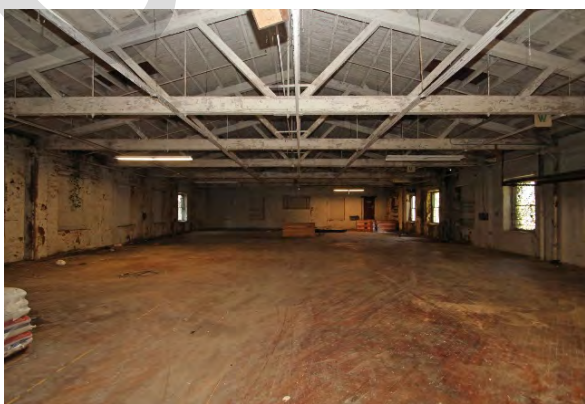
Photo 23 (left): Second floor of Mill #2, looking south.

Photo 24 (right): Second floor of Mill #2, looking north.

Photo 25 (left): Second floor of Mill #2, looking south.

Photo 26 (right): Second floor of Mill #2, looking north.

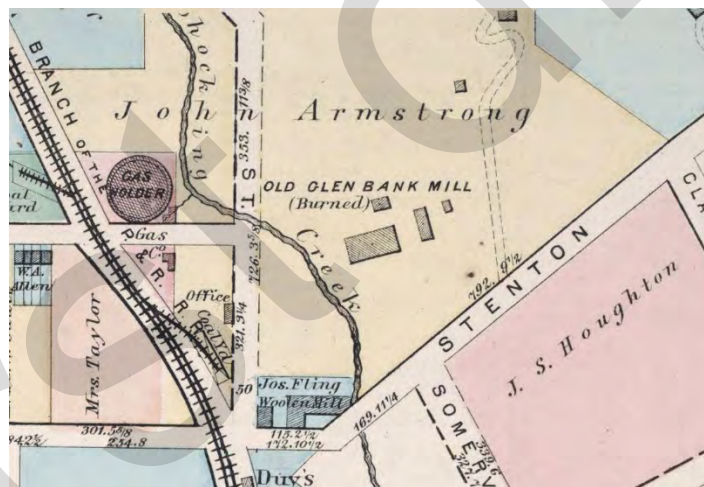
Figure 1: Map showing the Old Glen Bank Mill. From the *Atlas of the Late Borough of Germantown*, G.M. Hopkins, 1871 (from the collection of the Athenaeum of Philadelphia). The mill was located in the same general location as the present buildings. Stenton Avenue is now Wister Street (along the east side of the property). Belfield Avenue was built over Wingohocking Creek in 1912.

In 1875, John Bromley, one of Philadelphia's foremost carpet manufacturers, acquired the property that would later be occupied by the Bellevue Worsted Mills from landowner John Armstrong. Bromley quickly began construction on a small mill complex, which was completed in 1876 and became known as the Glencairn Woolen Mills. The mill replaced the earlier Glen Bank Mill, which was presumably built by Armstrong and is marked as "burned" on an 1871 map (**Figure 1**).

The origins and history of the Glen Bank Mill are largely unknown, as no reference to the mill has been found anywhere except the 1871 map and a later atlas dating to 1875. Bromley's motivation for opening a new mill in Germantown is also unknown, for his home and his enormous carpet mill were located several miles to the southeast, in the Kensington section of the city. Bromley's desire to locate in Germantown may have been due to the fact that some of the most skilled woolen yarn spinners were located in that part of the city, or perhaps because he wished to produce varieties of yarns not then offered by his usual suppliers (following the Philadelphia aspect of specialization in the textile industry,

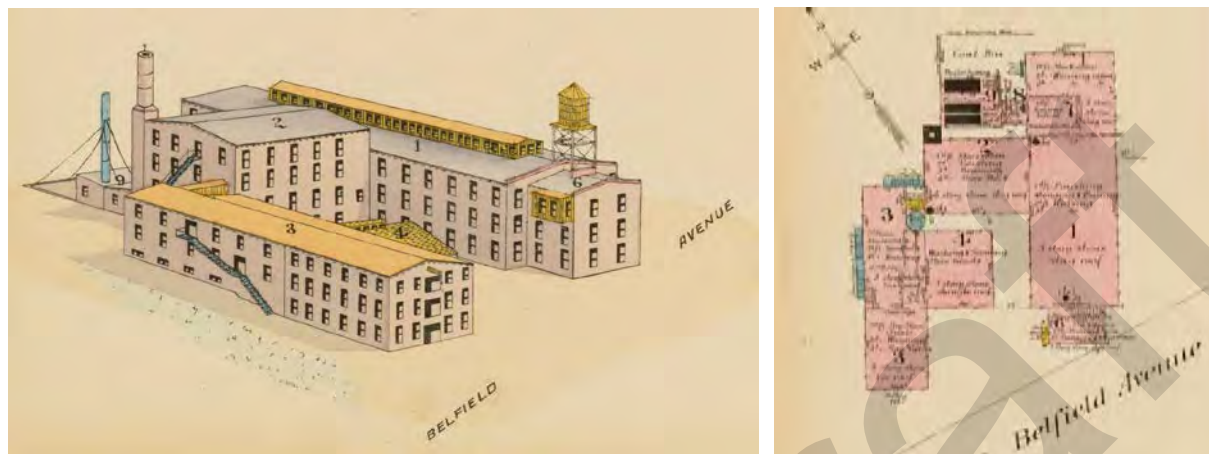
Figure 7 (left): Hexamer General Survey #2718, surveyed 1893. 3D view.
Figure 8 (right): Hexamer General Survey #2718, surveyed 1893. Plan view.
