HISTORIC STREETS ASSESSMENT REPORT

CITY OF PHILADELPHIA

DEPARTMENT OF STREETS

PHILADELPHIA CONTRACT NO.: 1220084

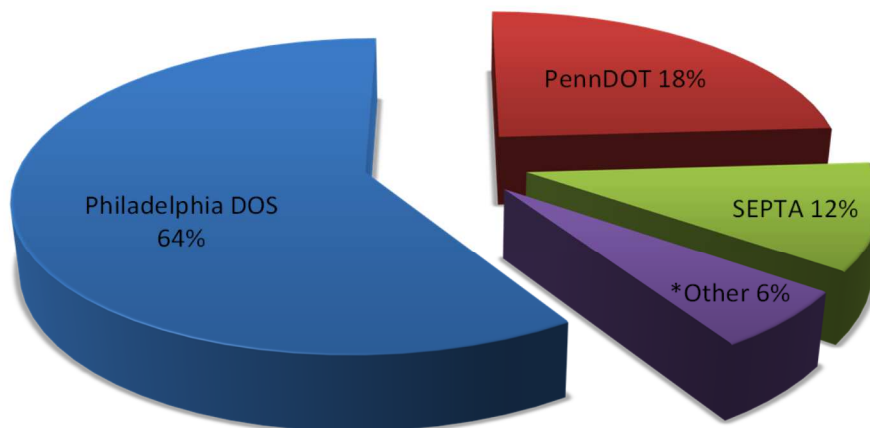
Figure 1.1: Responsible Entity

Of the 484 blocks in the current Inventory, the DOS indicated they are responsible for 309 blocks (64%); PennDOT is responsible for 90 blocks (18%); SEPTA is responsible for 57 blocks (12%); and the remaining entities mentioned are responsible for a total of 28 blocks (6%). Figure 1.1 provides a visual representation of this distribution. A majority of the remaining discussion in this report will focus only on the 309 blocks that are the responsibility of the DOS though the 2013 Philadelphia Historic Streets Inventory and Engineer’s Opinion of Probable Cost included as Appendix B provides information on all blocks.

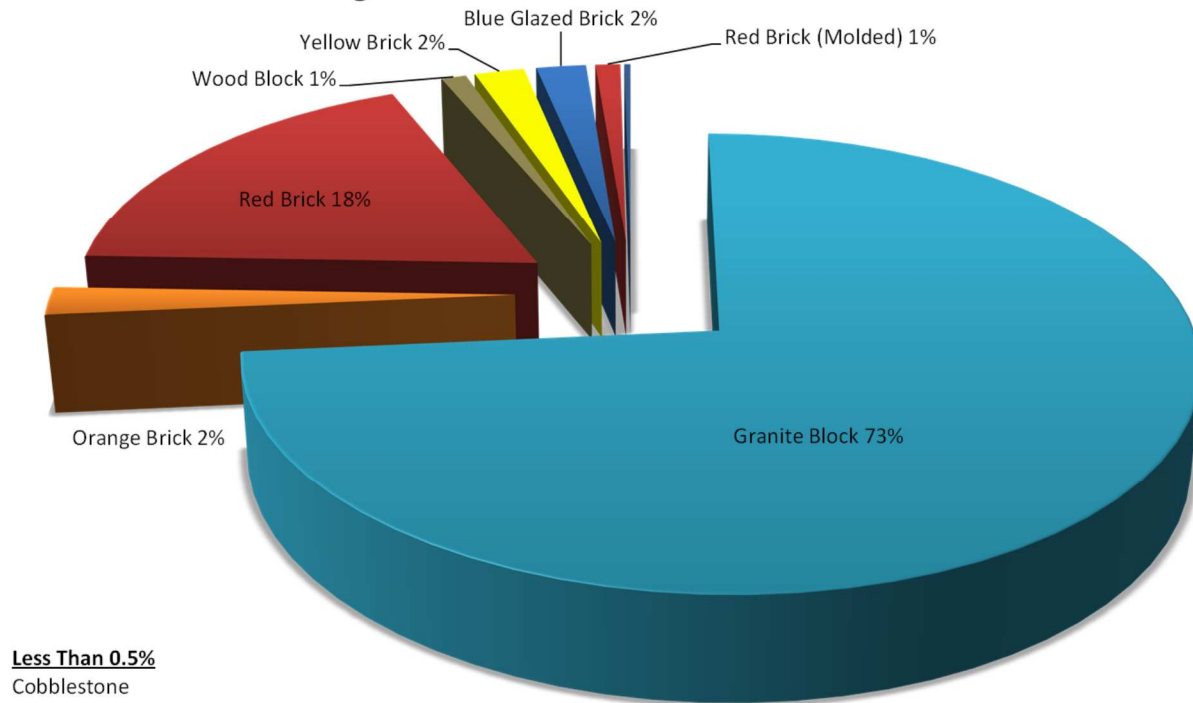
Figure 1.2: Current DOS Block Material

The DOS’s 309 historic blocks are comprised of eight (8) distinct materials. As in the 1999 Inventory, the majority of blocks are granite block (73%) and red brick (18%). Figure 1.2 shows a breakdown of the various materials present in 2013.

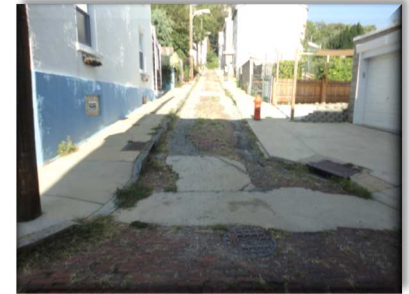
Maiden Street

- Maiden Street, 100 block, between Mansion and Silverwood Streets
- Waverly Street, 1400 block, between 15th and Carlisle Streets
- Reno Street, 400 block, between Lawrence and Leithgow Streets
- Orkney Street, N. 800 block, between Reno and Myrtle Streets
- American Street, S. 300 block, between Spruce and Delancey Streets
- Thomas Paine Place, 200 block, between Dock and 3rd Streets
- Mermaid Lane, E. Unit block, between Germantown Avenue and Winston Road
- Leithgow Street, N. 800 block, between a dead end and Reno Street
- Delancey Street, 1500 block, between 16th Street and a dead end
- Elbow Lane, 200 block, between Bank and Bodine Streets

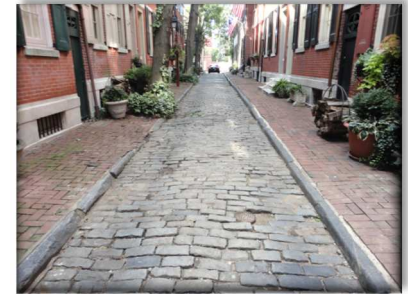
American Street

- American Street, S. 300 block, between Spruce and Delancey Streets
- Waverly Street, 1400 block, between 15th and Carlisle Streets
- Panama Street, 2400 block, between 24th and 25th Streets
- Philip Street, S. 300 block, between Spruce and Delancey Streets
- 2nd Street, S. 400 block, between Lombard and Stamper Streets
- 2nd Street, S. 300 block, between Delancey and Spruce Streets
- 2nd Street, S. 300 block, between Pine and Delancey Streets
- Cypress Street, 500 block, between 6th and Reese Streets
- Panama Street, 1800 block, between 18th and 19th Streets
- 2nd Street, S. 400 block, between Stamper and Pine Streets

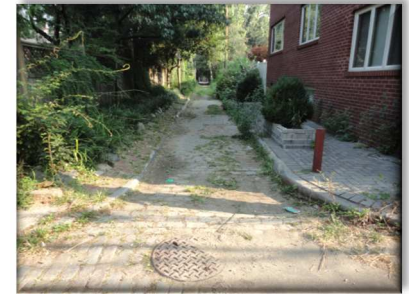
Orkney Street

- Orkney Street, N. 800 block, between Reno and Myrtle Streets
- Germantown Avenue, 8600 block, between Bethlehem and Rex Streets
- Maiden Street, 100 block, between Mansion and Silverwood Streets
- American Street, S. 300 block, between Spruce and Delancey Streets
- Abbottsford Avenue, W. 100 block, between Wayne and Green Streets
- Leithgow Street, N. 800 block, between Parrish and Reno Streets
- Reese Street, S. 500 block, between Rodman and Lombard Streets
- Hutchinson Street, S. 200 block, between Irving and Latimer Streets
- Sheldon Street, between Hermitage and Fountain Streets
- 2nd Street, S. 300 block, Delancey and Spruce Streets

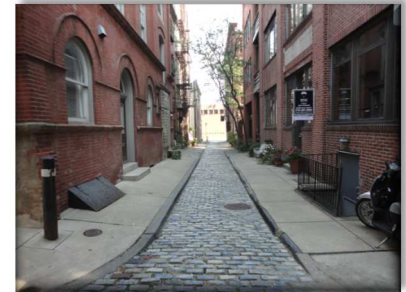
Mascher Street

- Mascher Street, N. Unit block, between Cuthbert and Arch Streets
- Perth Street, S. 400 block, Lombard and Addison Streets
- Filbert Street, 200 block, between 3rd and American Streets
- Waverly Street, 1400 block, between 15th and Carlisle Streets
- Delancey Street, 1500 block, between 16th Street and a dead end
- Station Street, 4400 block, between Levering and Gay Streets
- Leithgow Street, S. 200 block, between Locust Street and north dead end
- Reese Street, S. 300 block, between Delancey and Cyprus Streets
- Bouvier Street, between North and Melon Streets
- Panama Street, 2400 block, between 24th and 25th Streets

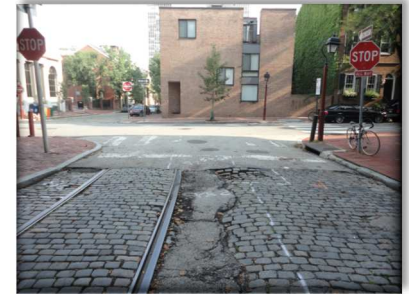
2nd Street, S. 400 block

- 2nd Street, S. 400 block, between Lombard and Pine Streets
- 2nd Street, S. 300 block, between Delancey and Spruce Streets
- 2nd Street, S. 300 block, between Pine and Delancey Streets
- Chadwick Street, S. 300 block, between Pine and Cypress Streets
- Panama Street, 2400 block, between 24th and 25th Streets
- Germantown Avenue, 8600 block, between Bethlehem and Rex Streets
- Philip Street, S. 300 block, between Spruce and Delancey Streets
- Ionic Street, 100 block, between Front and 2nd Streets
- 2nd Street, S. 400 block, between Lombard and Stamper Streets
- Bodine Street, S. 900 block, between Montrose and Christian Streets

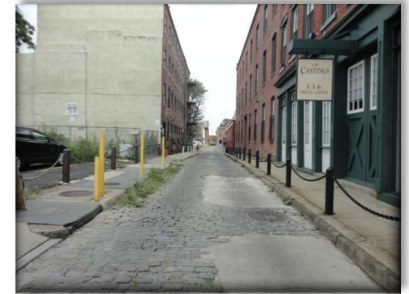
Quarry Street

- Quarry Street, 200 block, between Bread and 3rd Streets
- Sheldon Street, between Hermitage and Fountain Streets
- Reese Street, S. 300 block, between Delancey and Cyprus Streets
- Bonsall Street, S. 200 block, between Locust and Chancellor Streets
- Black Horse Alley, 100 block, between Letitia and 2nd Streets
- St. James Street, 500 block, between St. James Court and 5th Street
- St. James Street, 500 block, between Randolph Street and St. James Court
- Bread Street, N. 100 block, between Quarry and Race Streets
- Leithgow Street, N. 800 block, between Parrish and Reno Streets
- Lofty Street, 200 block, between Boone and Terrace Streets
