Vine Street Lot

Archaeological Data Recovery Plan

Prepared for:
The Durst Organization

April 9, 2020

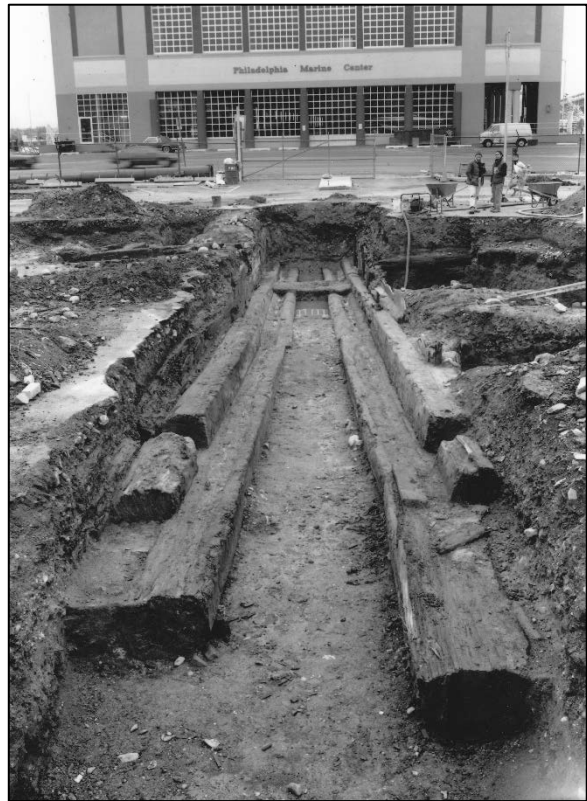
Photo 1. A view of the fully excavated shipway found during the 1987 excavations (Weber and Yamin 1988/2006).

The most notable find was the discovery of a well-preserved slipway—used for hauling ships out of the water for repair or refit. About 83 feet of this structure was uncovered, showing two parallel wooden rails set 8–9 feet apart, upon which a cradle would have been set. Small ships or schooners were then able to sail into the cradle from the river and, once secured, the ship and cradle could then be hoisted up the sloped rails to drier land, where it could be worked on (Weber and Yamin 1988/2006, 18-19, 31). Weber's report interpreted this shipway to likely date to the early nineteenth century under the occupation of Thomas Leiper, as the 1811 Paxton map shows a possible structure in the approximate location around that time (Paxton 1811).

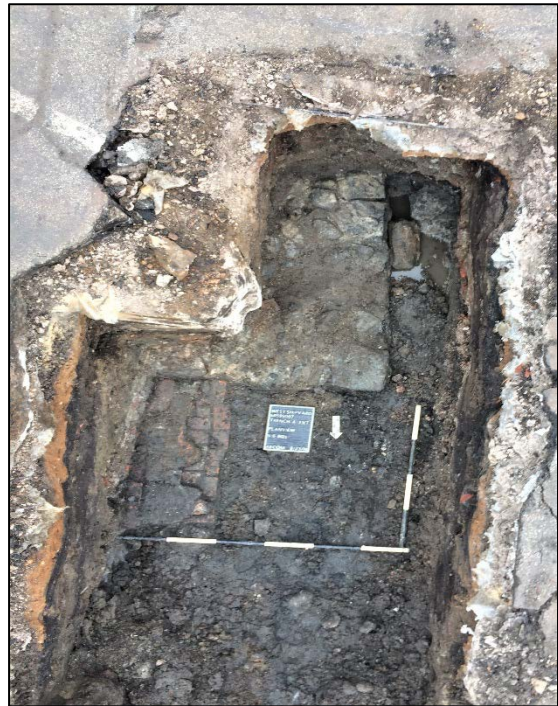
Photo 3. Southern end of Trench 4 plan view. Shown: Context 197, Feature 42, and Feature 44.

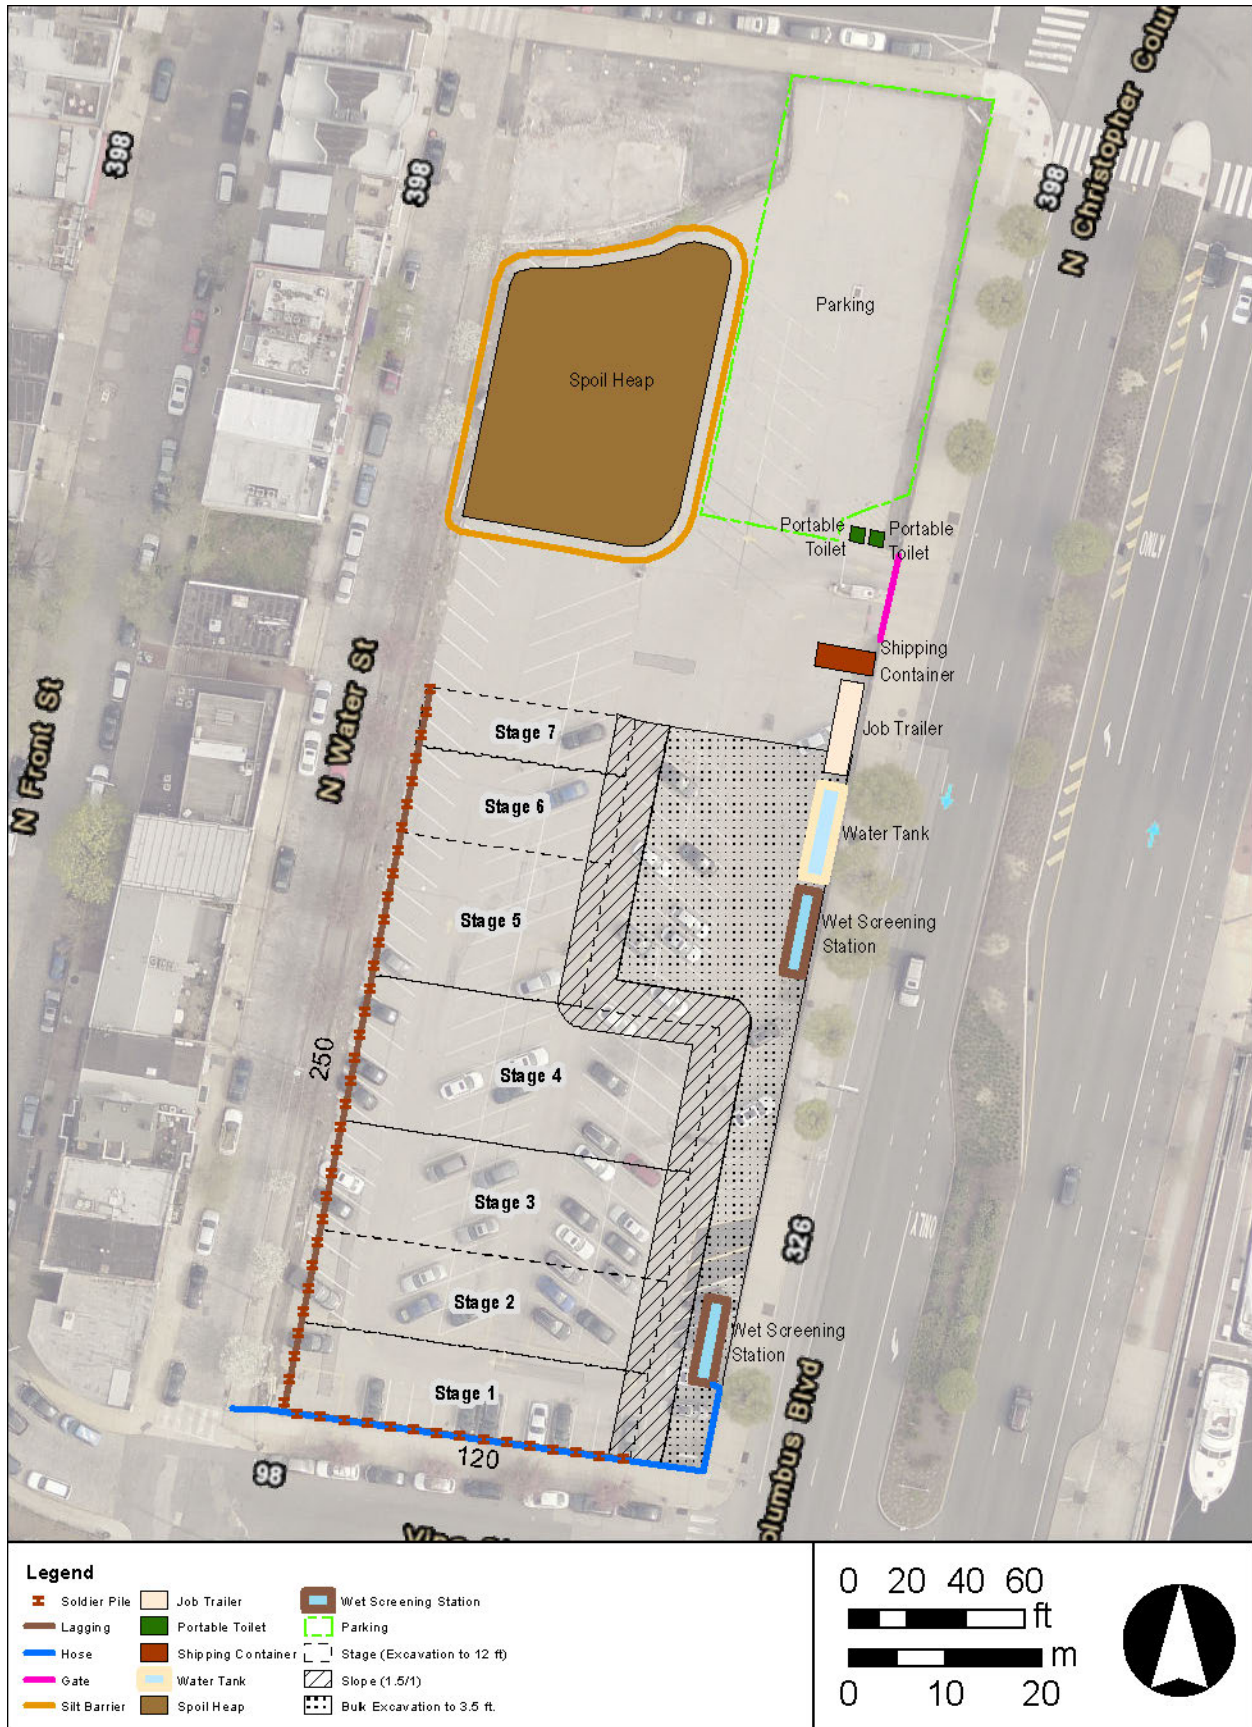
Figure 4. Map of the project area showing the proposed order of excavation and the layout of the site facilities.

AECOM plans to conduct a full depth (12-foot-deep) excavation across the full width (120 feet) of the West and Rakestraw lots (Stages 1-4) and a full-depth excavation of a 75-foot-wide span of the western half of the Porteus and Colley Lots (Stages 5-7) (see Appendix A: Figure 4). The remaining ground within the project area will be bulk excavated to a depth of 3.5 feet and examined for evidence of historic structures and features, but in these less sensitive areas excavation will be halted at this depth. Features found within this area will be documented and sampled as necessary. Logically, focusing the full-width excavation efforts on the southern lots (Stages 1-4) makes sense as they are known to have had substantial historic occupations during the shipbuilding and early mercantile periods and thus the density of archaeological resources in this area is apt to be high. Furthermore, these properties are associated with shipwrights like James West and Michael Hulings and merchants of the West family all of whom have substantive primary and secondary documentary records that can help to provide the necessary context to derive maximum interpretive advantage from the archaeological material recovered. Focusing efforts in the northern 3 stages (Stages 5-7) to the 75 feet closest to Water Street enables for the full examination of the early riverbank and its shipbuilding potential but excludes the less sensitive areas of artificial ground to the east which testing has shown has more limited informational potential. The bulk excavation of the remaining portions of the project area to 3.5 feet below grade will enable the delineation of post-Great Conflagration features and structures related to the mercantile period, but will not incur the logistical challenges of extending deeper and looking for wharf structure in deep deposits of homogenous dredge spoil, especially as the desired information about wharf construction and development can be derived from the full-depth excavations in Stages 1-4 to the south. This sampling strategy helps to limit the amount of ground that needs to be archaeologically investigated while maximizing the informational recovery such excavations will provide.

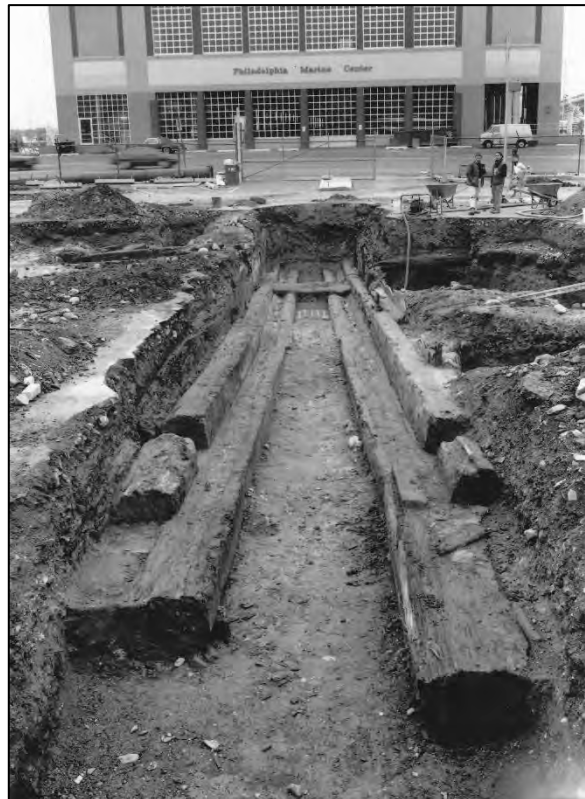
Photo 3.2. A view of the fully excavated shipway found during the 1987 excavations (Weber and Yamin 1988/2006)

The most notable find was the discovery of a well-preserved slipway—used for hauling ships out of the water for repair or refit. About 83 feet of this structure was uncovered, showing two parallel wooden rails set 8–9 feet apart, upon which a cradle would have been set. Small ships or schooners were then able to sail into the cradle from the river and, once secured, the ship and cradle could then be hoisted up the sloped rails to drier land, where it could be worked on (Weber and Yamin 1988/2006, 18-19, 31). Weber's report suggests that this shipway likely dates to the early nineteenth century under the occupation of Thomas Leiper, as the 1811 Paxton map shows a possible structure in the approximate location around that time (Paxton 1811).

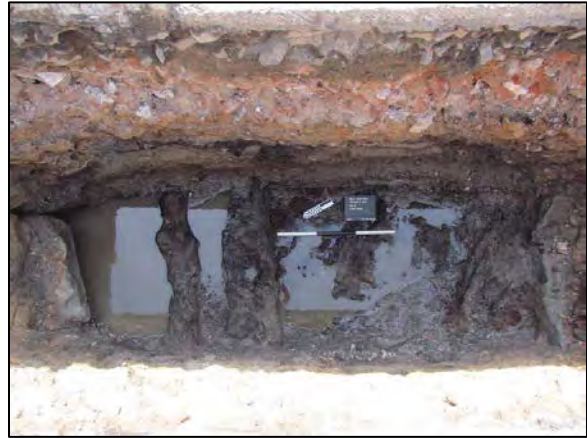
Photo 3.3. Logs forming part of a grillage wharf (Feature 6) located 6 feet below the surface of the parking lot (John Milner Associates, Inc. 2013, 32).

structures. Underlying these foundations, at a depth of 6 feet below ground surface (BGS), archaeologists found a series of logs laid parallel to one another and perpendicular to the riverbank (John Milner Associates, Inc. 2013, 31). These logs were interpreted as representing part of the earlier phase of wharfing out of the riverbank, a process accomplished using a grillage wharf system. This grillage wharf system used rafts of overlapping logs laid at right angles and then filled with stone and sediment in order to build out the land into the river. One full layer of this grillage was observed and documented, and another layer of perpendicular logs viewed briefly before water inundated and obscured the feature (John Milner Associates, Inc. 2013, 31). These logs showed evidence of hewing or joinery, but the matrix in which they appeared was full of woodworking debris. This surface was therefore interpreted as being part of an early pier or wharf upon which ships were built and other waterfront carpentry activities took place (John Milner Associates, Inc. 2013). This Feature 6 grillage wharf deposit was dated to the first quarter of the eighteenth century through diagnostic artifacts.

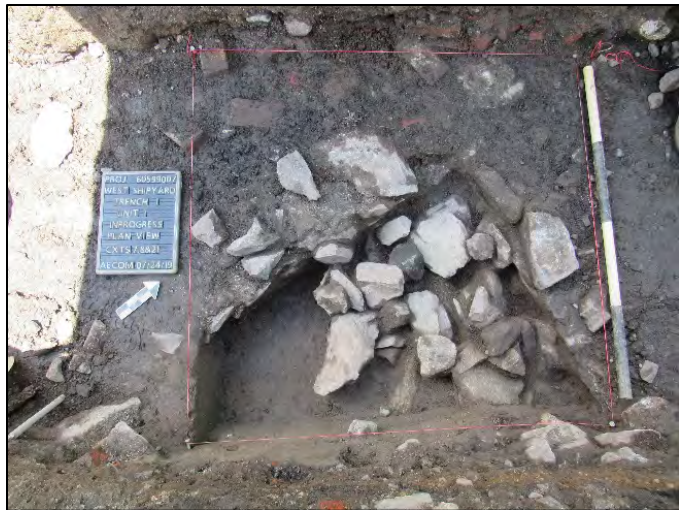
Photo 5.1. Test Unit 1 In-Progress Planview. Context 7, 21, and 6

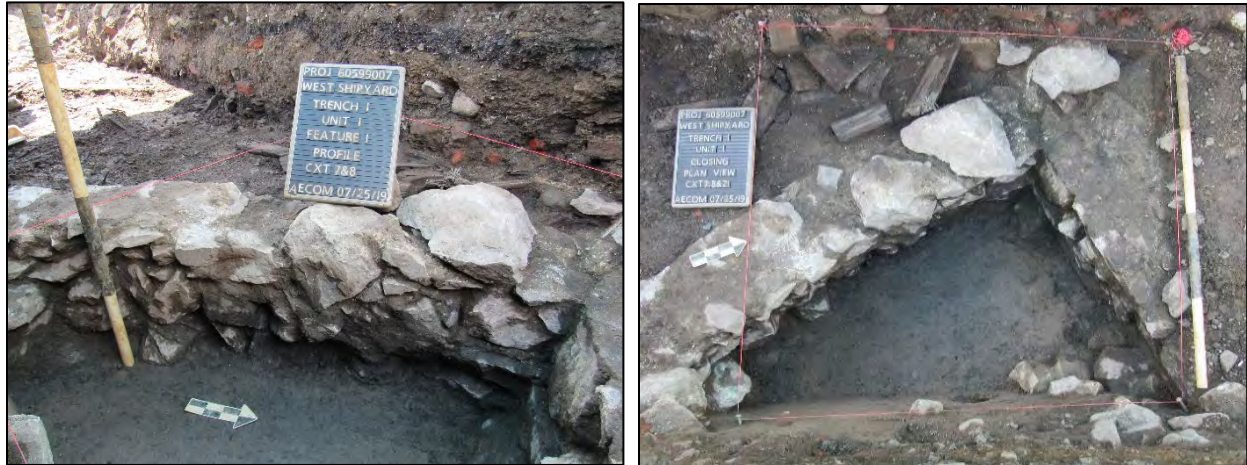
Photo 5.2. Feature 1 profile. Context 7 and Context 8 overlying Context 51 (left); Test Unit 1 closing plan view. Feature 1 and 2 including Context 7, 8, 21, and 51 (right).

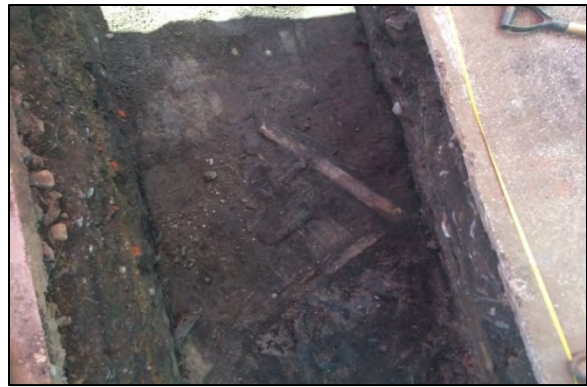
Photo 5.3. Plan view photo of the Feature 3 matrix, showing the dark soil and wood chunks (bottom) and the semi-articulated planking of Feature 4 (top).

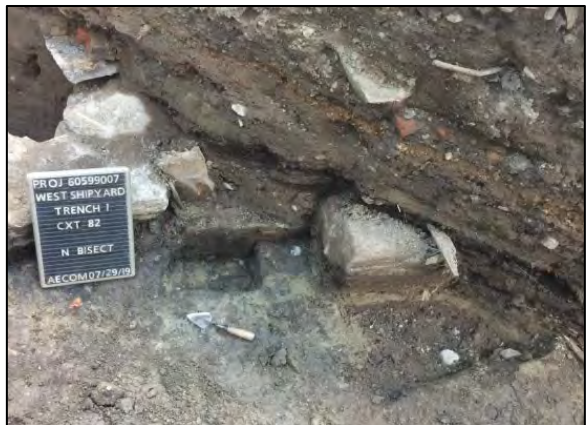
Photo 5.4. A view of the Feature 5 timber in profile, showing its thickness and position relative to the Feature 1/2 foundation.

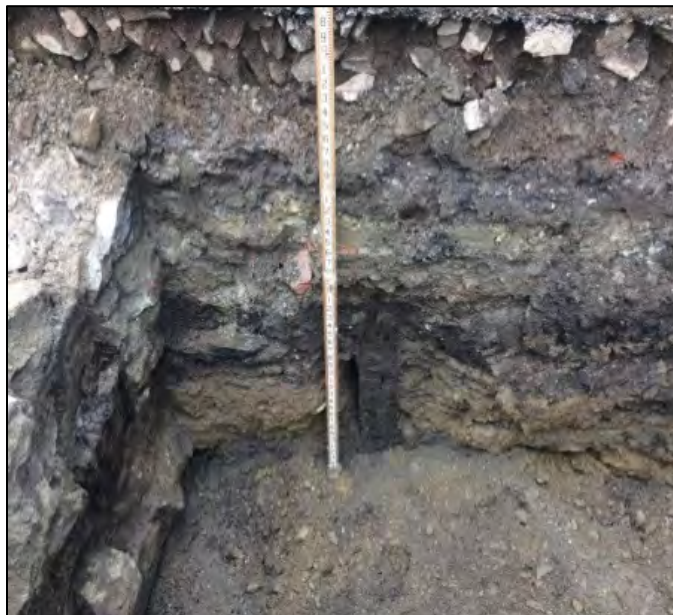
Photo 5.11. West wall profile of Trench 2, showing the Feature 9 post adjacent to the Feature 10 wall.

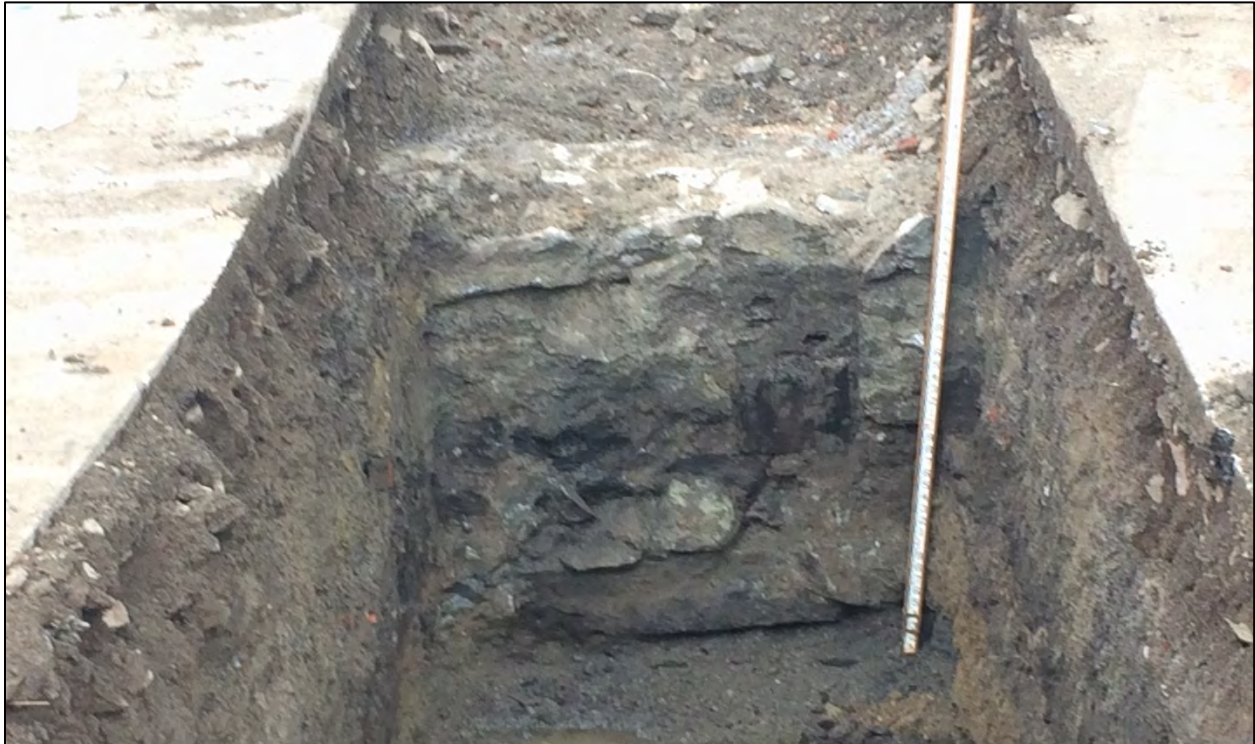
Photo 5.12. South profile of the Feature 10 stone wall.

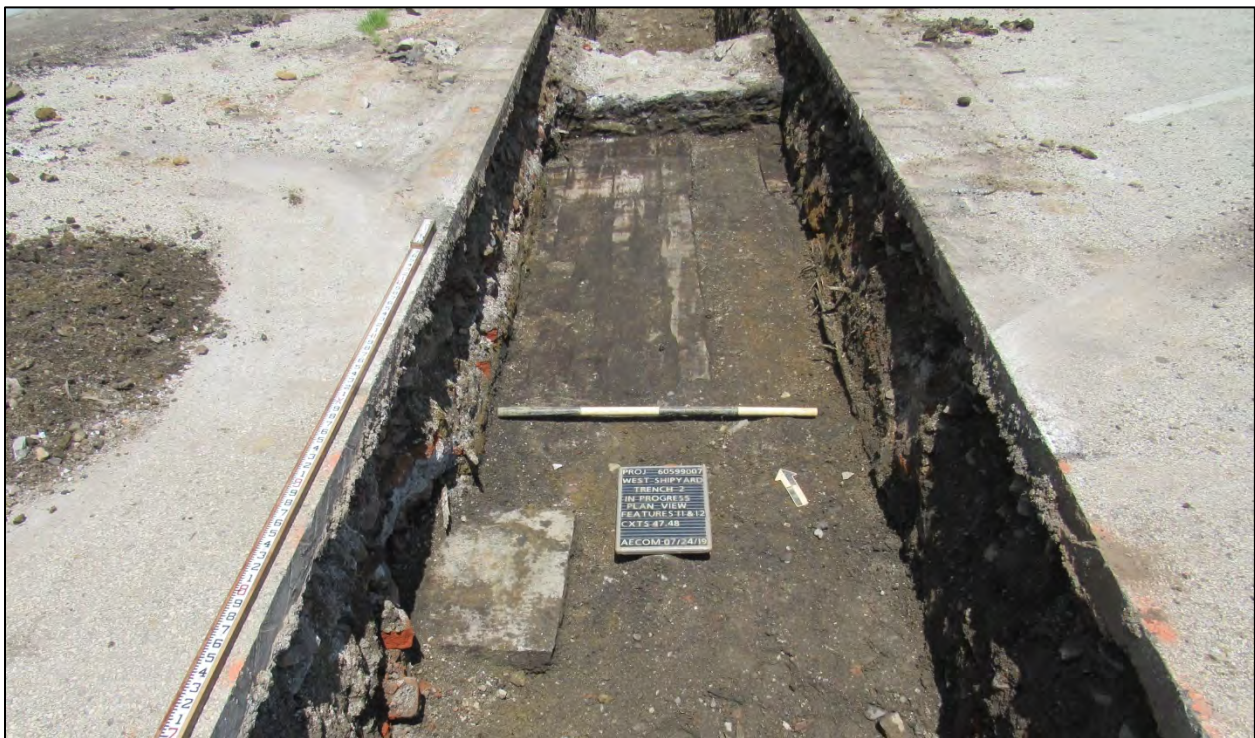
Photo 5.13. A view of the Feature 11 plank floor in Trench 2, showing how it meets up with the Feature 12 stone pillar base, facing north.

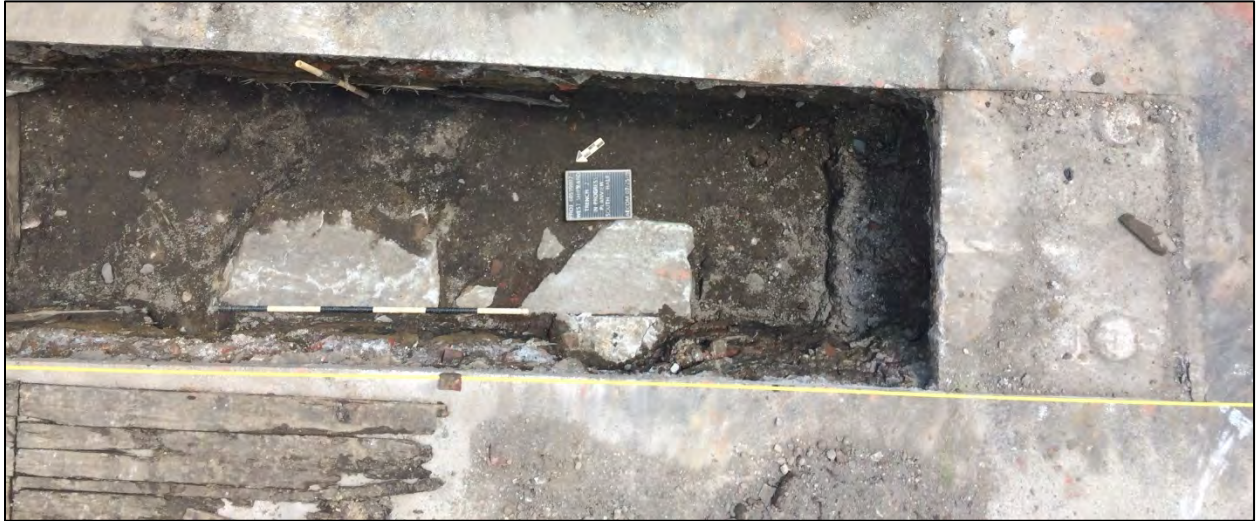
Photo 5.14. A view of Feature 13, the concrete footer for to metal post (right).

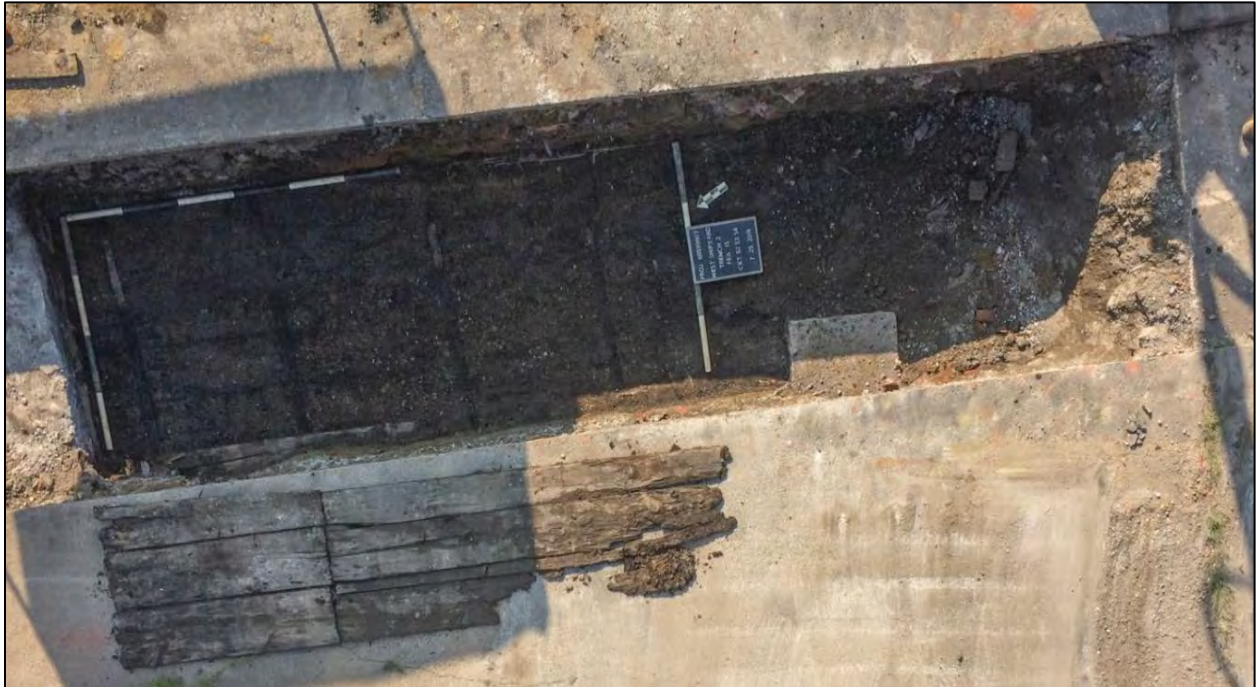
Photo 5.15. Plan view of the Feature 14 subfloor of compacted coarse sand supporting the wood floor joists of Feature 15.

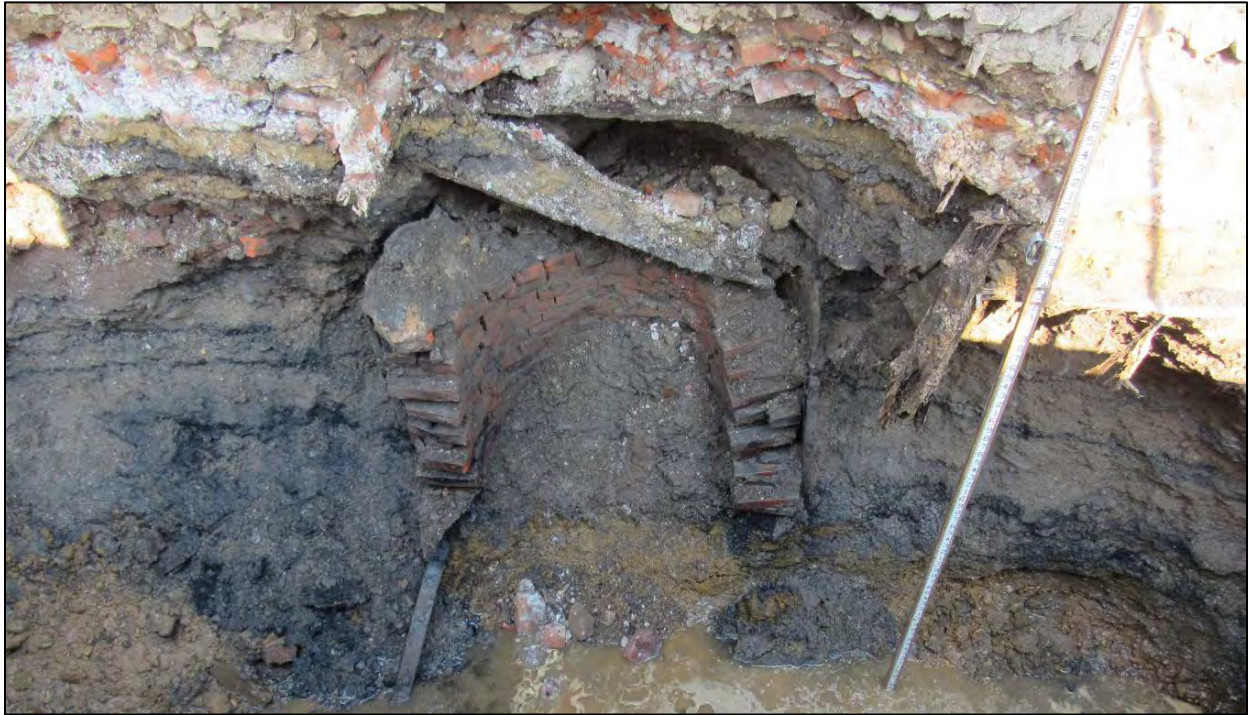
Photo 5.16. West wall profile of Trench 2, showing the Feature 16 well in profile. The well shaft was empty beneath its cap.

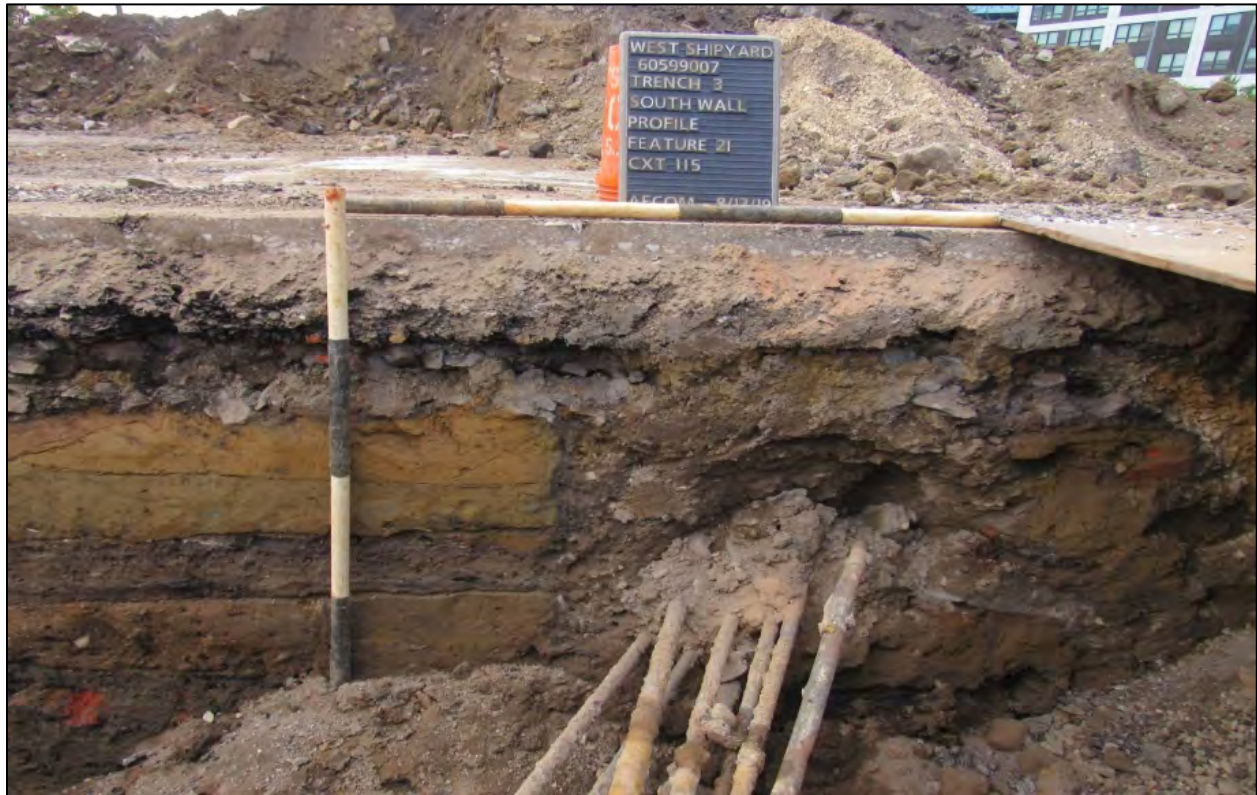
Photo 5.19. Feature 21 cutting through Context 110, 105, 107, 111, 112, and 113.

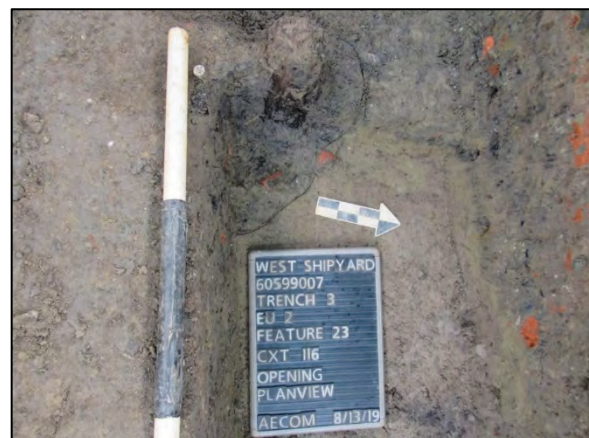
Photo 5.20. Post and posthole of Feature 23 in the southwest corner of Test Unit 2.

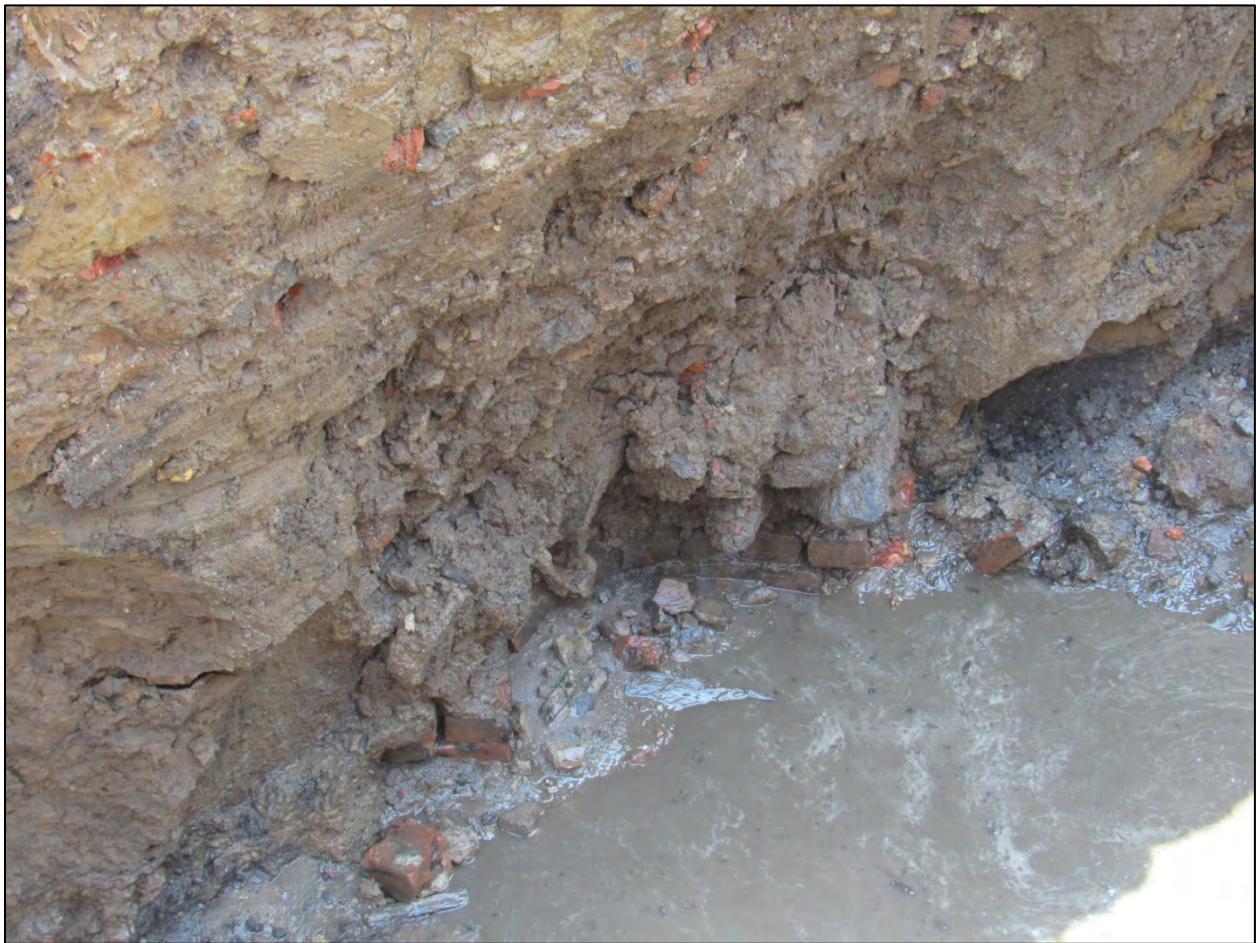
Photo 5.21. Brick shaft of Feature 31.

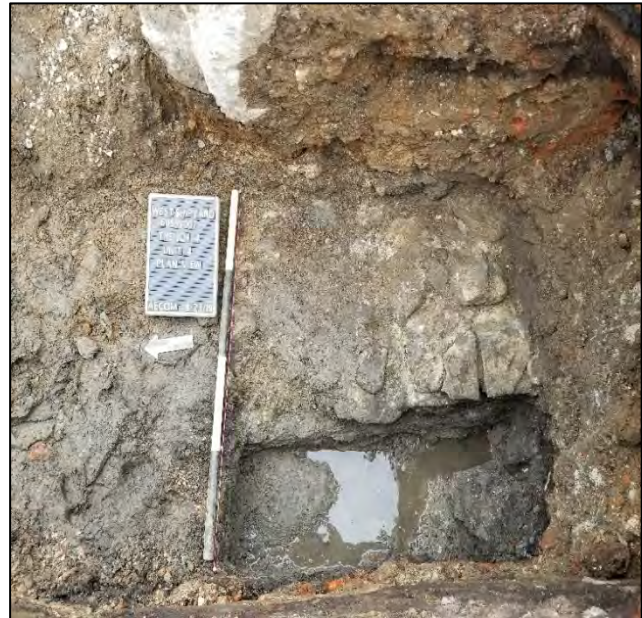
Photo 5.23. Unit 4 closing plan view after removing Context 197 and Context 198. Feature 42 (stone foundation) is sitting on Context 199.

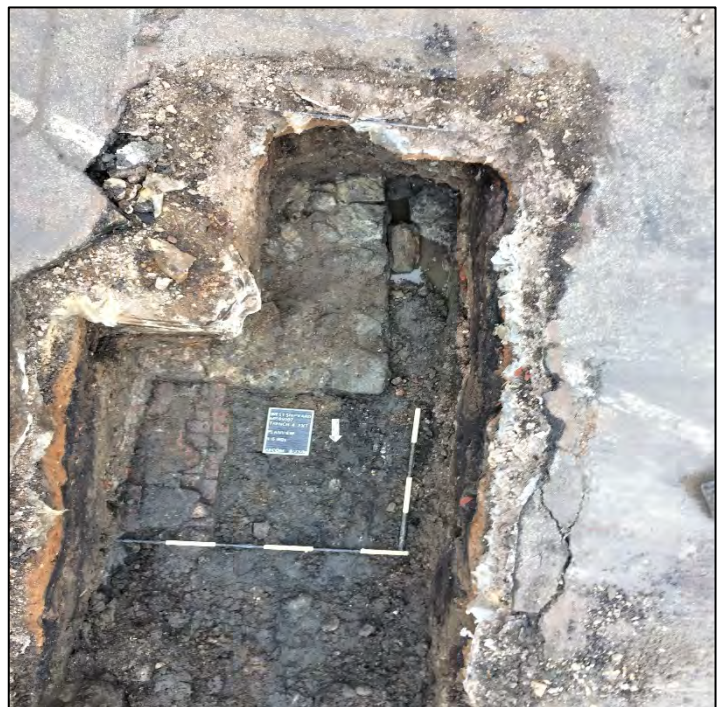
Photo 5.24. Southern end of Trench 4 plan view. Shown: Context 197, Feature 42, and Feature 44.

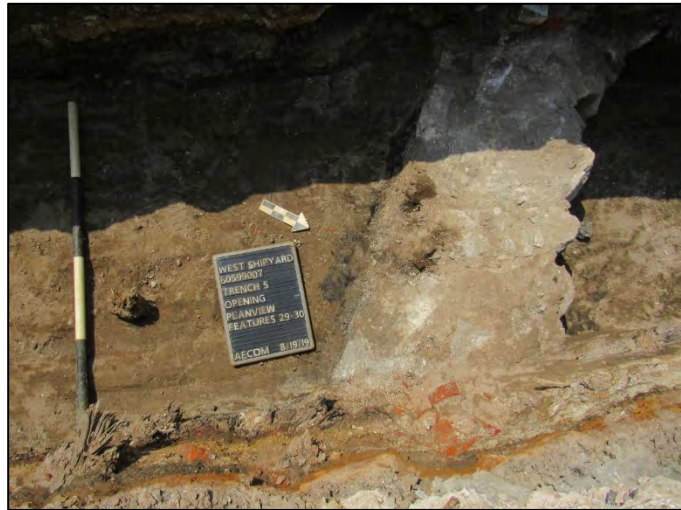
Photo 5.25. Feature 30 post (left); Feature 29 wall (right).

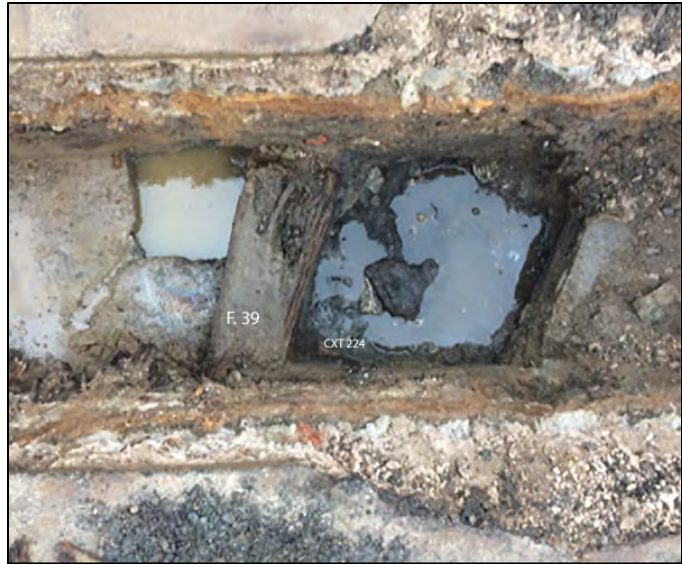
Photo 5.27. Feature 39 timber in Trench 5.
