ADDRESS: 1601 MT VERNON ST

Proposal: Rehabilitate building; construct addition

Review Requested: Review In Concept

PROPOSED INTERIOR ALTERATIONS TO AN EXISTING 3-STORY DWELLING (SINGLE FAMILY HOUSE) AND PROPOSED ADDITION OF A 3 STORY SINGLE FAMILY DWELLING W/ ROOF DECK. PILOT HOUSE AND BASEMENT.

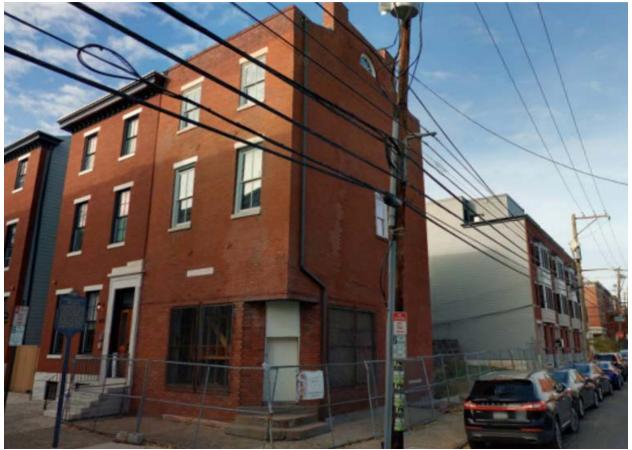
Figure 2: Elevations fronting Mt. Vernon and 16th Streets, 2021. Source: Cyclomedia.

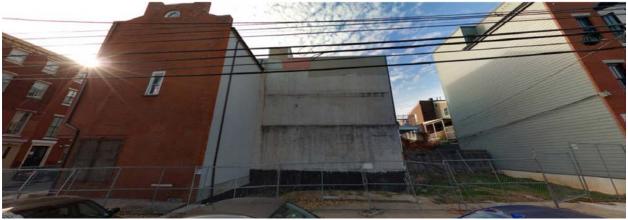
Figure 3: Photo showing the demolished rear ell of 1601 Mt. Vernon Street, 2021. Source: Cyclomedia.

10/11/2000	PHC designated the Spring Garden Historic District and classified 1601 Mt.	
	Vernon Street as significant.	
12/12/2003	PHC approved application for complete rehabilitation of building (main block and	
	ell) and construction of rear addition with garage.	
2006	The Department of Licenses and Inspections (L&I) issued multiple violations for	
	deteriorated, bulged, and fractured walls.	
2/1/2007	PHC approved application for complete rehabilitation.	
4/6/2009	PHC approved application for wall shoring and reconstruction.	
6/24/2010	PHC approved application for new roof and windows, and to stabilize walls.	
2/3/2011	PHC approved application for masonry repair and new windows.	
2/24/2011	Court order to repair roof, windows, walls, and floors.	
3/14/2012	PHC approved application for new windows.	
11/2/2012	Court order to demolish rear ell and reconstruct it within one year.	
12/2012	City demolished rear ell; rear wall of main block remained temporarily sealed for

Despite numerous approvals of building permit applications by the Historical Commission and its staff since 2003, the property was never restored, and the City abated an imminently dangerous condition by demolishing the rear ell in 2012. The main block was stabilized and its masonry repaired under the conservatorship. This in-concept application, submitted by a developer seeking to purchase the property, proposes to rehabilitate the main block and to construct a rear addition. Two schemes for the rear have been submitted.

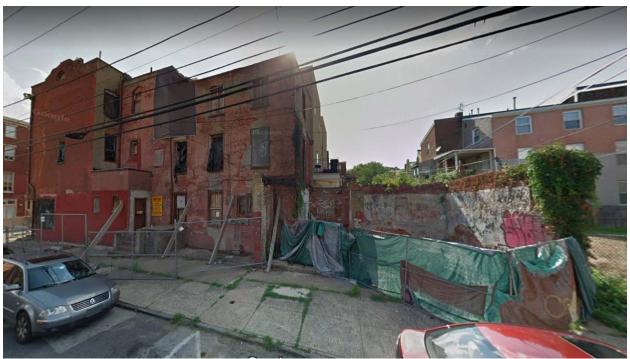
Figure 4: The dilapidated rear ell of 1601 Mt. Vernon Street just prior to demolition, 2012. Source: Google StreetView.

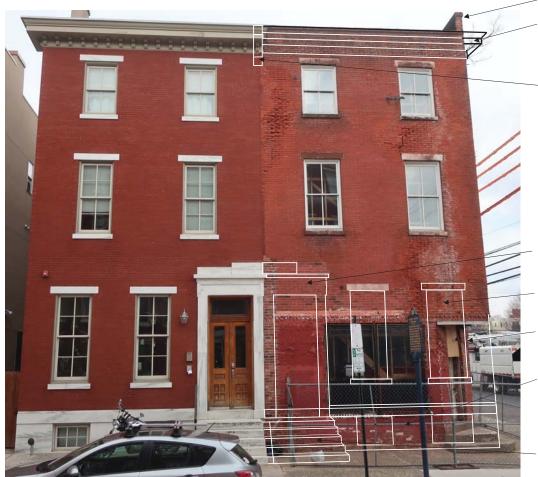
Remove non-original brick parapet 16th Street façade

New fabricated wood cornice to match that at 1603 Mt Vernon Street

New cornice transition at party wall to match that at 1605 -1607 Mt Vernon Street

New marble door surround and door opening with double wood doors and glazed transom to match that at 1603

New window openings at first floor to match original with marble heads and sills and new wood windows to match original

Remove non-original storefront including steel support structure

New marble base with new basement window openings to match original with new wood windows to match 1603 Mt Vernon

New marble stoop and railing to match 1603 Mt Vernon. Provide transition at party wall to match that at 1605-1607 Mt Vernon Street

- The application proposes to rehabilitate the main block by replicating the lost features in their original materials. A marble base, stoop, door surround, and lintels would be installed to reverse the storefront alteration. A wood cornice, door, and windows would also be installed. The work complies with Standard 6.

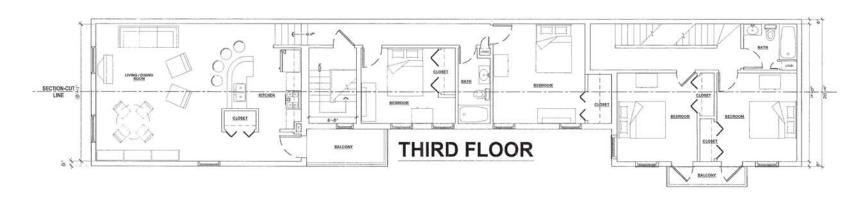
A100.3

Floor plans related to 2003 PHC approval of rear addition.
