NOMINATION OF HISTORIC BUILDING, STRUCTURE, SITE, OR OBJECT PHILADELPHIA REGISTER OF HISTORIC PLACES PHILADELPHIA HISTORICAL COMMISSION Submit all attached materials on paper and in electronic form (cd, email, flash drive) Electronic files must be Word or Word compatible

1. Address of Historic Resource (must comply with an Office of Property Assessment address) Street address: <u>3475 Collins Street</u> Postal code: <u>19134</u>

2. NAME OF HISTORIC RESOURCE Historic Name: Tioga Mills Current/Common Name:		
3. TYPE OF HISTORIC RESOURCE		
4. PROPERTY INFORMATION Condition:		
5. BOUNDARY DESCRIPTION Please attach a narrative description and site/plot plan of the resource's boundaries.

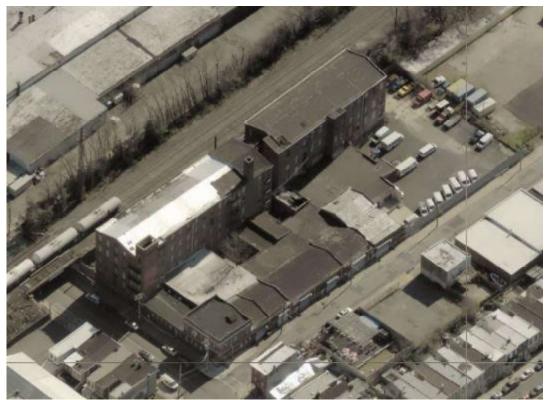
Figure 1: Recent aerial view, looking southeast (Pictometry, 2020).

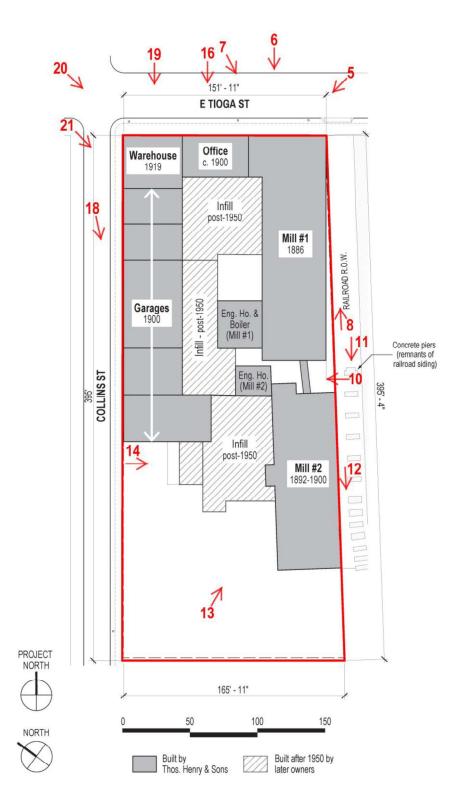
Figure 2: Site plan with property boundary and photo key.

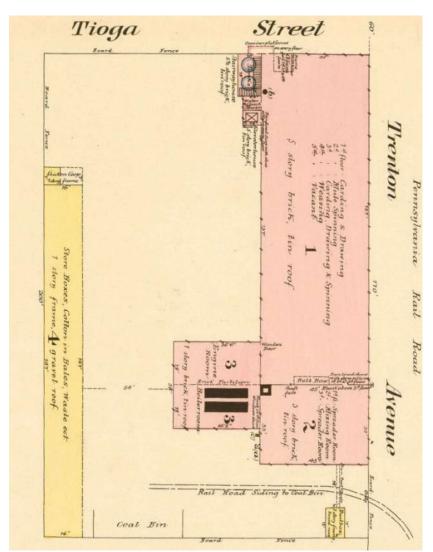
Figure 3 – Hexamer General Surveys, No. 2084, Tioga Mills (1886). Plan view. The original at-grade railroad siding, removed after the railroad was elevated around 1909, is depicted just south of Mill #1.

A fire insurance survey from 1886 (Figure 3) indicates that a railroad siding from the adjacent Philadelphia and Trenton Branch once entered the site just south of Mill #1. This siding existed at least until 1901 as indicated by a historic map published that year. Around 1909, the at-grade railroad was elevated and the siding was removed as evidenced by the 1920 Sanborn map (Figure 4). No remnants of the at-grade siding remain today. The concrete piers adjacent to the east elevation of Mill #2 (as seen in Figure 11) appear to be remnants of a later siding that served the Tioga Mills once the railroad was elevated, however there is no evidence of how goods would have been loaded onto or unloaded from the rail cars. The concrete piers are located on the railroad right-of-way and therefore are not part of the 3475 Collins Street property.

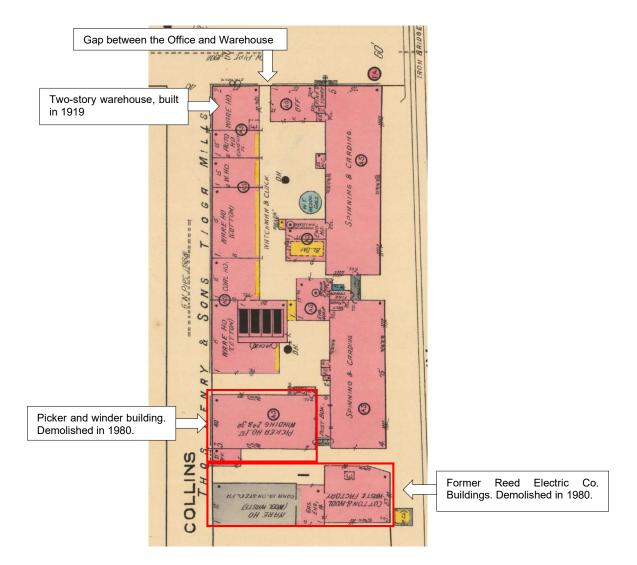
Figure 4: Sanborn Fire Insurance Map, 1920. As shown here, there was historically a gap between the Office building and Warehouse, which was probably infilled shortly after this map was published in 1920. Additionally, the map shows no evidence of a rail siding, suggesting that the siding that once existed was removed when the adjacent railroad was elevated (rail sidings are typically depicted on Sanborn maps when they exist).

Located between Mill #1 and the Warehouse, the Office is a one-story, painted brick building with a painted metal cornice (Figure 16). Although the building now has a flat roof, according to a period advertisement (Figure 17), it historically had a gabled roof. Only the north elevation, which faces Tioga Street, is visible; all other elevations abut adjacent buildings or infill additions. The building is nine bays wide, with six of the bays containing six-over-six, double-hung vinyl replacement windows with painted concrete infill panels below. Two of the bays contain modern, hollow metal doors while the ninth bay is covered with metal panels and electric meters. According to the period advertisement referenced above (Figure 17) and a 1920 Sanborn Map (Figure 4) the two westernmost bays were not part of the original building. These two bays were added later, and the matching brickwork and cornice suggests this happened not long after 1920. The interior was not accessible at the time of survey, however the building is currently being used as workshops and studios for artists and small businesses. As shown in the 1920 Sanborn map (Figure 4), the Office and Mill #1 were connected on the interior.

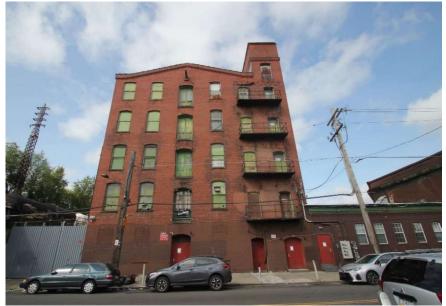
Figure 6: North elevation of Mill #1, view south.

At the northwest corner of the building, there is a rectangular fire stair tower that rises well above the gabled roof (Figures 6 and 7). On all four elevations, nearly all bays (exceptions are explained below) have a consistent fenestration pattern of segmental arched window openings. Most of the openings are covered with metal panels on the exterior side or have been infilled with concrete block, however many of the original twelve-over-twelve, double-hung wood windows still remain and are visible on the interior (Figure 9).

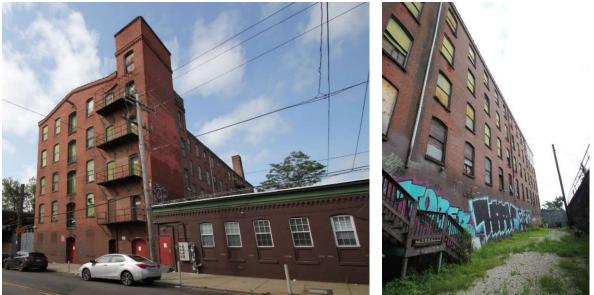
Figure 7 (left): North and west elevations of Mill #1 and the abutting Office building, view southeast. **Figure 8** (right): East elevation of Mill #1, view north. The open space to the right is part of the railroad rightof-way and is accessible from 3475 Collins Street through an easement agreement (as indicated on the site plan, above, the east elevations of Mills #1 and #2 are at or nearly at the property line).

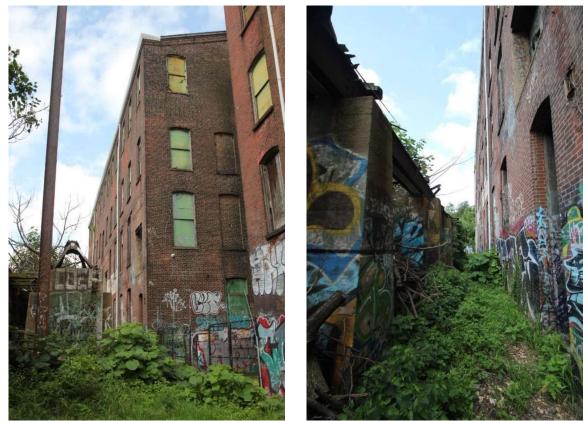
Figure 11 (left): North and east elevations of Mill #2, view south. **Figure 12** (right): East elevation of Mill #2, view south. The concrete piers at left are part of the former railroad siding but are located on the railroad right of way and are not part of the 3475 Collins Street property.

On the east, north, and west elevations, nearly all bays contain segmental arched window openings (Figures 11-14). Most of the openings are covered with metal panels on the exterior side or have been infilled with concrete block, however many of the original nine-over-nine, double-hung wood windows still remain and are visible on the interior (Figure 15). There are no windows on the south elevation, which consists of a blank brick wall (Figure 13). At the north end of the west elevation, a one-story brick engine house extends into the former courtyard space but is now enveloped by the one-story infill additions that were built during the 1950s and later (each mill building had its own engine house). The engine house was built with Mill #2, to which it is internally connected, and is not counted as a separate resource. Above the first floor, the west elevation contains original wood loft doors on each floor in the third bay from the north and in the southernmost bay (Figures 13 and 14). The doors are similar to those in Mill #1. In the center of the west elevation, there is a rectangular tower that historically contained bathrooms and supported a water tank on top (Figures 13 and 14).

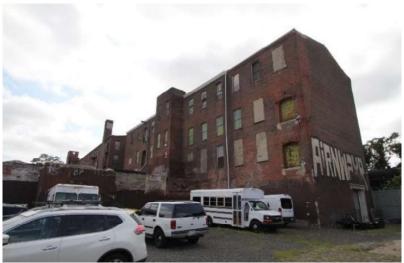
Figure 13: West and south elevations of Mill #2, view northeast.

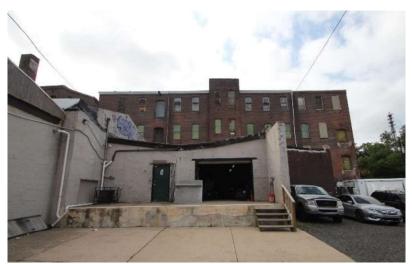
Figure 14: West elevation of Mill #2, view east. The one-story, concrete block structure with loading dock in the foreground is part of the post-1950s additions.

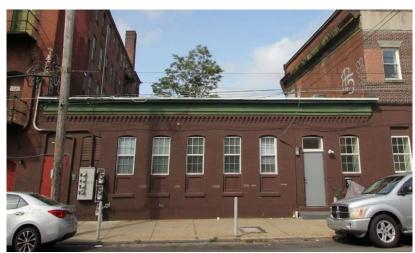
Figure 16: North elevation of the Office building, view south. The two westernmost bays (far right) were not part of the original building and were likely added shortly after 1920.

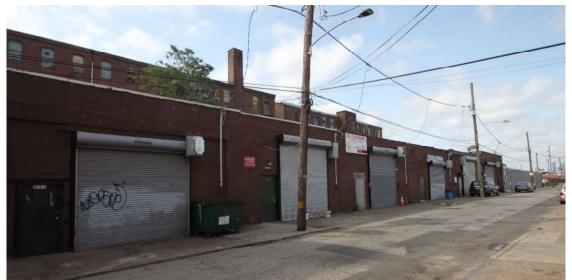
Figure 18: West elevation of the Garage building, view southeast. As shown in Figure 17, this elevation once contained smaller openings with windows rather than the garage doors that exist today (the doors were likely installed after 1950).

Located south of the Warehouse, the Garage building is a one-story brick building with numerous roll-down metal garage doors that face Collins Street (Figure 18). The interiors were not accessible at the time of survey, however the building is currently being used workshops and studios for artists and small businesses. According to the 1920 Sanborn map (Figure 4), the Garage building historically contained a number of individual spaces that were separated by party walls and were not internally connected. These spaces were used for the storage of raw cotton, coal, and automobiles. The period advertisement referenced above (Figure 17) appears to show a row of windows on the Collins Street elevation rather than large garage openings. Although little evidence of these openings remains, it is possible that at the time the ad was published in 1918, the garage openings were located on the east side of the building, facing what was then the open center of the site. It was only with the construction of the later infill additions in the 1950s that the garage openings were relocated to the Collins Street side.

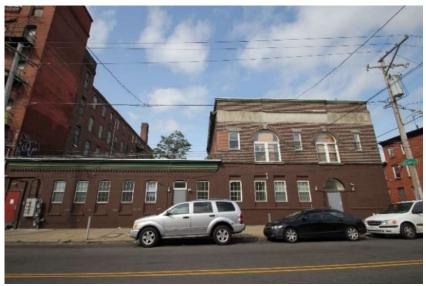
Figure 19: North elevation of the Warehouse, view south. As seen in this view and in Figures 20 and 21, below, the stucco band above the second floor windows was historically the location of a cornice as seen in Figure 4.

Located at the northwest corner of the site, the Warehouse is a two-story brick building reflecting the Georgian Revival style (Figures 19-21). The brick is painted on the first floor. On the north elevation, there is a hollow metal door with a single light arched transom and a number of double-hung, vinyl replacement windows on the first floor. On the second floor, there two large arched openings containing pairs of double-hung metal replacement windows with single light transoms and a concrete keystone. These openings are located between much smaller one-over-one, double-hung metal replacement windows with splayed concrete lintels. On the west elevation, there are a number of infilled window openings on the first floor as well as two double-hung metal replacement windows, two with splayed concrete lintels. Above the second-floor windows on the north and west elevations, there is band of stucco where the metal cornice was historically located (the cornice remains intact only on the east elevation). Above the stucco band and cornice, there

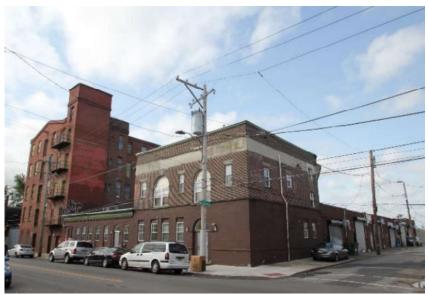
Figure 20: North and west elevations of the Warehouse, view southeast.

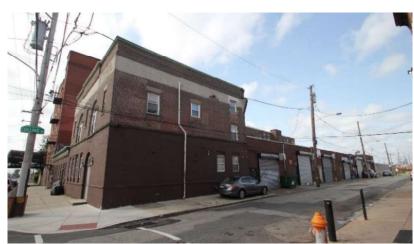
Figure 21: West elevation of the Warehouse, view southeast.

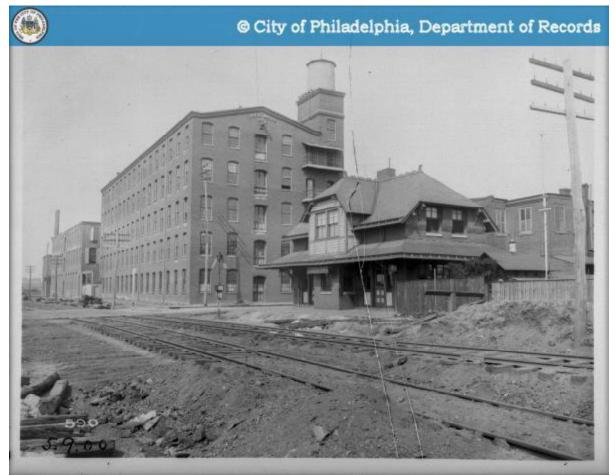
Figure 21: Looking south to Mill #1 in 1900 (Philadelphia Dept. of Records). This image shows the adjacent railroad at grade, prior to its elevation around 1909. Mill #2 also has yet to be expanded to four stories. The building in the foreground is a former Pennsylvania Railroad Depot, which was demolished when the railroad was elevated.

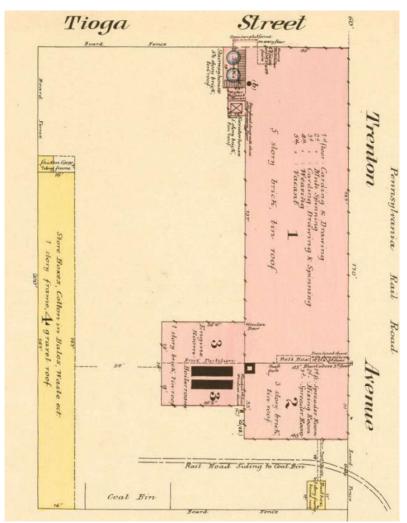
Figure 22 – Hexamer General Surveys, No. 2084, Tioga Mills (1886). Plan view. The original railroad siding, removed after the railroad was elevated around 1909, is depicted just south of Mill #1. The boiler house and engine room are also shown, indicating openings into the main mill building (for this reason, the boiler house and engine room are not counted as separate resources).

The 1886 Hexamer survey provides some insight into the production process at Tioga Mills. Cotton bales would be delivered to the site by rail, utilizing a siding from the adjacent Philadelphia and Trenton Branch of the Pennsylvania Railroad (initially located at grade as seen in Figure 23, the line was elevated after 1900). The raw material would then be stored in a one-story shed along

the west side of the property (this structure was replaced by the Garage building around 1900) and eventually moved into the building for carding, which took place on the first floor and was the process by which the raw fibers would be untangled, straightened and blended together in preparation for spinning. Carding machines were the heaviest equipment used in the spinning process, and therefore were generally located on the first floor of a spinning mill. Once the carding process was complete, the cotton would be moved upstairs to the second floor where it would be spun into yarn. Spinning machines, also known as mules in this case (another type, ring spinning machines, were not used in Tioga Mills), were lighter and were typically found on the upper floors. Once the spinning process was complete, the yarn would then be wound from the spindles onto reels. Reeled yarn constituted the finished product as it concerned Thomas Henry & Sons. In keeping with the aspect of specialization that characterized the Philadelphia textile industry, the reeled yarns would then be dyed offsite by a separate company. It was only when the yarns were dyed and processed by the dye company that they would be ready for weaving by one of Kensington's numerous cotton hosiery manufacturers.

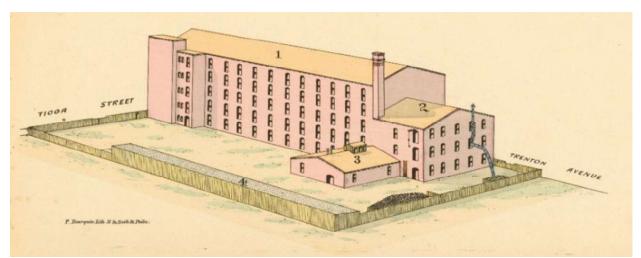
Figure 23 – Hexamer General Surveys, No. 2084, Tioga Mills (1886). 3D view, looking northeast Mill #1 from Waterloo Street (later renamed Collins Street). As seen here, the two southernmost bays were originally only three-stories tall, expanded around 1900 to five stories.

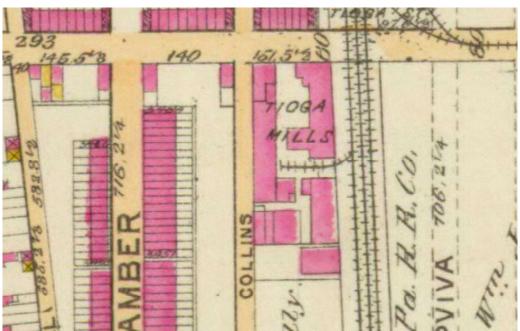
Figure 24 – Bromley Atlas of the City of Philadelphia, 1901. Note the rail siding between Mills #1 and #2.

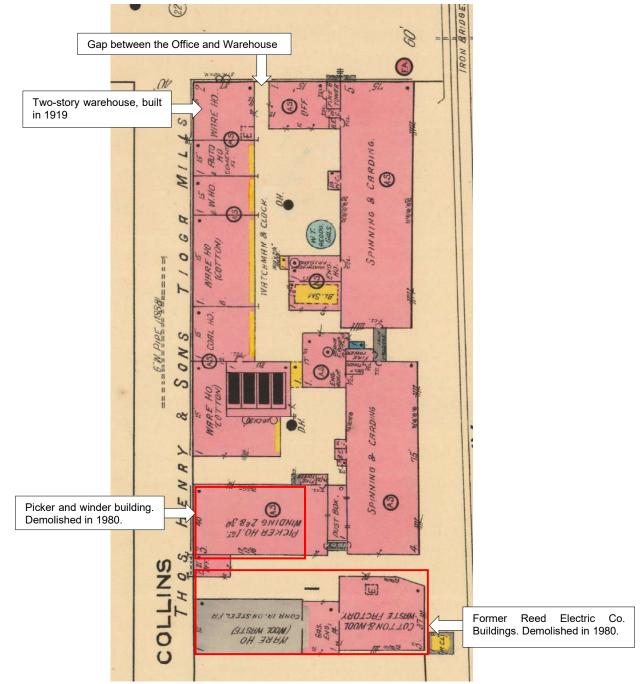
Figure 25 – Sanborn Fire Insurance Map, 1920. As shown here, there was historically a gap between the Office and Warehouse buildings, which was probably infilled shortly after this map was published in 1920. Additionally, the map shows no evidence of a rail siding, suggesting that the siding that once existed was removed when the adjacent railroad was elevated (rail sidings are typically depicted on Sanborn maps when they exist).

construction of a two-story warehouse at the northwest corner of the property in 1919 as shown in the 1920 Sanborn map (Figure 25).²³

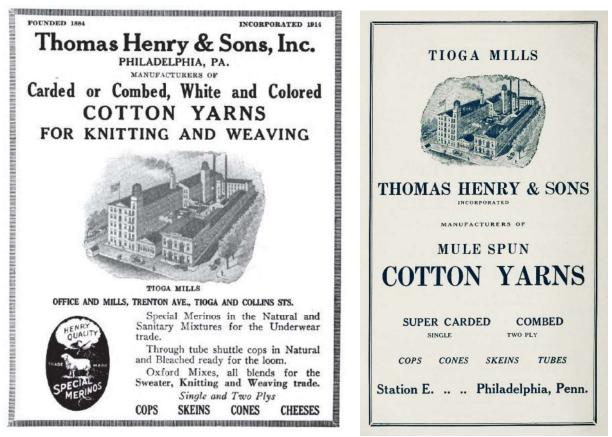
Figure 26 (left) – Advertisement in Textile World, December 1918.

Figure 27 (right) – Advertisement in the Official American Textile Directory, 1922. The image included in both ads depicts the site around 1918 and is a fairly accurate representation of the complex at that time. The changes that have occurred between 1918 and today are discussed above in the integrity assessment.

The image used in the advertisements also includes a three-story, approximately 50' by 90' picker and winding building that extended from the west elevation of Mill #2 to Collins Street as shown in plan in the 1920 Sanborn map (Figure 4). Built by Thomas Henry & Sons around 1900, this building was demolished in 1980, as was a small group of one- to three-story buildings at the south end of the site, also shown in the 1920 Sanborn map (these buildings are not seen in the advertisements because they are blocked from view by the picker and winder building). Built by the Reed Electric Company around 1900, the buildings were leased by Thomas Henry & Sons around 1920 for the processing of cotton and wool waste materials, a tertiary function in the overall yarn manufacturing process. The company acquired the buildings from the Reed Electric Company in 1923, only three years before Tioga Mills closed down and Thomas Henry & Sons moved to Nashville, therefore they were never essential to the company's operations.
