**ADDRESS: 915-17 S 11TH ST**

Name of Resource: South Philadelphia State Bank

Proposed Action: Designation

**NOMINATION OF HISTORIC BUILDING, STRUCTURE, SITE, OR OBJECT  
PHILADELPHIA REGISTER OF HISTORIC PLACES  
PHILADELPHIA HISTORICAL COMMISSION**

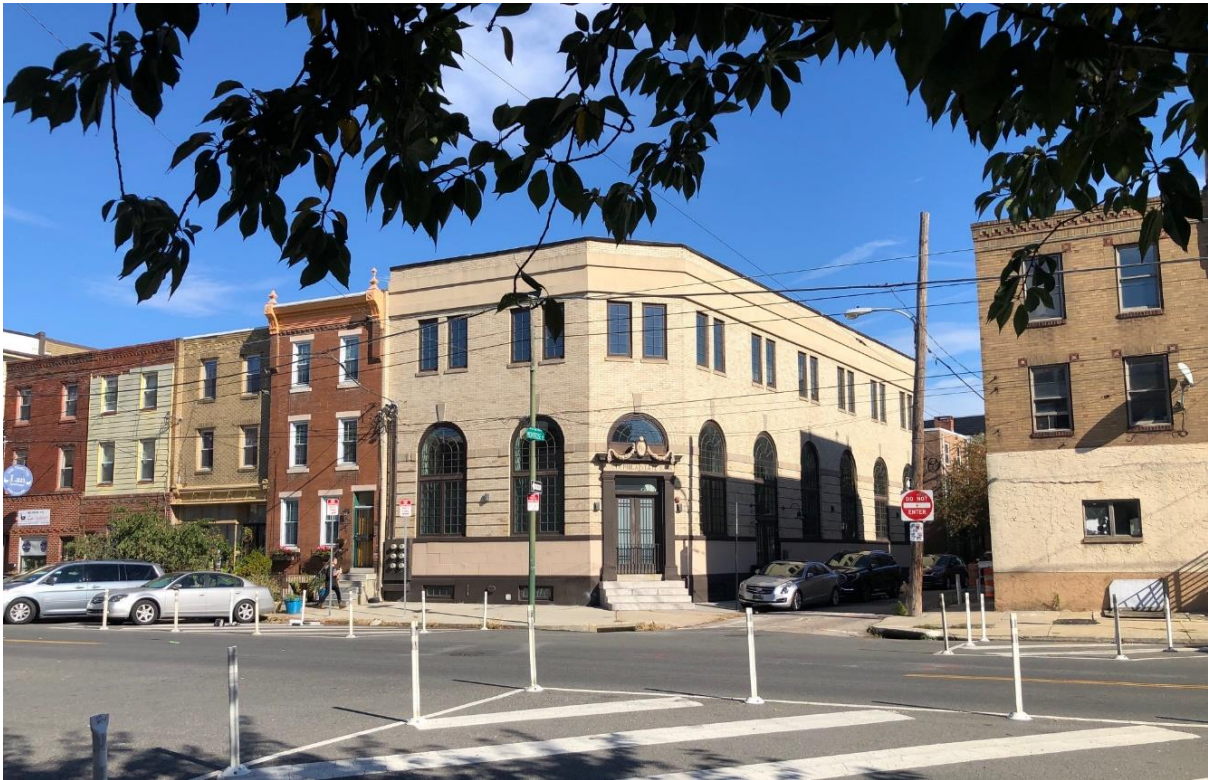
*915-17 S Broad Street, 2023. View of former South Philadelphia State Bank, located at the corner of S. 11<sup>th</sup> Street and Montrose Street.*

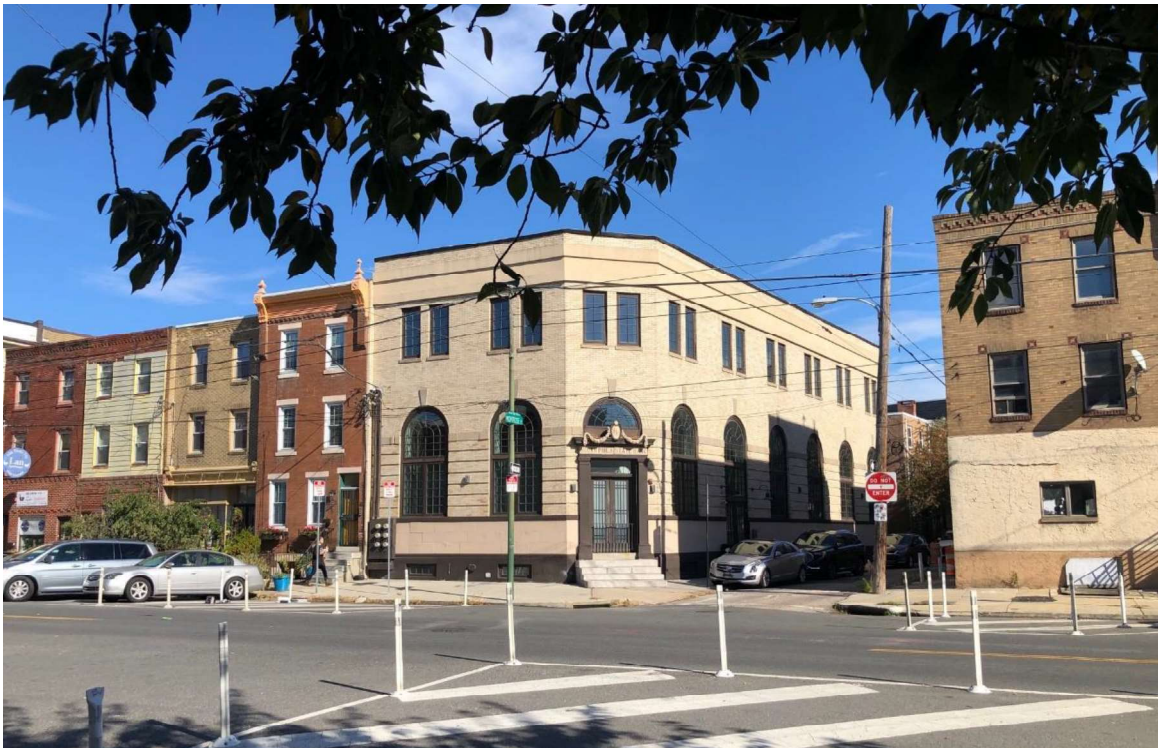
**Figure 3:** View of S. 11<sup>th</sup> Street and Montrose Street facades.

The most noticeable feature of the exterior is a series of very large arched windows—two on the 11th Street façade and six on the Montrose Street facade. In keeping with the simplified exterior, these windows do not have surrounding moldings, with the exception of a plain raised masonry keystone, but changes in the yellow brick work add interest. Around each arched opening, three header courses of brick are laid radially. Between each window, every sixth course of yellow brick is recessed to create a slight rusticated appearance. Above this rustication is a raised masonry belt course which separates the lower wall from the upper flat wall, also of yellow brick.

A plain continuous raised molding extends under all the windows. Under this raised molding are three courses of large flat masonry blocks whose joints are de-emphasized creating a continuous somewhat flat surface. Under this is another raised flat molding which forms the upper boundary of three courses of much smaller masonry blocks. This area has several small rectangular windows on both facades almost even with the sidewalk to what is likely a basement area.

Above the large arched windows is a row of smaller vertical rectangular windows arranged in pairs centered above each arched window below. Above these windows is a cornice formed of three bands of smooth masonry with the center band recessed. It appears these have been applied to the surface of the brick and a small portion of the brick wall extends above the smooth masonry.

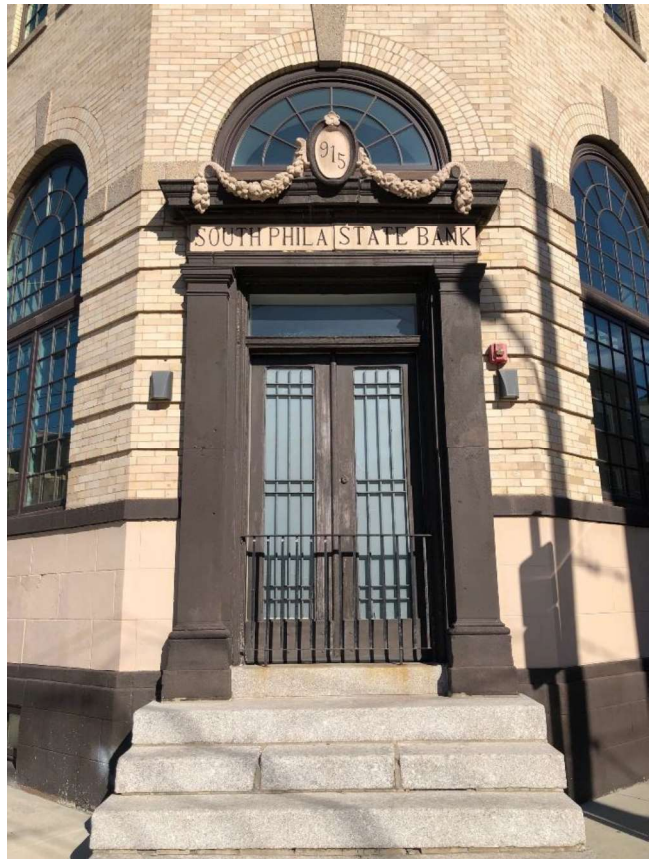
**Figure 5:** Former main entrance at 11th Street and Montrose Street.

The building takes advantage of its corner location by cutting off the walls near the corner at a 45-degree angle. Set in this angled facade are double glazed entrance doors with glass transom and flanking Doric pilasters at the top of a flight of five granite stairs. Above the transom, in the frieze area, is a name plate, and a pair of garlands hang over the entablature's cornice. Centered on the entablature is a cartouche with the building's street number on it centered on the sill of another arched window over the door. A pair of rectangular windows are centered on this wall as well. This doorway really presents the only applied decoration on the exterior and clearly advertises the public entrance. A less decorated but large doorway is found around the Montrose St. side of the building as a component of the second arched window assembly.

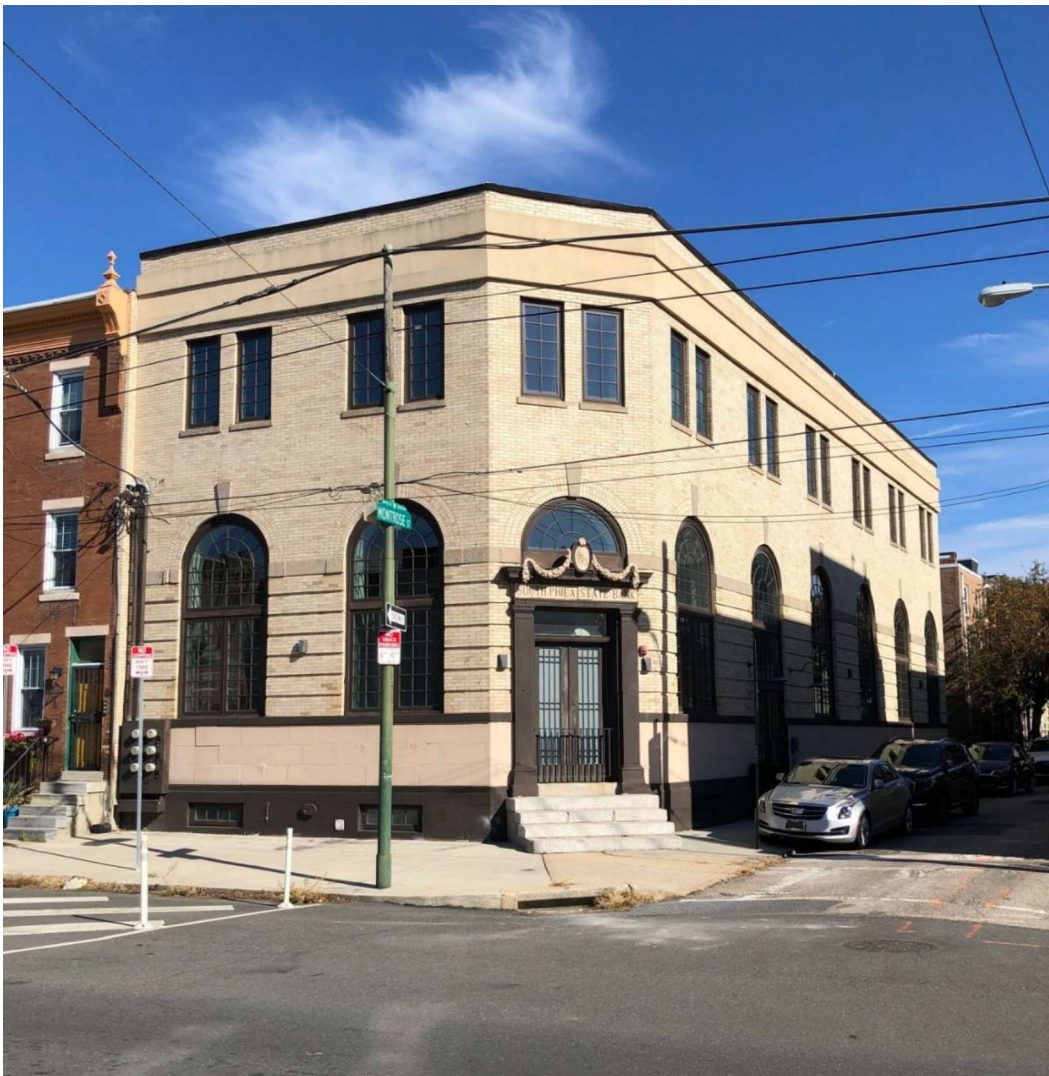
*Figure 10: View of building from S. 11<sup>th</sup> Street.*
