ADDRESS: 126 DELANCEY ST

Proposal: Legalize replacement of front steps

Re: 126 Delancey Street – Stair and Railing Replacement

- Front Exterior Steps

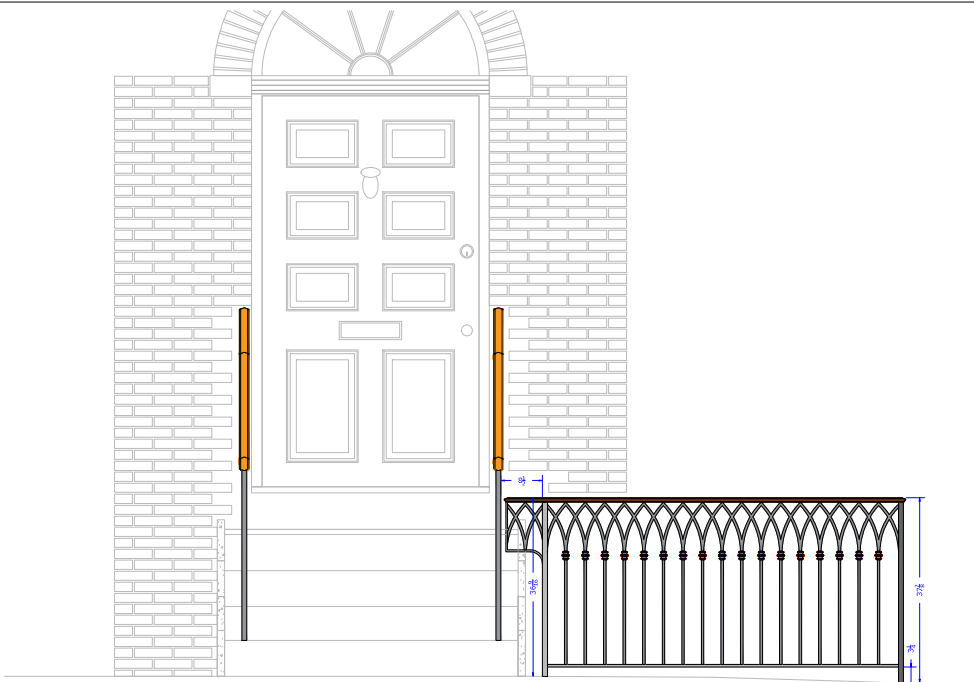
Detail 04: Front Elevation
Scale: 1" = 1'-0"

- Railing Frames & Infill are HOI's standard steel materials
 - HOI standard Posts 1" square
 - HOI standard Balusters $\frac{1}{2}$ " square
 - HOI standard Cap Under Bar $1\frac{1}{4}$ " x $\frac{3}{8}$ " flat bar
- Top Molding & Collars are HOI's standard bronze materials
 - HOI #4534 standard bronze profile
 - HOI #EPV-4534 Vertical Volute
 - HOI #184 standard bronze collar
- Gate to be fabricated from the same materials as the railings
- Railings & Gate to be painted HOI's Standard Black
- Bronze to be polished HOI's standard Satin Finish
- Railing Posts to be core drilled and grouted in place

The Project further involves, and this Application seeks approval for, the proposed replacement of an existing railing, which, based on the historic photos of the Property included in the attached materials, is not historic or original to the Building. The proposed new railing is shown in the attached plans and was designed to mimic a railing design used at another nearby historic property.
