**ADDRESS: 614 PINE ST**

Proposal: Construct rear addition and roof deck

Review Requested: Final Approval Owner: Qian Jin Real Estate LLC Applicant: Sam Xu, Constrecture, LLC

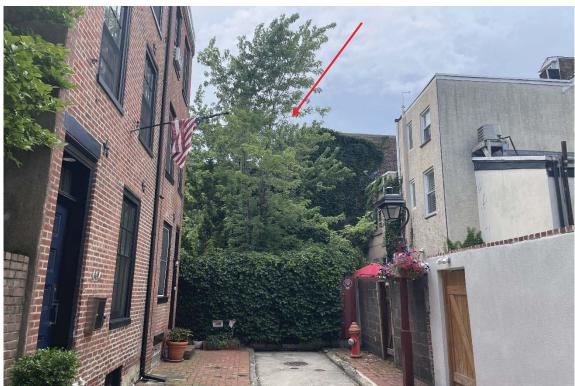
Figure 2: Rear ell of subject property as seen from Waverly St (looking west). The end of the existing three-story portion is indicated by the arrow.

The proposed addition and roof decks would not be visible from Pine Street but would be visible from the side and rear from Waverly and Addison Streets as well as a pedestrian greenway which runs from Pine Street to Addison Street.

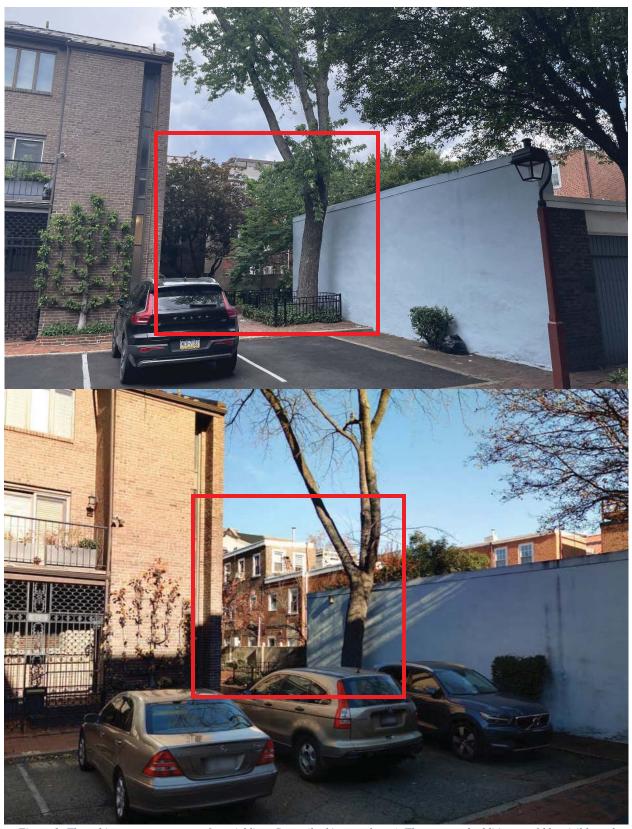
Figure 3: The subject property as seen from Addison Street (looking northeast). The proposed addition would be visible and should be designed to be compatible with the existing building. Top image taken by PHC staff, bottom, winter image from Cyclomedia.phila.gov.

- The roof deck and pilot house would require the demolition of a small portion of the roof of the main block.
- While the addition would not be visible from Pine St, the rear of the property is visible from a pedestrian greenway as well as Waverly St and Addison St.
- o The third-story addition is very tall with a very large floor-to-ceiling height. The addition should be reduced in height by several feet.

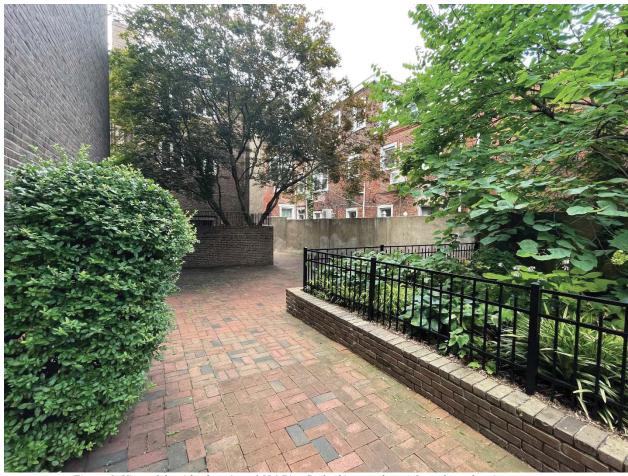
Figure 6: View of the side elevation of 614 Pine St (looking northeast) from the pedestrian greenway.

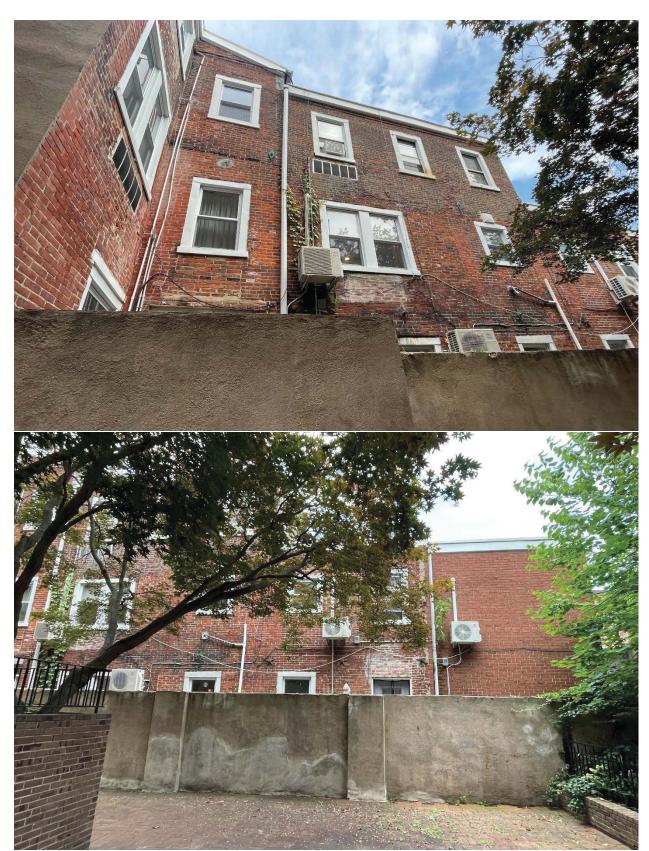
Figure 7: West elevation of 614 Pine St, viewed from the greenway.
