ADDRESS: 148, 150, 152, 154, 156, AND 158 N 2ND ST

Proposal: Demolish two buildings and construct six-story building

Review Requested: Review In Concept

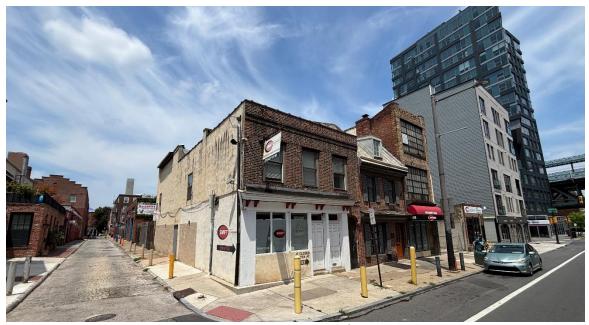
Figure 2: Proposed massing with surrounding context.

The new six-story building will rise to 65 feet, aligning with the height of the adjacent building to the north (160-164 N 2nd St). Its massing is intentionally set back from the historic corner buildings, creating bu er zones on all sides and allowing for distinct entry points to the new structure from both 2nd and Quarry Streets.

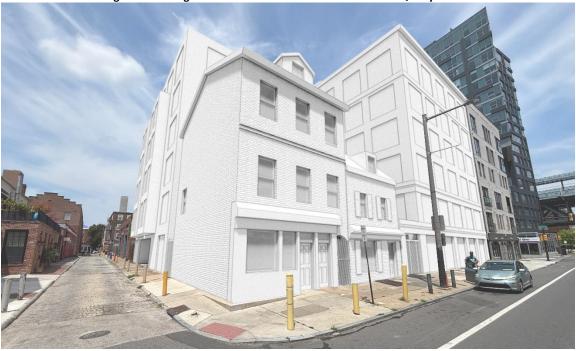
Figure 3: Existing conditions at the corner of 2nd Street and Quarry Street.

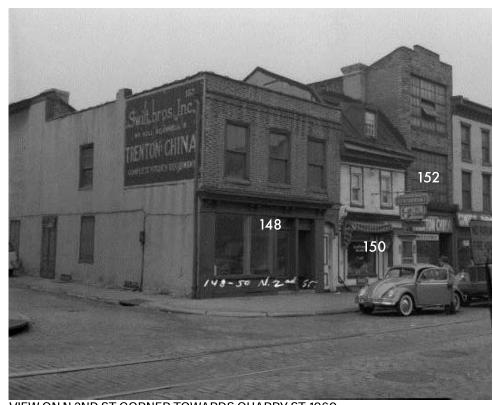
VIEW ON N 2ND ST CORNER TOWARDS QUARRY ST, 1960

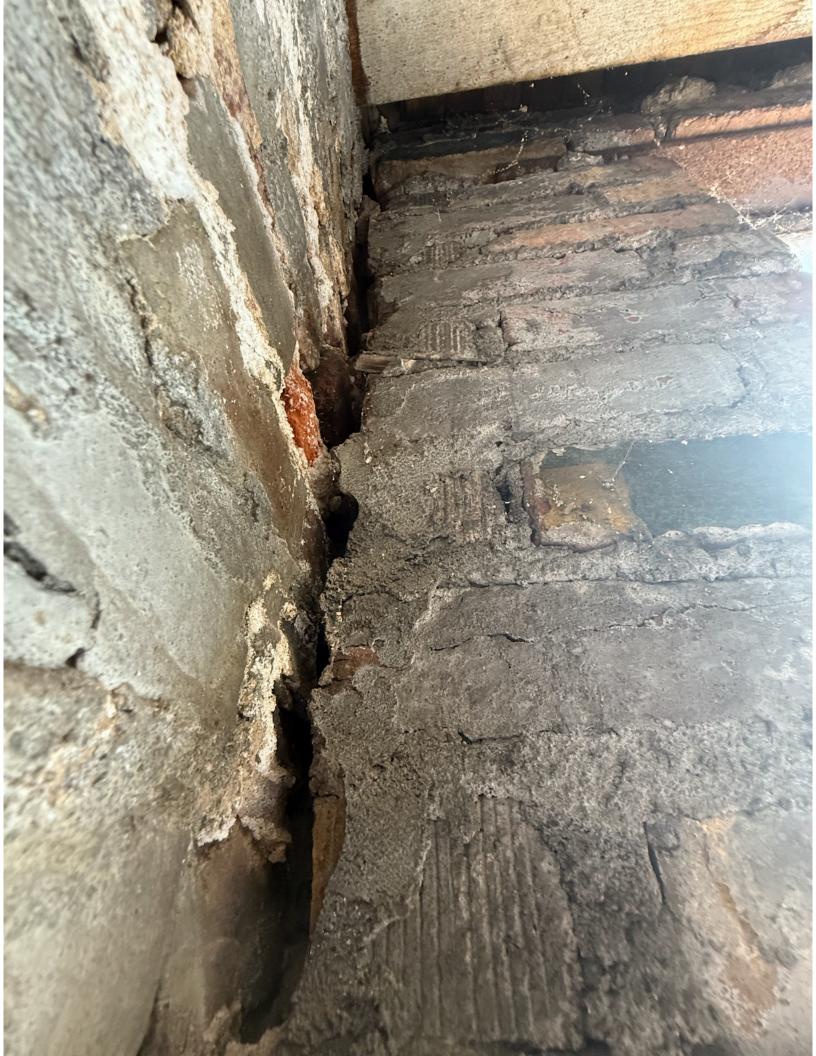
Photo 4 – front wall is bowing out and masonry is deteriorated

- The existing building is a three-story masonry and timber structure built approximately 100 years ago.
- Based on pictures of the front wall circa 1915, the existing wall was built after.
- The wall does not appear to be structurally attached to the existing building.
- The front wall is separating from the building as can be seen by cracks at the roof level.
- The masonry wall is bulging excessively and the 2^{nd} and 3^{rd} floor levels.
- The masonry mortar joints are showing signs of moisture rot and are not structurally adequate.
